# Türkiye Earthquake

## **RECONNAISSANCE REPORT**

February 6, 2023 Kahramanmaraş-Pazarcık ( $M_w$ =7.7) and

Elbistan (M<sub>w</sub>=7.6) Earthquakes

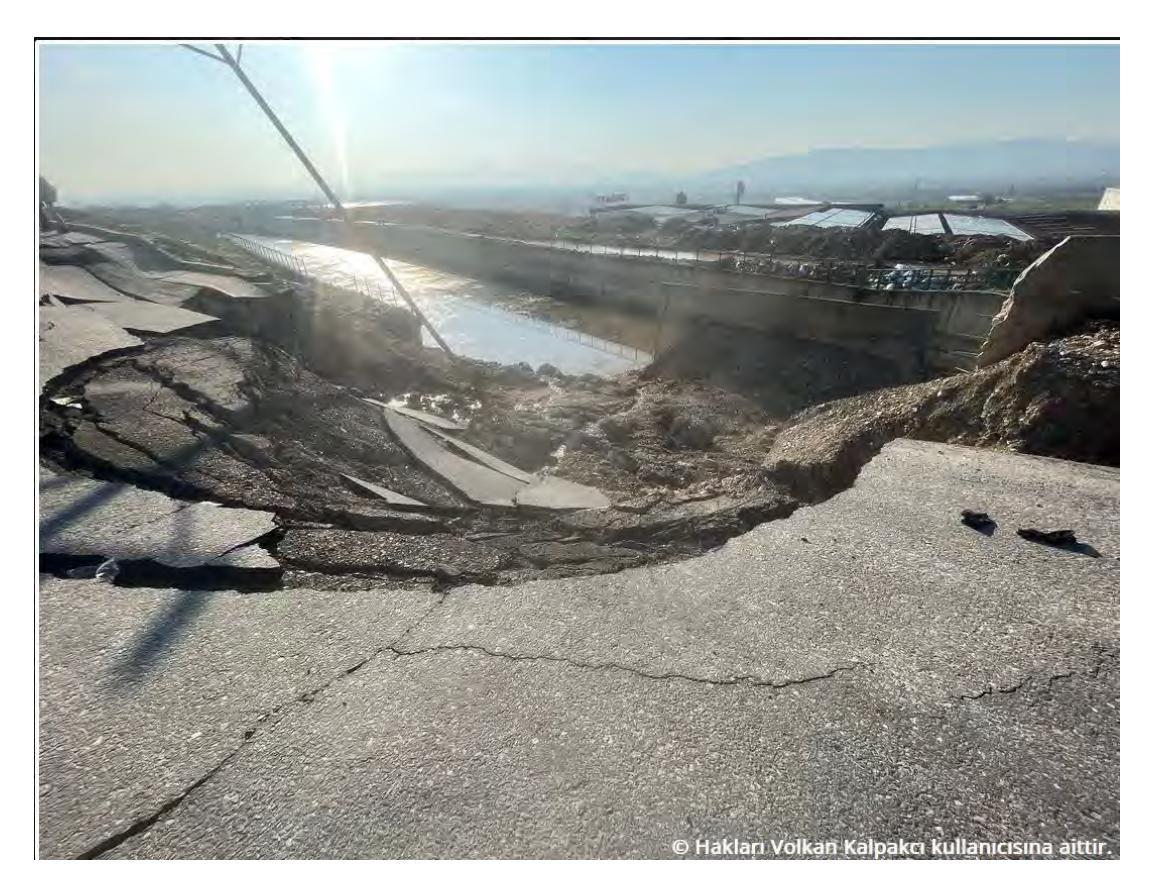
**Figure 5.5.** Liquefaction-induced slope instability of a retaining wall by State Hydraulic Works Canal in Kahramanmaraş city center photo by Dr. Volkan Kalpakçı

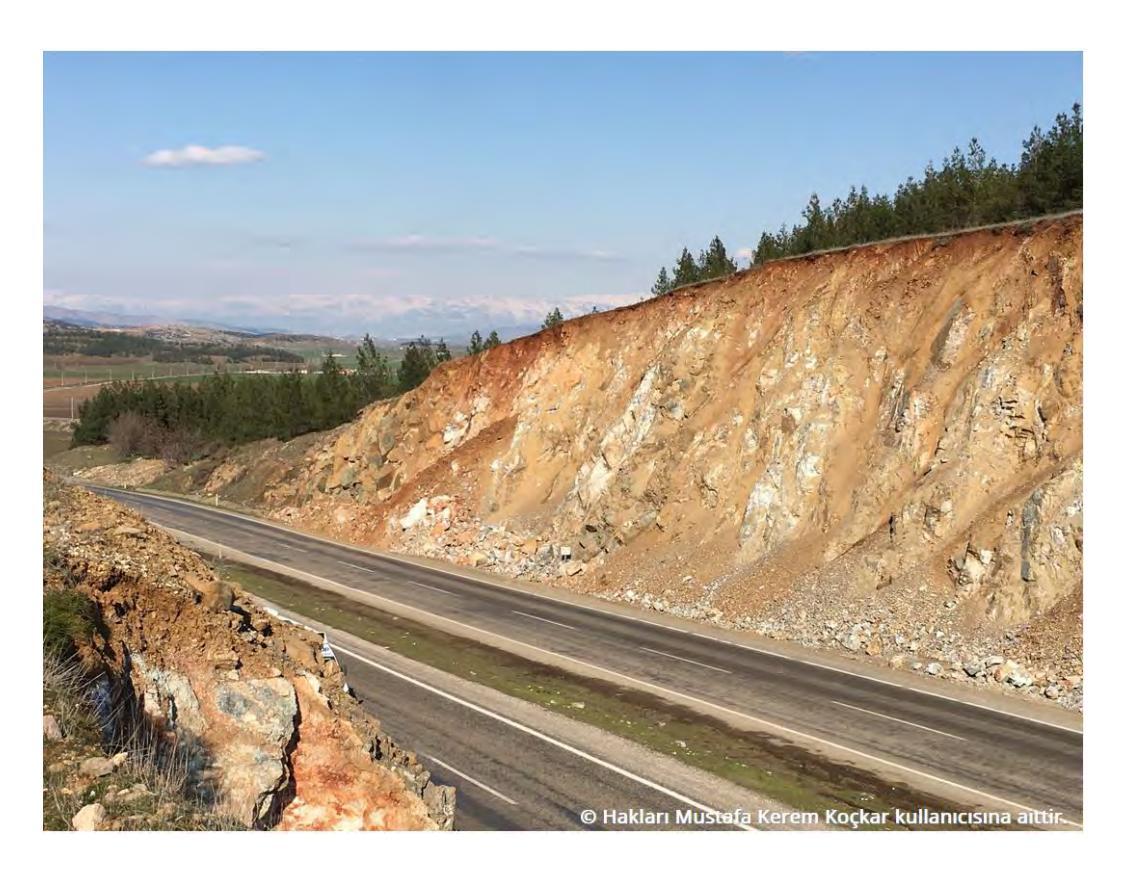
Figure 5.37. Rock debris flows in Nurdağı

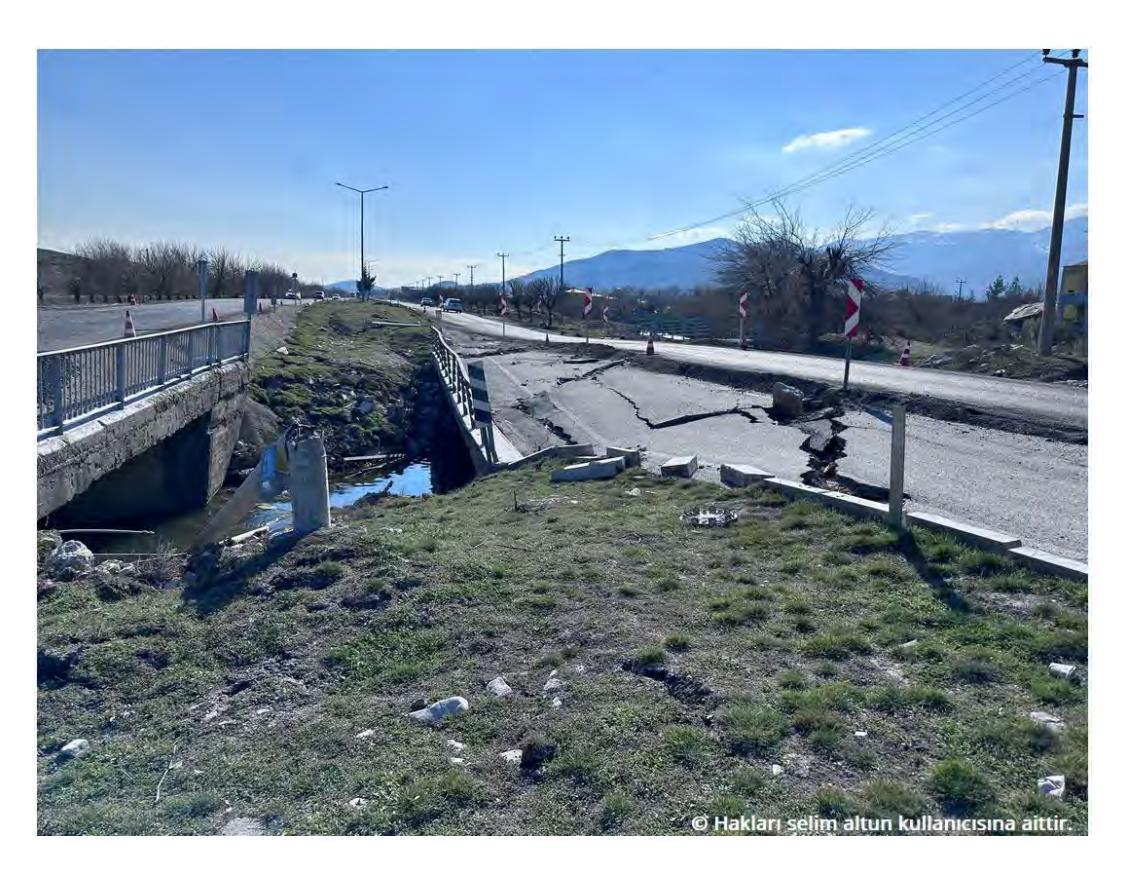
Figure 5.39. Bridge failure on the highway between Nurdağı and Turkoğlu

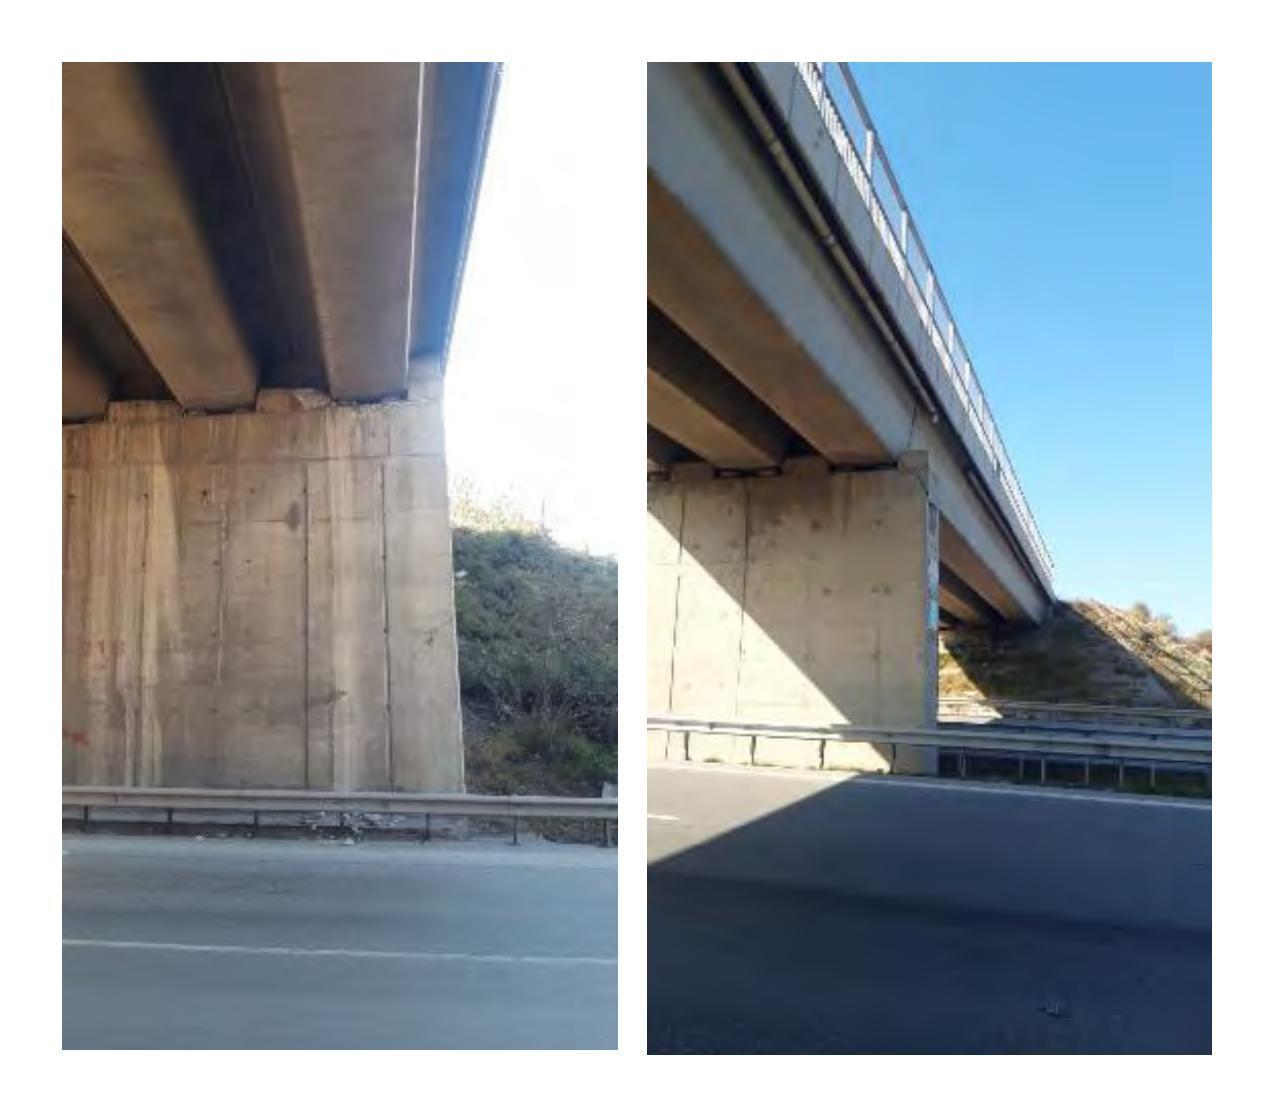
**Figure 5.95.** Damaged seismic shear keys beneath the viaduct deck at Çankaya-Belen intresection (36.54796°N, 36.15087°E, Photo by: Pelin Özener)

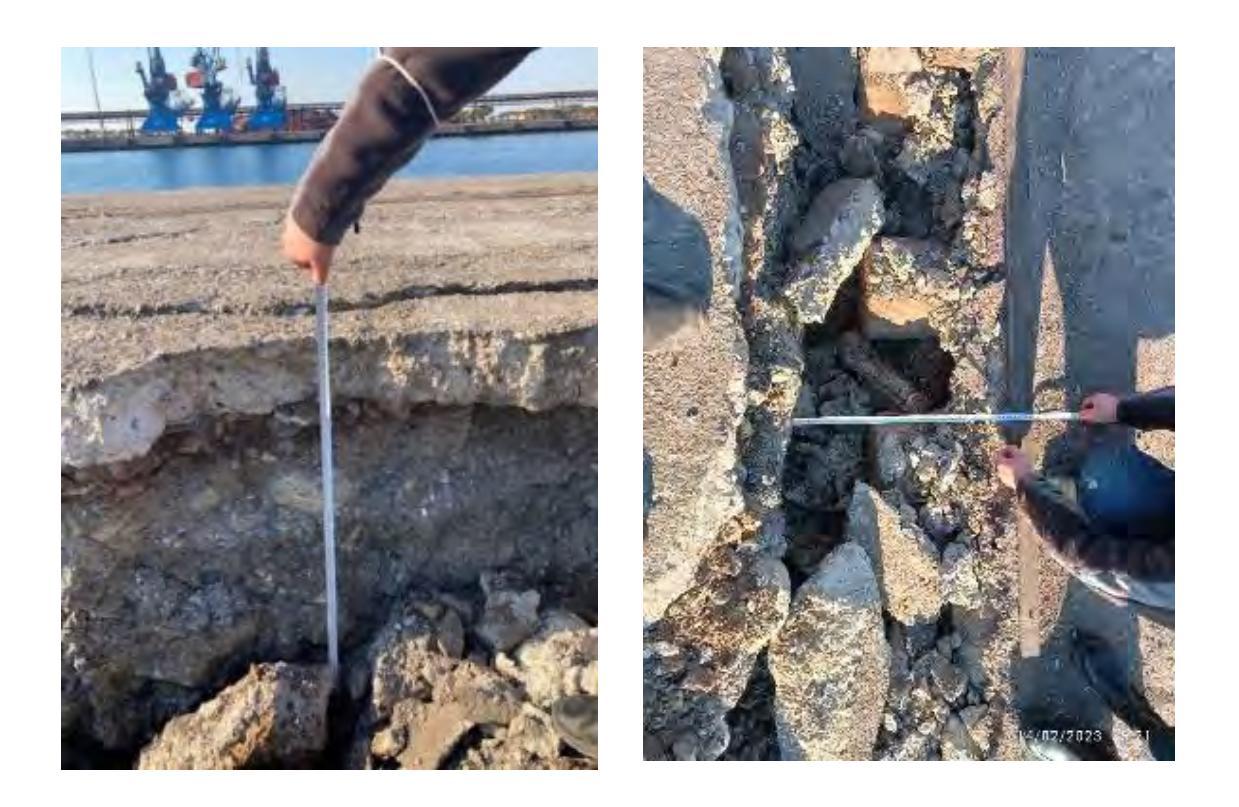
**Figure 5.100.** Vertical and Lateral displacements occurred in block type gravity quay wall (36.73011°N, 36.19681°E, Photo by: Pelin Özener, M. Murat Monkul)

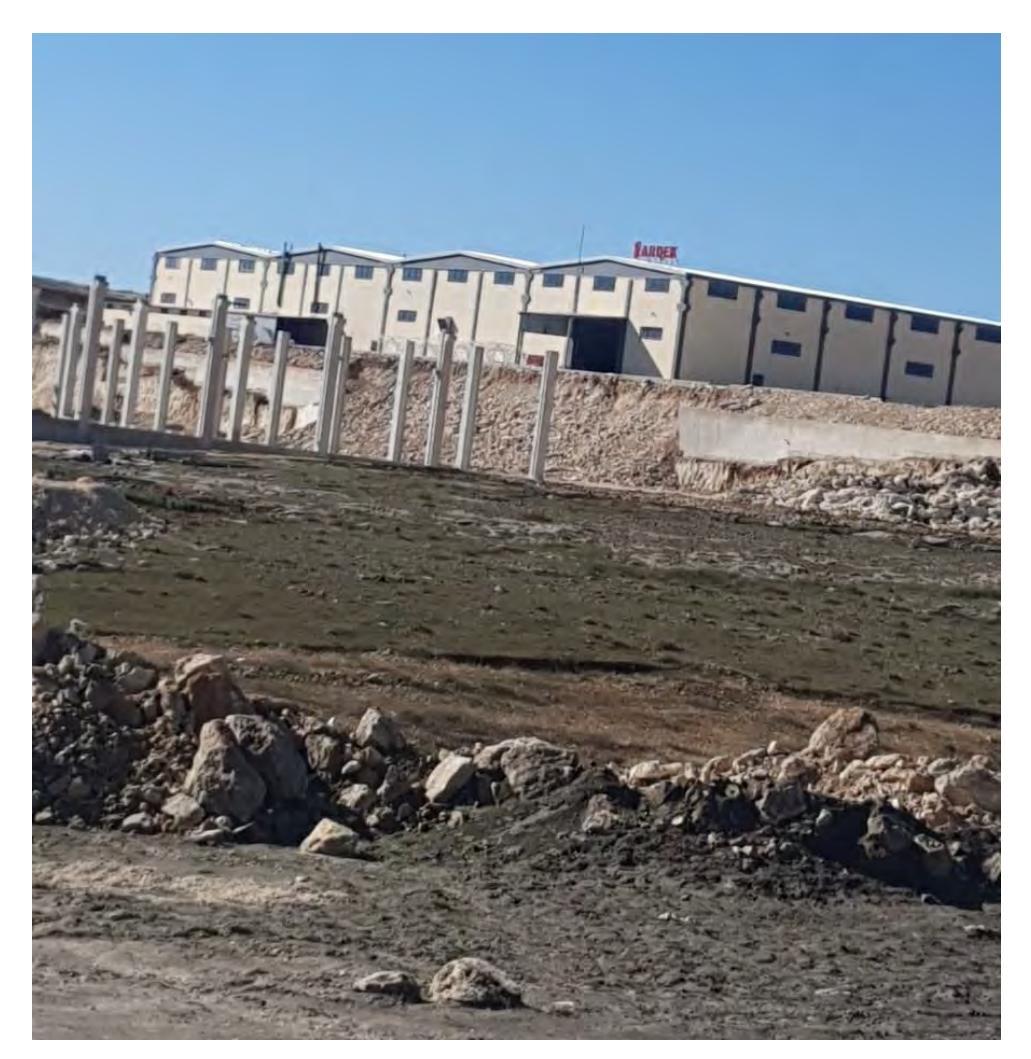
Figure 5.115. A collapsed retaining wall in organized industrial zone of Eyyübiye

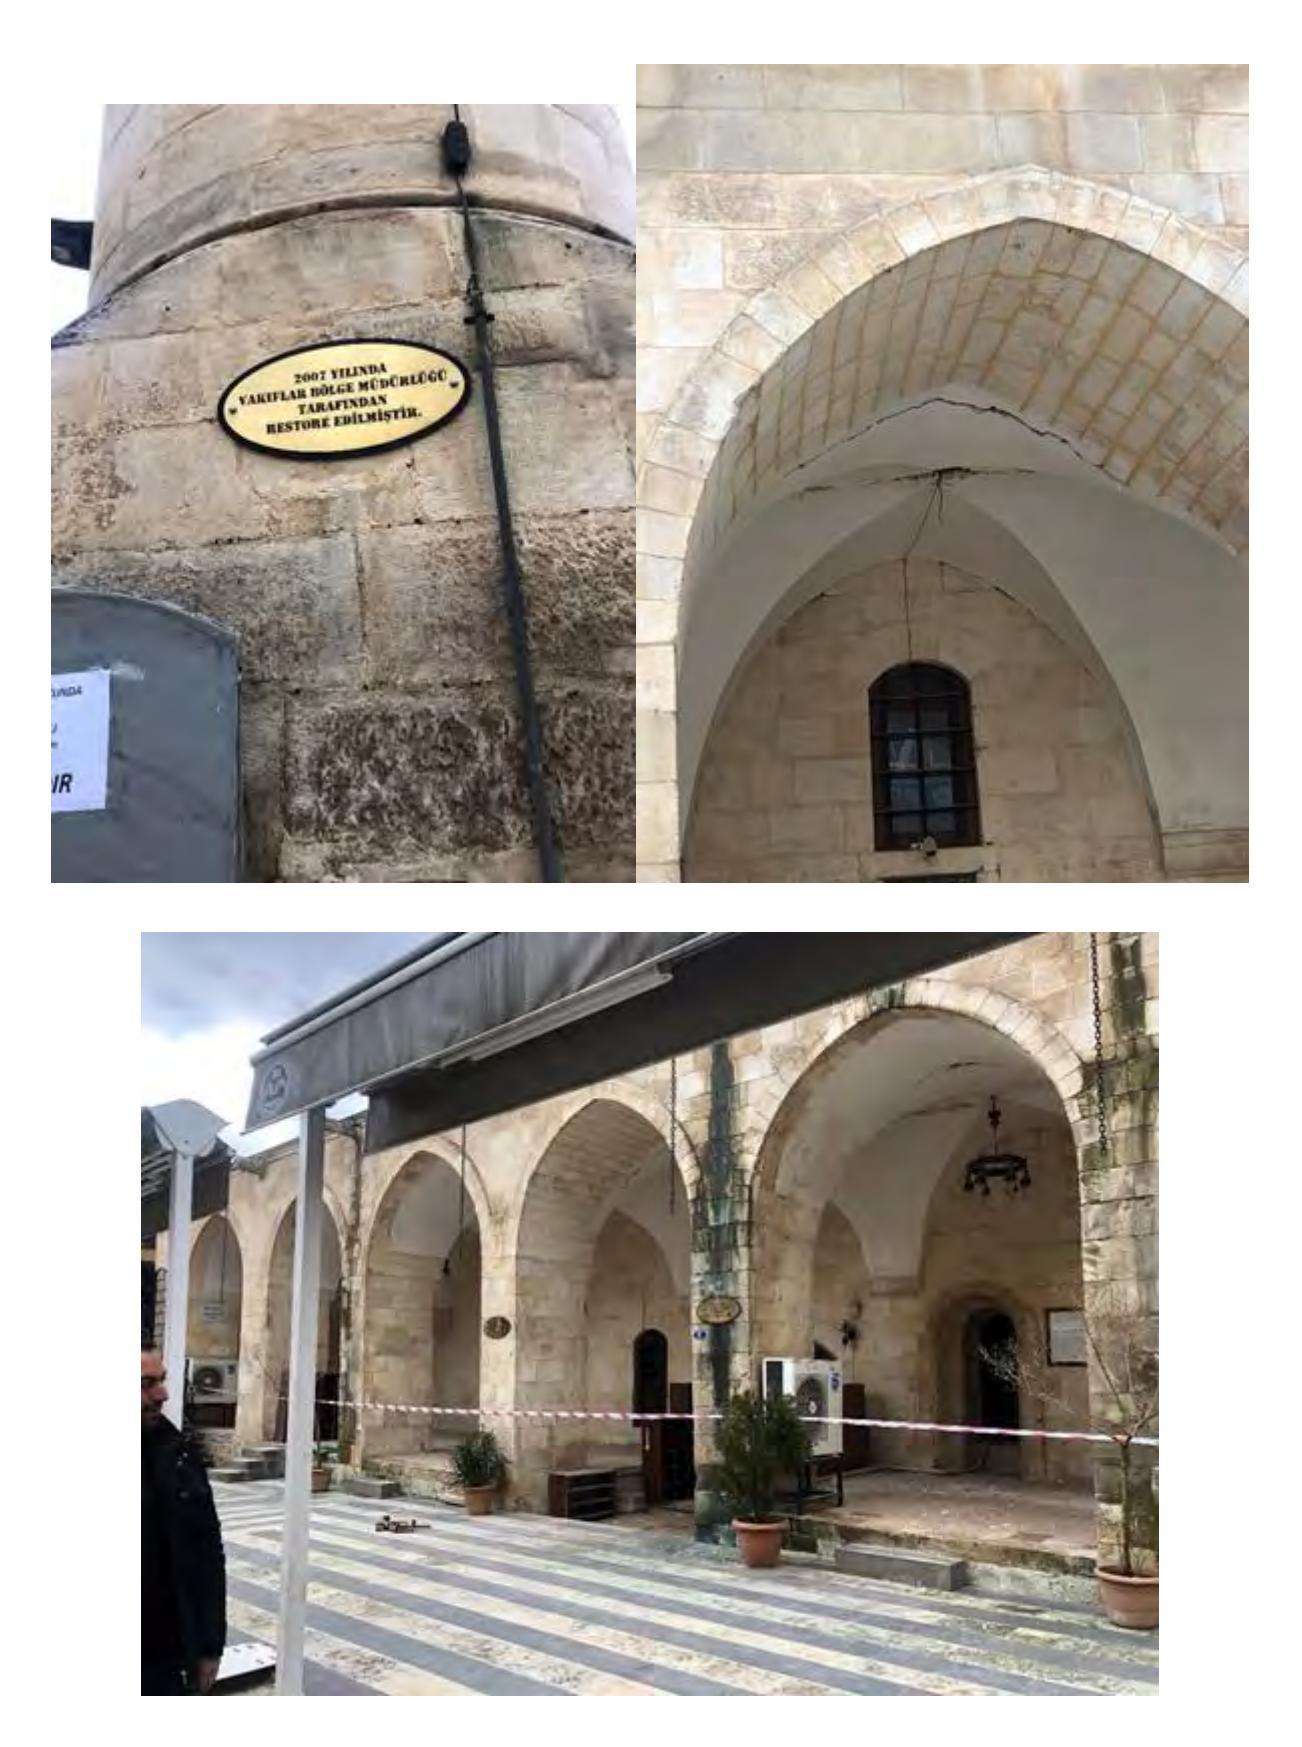
**Figure 5.116.** Karakadı Mosque (heavily damaged) Photo by Assist. Prof. Dr. Eyyüb Karakan and Prof. Dr. Alper SEZER

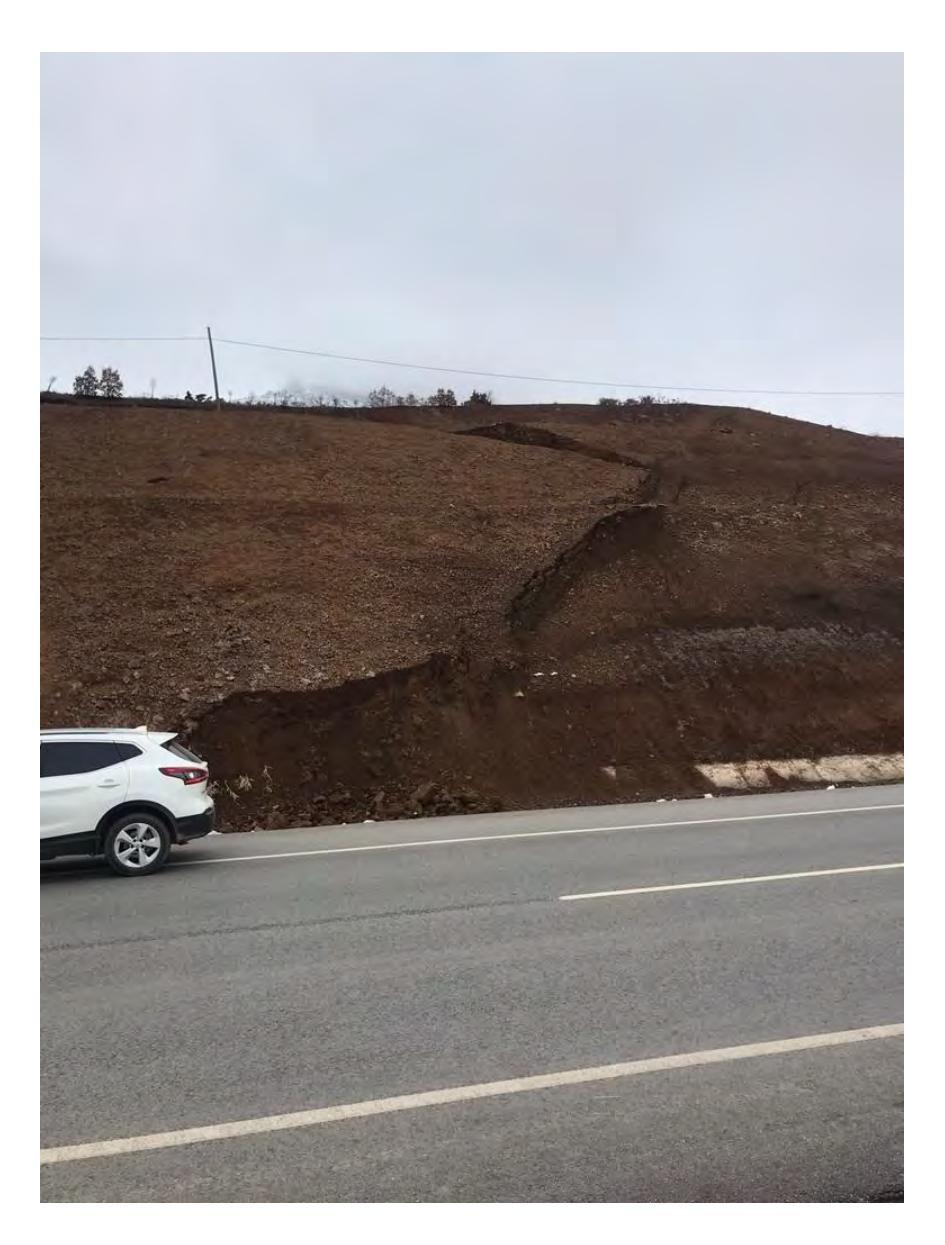
Figure 5.138. Planar sliding mass on the roadside (hekimhan-sivas Road)

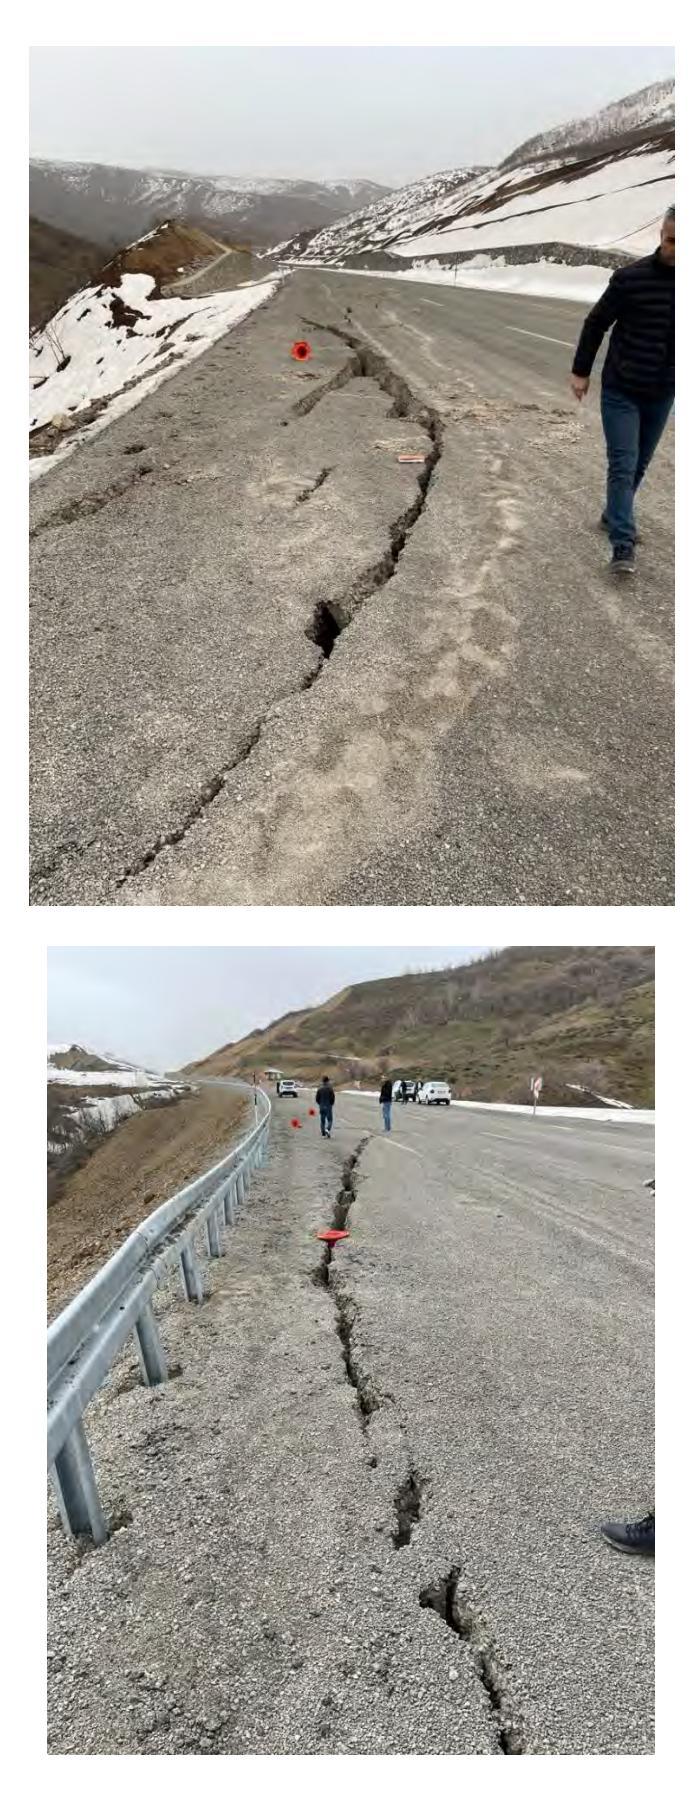
Figure 5.143. Earthquake-induced tension cracks in the road fill zone (bingol-elazig road junction)

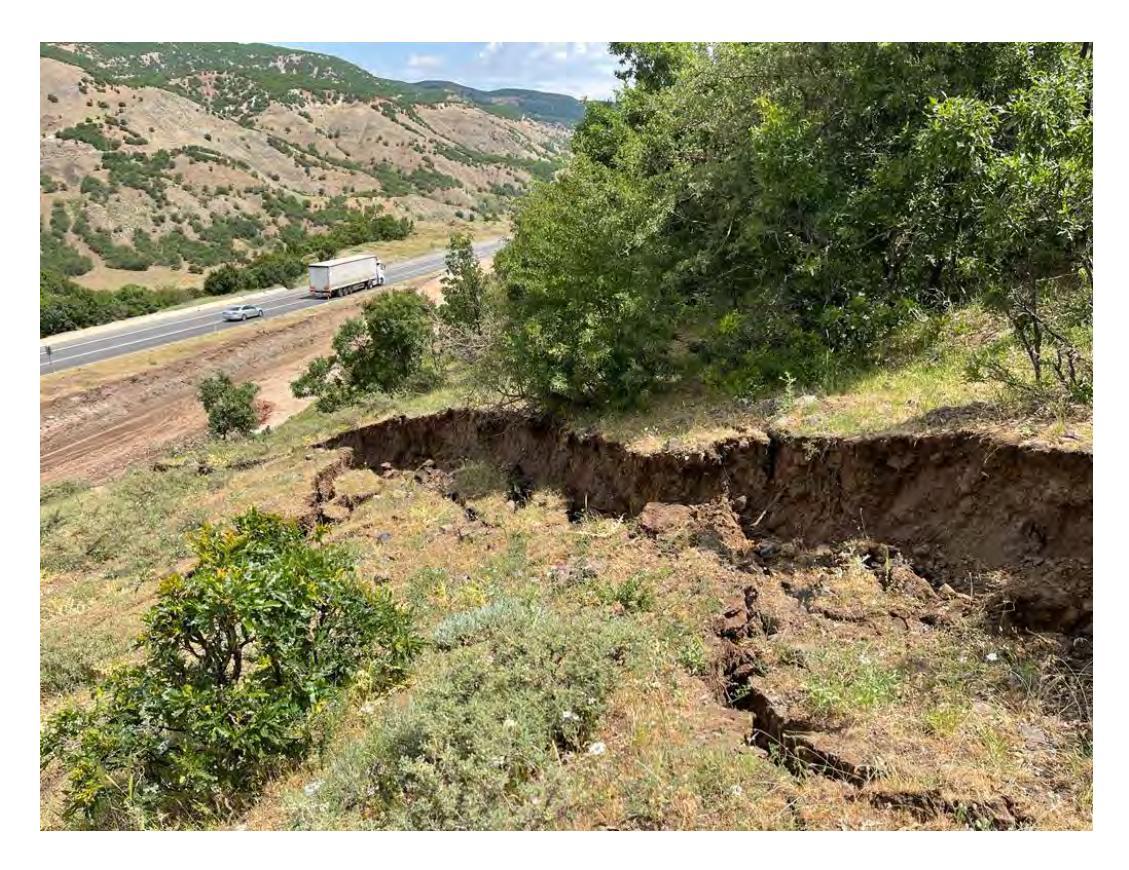
Figure 5.148. Landslide induced by earthquake (Bingöl-Karlıova road)

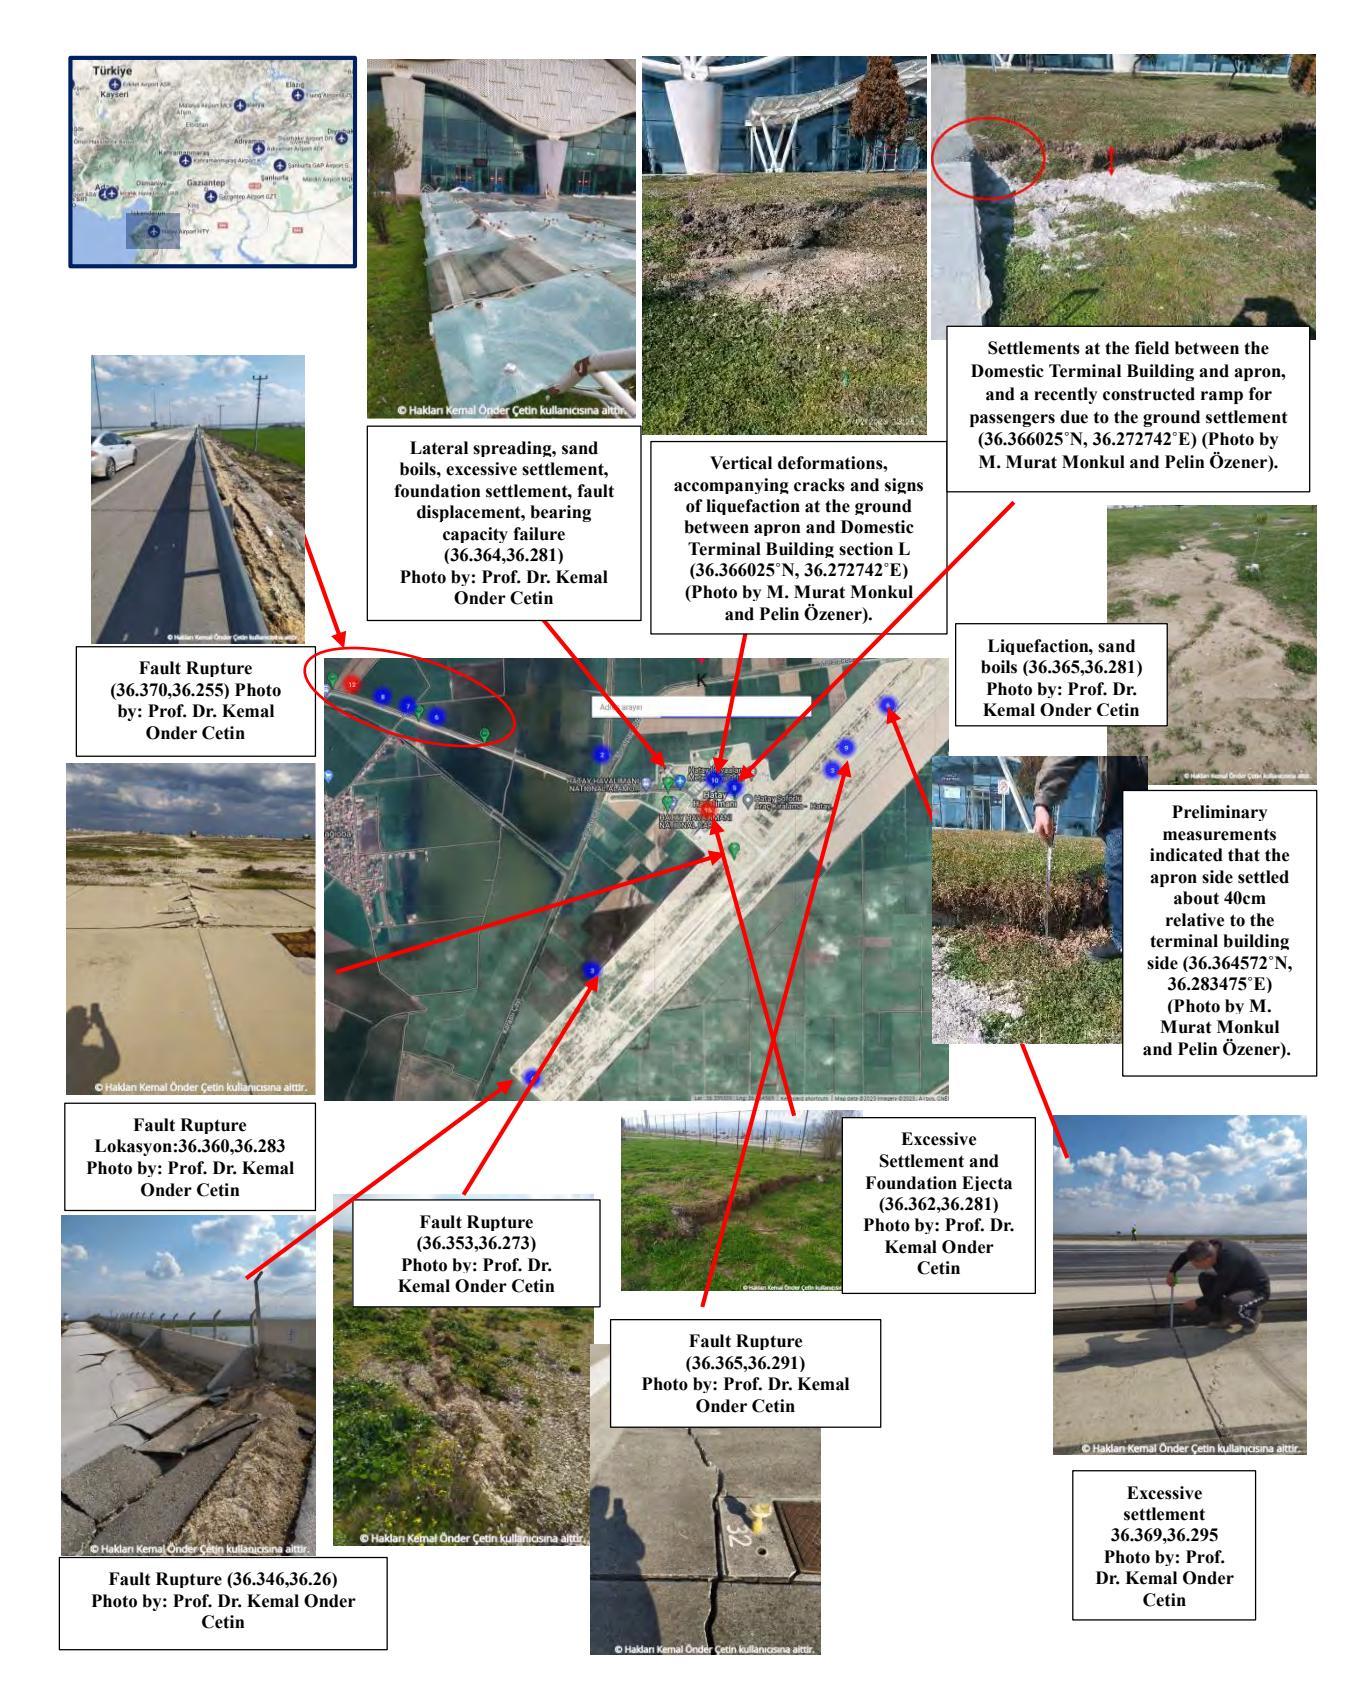
Figure 5.164. Hatay Airport ground deformation and liquefaction features

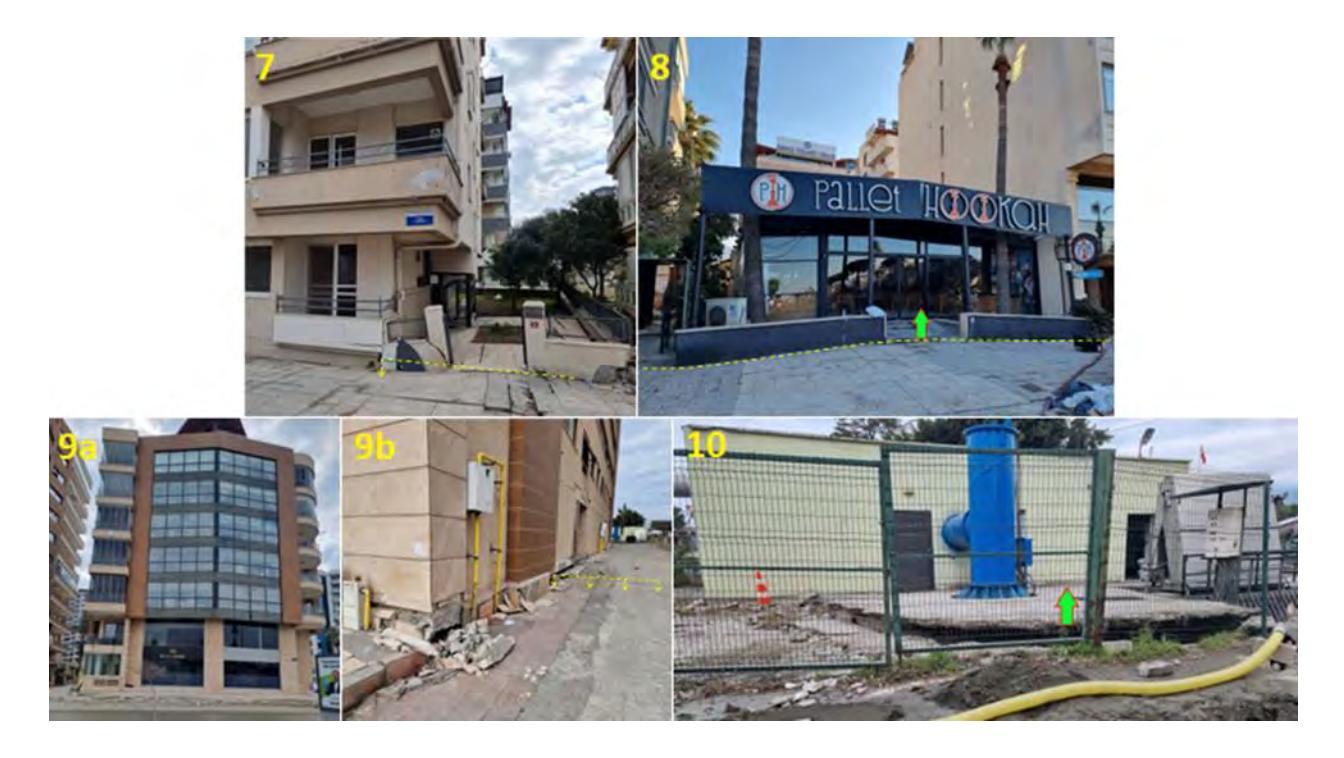
**Figure 5.193.** Structural deformations because of soil liquefaction on Bahçeli Sahil Evler Street (captioned by Ertan Bol, 7: 36.590859 - 36.178742; 8: 36.590709 - 36.177793; 9a and b: 36.590761 - 36.175848)

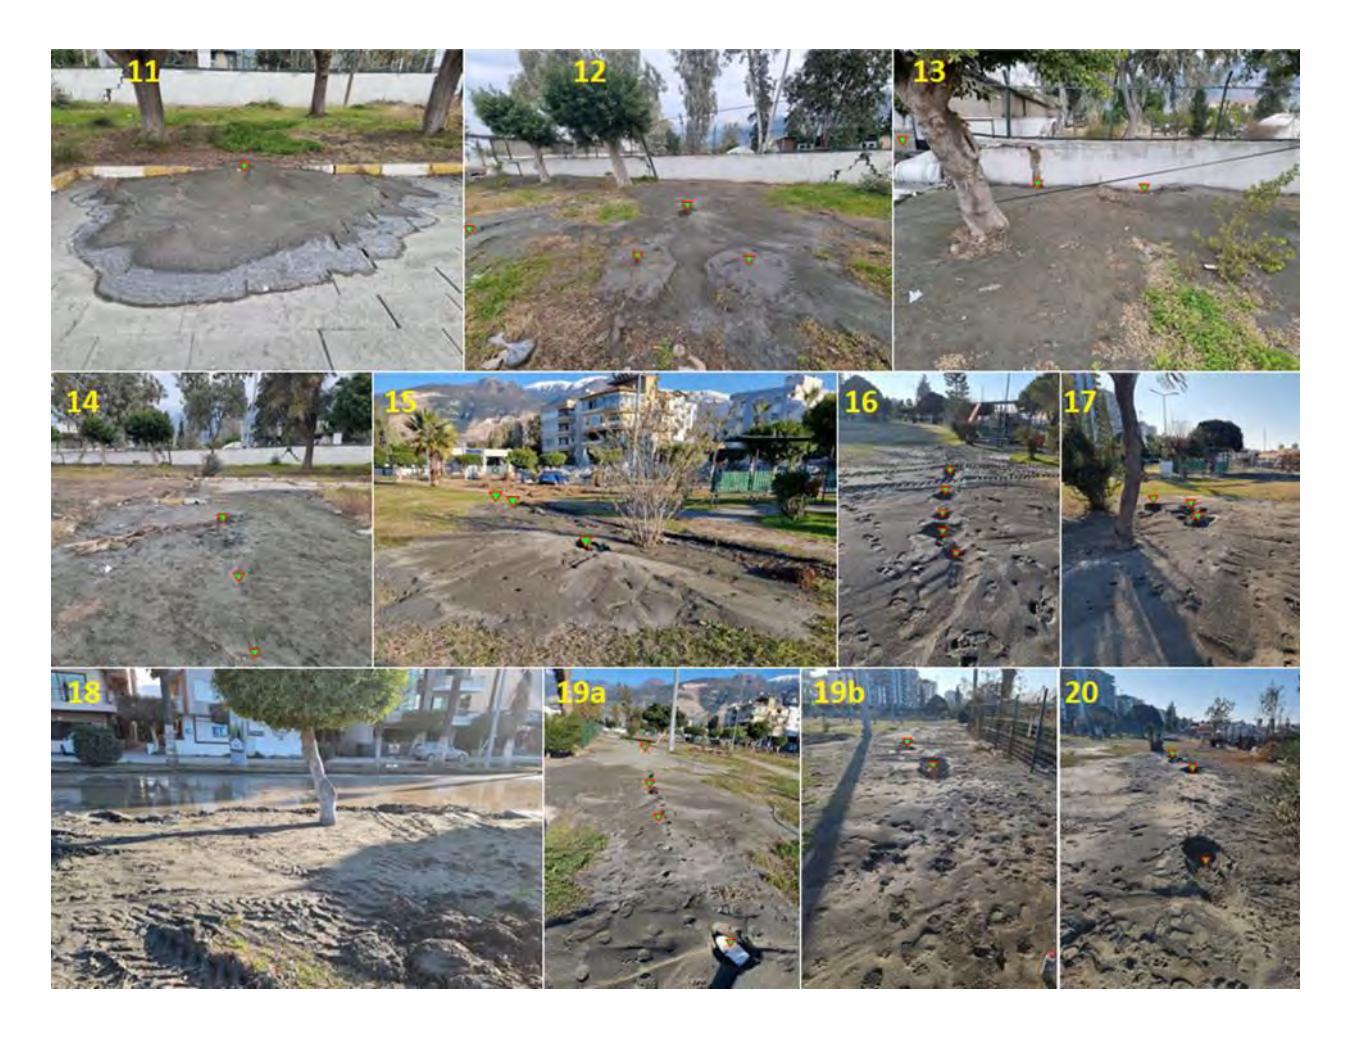
**Figure 5.194.** Sand ejecta points of the liquefied area in the coastal park on Bahçeli Sahil Evler Street (captioned by Ertan Bol, 11: 36.591343 - 36.179531; 12: 36.591416 - 36.179457; 13: 36.591636 - 36.179500; 14: 36.591423 - 36.179390; 15: 36.591334 - 36.178781; 16: 36.591130 - 36. 178106; 17: 36.591326 - 36.178147; 18: 36.590959 - 36.178157; 19a: 36.591289 - 36.178264; 19b: 36.591386- 36.178672; 20: 36.591386 - 36.177916)

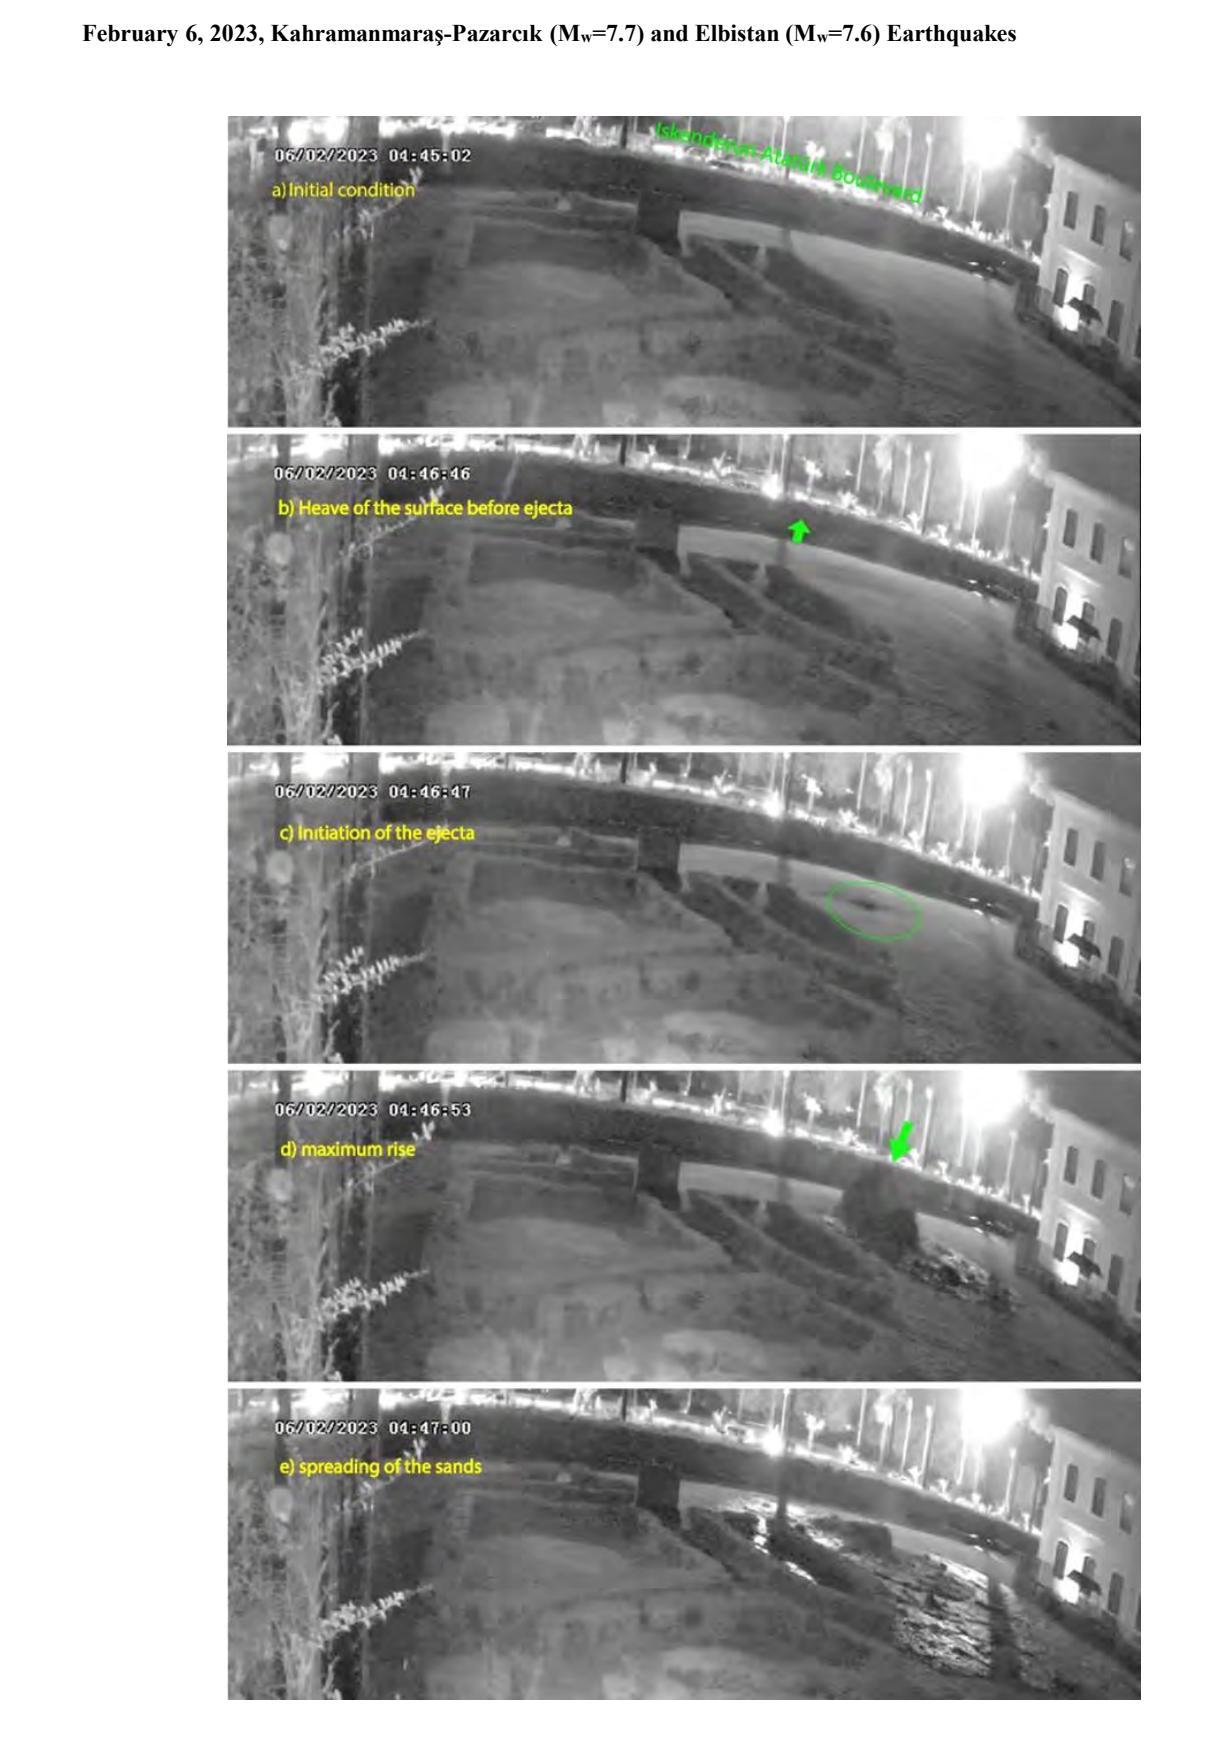
**Figure 5.198.** Sand ejecta video pictures of the liquefied area in the Atatürk Boulevard, Iskenderun, Hatay (The region in Figure 5.197, Pic. 22: 36.593954 - 36.161100)

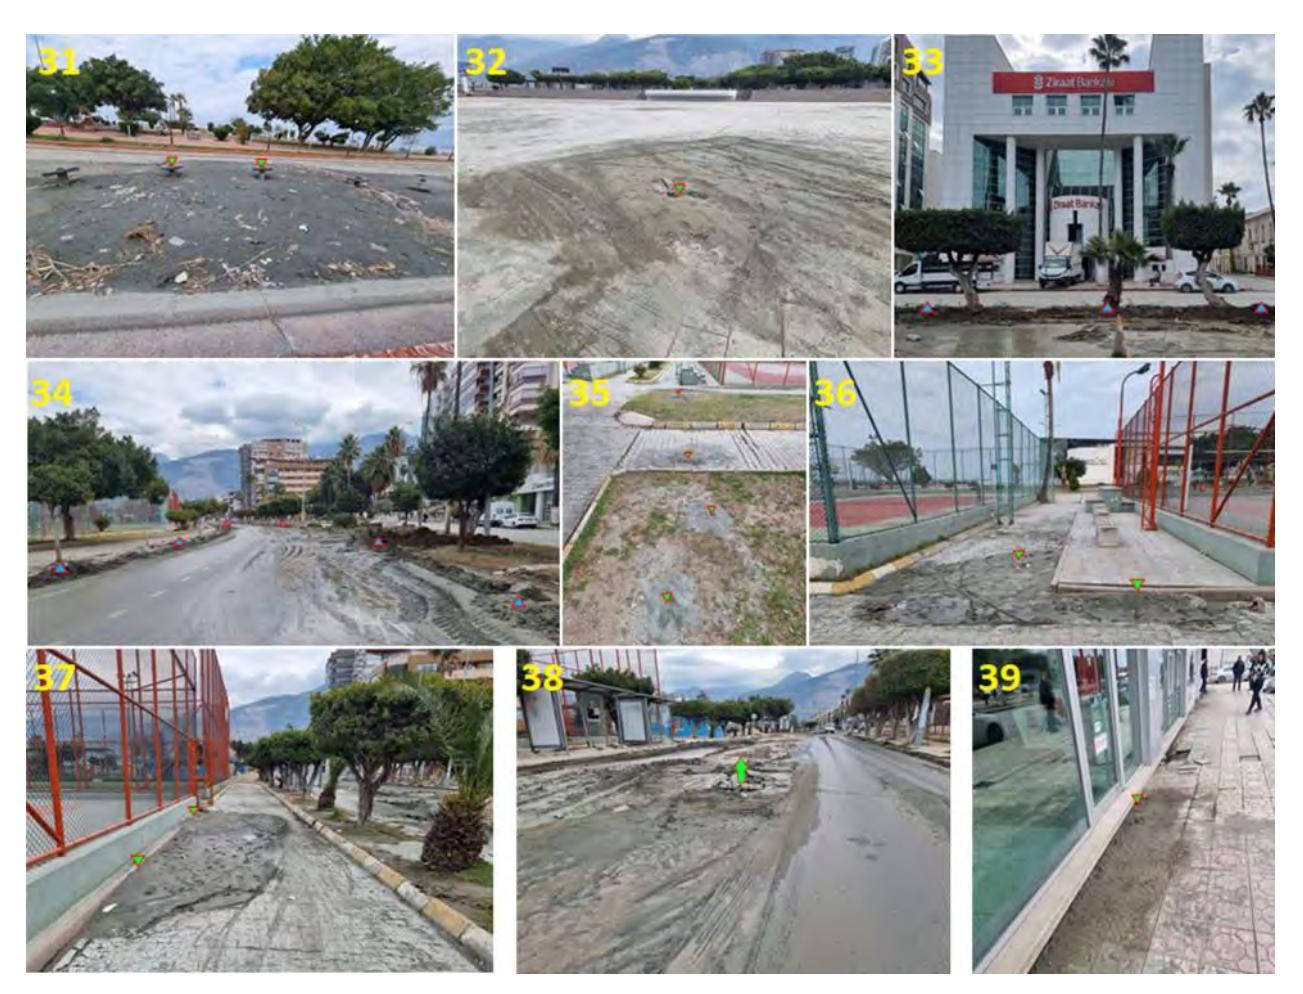
**Figure 5.200.** Sand ejecta points of the liquefied areas in the coastal park on west part of the Atatürk Boulevard, Iskenderun, Hatay (captioned by Ertan Bol, 31: 36.592195 - 36.170998; 32: 36.591758 - 36.172110; 33: 36.590815 - 36.173540; 34: 36.590613 - 36.173995; 35: 36.591123 - 36.173782; 36: 36.590755 - 36.174565; 37: 36.590755 - 36.174565; 38: 36.590692 - 36.175006; 39: 36.590492 - 36.173901)

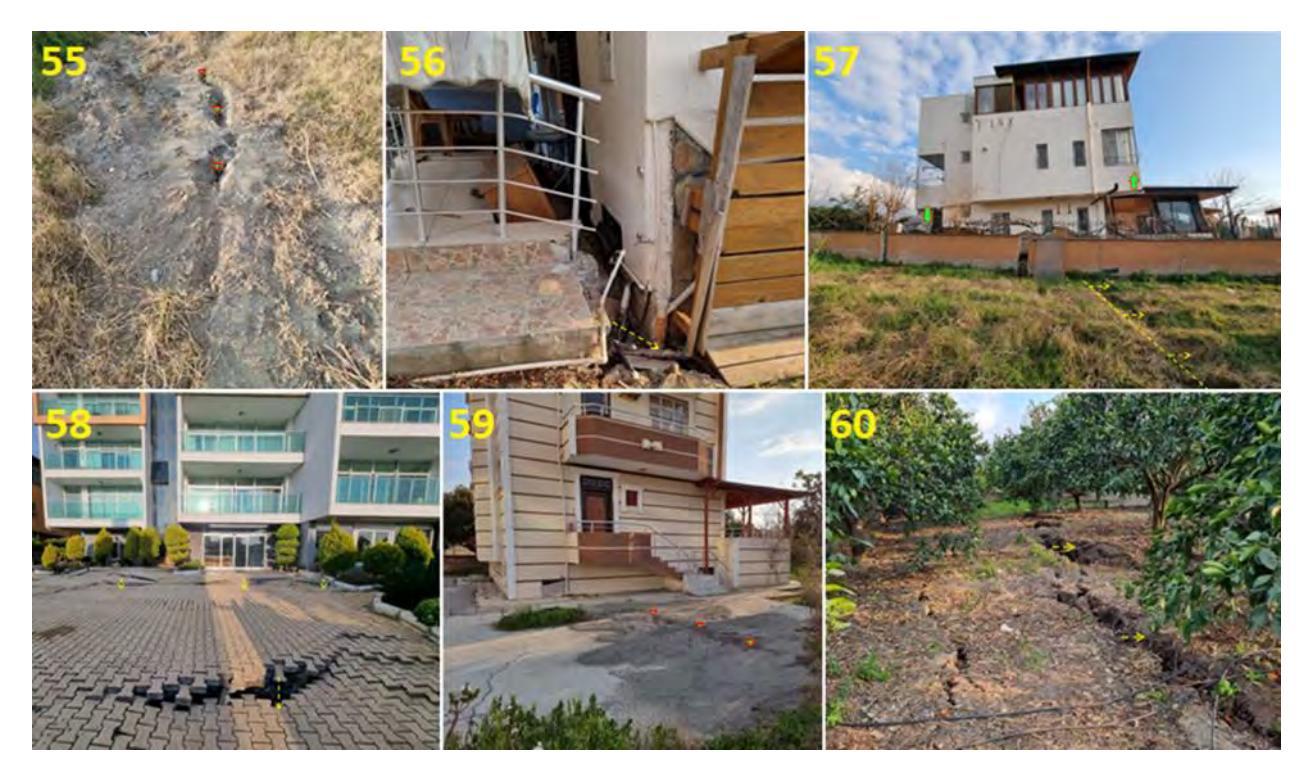
**Figure 5.207.** Lateral spreading sites of Dörtyol, Hatay (North Part) (captioned by Ertan Bol, 55: 36.821664 - 36.178360; 56: 36.821689 - 36.178636; 57: 36.821738 - 36.178602; 58: 36.821353 - 36.178545; 59: 36.821392 - 36.178267; 60: 36.821153 - 36.178988)
