# Türkiye Earthquake

## **RECONNAISSANCE REPORT**

February 6, 2023 Kahramanmaraş-Pazarcık ( $M_w$ =7.7) and

Elbistan (M<sub>w</sub>=7.6) Earthquakes

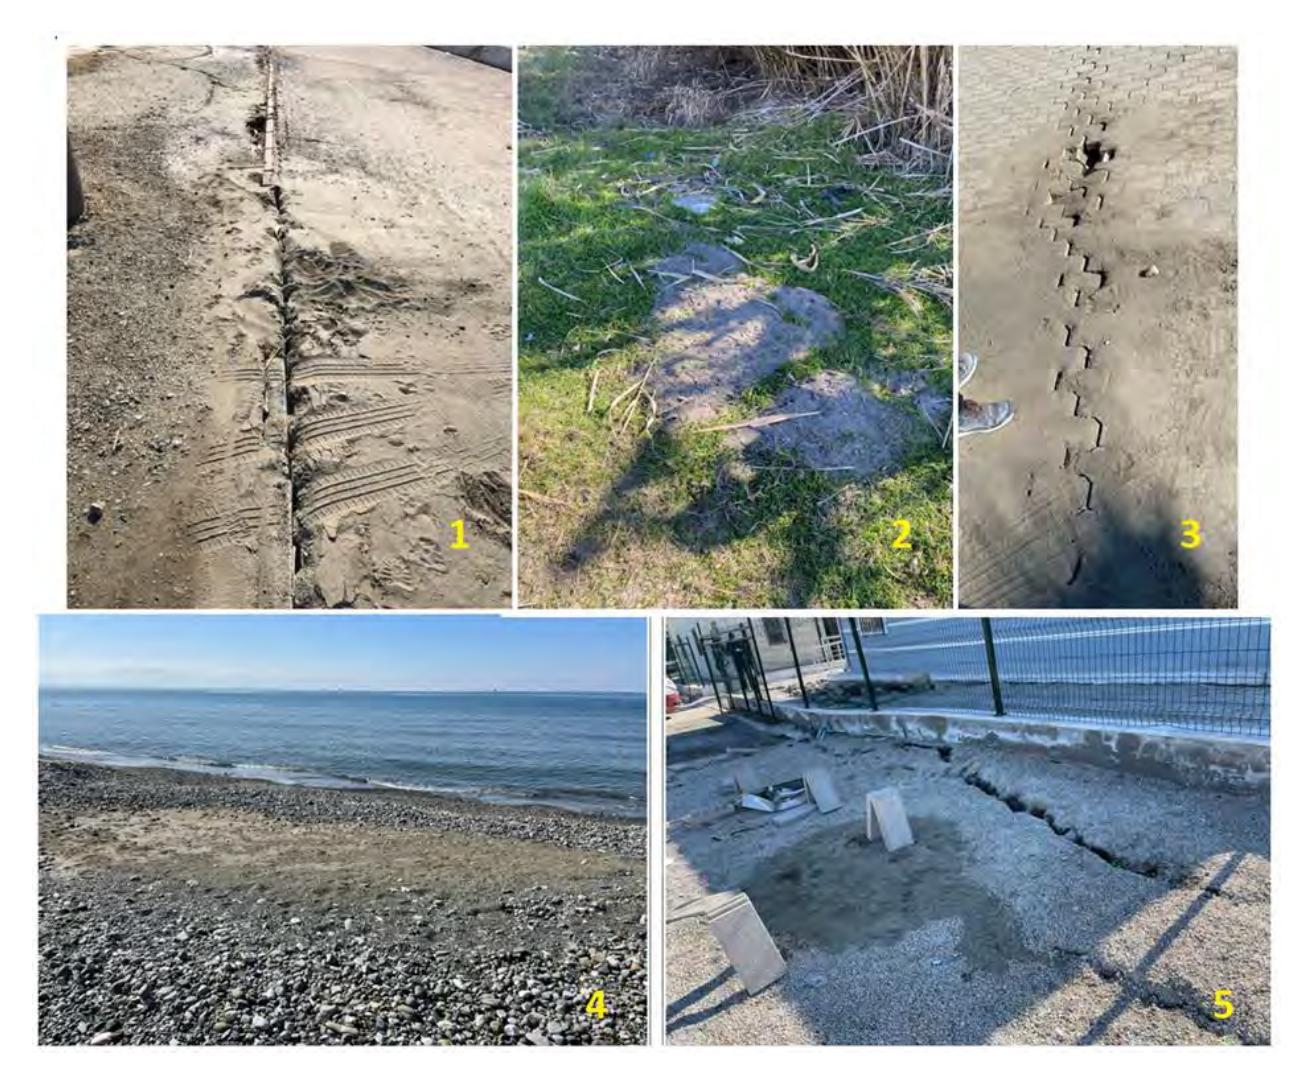
**Figure 5.214.** Sand ejecta and cracks near Hatay Dörtyol beach (captioned by Kemal Önder Çetin 1: 36.81589167°N, 36.1845972°E; 2: 36.81283056°N ,36.1818194°E; 3: 36.812789°N, 36.1814583°E; 4: 36.8183278°N, 36.177867°E; 5: 36.82108056°N, 36.17467°E)

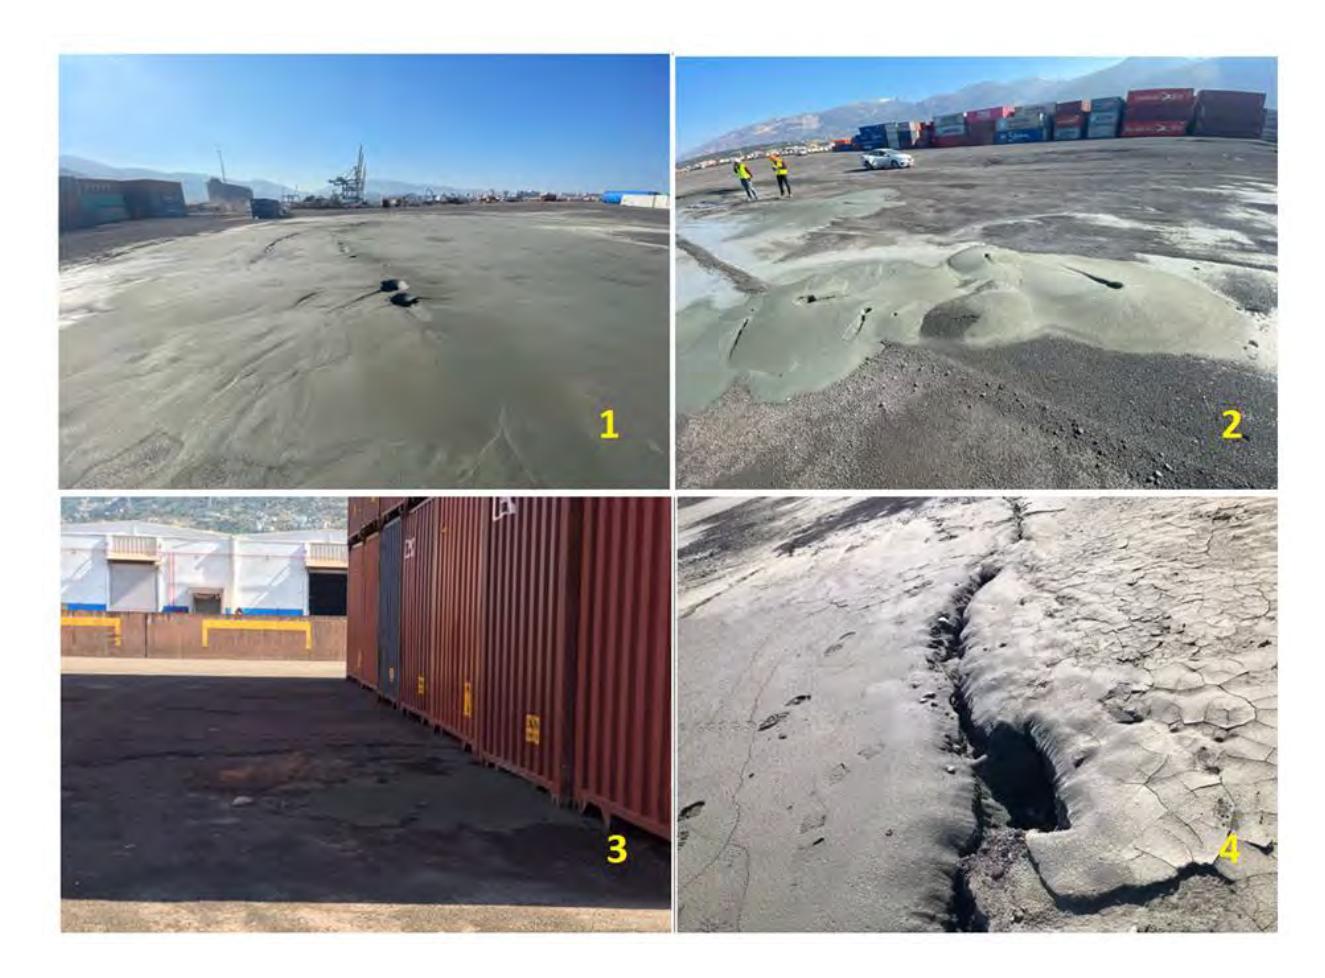
**Figure 5.216.** Areas with liquefaction induced sand ejecta in İskenderun Port Region (captioned by 1: SahaGözü Team, 36.60231389°N, 36.1928°E; 2: SahaGözü Team, 36.604289°N, 36.192972°E; 3: Kemal Önder Çetin, 36.6033278°N, 36.194472°E; 4: Kemal Önder Çetin, 36.60402°N, 36.1921083°E

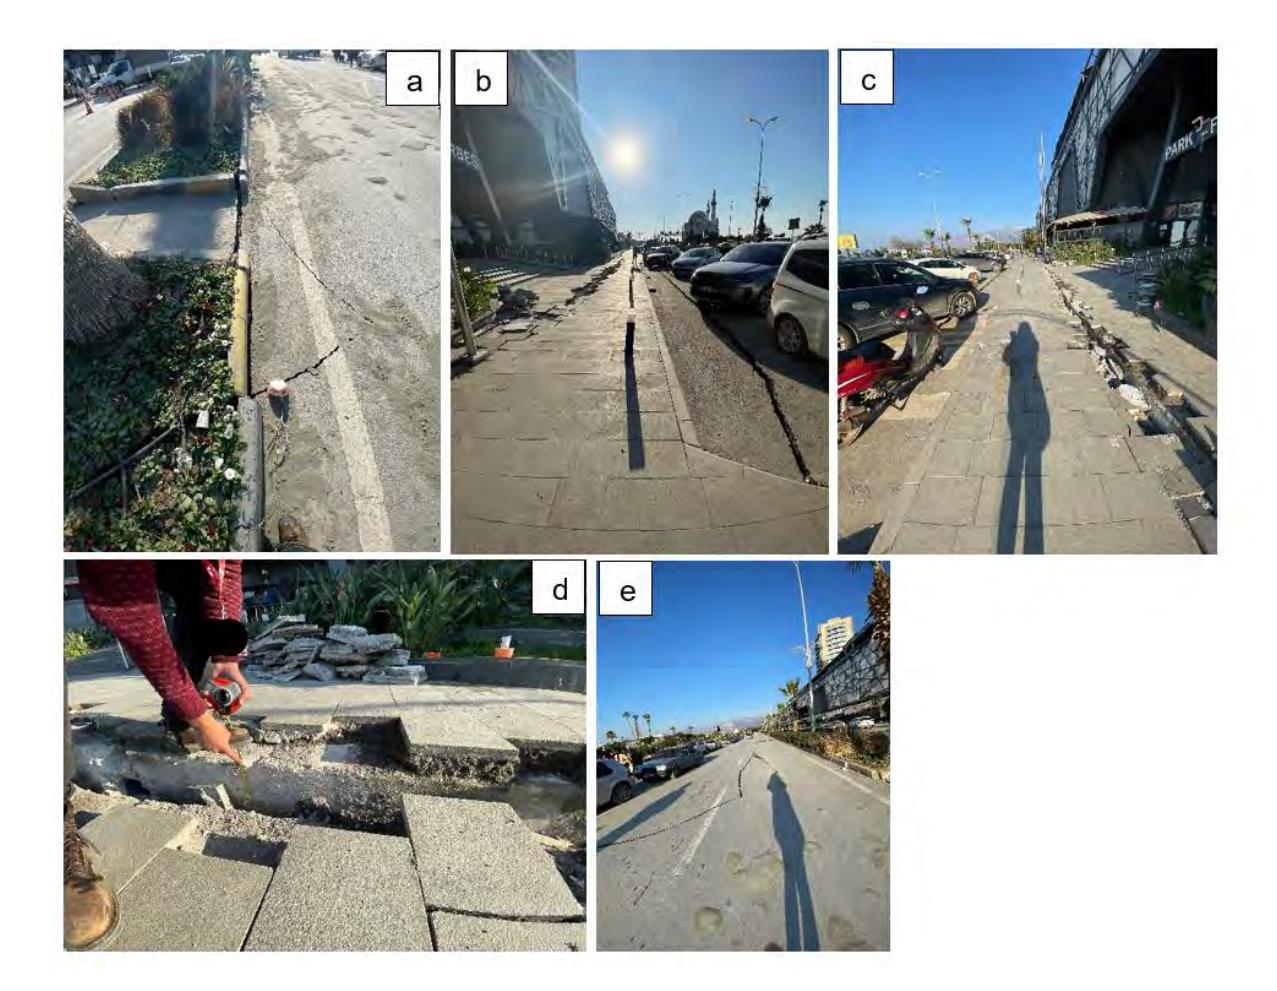
**Figure 5.218.** Liquefaction manifestations on Ataturk Boulevard near Forbes Shopping Center (~ 36°35'36.52"N/ 36° 9'34.67"E): a) sand boils on Ataturk Boulevard; b) cracks formed due to lateral deformation; c) cracks formed due to lateral deformation; d) liquefaction induced settlements; e) cracks formed due to lateral deformation. Photo by Ozgun Numanoglu, Tugce Baser, *and* Serhat Erinmez

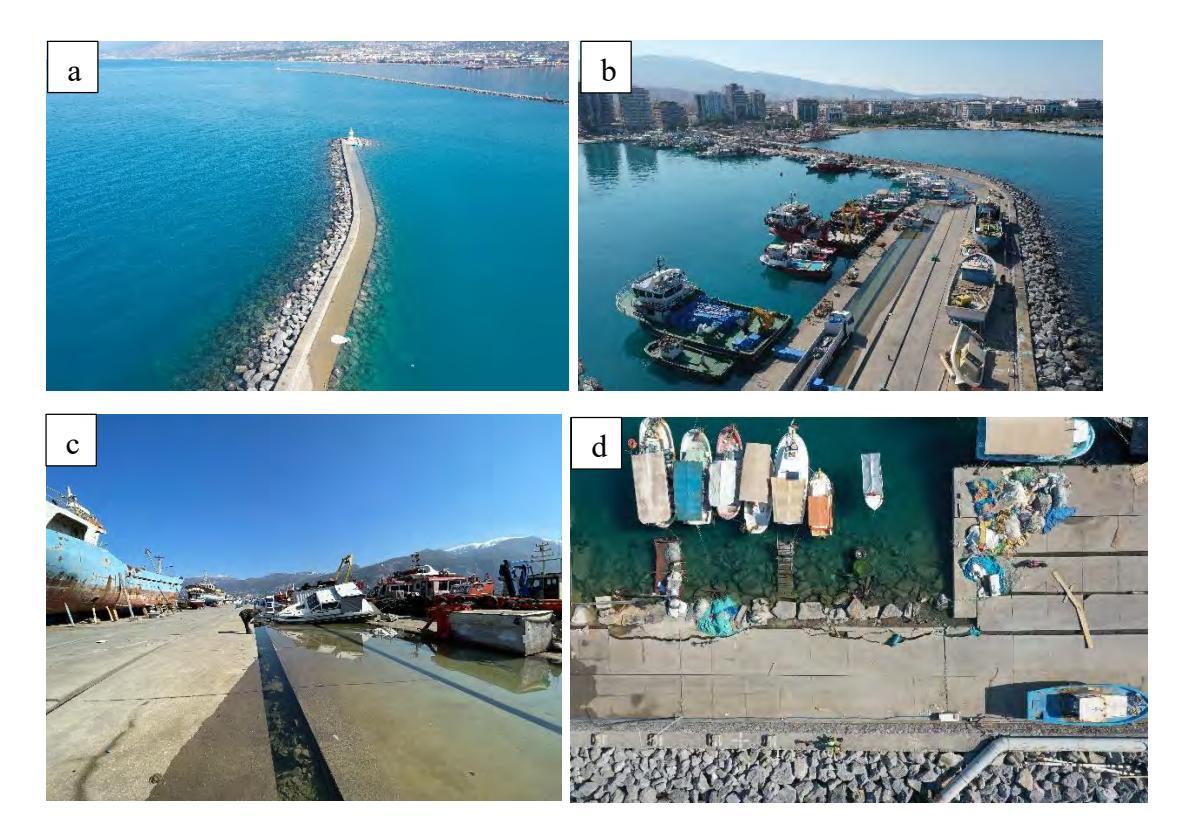
**Figure 5.223.** Ground Settlements and Lateral Deformations on Iskenderun Dock ( $\sim$  36°35'40.67"N/ 36° 10'38.69"E): a) Ground subsidence at the pier and the lighthouse; b) Ground subsidence at the dock; c) Ground subsidence and lateral deformations of the concrete panels; d) lateral deformations and cracks on the concrete panel Photo by Ozgun Numanoglu, Tugce Baser, and Serhat Erinmez

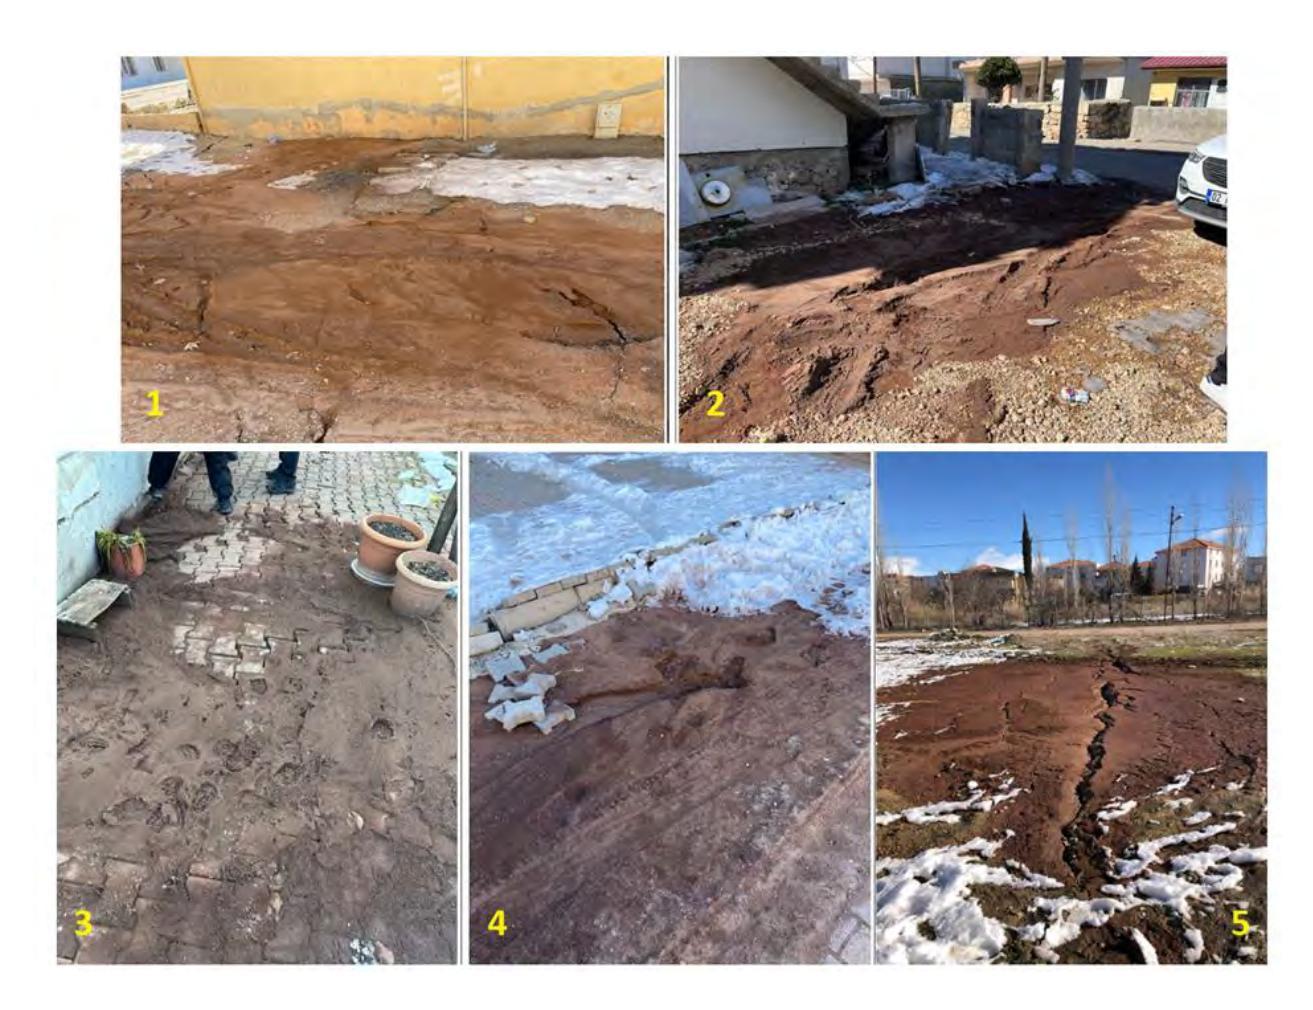
**Figure 5.224.** Liquefaction induced sand ejecta in Adıyaman Gölbaşı region (captioned by 1: Kemal Önder Çetin 37.7840417°N, 37.63517°E; 2: Kemal Önder Çetin 37.7865194°N, 37.630925°E; 3: Ayhan Gürbüz 37.7862917°N, 37.631728°E; 4: Kemal Önder Çetin 37.7877694°N, 37.642589°E; 5: Kemal Önder Çetin 37.78166°N, 37.62913056°E)

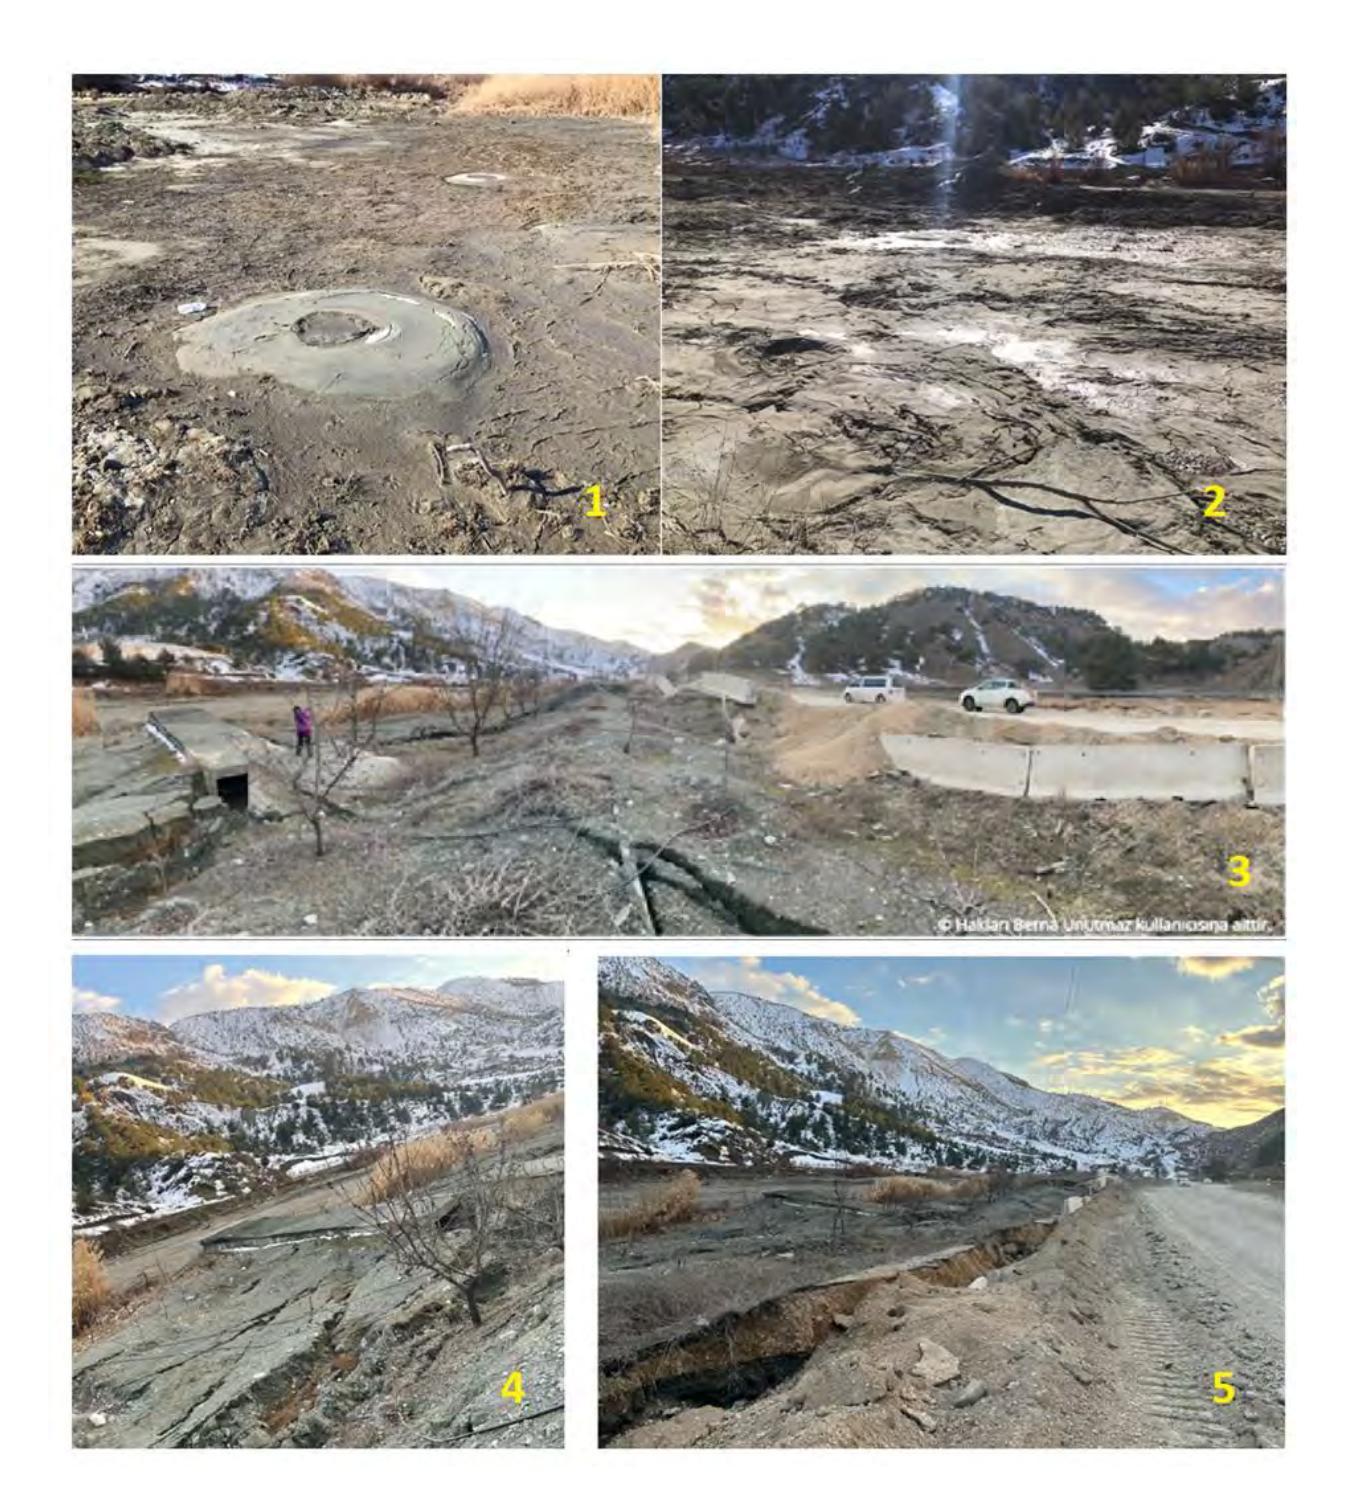
**Figure 5.230.** Sand ejecta and lateral spreading observed on Malatya-Kahramanmaraş Road (captioned by 1: Kemal Önder Çetin 37.86305278°N, 37.7677083°E; 2: Kemal Önder Çetin 37.86312°N, 37.76752°E; 3: Berna Unutmaz 37.865°N, 37.77116°E; 4: Berna Unutmaz 37.865367°N, 37.771156°E; 5: Ayhan Gürbüz 37.86551389°N, 37.771183°E)

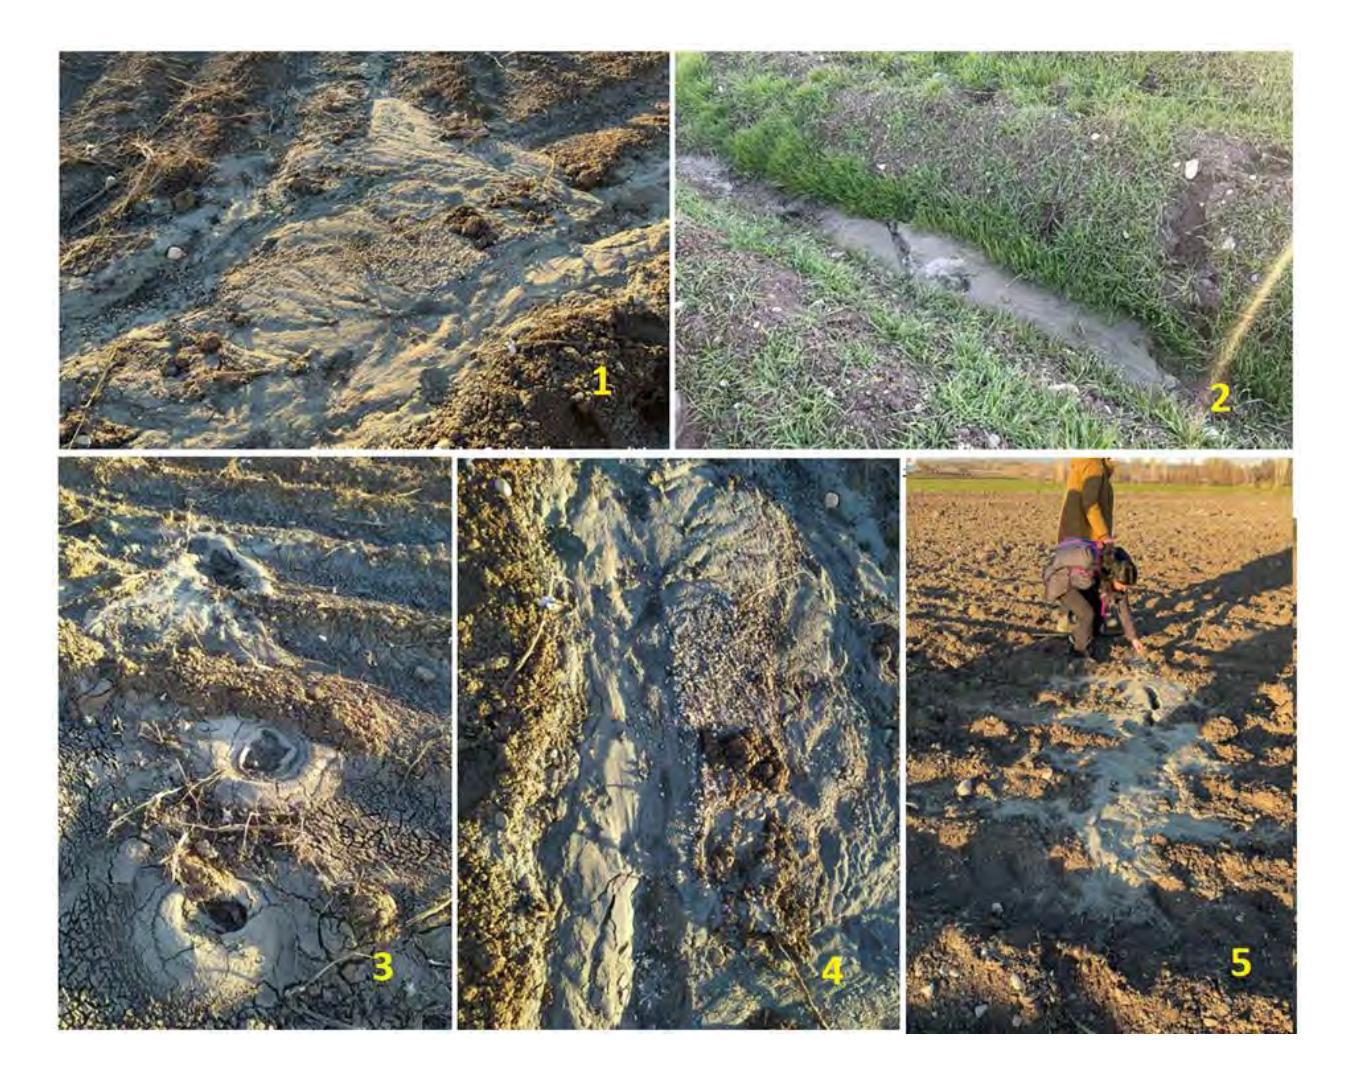
**Figure 5.231.** Liquefied areas on Osmaniye - Adıyaman road (captioned by Kemal Önder Çetin 1: 37.33691°N, 37.04542°E; 2: 37.3372°N, 37.0454056°E; 3: 37.336745°N, 37.0452559°E; 4: 37.336956972°N, 37.045499972°E; 5: 37.337375°N, 37.0455083°E)

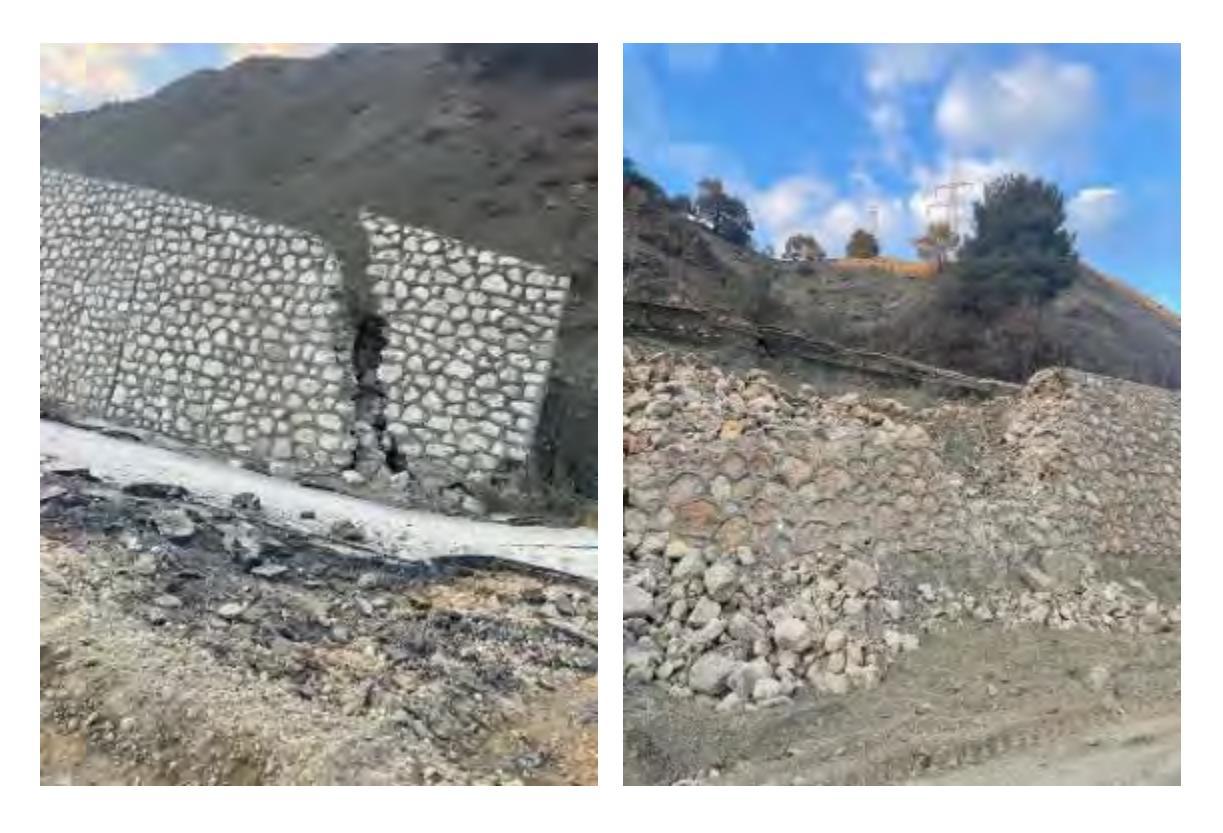
Figure 5.236. Collapsed/cracked stone walls, Location: around37.86345N, 37.76782E

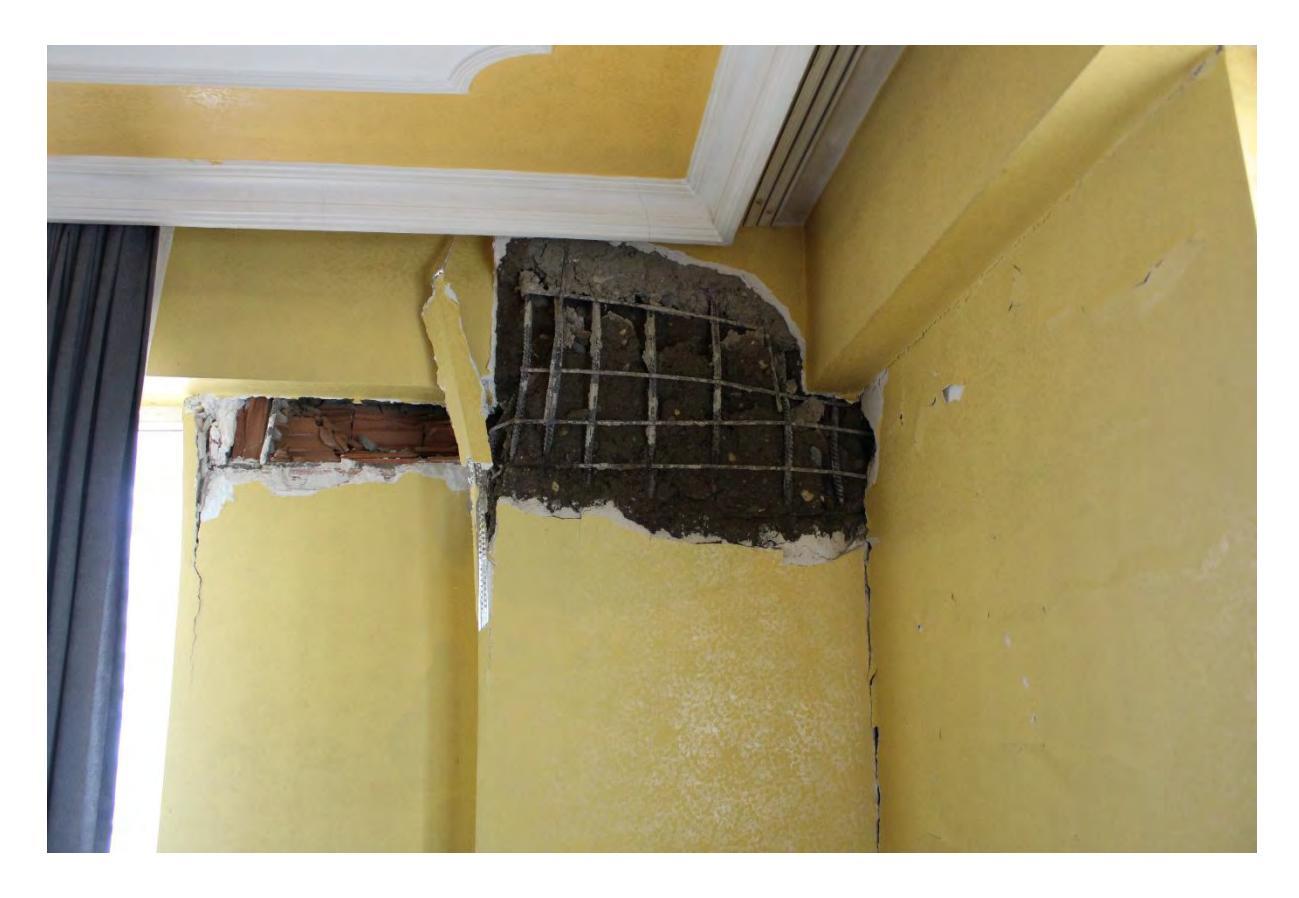
Figure 7.24. Structural damages (Buckling) at column in Diyarbakır

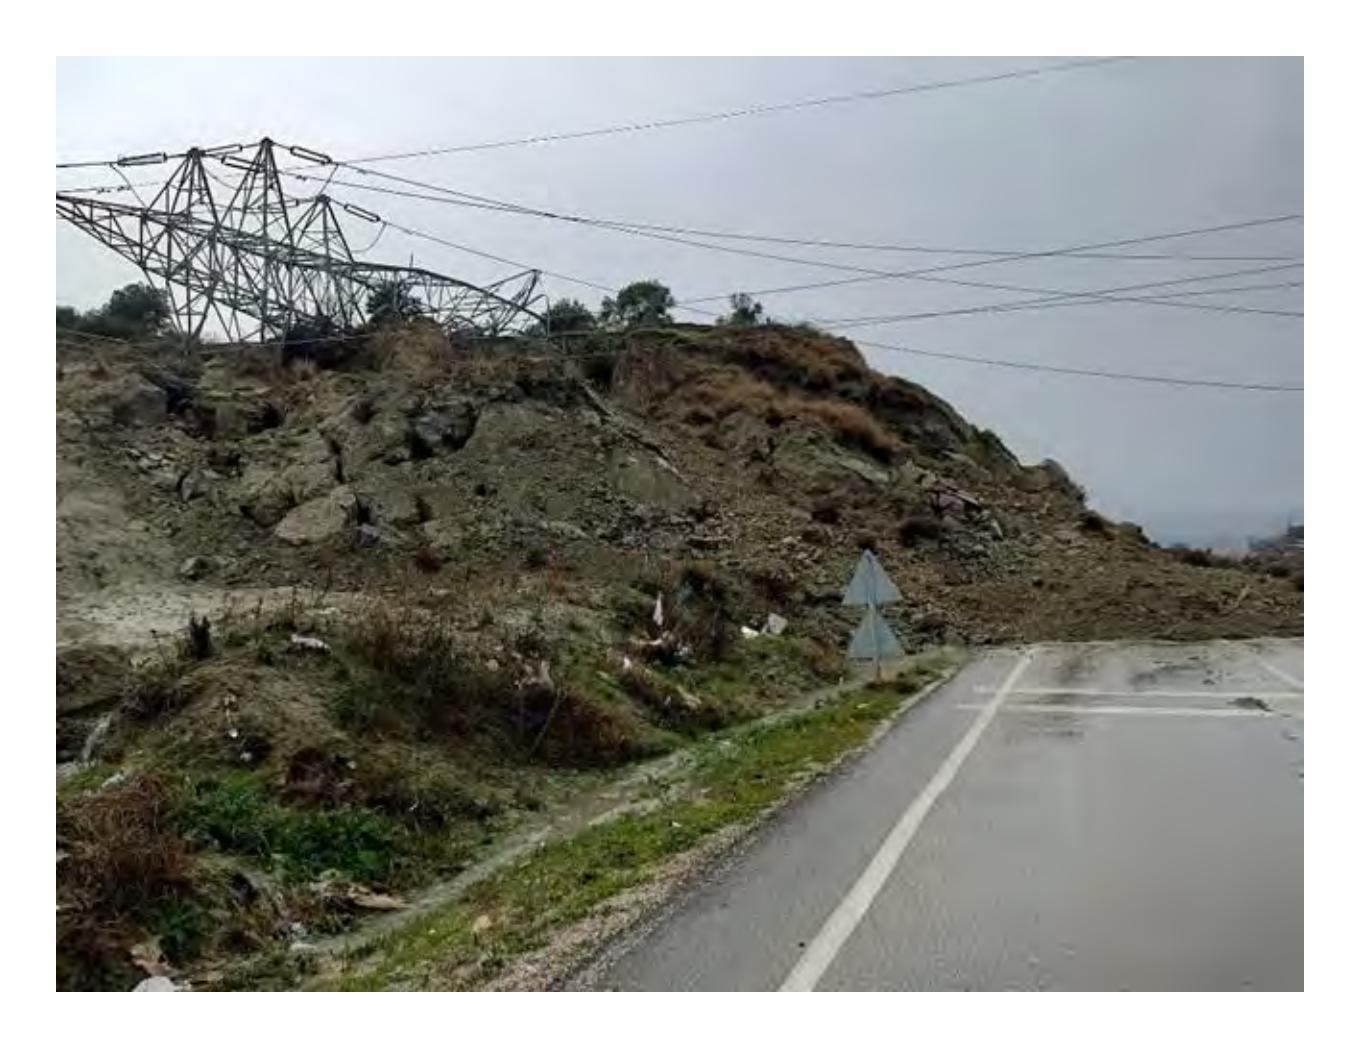
Figure 7.33. Slope failure in the proximity of the Afrin subdistrict.

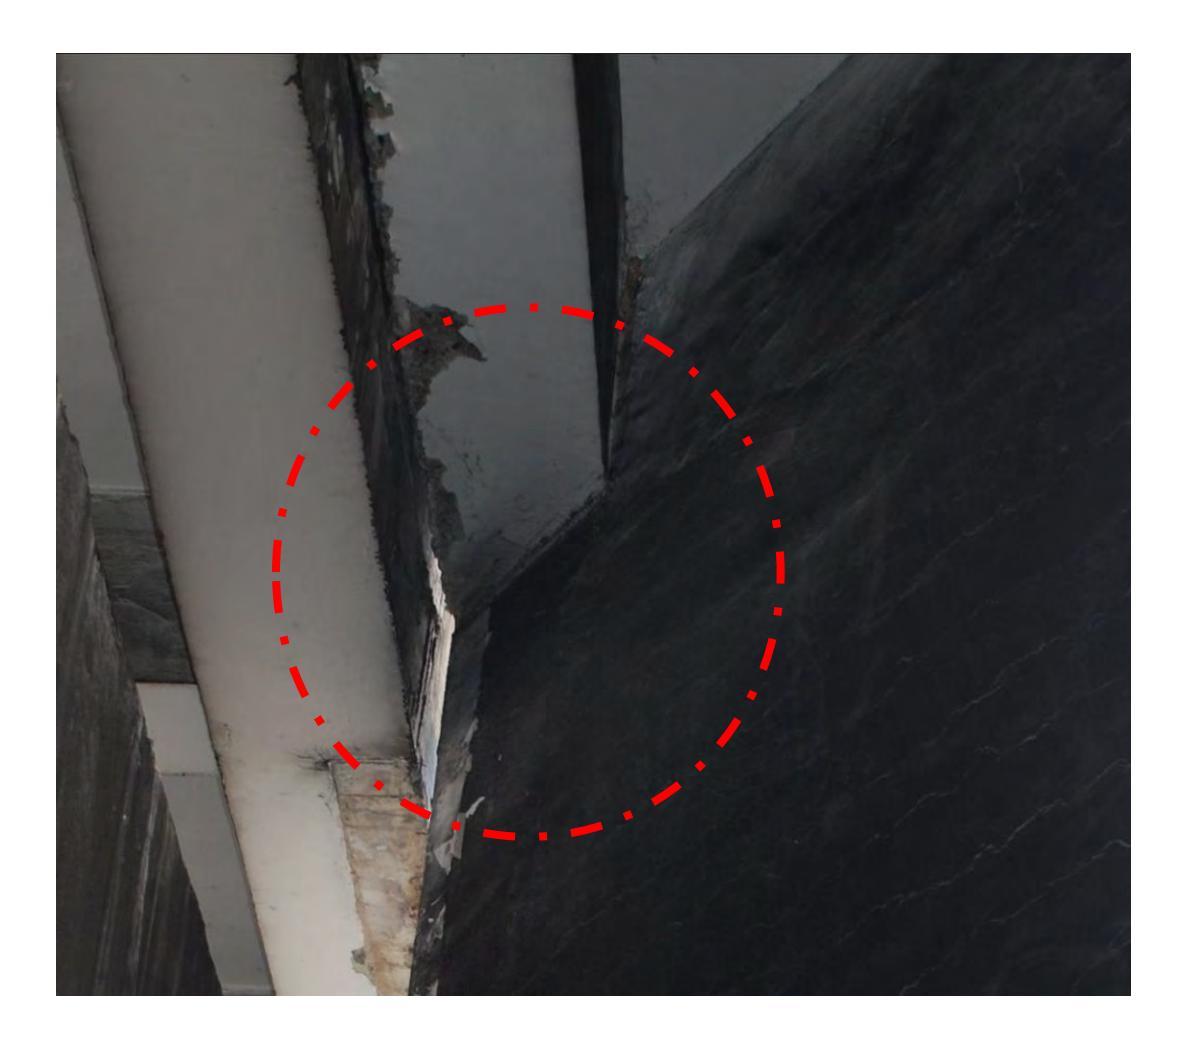
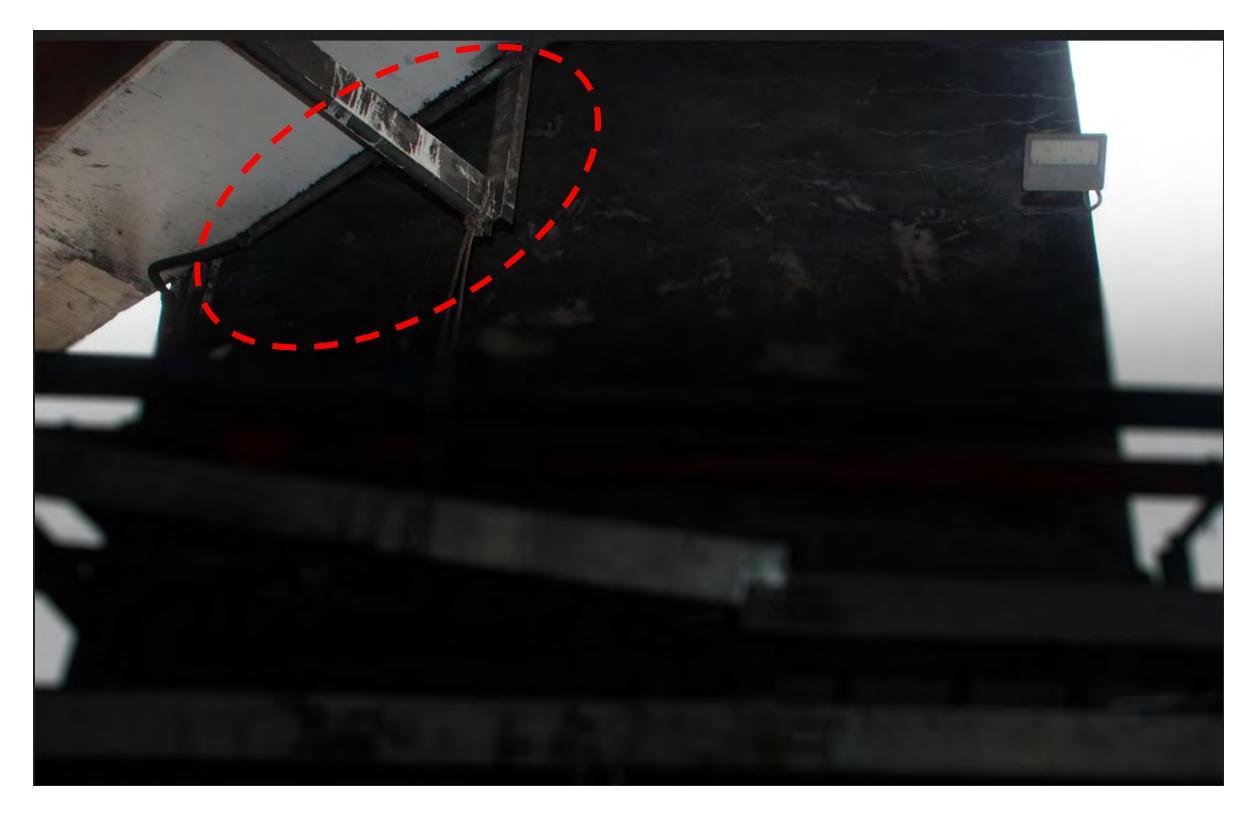
As shown in photos above, two adjacent buildings touched each other as a result of the earthquake load. It shows the gap in between these two buildings is insufficient which causes sequential damages. It can be seen from first figure that the structure is seperated. However, in the second one which is an another view of the same structure, the structure touched due to the torsional effect.

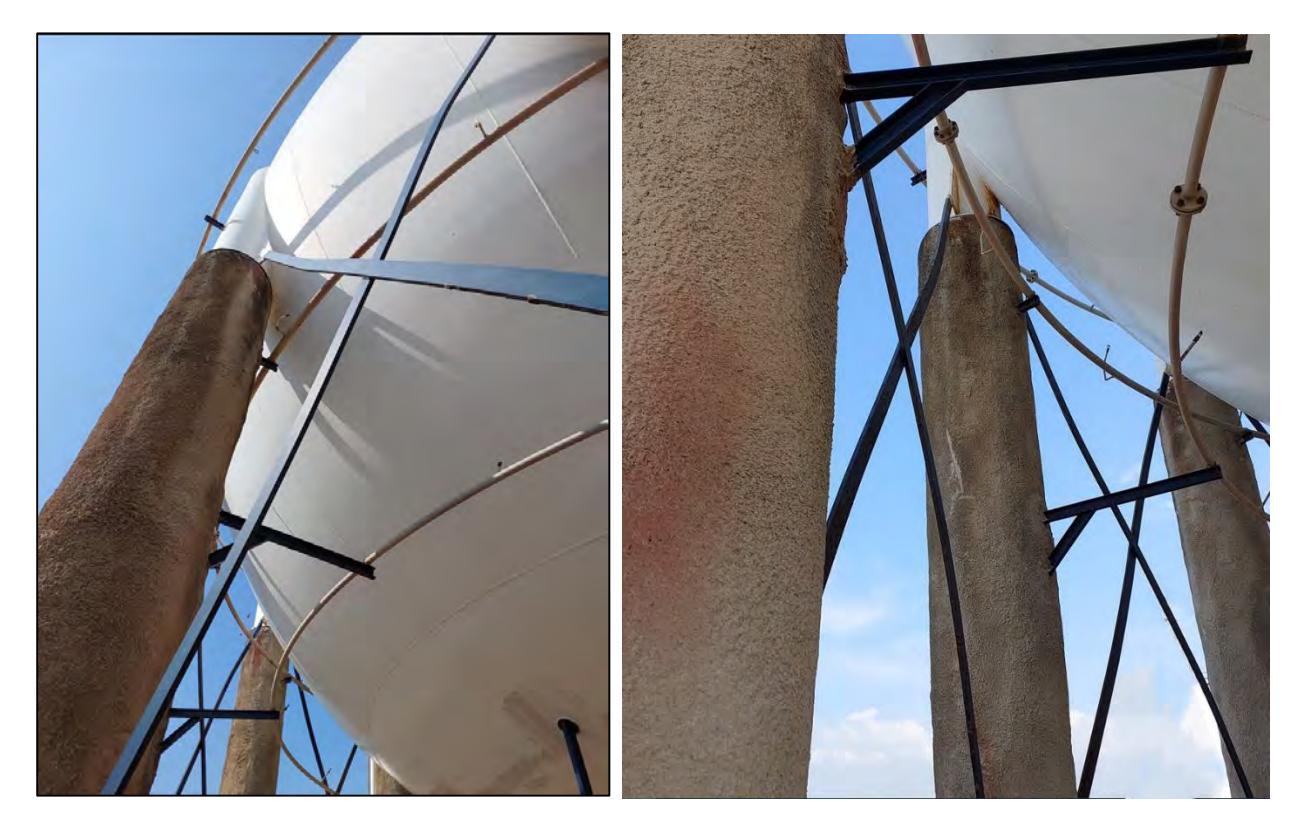
The figure above clearly shows that the bracing members should be designed under both compressive and tensile force.

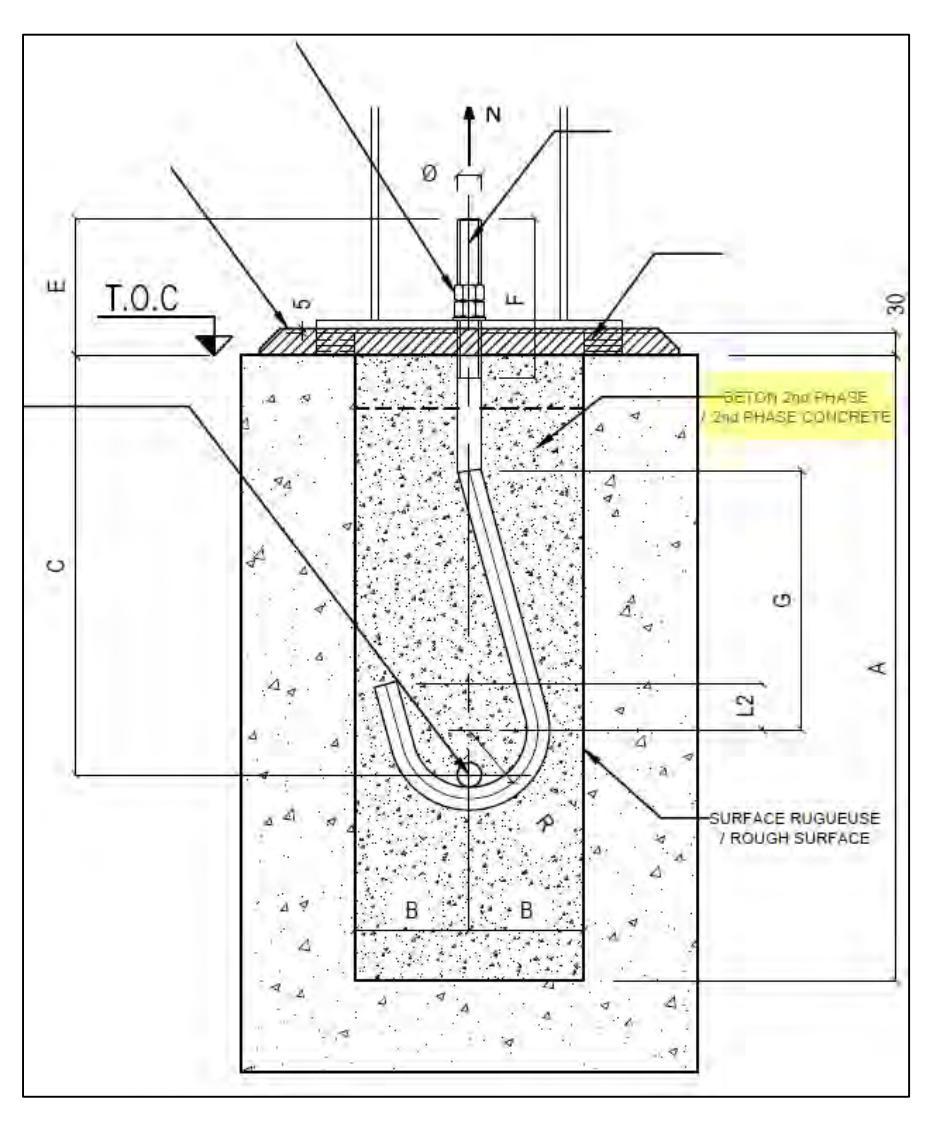
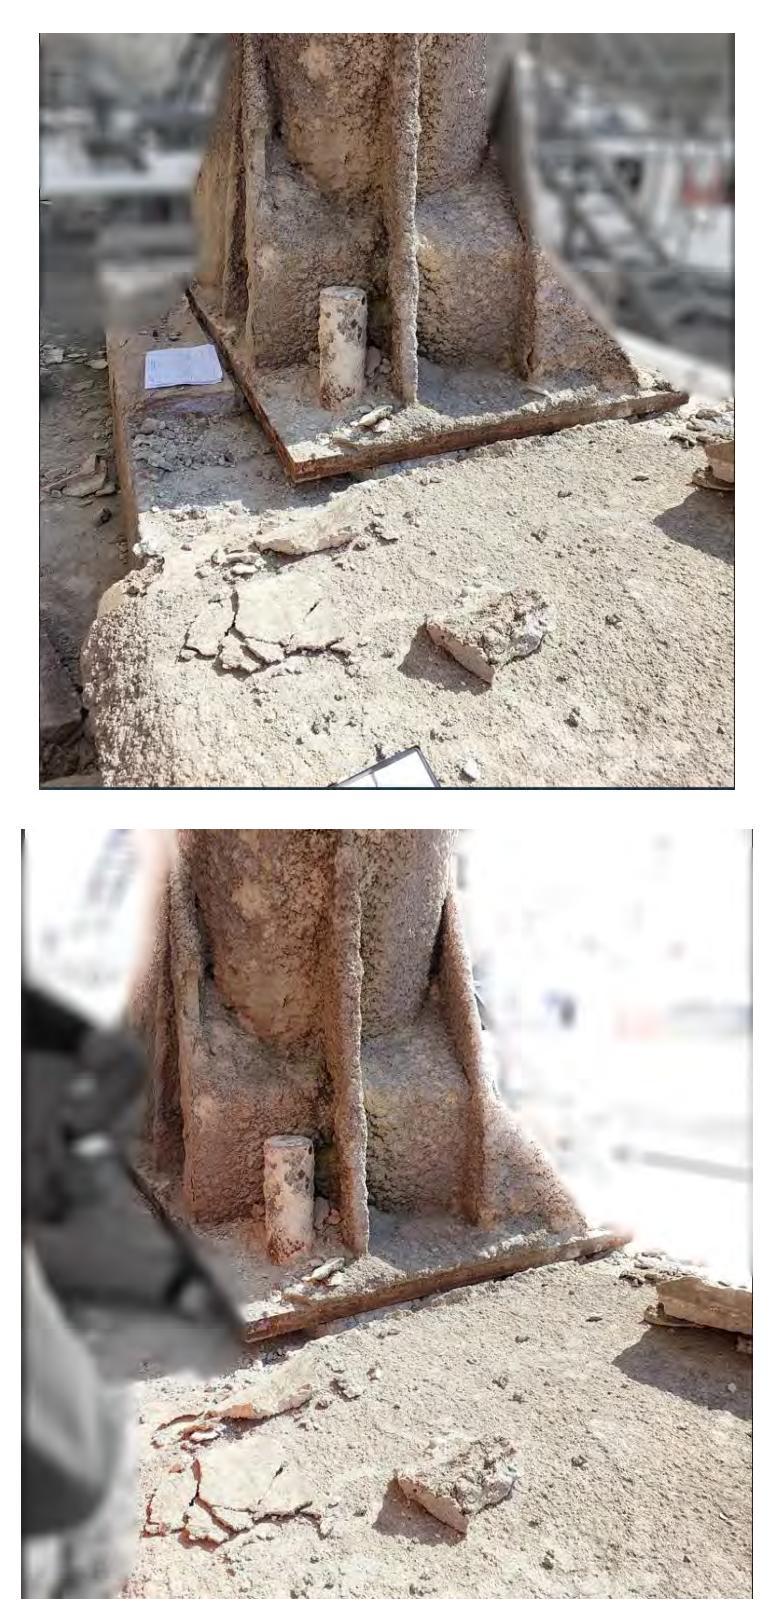
During the investigations after earthquake, a pocket is detected where the second pouring is missing. The columns base was free to move under horizontal load during earthquake. Please see

As a result, the second phase concrete pouring is very important for earthquake behavior of structure. The pocket shall be filled after the placing the anchorages.

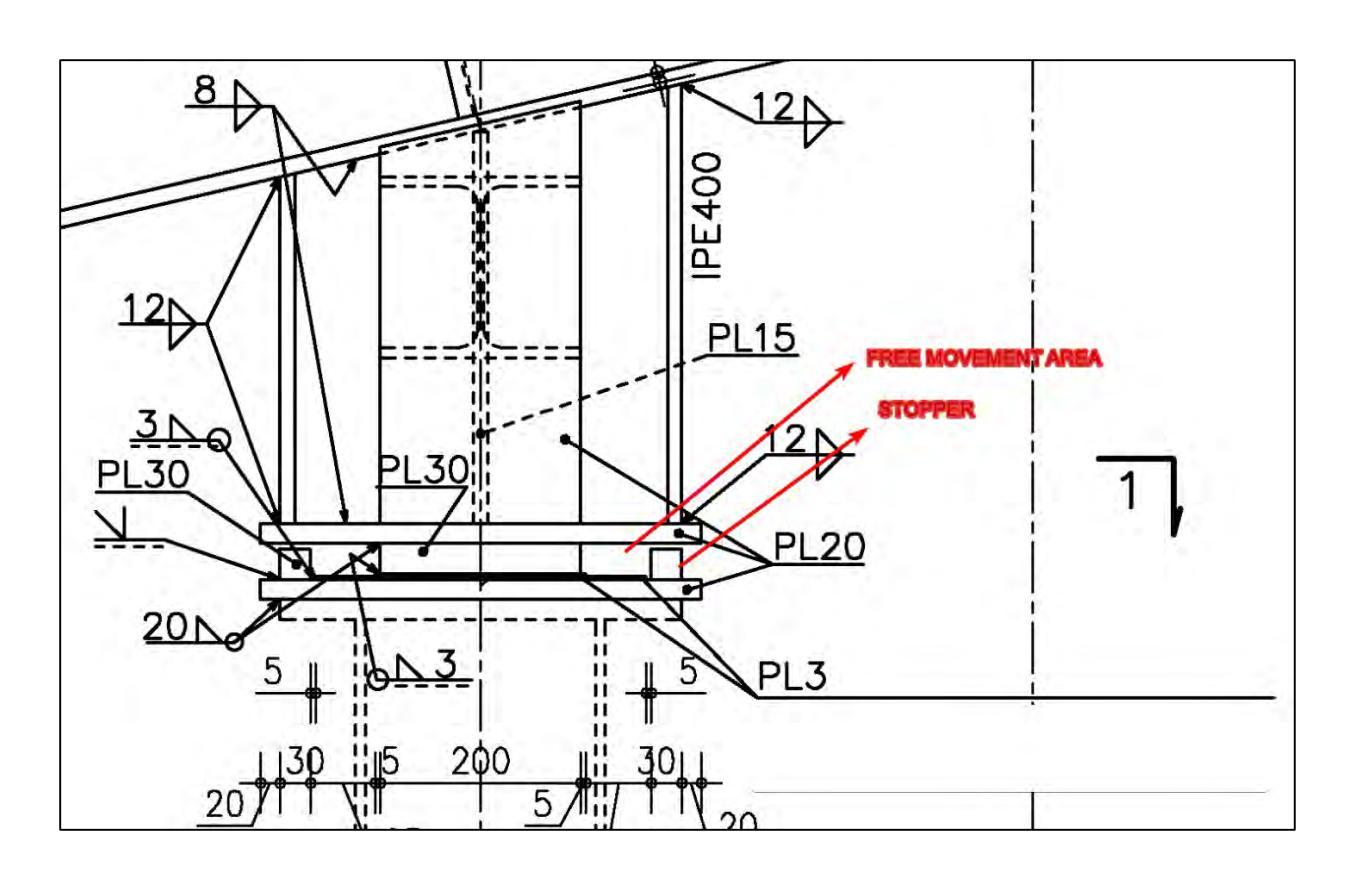
However, during the investigations after earthquake, it is detected that the movement during earthquake is absolutely more than predicted, so the sliding connection dimension is not sufficient. There are several reasons for this issue, for example tilt of foundations, unexpected mechanism cases and plastic hinges. Please see following figures to see the insufficient sliding connection details after earthquake. The stoppers are clashed with members and deformation occurred.

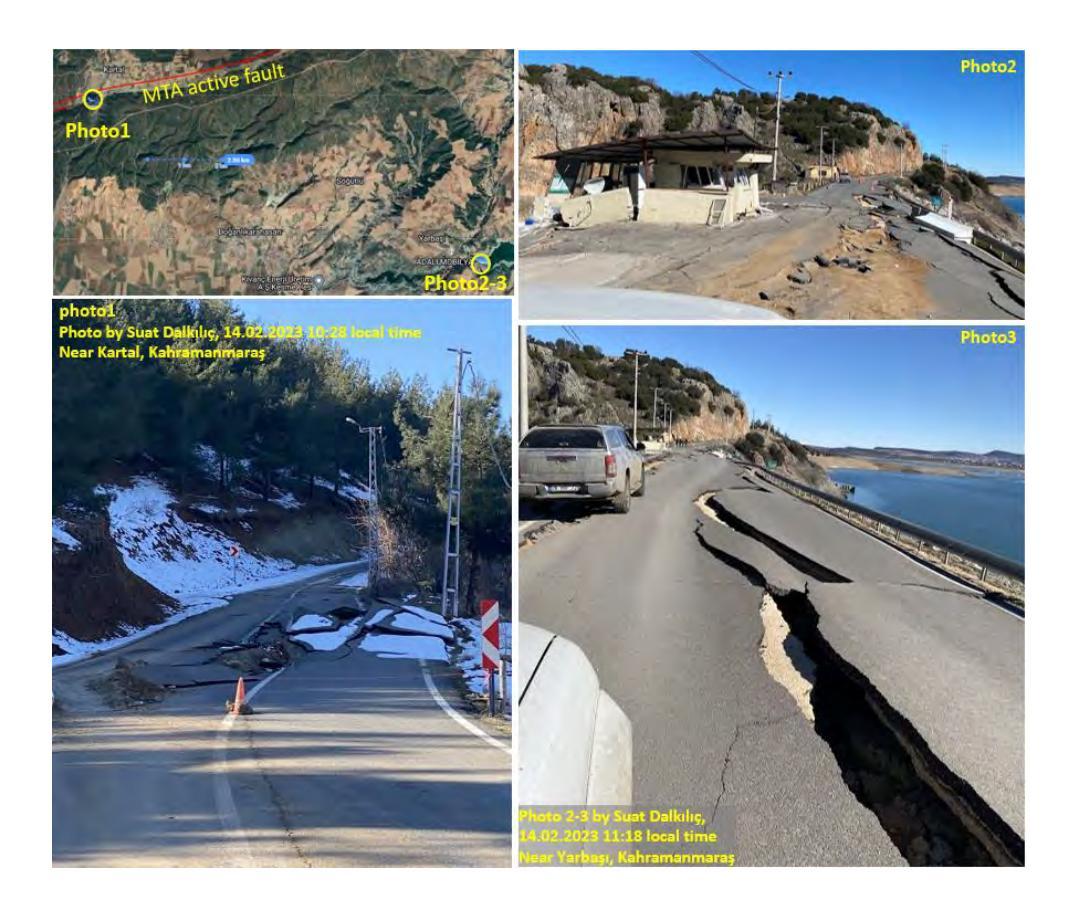
**Figure 10.8.** Landslides and surface cracks on the roads, near Kartal and Yarbaşı, Kahramanmaraş (Active fault data from Emre et al. (2013)).
