# Türkiye Earthquake

## **RECONNAISSANCE REPORT**

February 6, 2023 Kahramanmaraş-Pazarcık ( $M_w$ =7.7) and

Elbistan (M<sub>w</sub>=7.6) Earthquakes

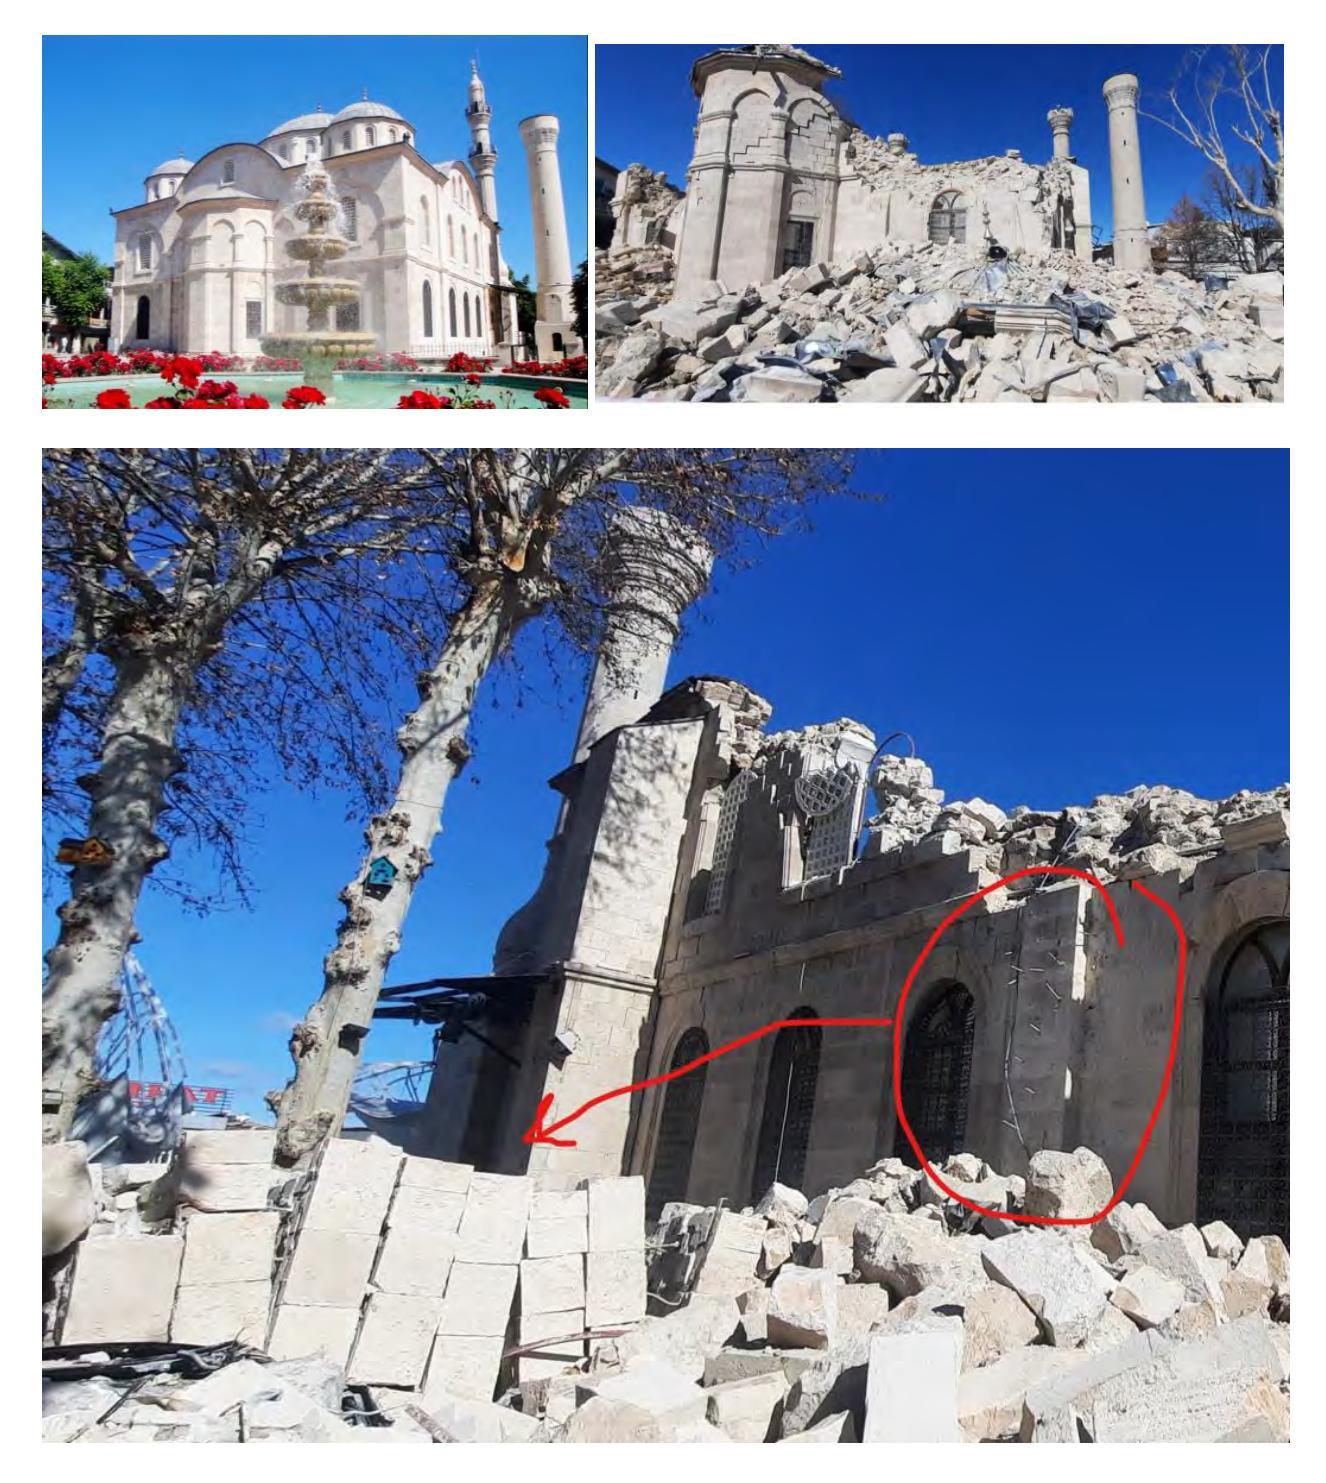
Figure 11.4. Yeni Cami (new mosque) before and after pictures and short anchorage.

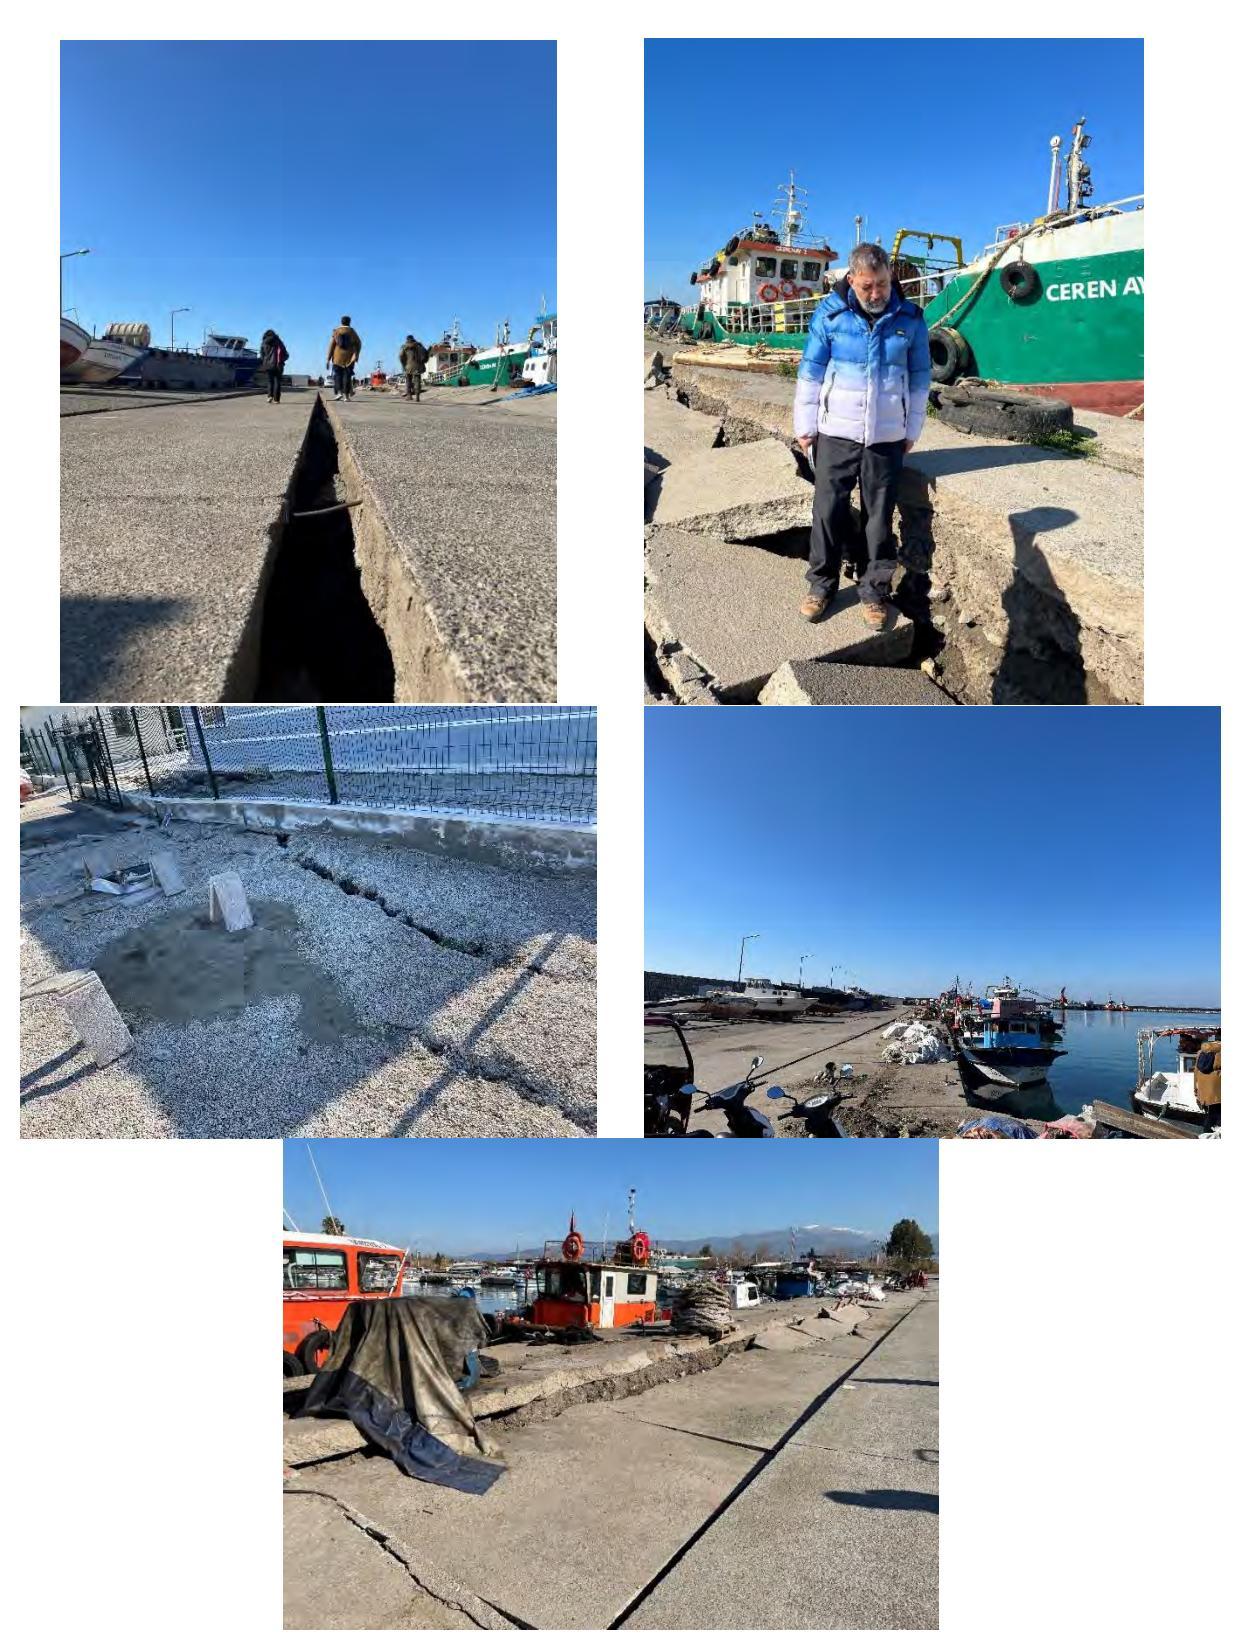
**Figure 12.6.** Structural damage at Dörtyol Fishery Port (Photos by METU DMAM Geotechnical Investigation Team, Prof. Dr. Kemal Önder Çetin)
