SDSU STRUCTURAL ENGINEERING RESEARCH PROJECT

Report No. SERP - 23/03

Reconnaissance Report of Observed Structural Bridge Damage

M_w 7.8 Turkiye (Turkey) Earthquake of 2023

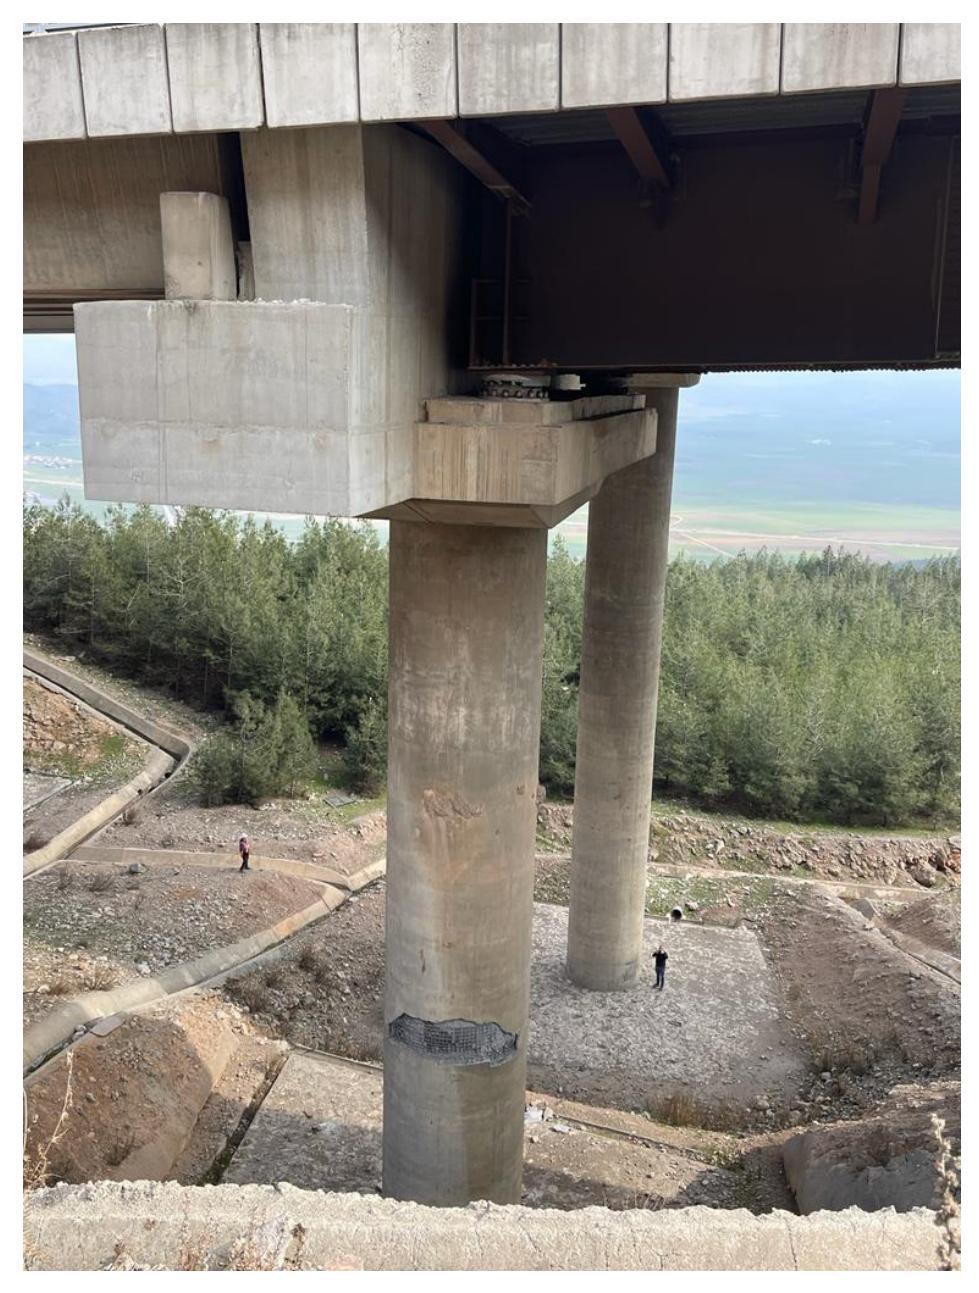
Fig. 4.1-1. Overall view of bent with 10' diameter RC bridge columns and plastic hinge for one column at about ¼ the way up its height, Bridge 1

A single column plastic hinge formed at these two adjacent bridge structures of Bridge 1, but not at the bottom of the column where it is expected and detailed for, since this is where the moment is largest for a cantilever column. The plastic hinge developed in the transverse bridge direction at about ¼ up the height of the column length (Fig. 4.1-1). A side view of the plastic hinge region is given in Fig. 4.1-3. On one side of the plastic hinge the vertical column steel buckled and the transverse steel yielded over several rebar (Fig. 4.1-4), while on the opposite side a large portion of cover concrete spalled off, but with no signs of transverse steel yielding or vertical rebar buckling (Fig. 4.1-5). The most reasonable explanation for why a plastic hinge occurred 25% up the column height, instead of at the column/footing interface, as expected, is that there were vertical bar cutoffs at this location, reducing the moment capacity to the point that the moment demand/capacity ratio was larger there than at the column base (Fig. 4.1-6).

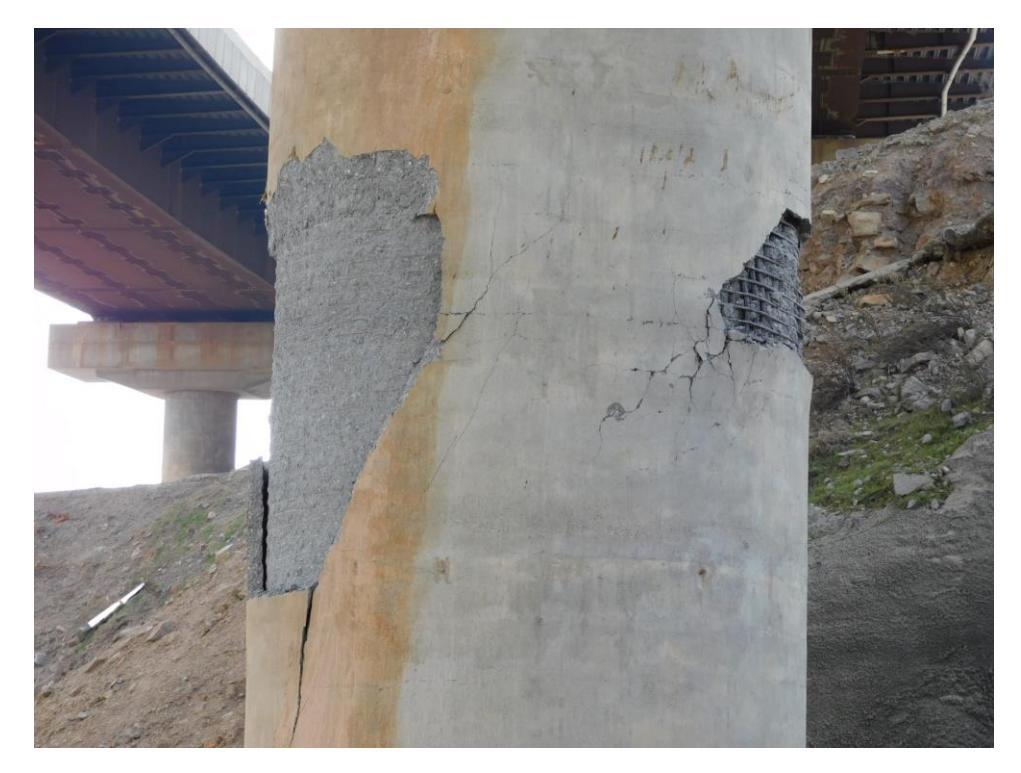
Spalling of unconfined cover concrete on both sides of this plastic hinge clearly indicates nonlinear cyclic behavior in the transverse direction of the bent, with compressive concrete strains of at least 0.005 (and probably beyond 0.01 based on the observed damage) in both loading directions [8, 11]. Vertical rebar buckling also shows that nonlinear cyclic behavior occurred, as the steel must yield and reach large strains in tension before direction reversal, which results in compressive stresses and forces in the rebar before the concrete takes any significant compression from the combined section moment and axial force. This phenomenon does not occur under monotonic loading where the concrete is always in compression on one side of the neutral axis [11].

future moderate to big earthquakes, or aftershocks, could collapse this large and important bridge structure by providing a few more cycles to the existing plastic hinge. It is of interest that in the plastic hinge region on the side of the column where the vertical bars did not buckle, the transverse rebar is seen to have constant curvature around the section with nice, even spacing (Fig. 4.1-5 and the left side of Fig. 4.1-3), and no indication of being bent out of position, as is clear on the side of the column with vertical rebar buckling (Fig. 4.1-4 and right side of Fig. 4.1-3).

Fig. 4.1-3. Side view of plastic hinge region of 10' diameter RC bridge column, Bridge 1

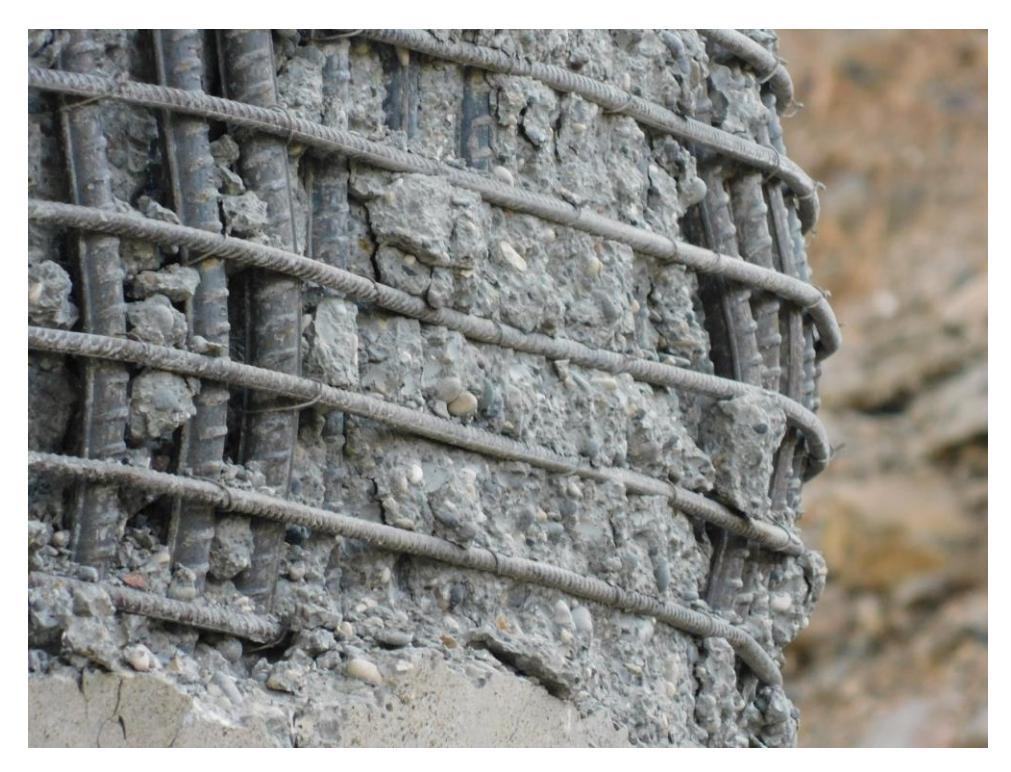
Vertical rebar buckling in a column plastic hinge indicates that it very nearly failed, with only a couple of more cycles needed, which could have resulted in complete collapse of the structure. Note that the spacing of the transverse steel looks good (Fig. 4.1-5), but the bar size appears to be too small for a ductile plastic hinge to develop. This is probably because the plastic hinge was not expected at this location with, perhaps, larger transverse rebar provided towards the bottom of the column. While bar cutoffs is the most likely reason a plastic hinge formed part way up the column height, it is possible that this location had a larger moment demand than at the base of the column due to the combined effects of the transverse mass and

Vertical rebar buckling is critical because the rebar strains (tension and compression) on both sides of a buckled wave are very large, resulting in only a few tension/compression strain cycles to cause low-cycle fatigue failure and rupture of the vertical steel. From Fig. 4.1-4, it is clear that the transverse rebar is deformed and at high strains (visibly straight on the sides of the column and tightly curved and bent around the buckled vertical steel), and once the transverse rebar ruptures the core concrete suddenly becomes unconfined, and may not be able to support even the dead load of the bridge structure, resulting in complete bridge collapse. So the combined effects of vertical rebar buckling and fracture after a few cycles, as well as yielding and rupture of transverse rebar, would not only cause the core concrete to suddenly become unconfined, it would provide the wide-open spaces required to allow this now-unconfined and crushed concrete to just pour out of the plastic hinge region. Therefore,

Fig. 4.1-4. Close-up view of column plastic hinge, with buckled vertical rebar and yielded transverse rebar, Bridge 1

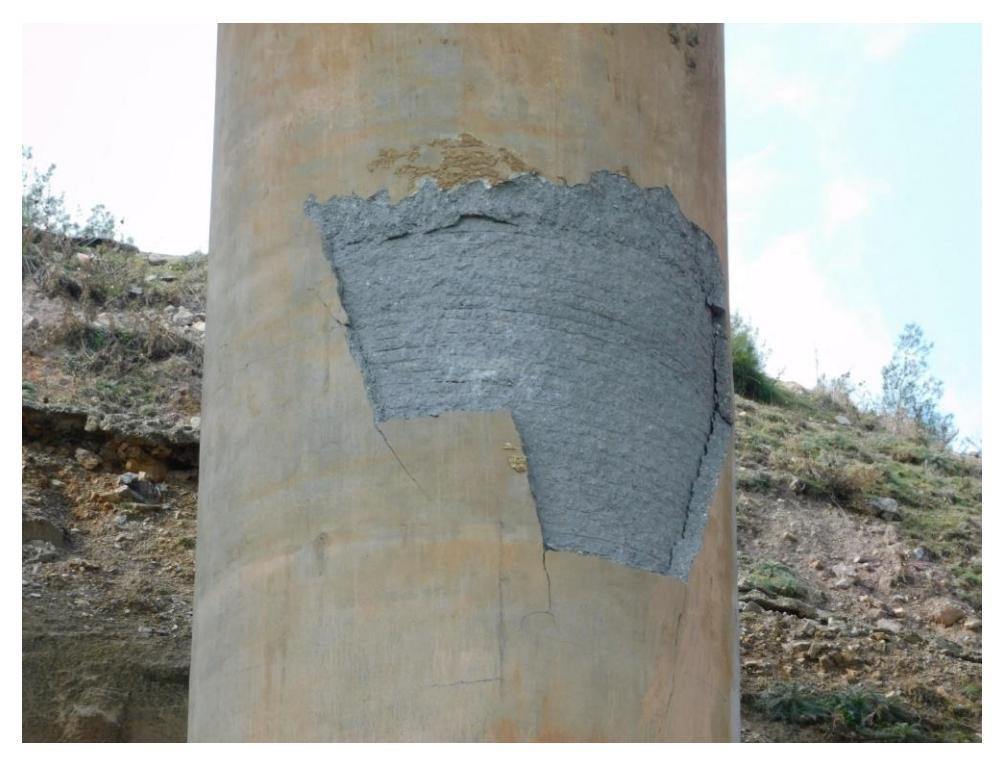
Fig. 4.1-5. Close-up view of column plastic hinge, spalling of cover concrete (opposite side to where vertical bars had buckled), Bridge 1

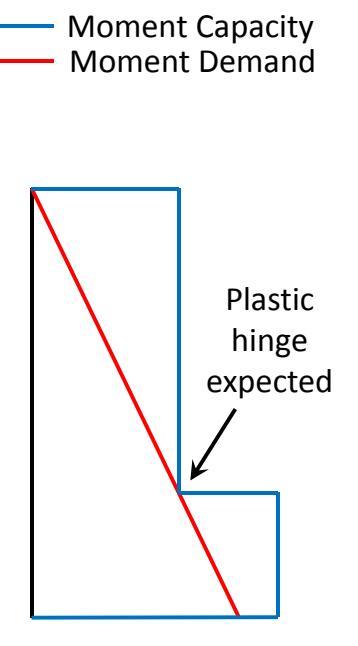
Fig. 4.1-6. Column moment demand and moment capacity when bars are cutoff at ¼ location of the column height, Bridge 1

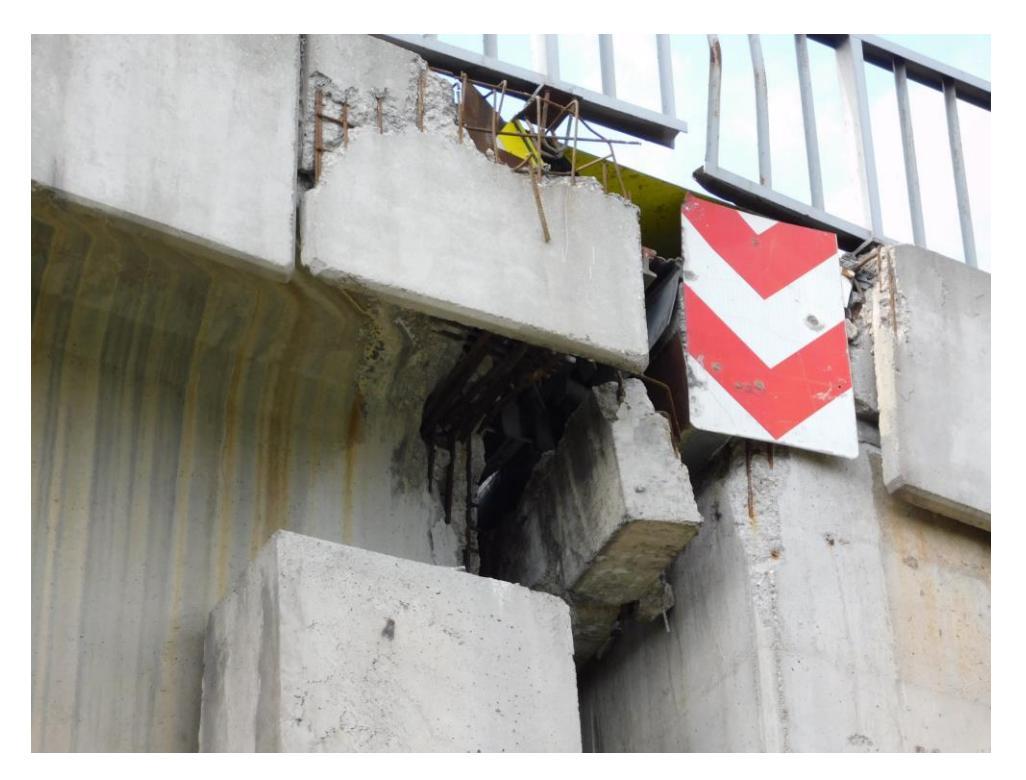
In addition to the column plastic hinge discussed above, damage and spalling at the abutment from longitudinal and transverse banging of the superstructure was evident (Fig. 4.1-7).

Fig. 4.1-7. Damage at abutment, Bridge 1

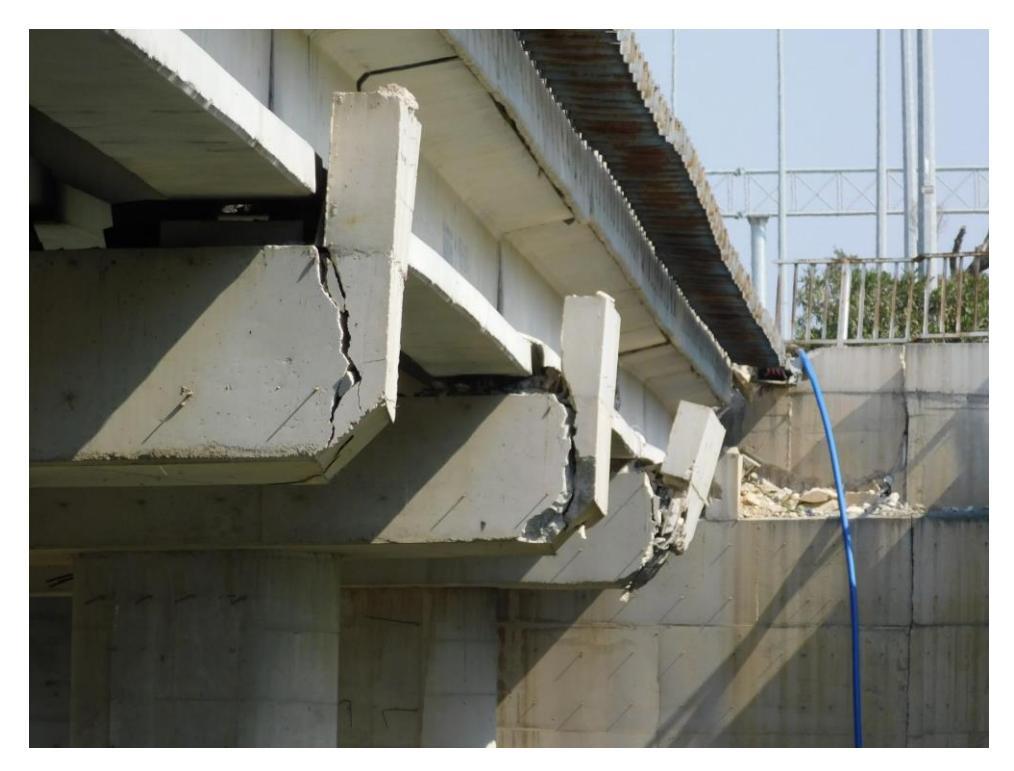
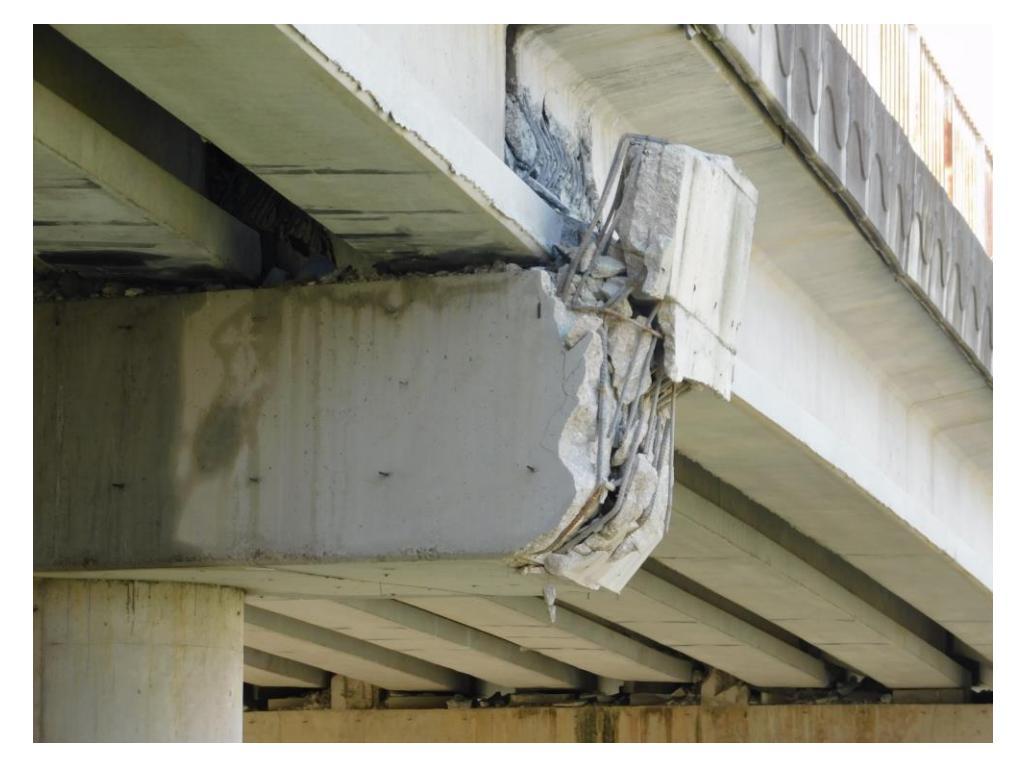
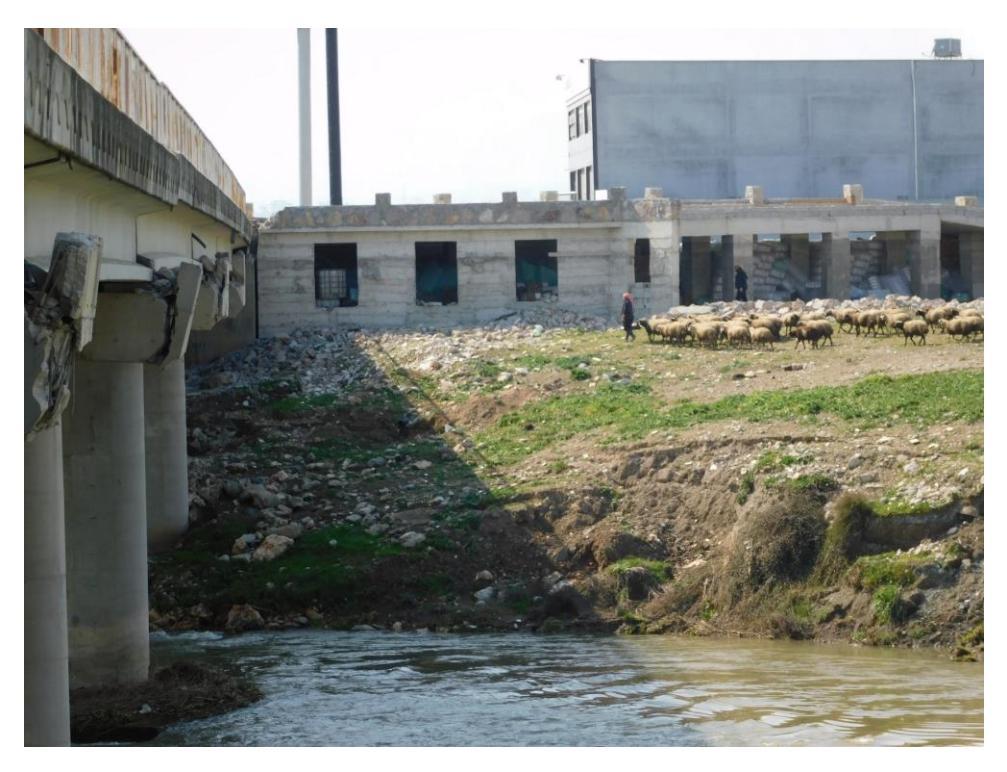
Lateral motion of the bridge caused severe damage and failure of external shear keys (Figs. 4.2-2 through 4.2-4). Combined lateral, longitudinal and vertical motion resulted in many rubber bearing pads that had supported the simply-supported girders to fall to the ground (Fig. 4.2-5 shows one). End regions of all of the precast concrete girders were significantly damaged from large vertical (as well as longitudinal and horizontal) accelerations and forces, including impact, resulting in shear cracks and extensive spalling of the concrete, as shown in Figs. 4.2-6 through 4.2-8. The spalling reached a long distance out into the girders (Figs. 4.2-6 and 4.2-8), far beyond the supports. In many cases there was no concrete left, with just the rebar cage remaining toward the girder end (Fig. 4.2-7) supporting the end shears. This brings up an interesting question as to what happened to the prestressing strands, and associated prestressing force, as the concrete around the strands spalled out. A coiled-up prestressing

Fig. 4.2-2. Failed exterior shear keys, Bridge 2

Fig. 4.2-3. Closer view of failed exterior shear key and end-of-girder damage, Bridge 2

Fig. 4.2-4. Another view of failed exterior shear keys, Bridge 2

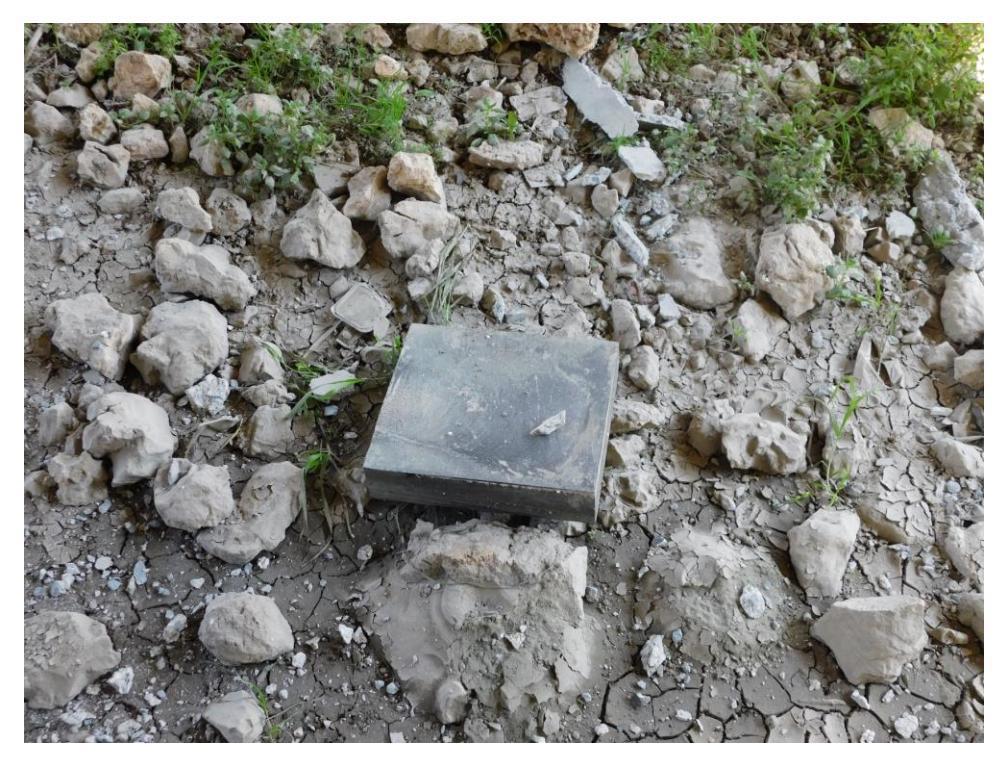
Fig. 4.2-5. Rubber bearing pad on ground; one of many, Bridge 2

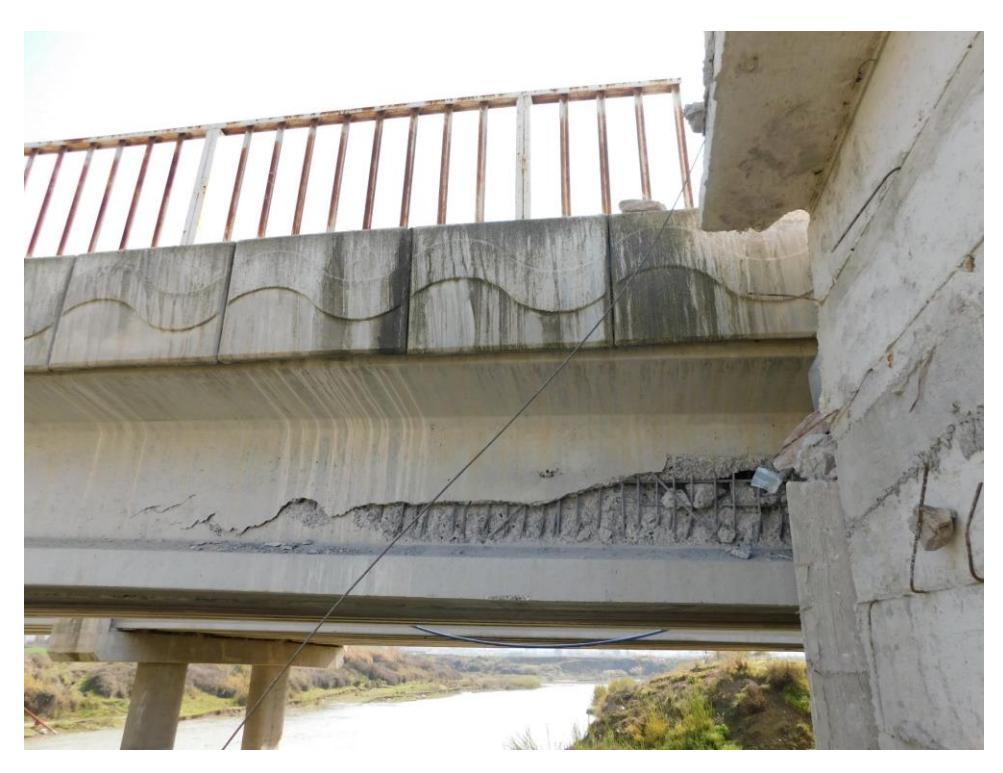
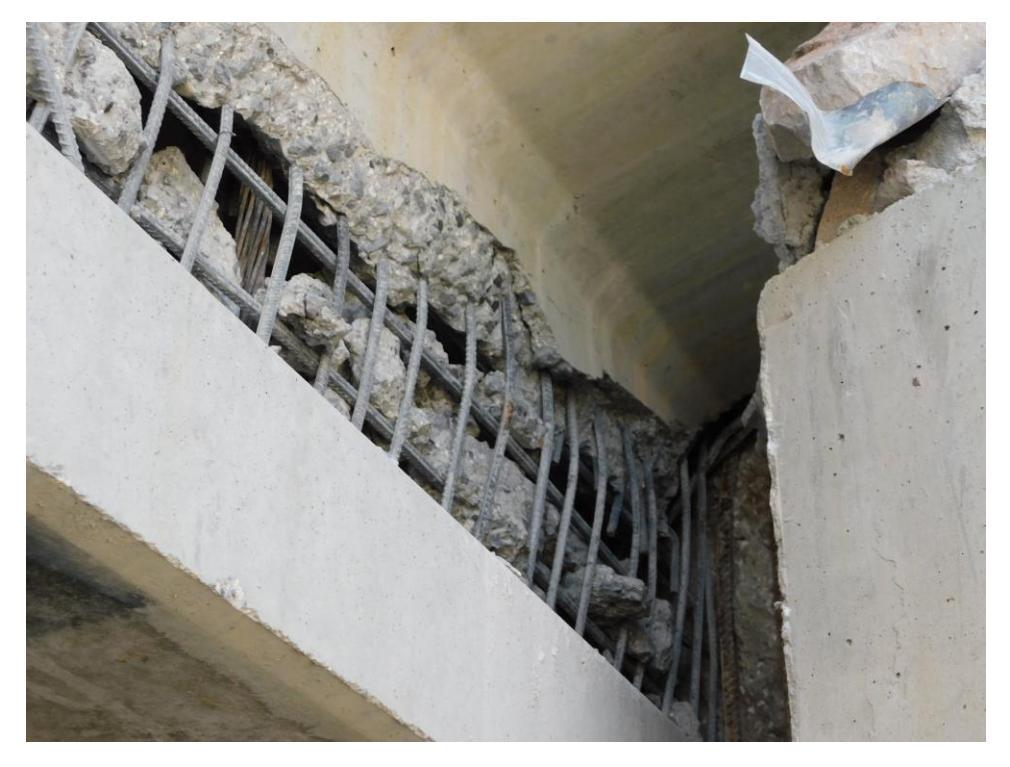
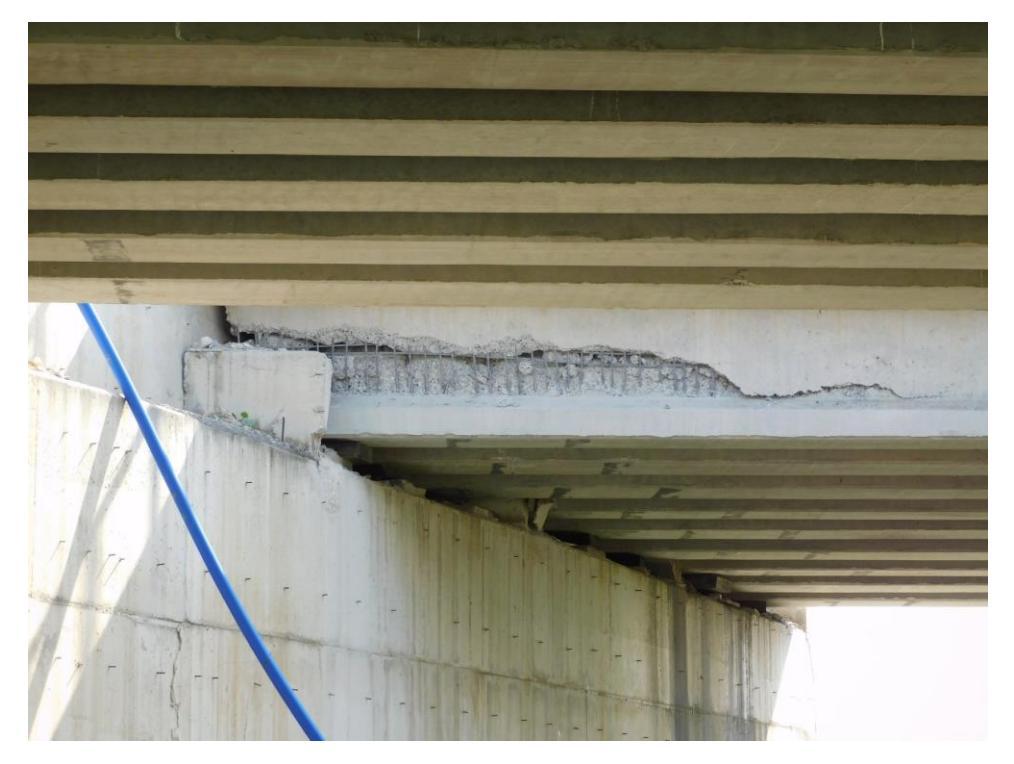
The extensive damage to the ends of both internal and external girders appears to be a result of a sequence of events; first diagonal shear cracks form just beyond the supports from large vertical accelerations and forces, including multiple impacts from girder-end liftoff and slamming back down (peak vertical spectral acceleration is 1.64 g), then concrete begins to spall off at the girder ends due to the combined effects of the large vertical, transverse and longitudinal forces, including impact in all three directions. With no concrete left at the girder ends there is nothing to hold the prestressing steel to the girder end region, with the transfer length moving forward to where there is still concrete, causing added damage to the already-cracked and spalled girder end region, with more spalling and slip, and so on, until a much longer distance of damage has developed than from just diagonal shear cracking. As seen in Figs. 4.2-6 and 4.2-8, the spalled region at the girder ends is very long for exterior girders, with similar damage occurring to interior girders (Figs. 4.2-11 through 4.2-13). Severe twisting and bending of one precast girder happened, as seen in Figs. 4.2-14 through 4.2-16.

Fig. 4.2-6. Damage to end of precast girder, Bridge 2

Fig. 4.2-7. Closer view of damage to end of precast girder, Bridge 2

Fig. 4.2-8. Damage over long range to end of exterior precast girder, Bridge 2

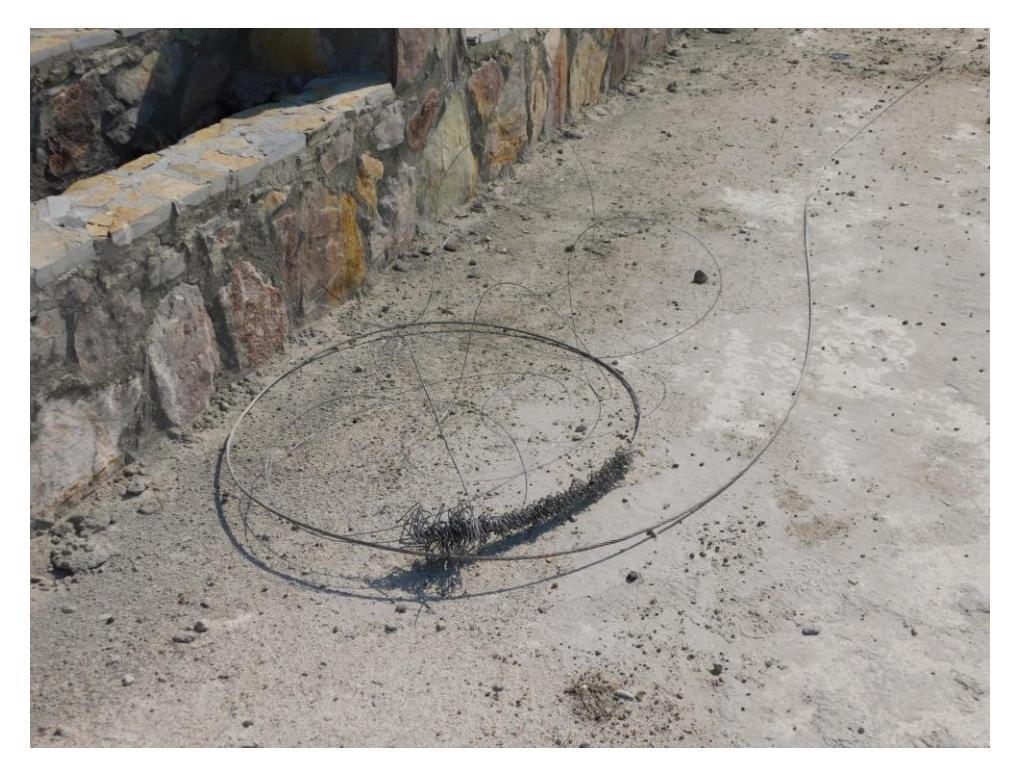
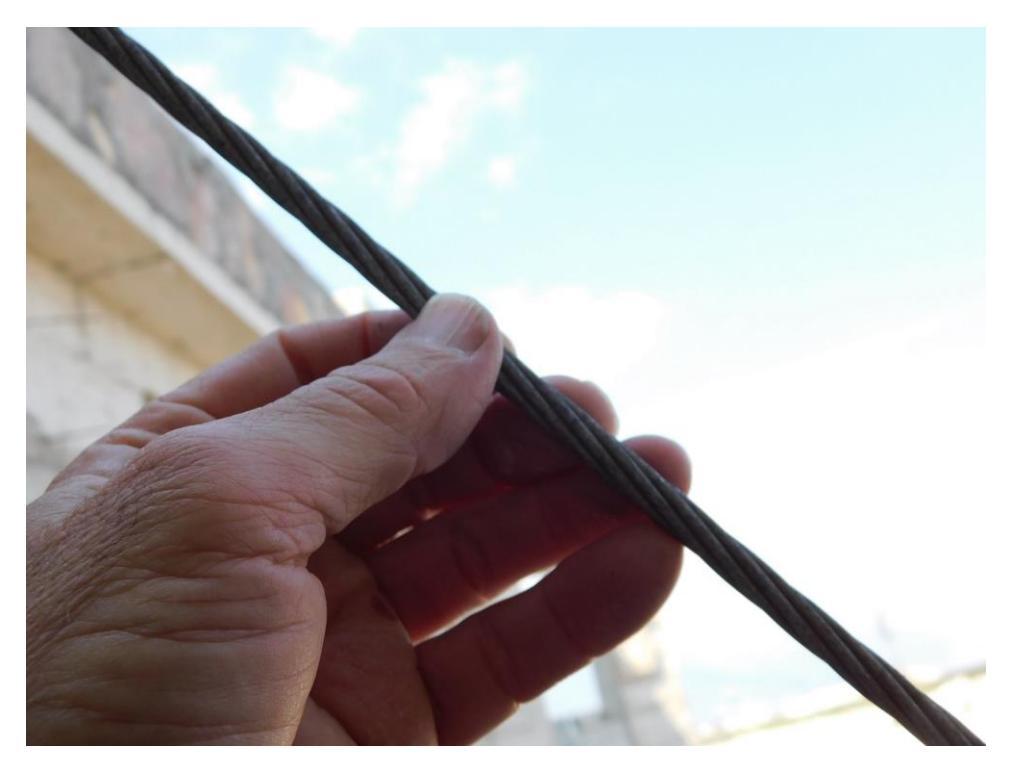
strand was found adjacent to one of the bridge abutments that had flown out of a girder (Figs. 4.2-9 and 4.2-10).

Fig. 4.2-9. Prestressing cable at end of precast girder, Bridge 2

Fig. 4.2-10. Close-up view of prestessing cable near end of precast girder, Bridge 2

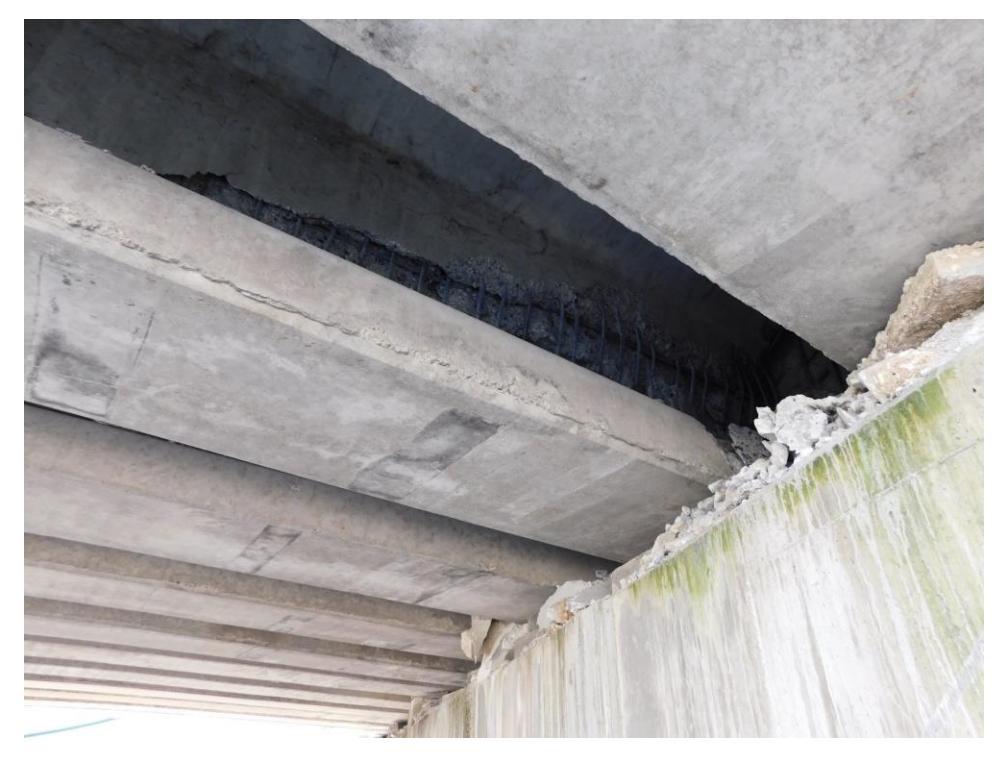
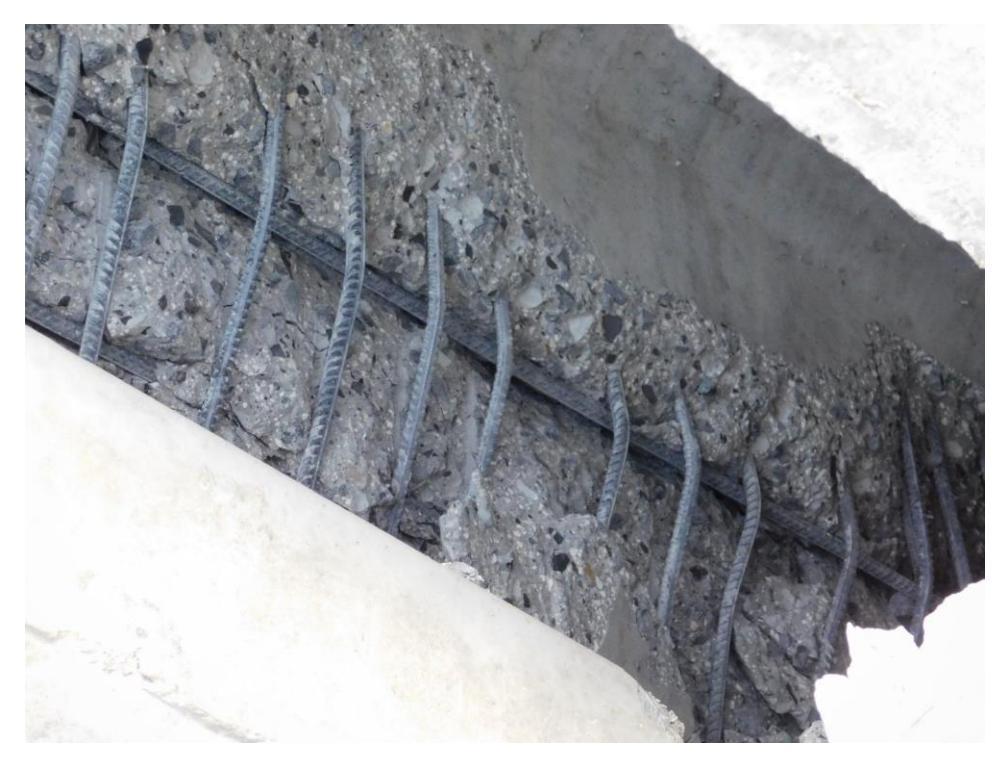
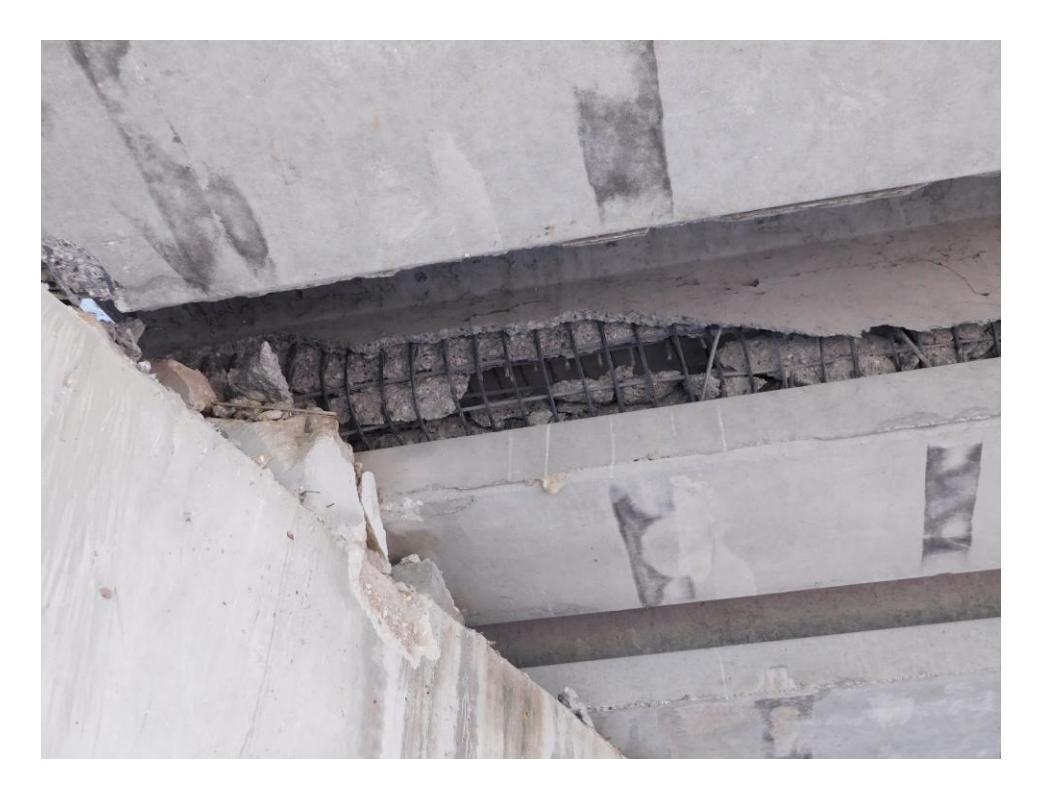
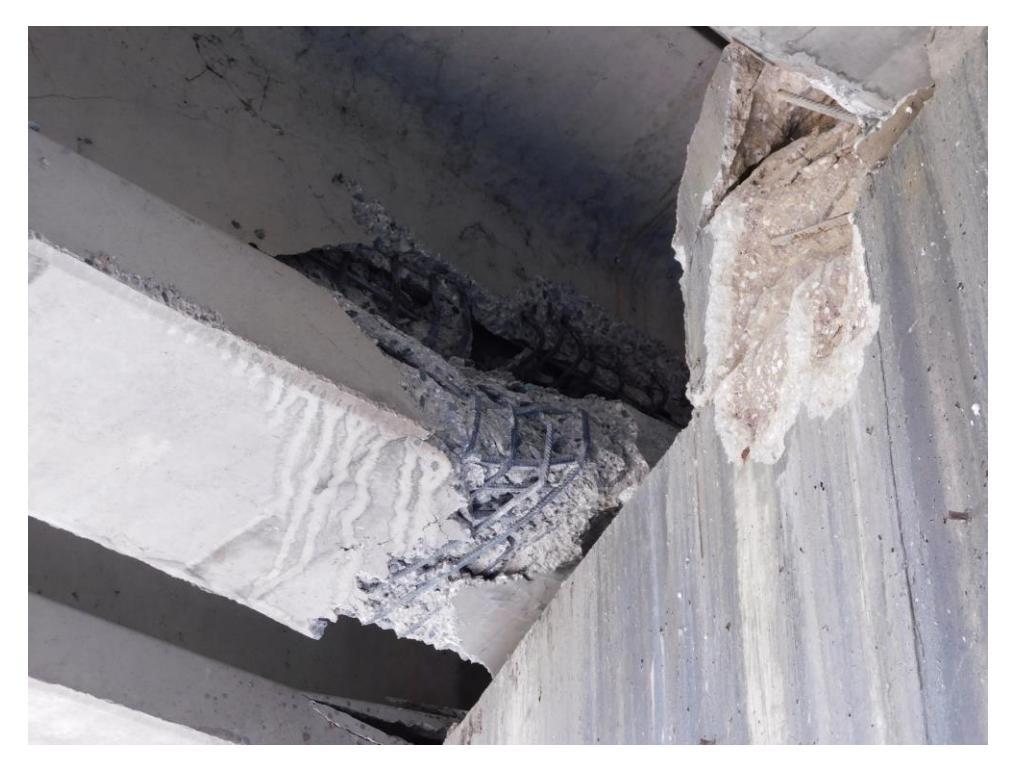
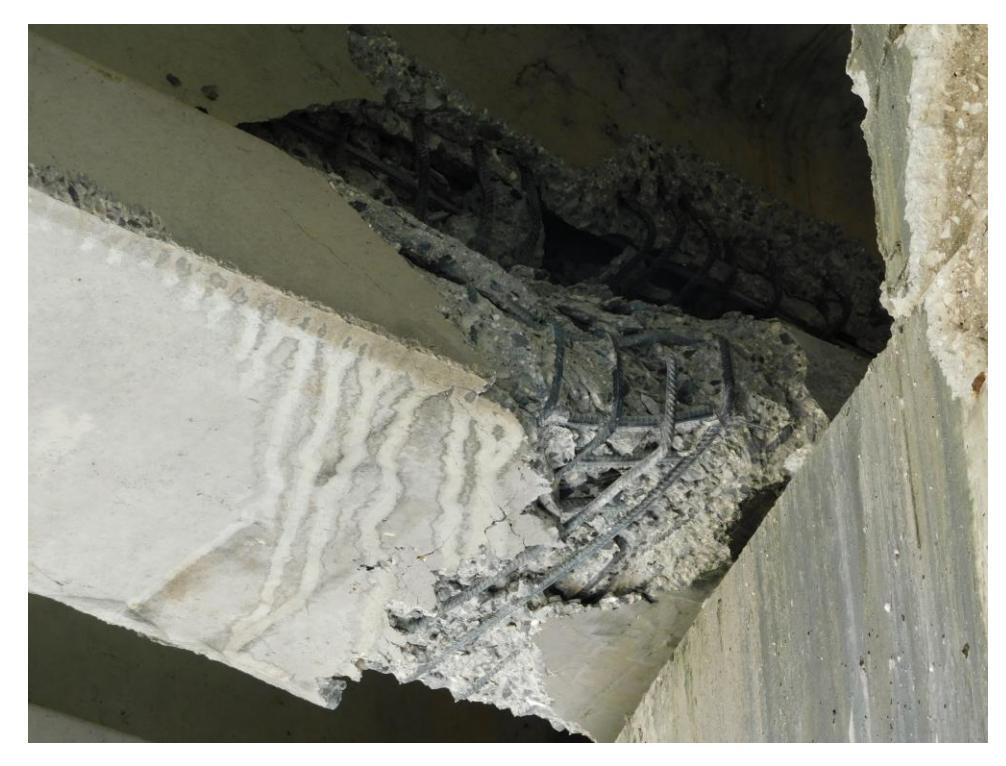
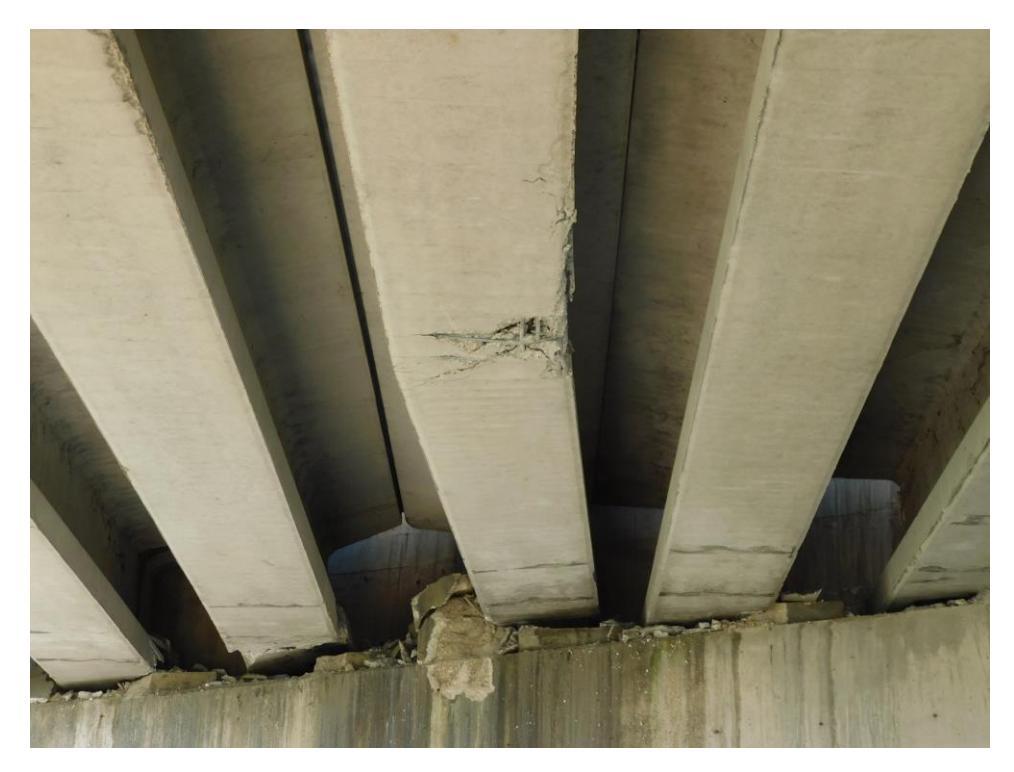
Fig. 4.2-11. Interior girder damage at end of precast girder, Bridge 2

Fig. 4.2-12. Close-up view of interior girder damage at end of precast girder, Bridge 2

Fig. 4.2-13. Significant interior girder damage at end of precast girder, Bridge 2

Fig. 4.2-14. Significant interior girder damage at end of precast girder, Bridge 2

Fig. 4.2-15. Closer view of significant interior girder damage at end of precast girder, Bridge 2

Fig. 4.2-16. Lateral/vertical bending and damage of interior girder at mid-span and shear key damage at girder end, Bridge 2

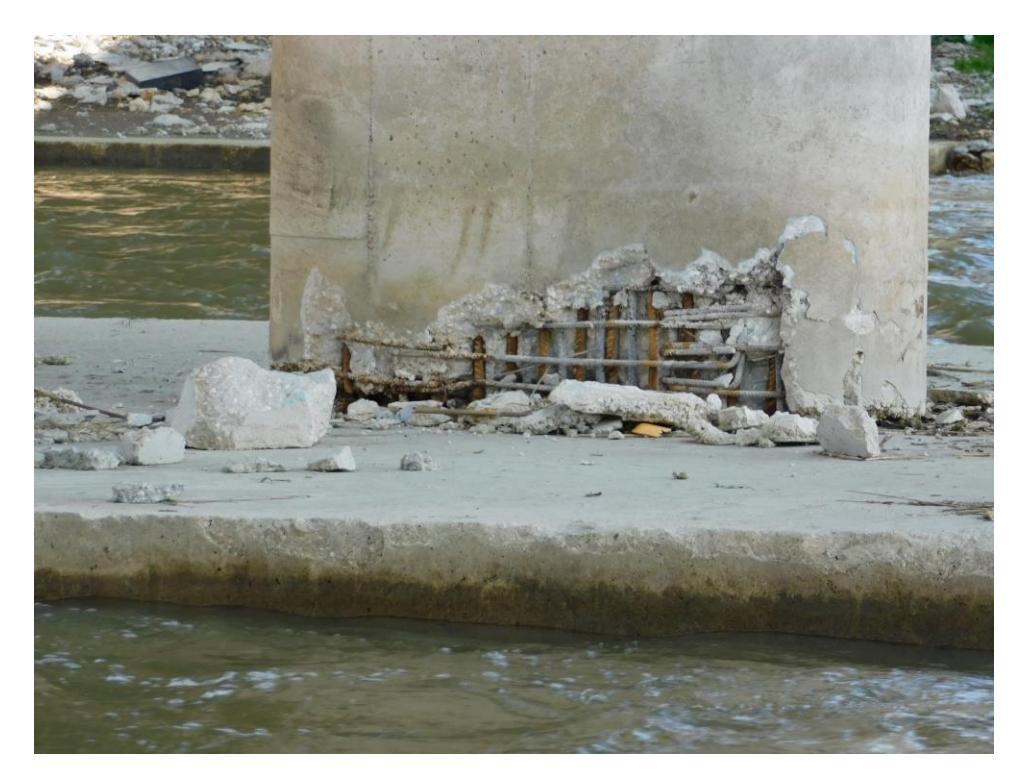
Plastic hinges developed at the base of the columns in the longitudinal direction, which is the weak column direction (Fig. 4.2-17). Settlement occurred at both approaches to the bridge (Figs. 4.2-18 and 4.2-19), requiring vehicles to slow down to enter and exit the structure. However, traffic should not be allowed on this bridge as it is just a matter of time before complete span collapses occur from continued traffic loading and/or earthquake aftershocks due to the poor condition at all of the girder ends.

Fig. 4.2-17. Plastic hinging at base of RC column, Bridge 2

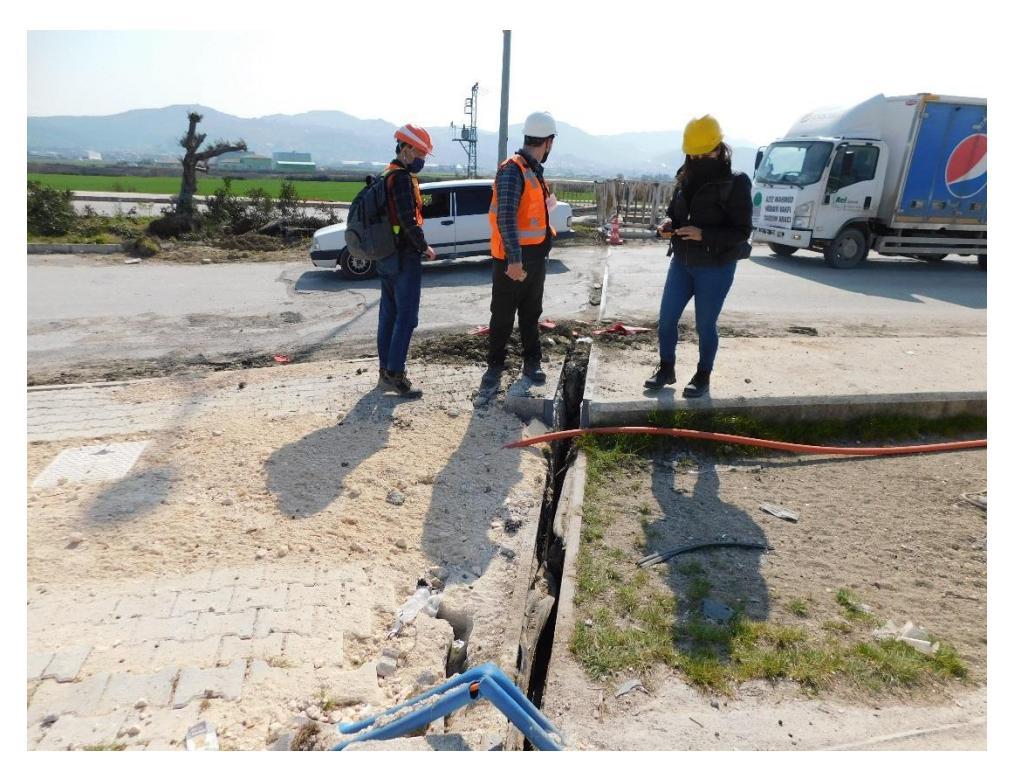
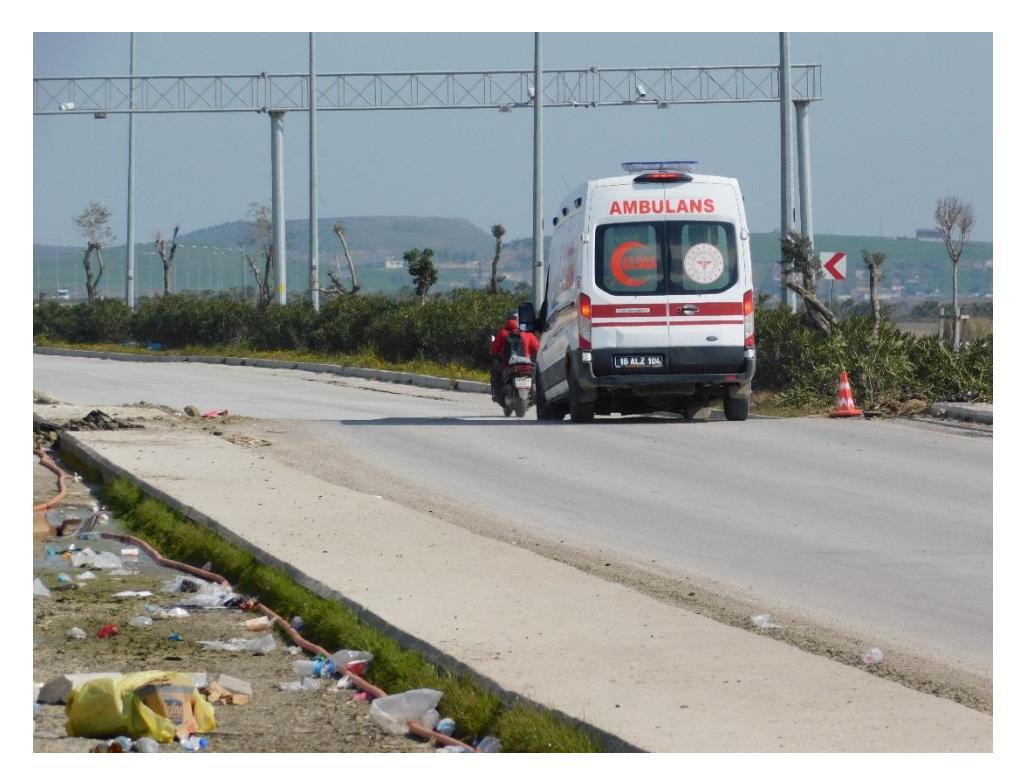
Fig. 4.2-18. Settlement of approach to bridge, View 1, Bridge 2

Fig. 4.2-19. Settlement of approach to bridge, View 2, Bridge 2

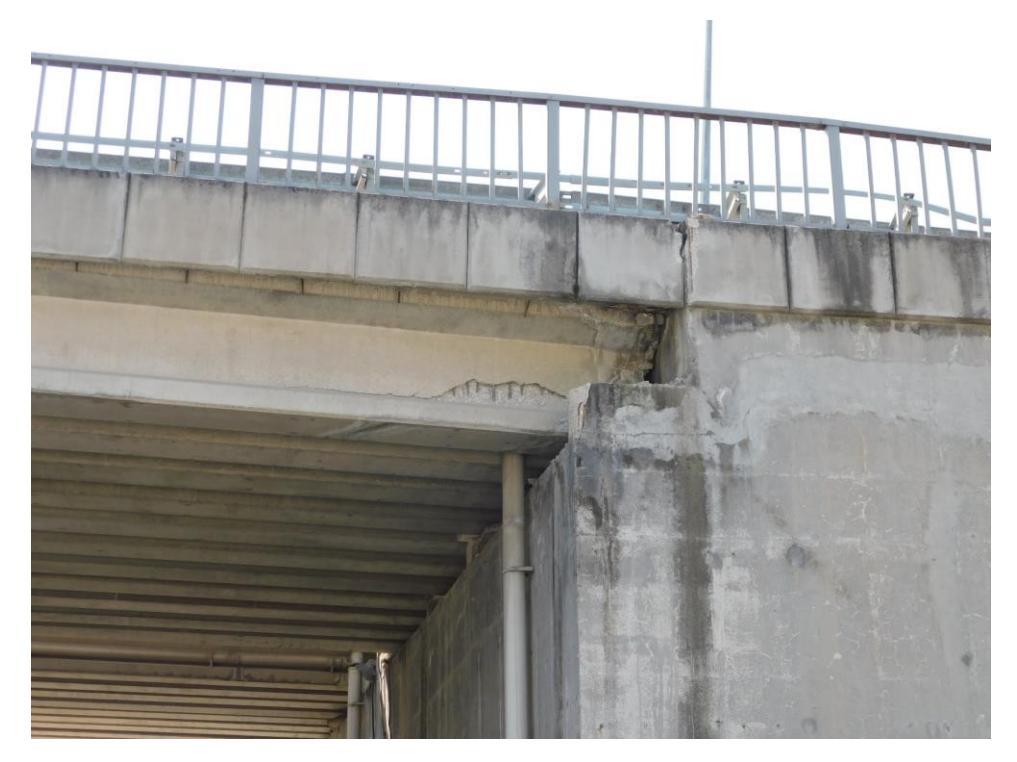
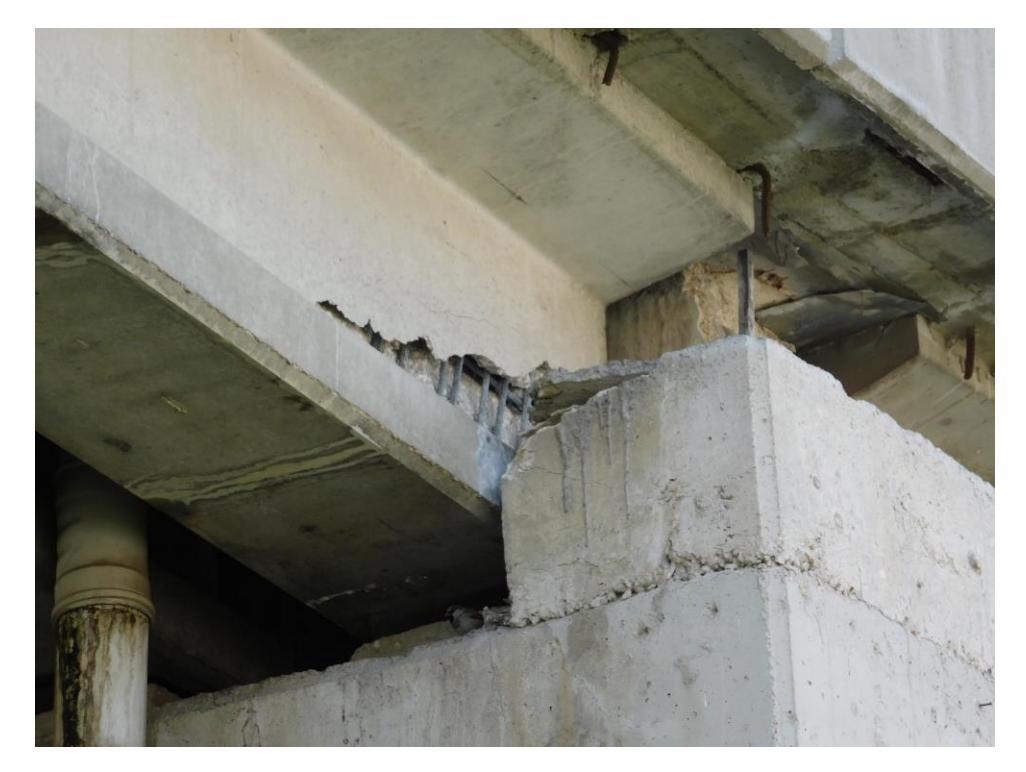
At the same time that the girders were being lifted off of their seats and slammed back down again, large horizontal and longitudinal forces were occurring, adding to the damage at the girder ends, and causing the shear key damage and failures that were observed (Figs. 4.3-5 and 4.3-6). Since the precast girders are only connected to each other through the cast-in-place (CIP) topping slab, they are free to move about almost independently of each other away from the deck. Adding at least one diaphragm along the length of each span would have helped the bridge move as a unit rather than as independent precast girders, which would have been even more important for Bridge 2.

Fig. 4.3-3. Damage at end of Bridge 3 precast girders

Fig. 4.3-4. Close-up view of damage at end of Bridge 3 precast girder
