SDSU STRUCTURAL ENGINEERING RESEARCH PROJECT

Report No. SERP - 23/03

Reconnaissance Report of Observed Structural Bridge Damage

M_w 7.8 Turkiye (Turkey) Earthquake of 2023

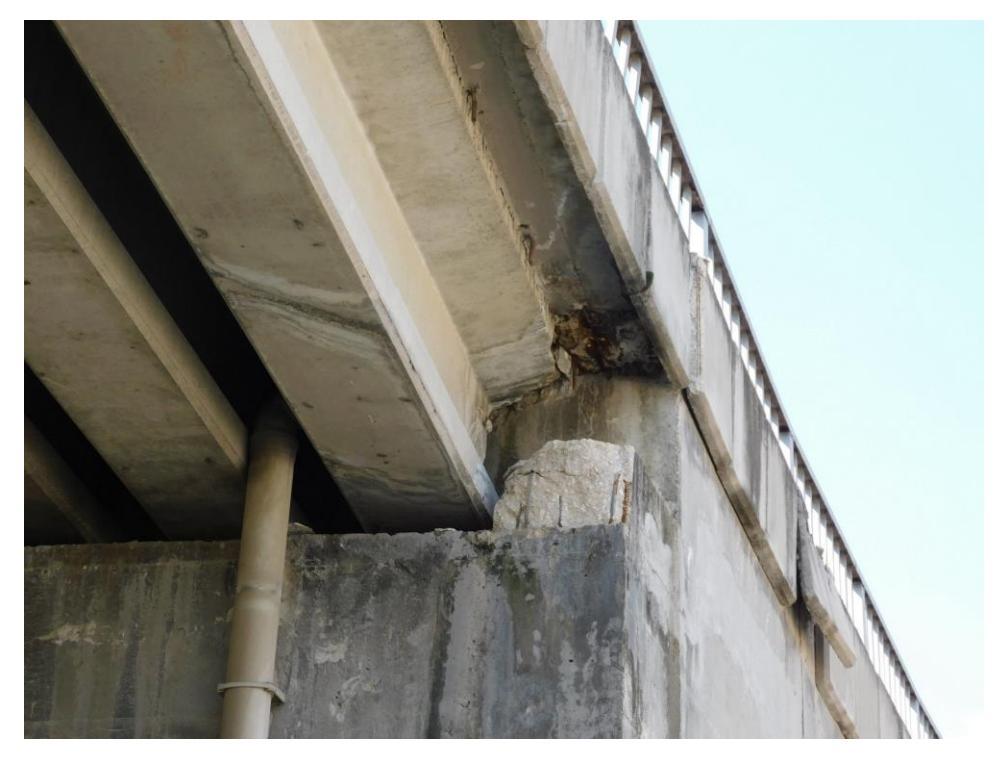
Fig. 4.3-5. Damage of external shear key at Bridge 3 abutment

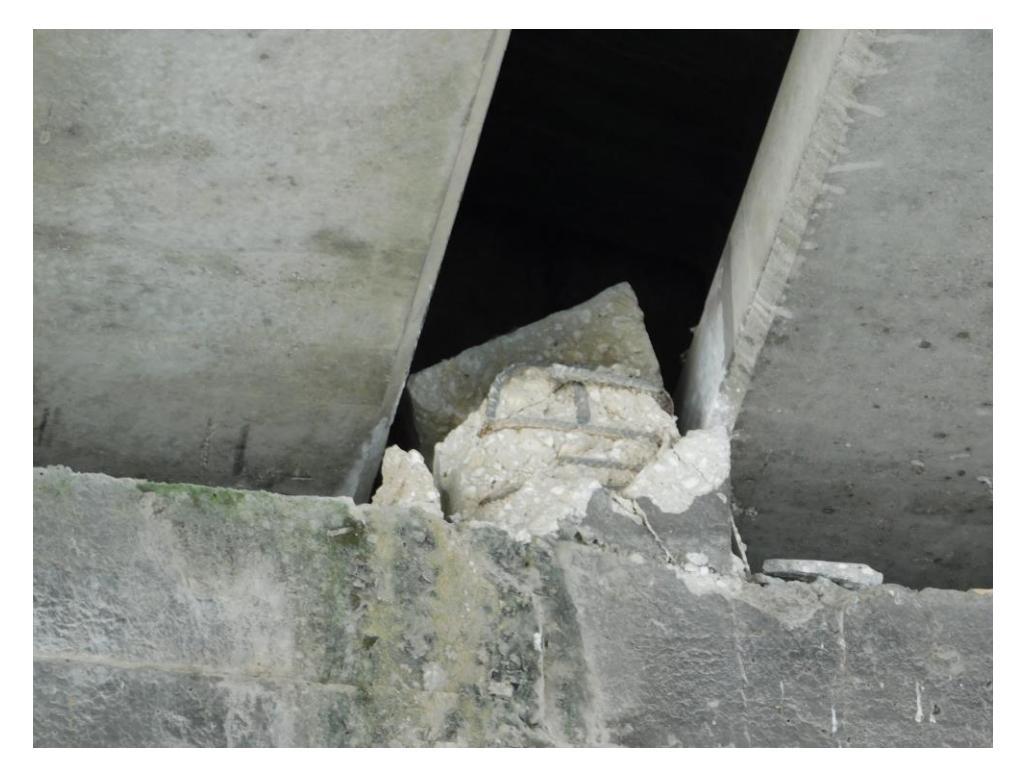
Fig. 4.3-6. Damage of internal shear key at bent of Bridge 3
