# Türkiye Earthquake

## **RECONNAISSANCE REPORT**

February 6, 2023 Kahramanmaraş-Pazarcık ( $M_w$ =7.7) and

Elbistan (M<sub>w</sub>=7.6) Earthquakes

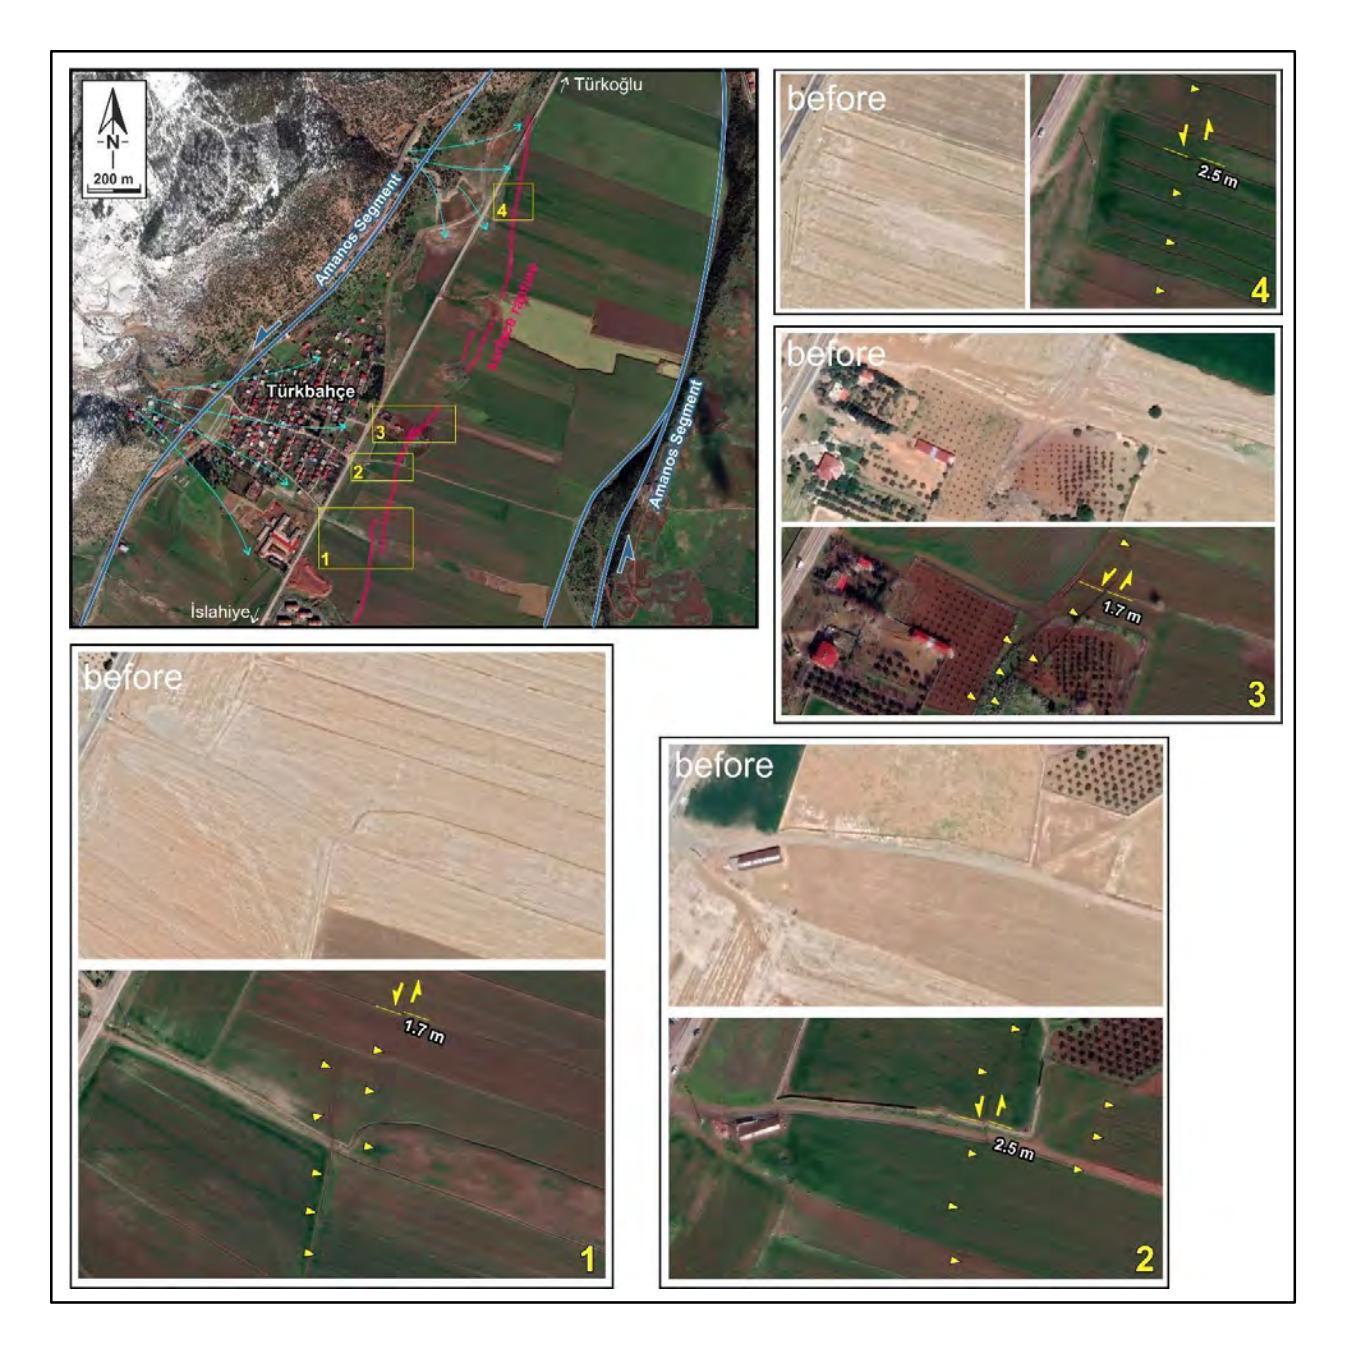
For example, surface faulting can be observed in the MAXAR satellite images of the Türkbahçe Village vicinity to the north of İslahiye (Figure 3.4). In this area, man-made features such as stabilized roads, farm borders, and walls are left-laterally displaced, which continues approximately 2 km in a general right-stepping geometry. Here, in this report, comparisons were made at points where the displacements were best observed using Google Earth (https://earth.google.com/) images, and in Figure 3.4. pre-and post-earthquake figures are presented. The measured displacement amount in these images reaches up to 2.5 m.

Figure 3.4. Satellite photos downloaded from MAXAR showing surface rupture and estimated displacements associated with the first event (Mw=7.8) between Türkoğlu and İslahiye (<u>https://www.maxar.com</u>).

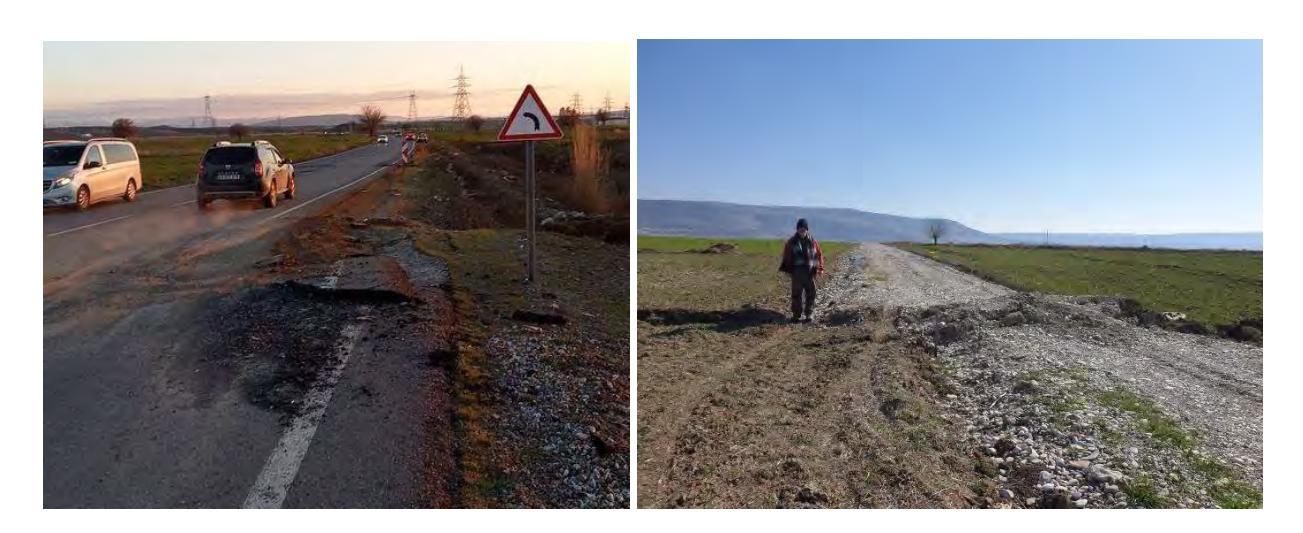
During the field observations, many deformation zones and offsets features were also documented along with the surface ruptures observed on the satellite images. Some of these are left-lateral offsets observed on the asphalt roads near Güzelyurt and Pazarcık, where the displacement is about 2.4 m (Figure 3.5). In addition, a left lateral displacement on the railway around İslahiye is developed on the Amanos segment after the Pazarcık earthquake (left panel of Figure 3.6). Similar field observations are also documented along the Sürgü segment. The left lateral offset observed on a garden fence reveals the lateral component of the Elbistan earthquake fault. The displacement amount measured at this point reaches up to 6.7 m (right panel of Figure 3.6).

**Figure 3.5.** Photos of the surface fault rupture of the Pazarcık earthquake (Mw=7.8) offsetting the roads near Güzelyurt and Pazarcık (taken by M. Tolga Yılmaz and Erdin Bozkurt respectively).

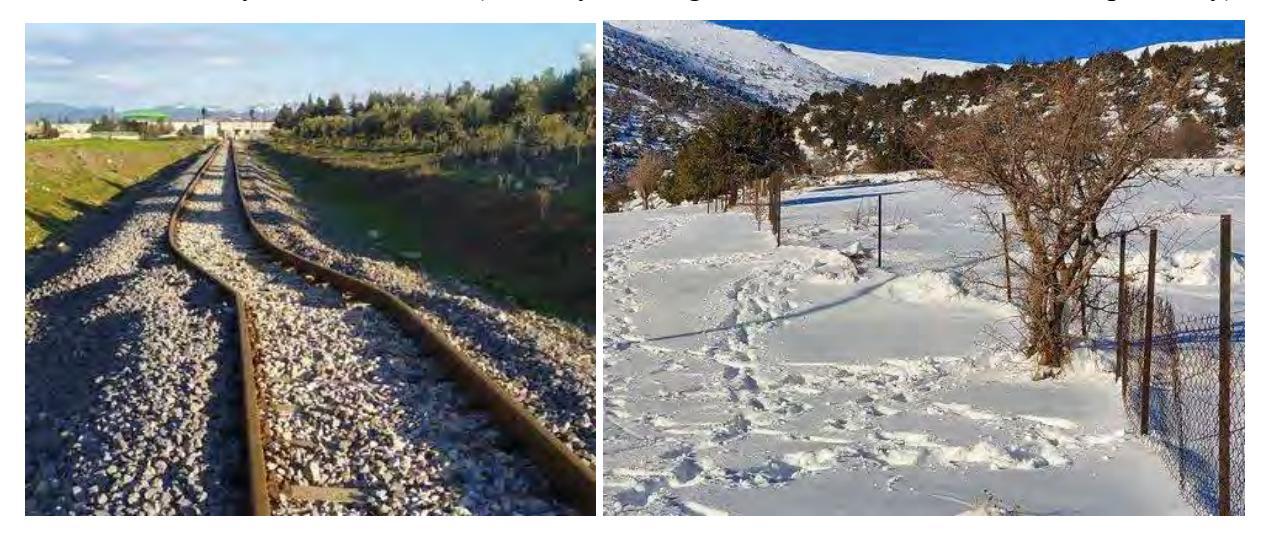
**Figure 3.6.** The photo on the left (taken by K. Önder Çetin) shows the deformation on the railroad track caused by the surface fault rupture of the Pazarcık earthquake ( $M_w$ =7.8) near İslahiye. The photo on the right (taken by Taylan Sançar) shows the 6.7 m fence offset along the Sürgü-Çardak fault that ruptured during the Elbistan earthquake ( $M_w$ =7.7).

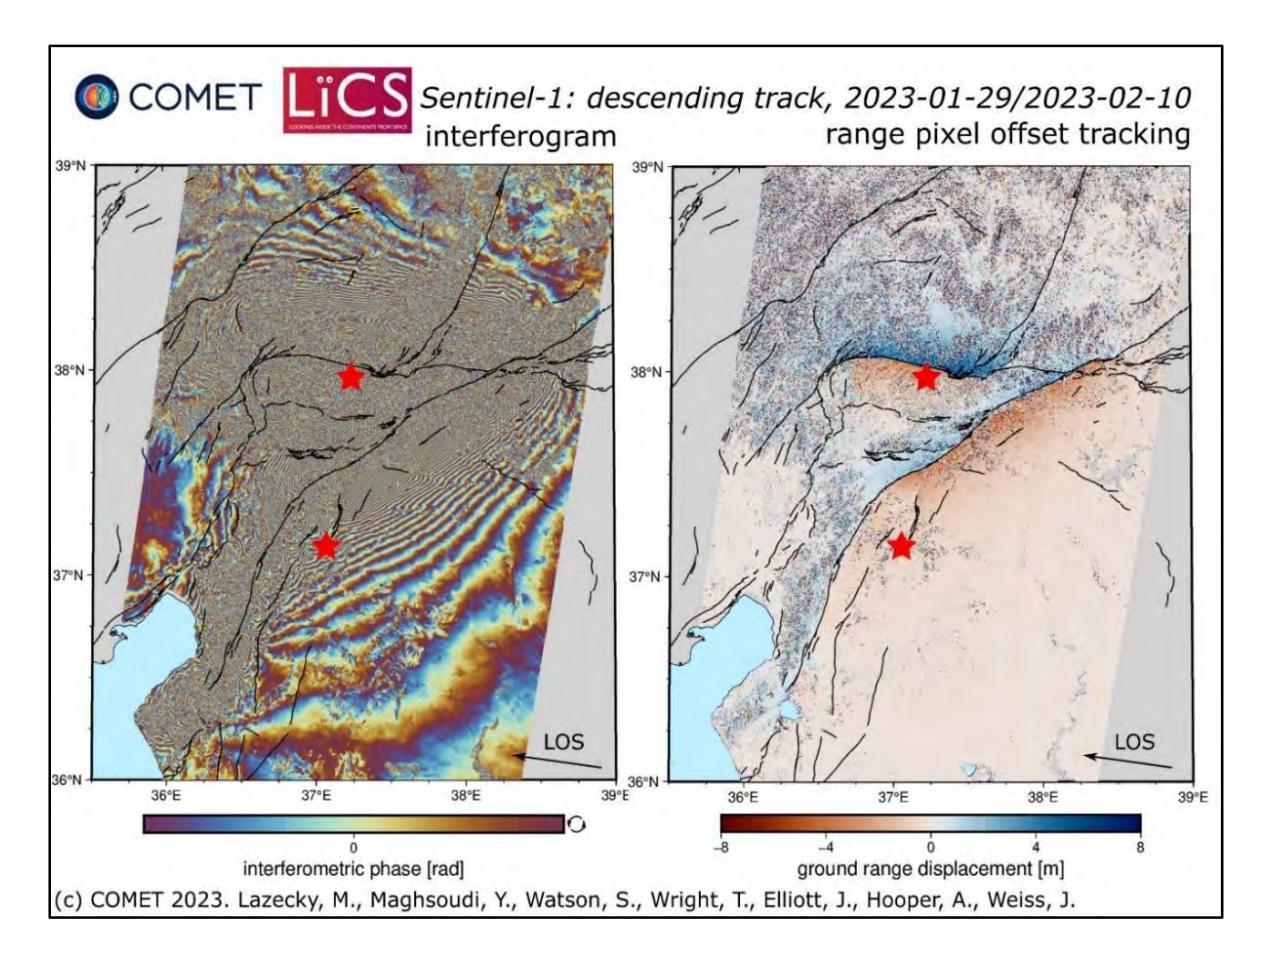
The deformation of the ground during the M7.8 Pazarcık and M7.7 Elbistan earthquakes was captured by satellite radar, which reveals a detailed picture of the large-scale motions of the earth's surface as a result of the earthquakes. Figure 3.7 shows the first interferogram, with colored fringes indicating how the ground has moved towards or away from the satellite between two data acquisitions (on the 29<sup>th</sup> of January and the 10<sup>th</sup> of February 2023). The range pixel offset tracking in Figure 3.7 (right panel), shows the ground displacement in meters, with greater intensity of color indicating larger displacements.

Preliminary data suggest greater displacement across the NE segments of the EAFZ fault during the M7.8 Pazarcık earthquake on the order of 3 - 7 m and relatively lower displacements on the fault segment directly above the hypocenter. The M7.7 Elbistan earthquake has displacements of 2 - 8 m, greatest in the central section of the Sürgü segment, close to the earthquake hypocenter. These are the preliminary results, and much greater detail can be achieved with future modeling of the data. The geodetic data show that many of the segments identified in Figure 3.1 were active in the two earthquakes and hosted significant displacement over rupture lengths of 300 km and 100 km, respectively (Figure 3.7).

**Figure 3.7.** Sentinel-1 interferogram and range pixel offset tracking showing the ground deformation that occurred during the M7.8 Pazarcık and M7.7 Elbistan earthquakes (epicenters indicated by red stars). Figure from COMET (Centre for the Observation and Modelling of Earthquakes, Volcanoes, and Tectonics, 2023; courtesy of Lazecky, M., Maghsoudi, Y., Watson, S., Wright, T., Elliott, J., Hooper, A., and Weiss, J; method from Lazecky et al., 2020).

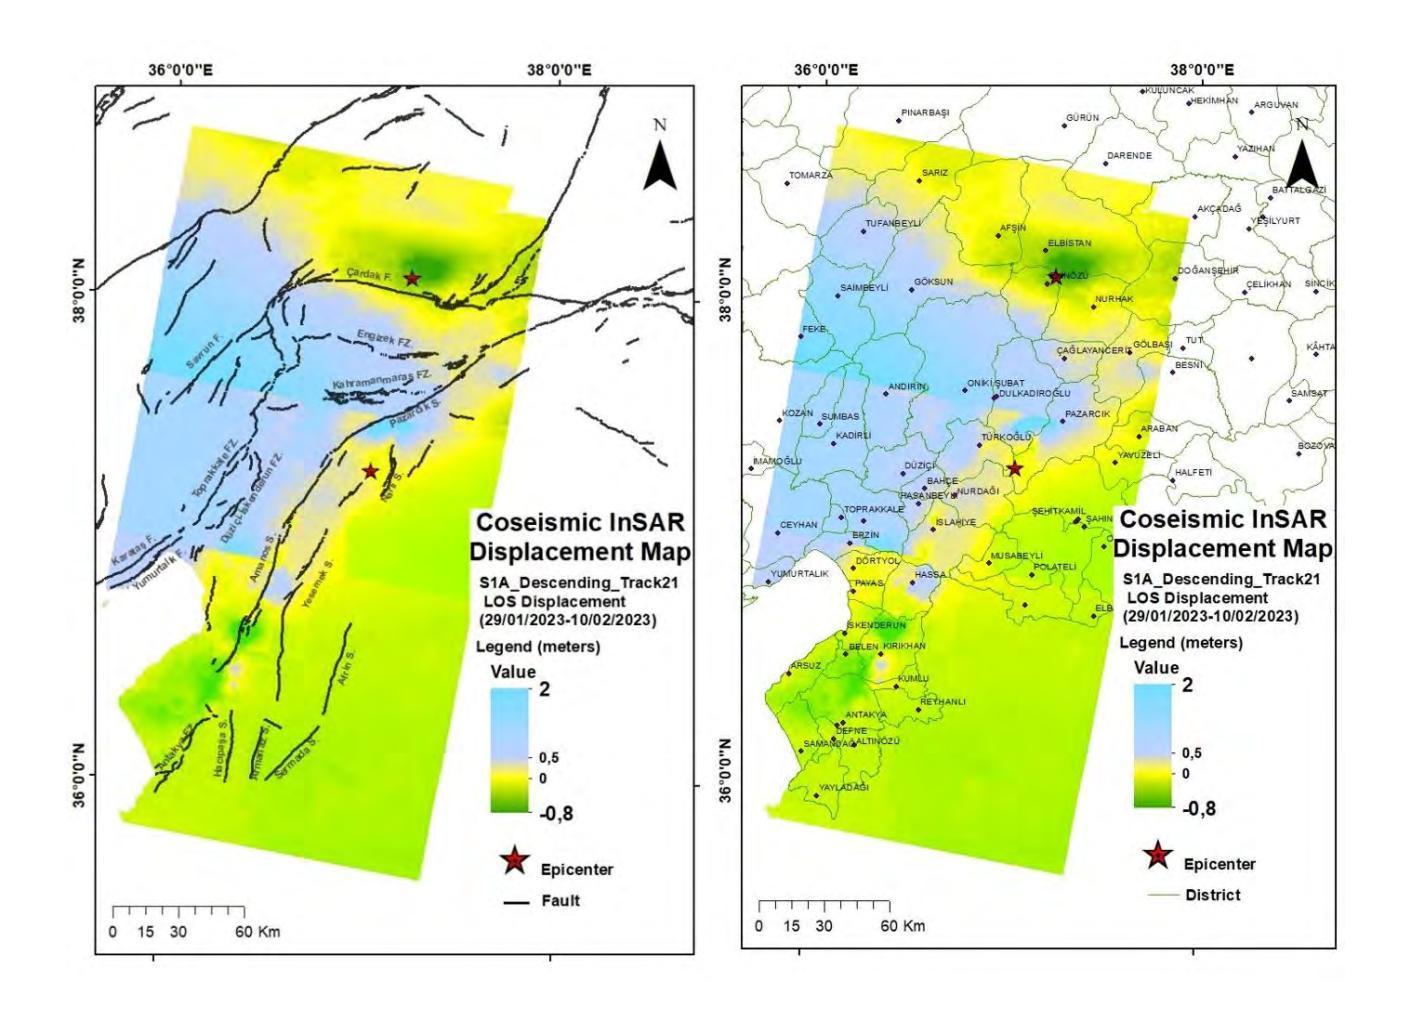
In the deformation map generated using the scenes acquired 4 days after the event, the displacement signal in the InSAR data showed up to 2 meters of uplift and up to 0.5 meters of subsidence zones indicating where the earthquakes took place. A slight subsidence was observed along the East of Yesemek and Narlı Segments of the Ölüdeniz Fault Zone. In addition, subsidence zones were apparently observed as about -0.8 meters along the fault line of the DAF Amanos Segment. In the north, deformations were also observed above -0.5 meters in the north of the Çardak Fault (Figure 3.9).

**Figure 3.9.** On the left panel, Sentinel 1 A Track 21 descending coseismic displacement map between 29/01/2023 -10/02/2023 dates. On the right panel, S1A Track 21 descending coseismic displacement map with district vector data.

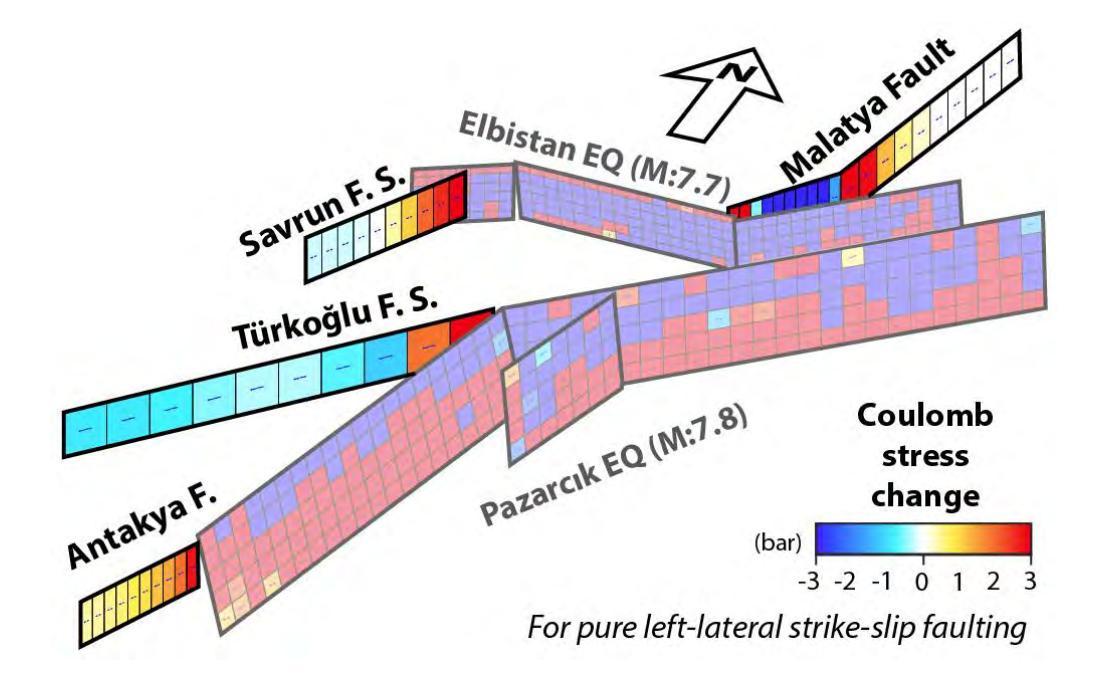
**Figure 3.10.** Coulomb static stress change on the neighboring fault segments after the recent earthquake sequence. Calculations made for left-lateral strike-slip faults using finite fault solutions computed by USGS.

At the time of writing this text, another earthquake with M6.3 occurred on 20 February 2023 along the Orontes (Antakya) fault segment near Samandağ, Hatay and caused additional panic. As mentioned previously, this event took place along the fault segment where especially M7.8 Pazarcık earthquake transferred up to 3 bar of additional static stress (Figure 3.10).

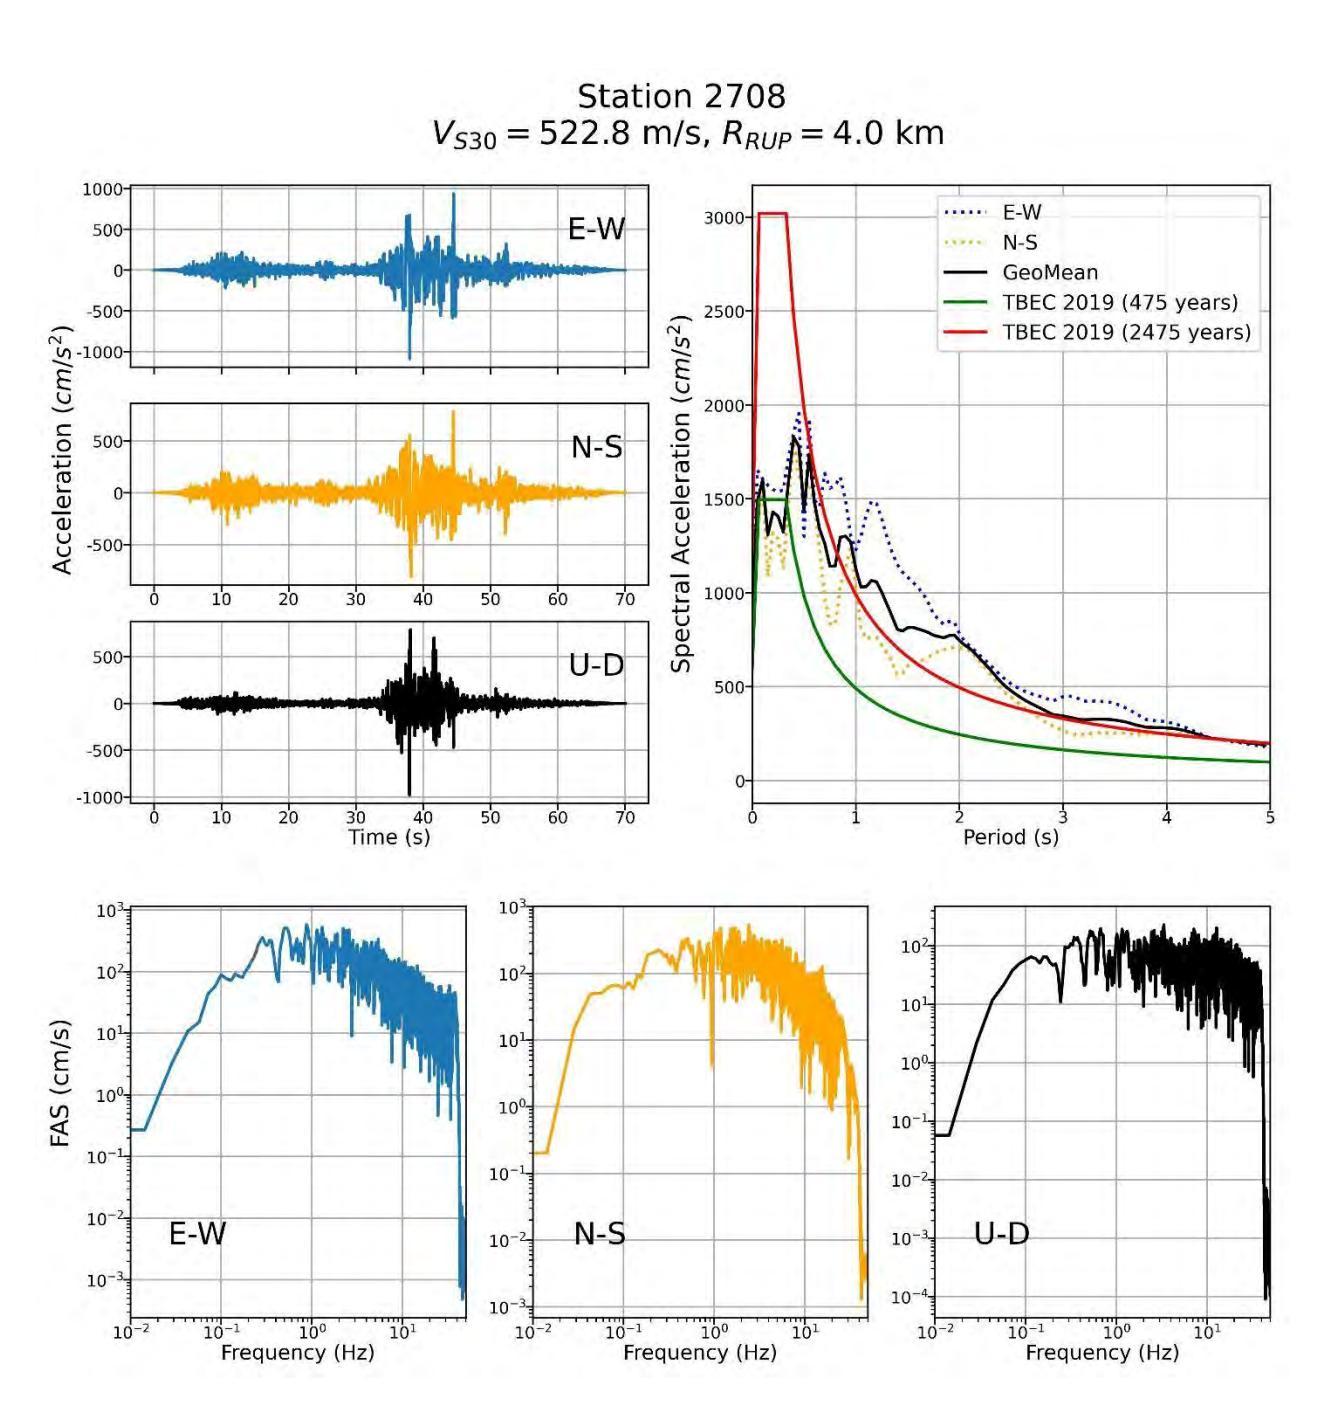
**Figure 4.8.** Recorded three-component ground accelerations, corresponding Fourier amplitude spectra (FAS) and response spectra (with 5% damping) in comparison with the most recent building code (TBEC, 2019) at selected station 2708 due to Pazarcik (Mw=7.7) event

Station 2708 is located in Islahiye, Gaziantep, on a site with NEHRP site class C (site class ZC of TBEC, 2019) and at a rupture distance of 4 km. We note that multiple wave packets were observed in the accelerogram. Both the FAS and response spectra were computed based on the entire time series, including all wave packets provided by AFAD. The maximum horizontal PGA is recorded in the EW direction as 1089 cm/s<sup>2</sup>, while the vertical PGA value was recorded as 977 cm/s<sup>2</sup>. The broadband nature of the response spectrum is attributed to the multiple wave

packets observed in this large event. Response spectra from both horizontal components show peaks in the short period range. Despite being located on stiff soil conditions; the response spectra of the EW component show clear amplifications also in the longer periods with a particular peak around 1.2 seconds. The geometric mean of two horizontal response spectra exceeds the design spectrum corresponding to a return period of 475 years at almost all periods. The same geometric mean exceeds the design spectrum for a return period of 2475 years for periods longer than 0.7 seconds. We note that the most destruction was concentrated in this region based on the first observations in the field.

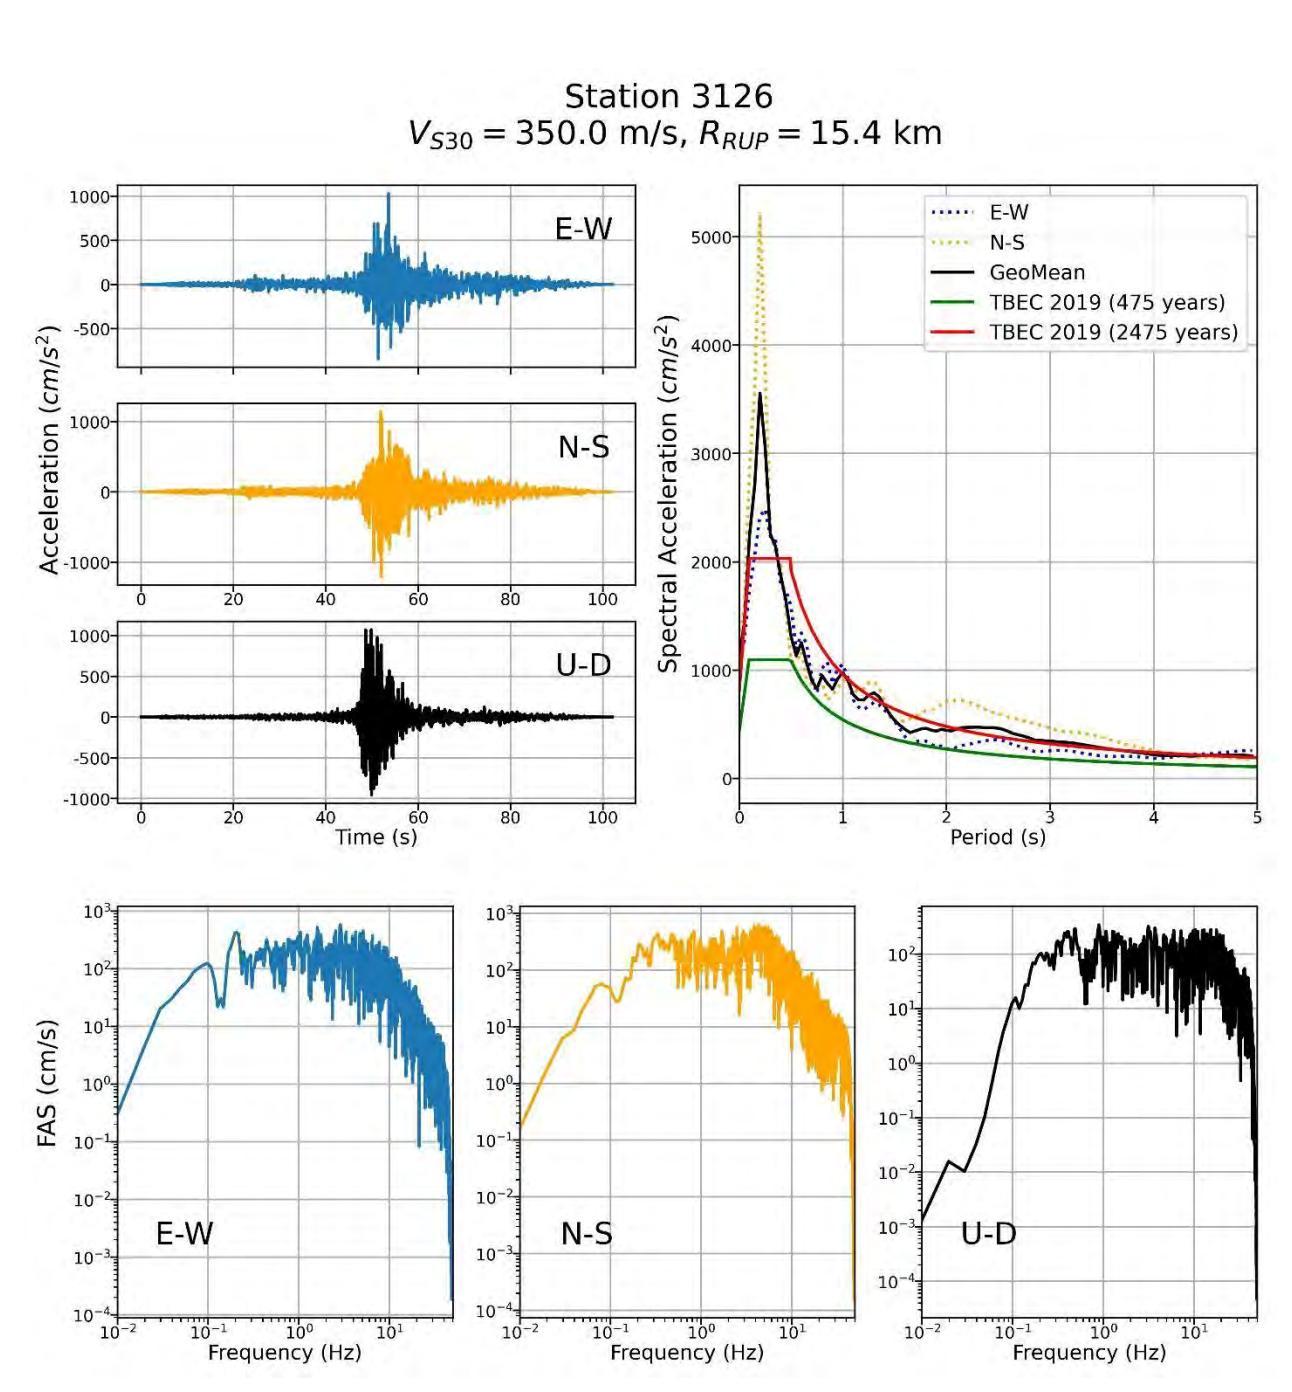
**Figure 4.9.** Recorded three-component ground accelerations, corresponding Fourier amplitude spectra (FAS) and response spectra (with 5% damping) in comparison with the most recent building code (TBEC, 2019) at selected station 3126 due to Pazarcik (Mw=7.7) event

Station 3126 is located in Antakya, on a site with NEHRP site class D (site class ZD of TBEC, 2019) with a rupture distance of 15.4 km. The maximum horizontal PGA is recorded in the NS direction as 1210 cm/s<sup>2</sup>. The vertical PGA value is 1070 cm/s<sup>2</sup>. We observe that the acceleration recorded in the vertical direction are similar to those recorded in the horizontal direction in terms of frequency and amplitude content. The response spectra of both EW and NS components indicate amplifications around 0.3 seconds and both exceed the design spectrum for a return period of 475 years. The geometric mean is above the design spectrum for a return period of 2475 years for periods less than 0.4 seconds and below for longer periods.

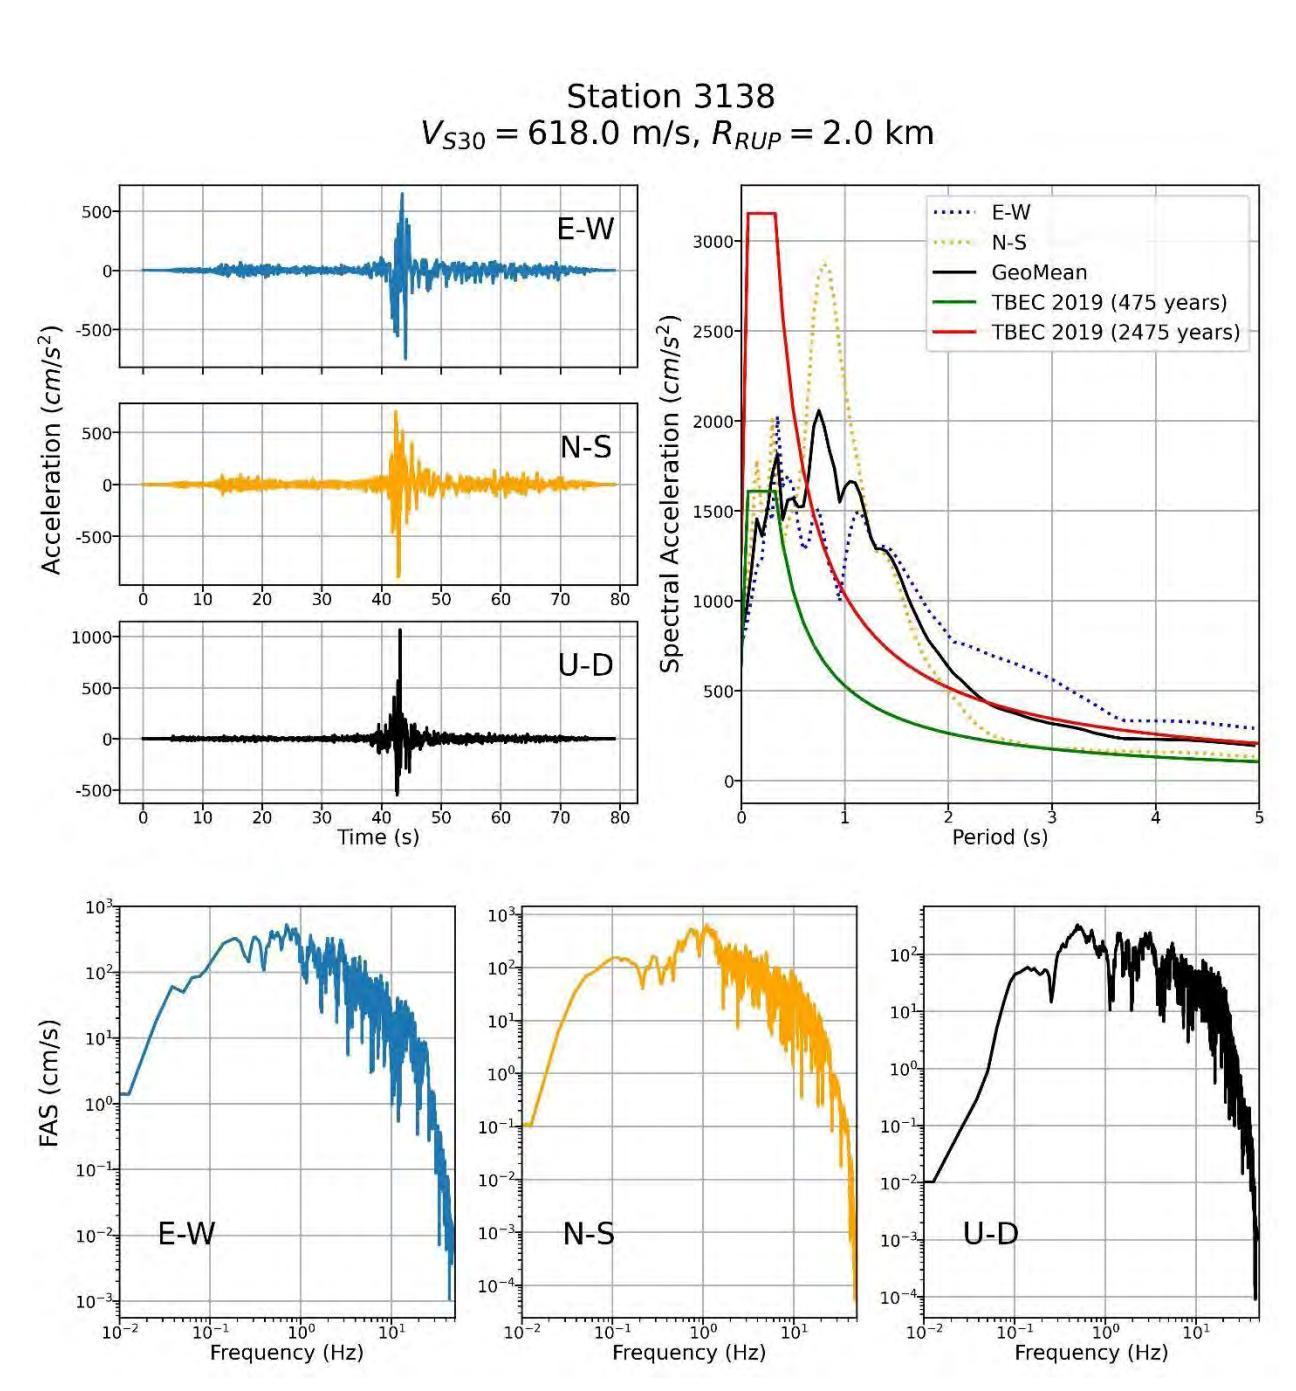
**Figure 4.10.** Recorded three-component ground accelerations, corresponding Fourier amplitude spectra (FAS) and response spectra (with 5% damping) in comparison with the most recent building code (TBEC, 2019) at selected station 3138 due to Pazarcik (Mw=7.7) event

Station 3138 is located in Hassa, Hatay on a site with NEHRP site class C (site class ZC of TBEC, 2019) with a rupture distance of 2 km. The acceleration records suggest potential directivity effects. When velocities are investigated, this record indicates forward directivity effects characterized by short-duration and high-amplitude, two-sided long-period velocity pulses. The geometric mean of horizontal response spectra indicates broadband period content and exceeds the design spectrum for a return period of 475 years for periods longer than 0.4 seconds.

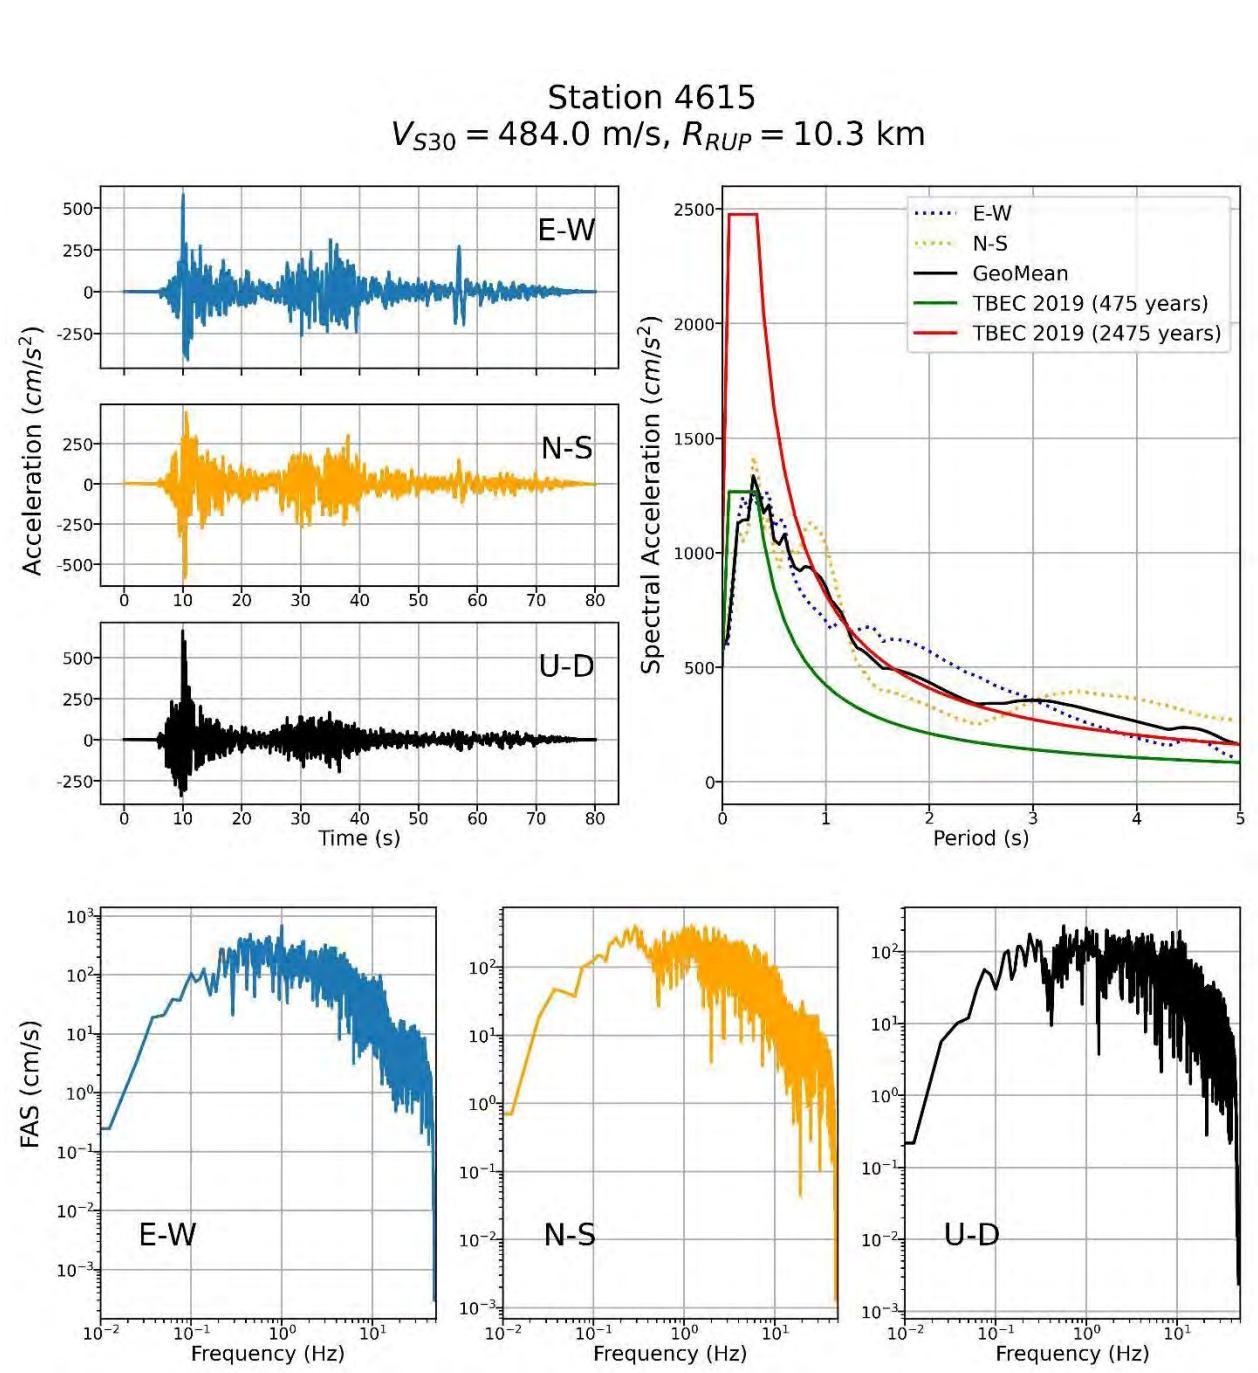
**Figure 4.11.** Recorded three-component ground accelerations, corresponding Fourier amplitude spectra (FAS) and response spectra (with 5% damping) in comparison with the most recent building code (TBEC, 2019) at selected station 4615 due to Pazarcik (Mw=7.7) event

Station 4615 is located in Pazarcik on a site with NEHRP site class C (site class ZC of TBEC, 2019) at a rupture distance of 10.3 km. This record also displays broadband response spectra, possibly due to the multiple wave packets. The maximum PGA value is recorded in the vertical component as 664 cm/s<sup>2</sup>. The geometric mean spectrum is observed to exceed the 475-year design spectrum at periods larger than 0.5 s, and it is shown to be similar to the 2475-year design spectrum at periods larger than 1 s.

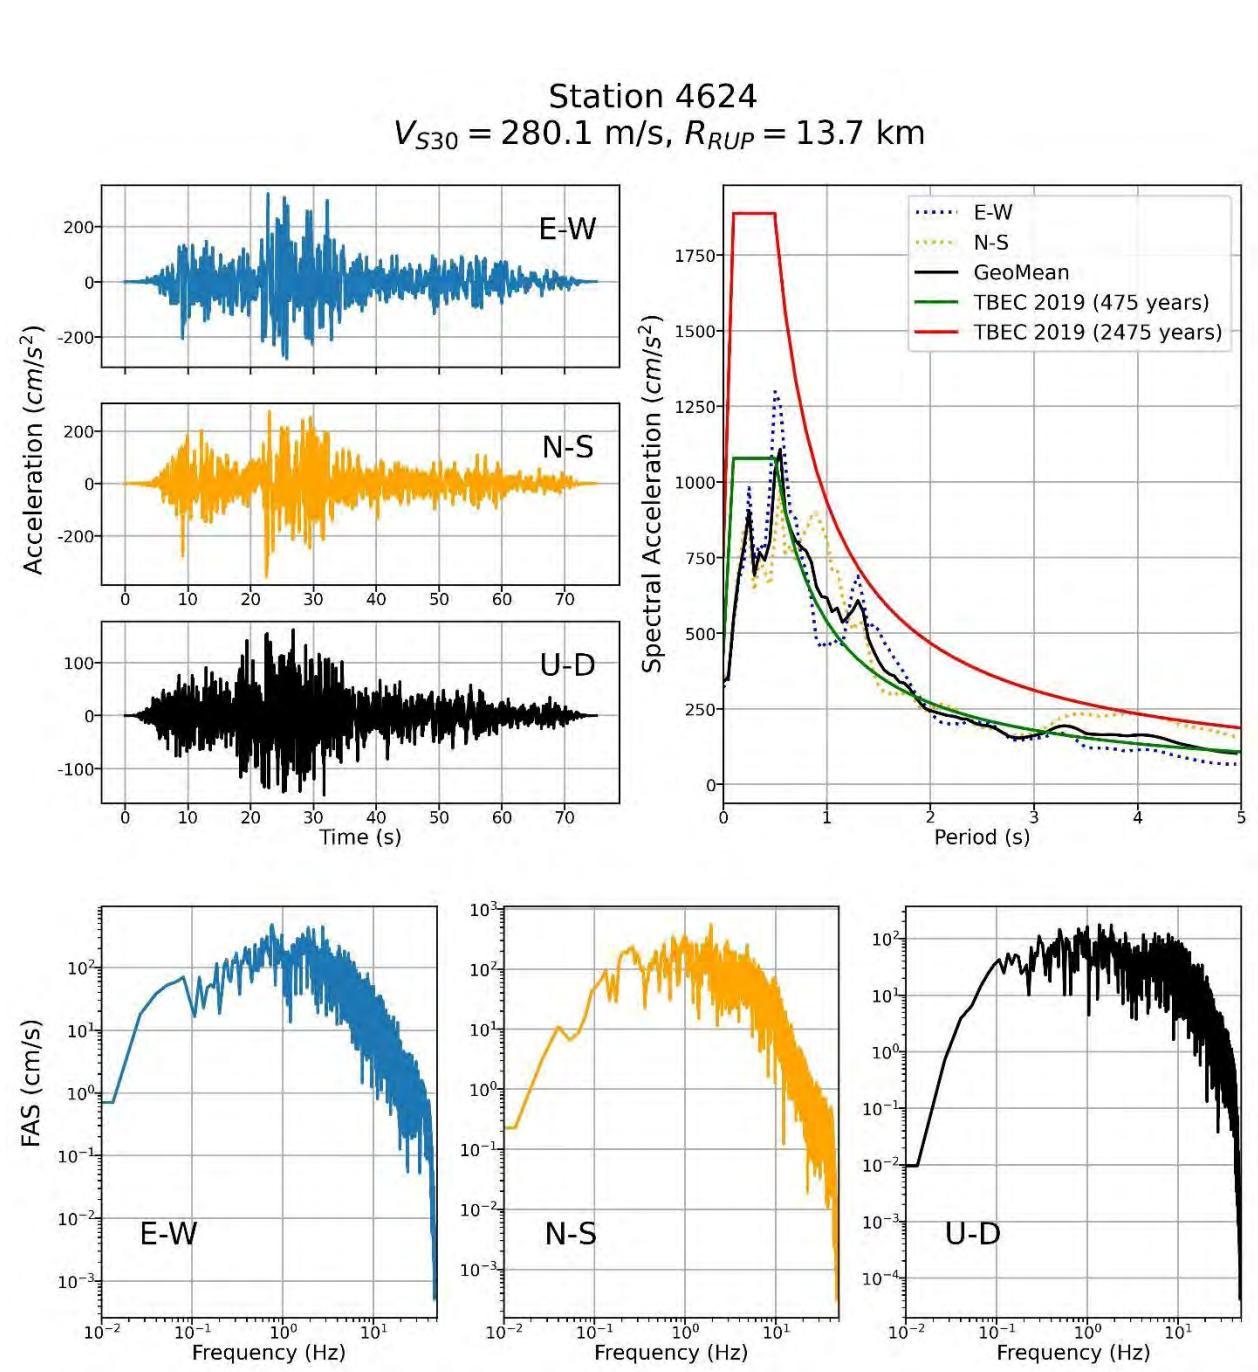
**Figure 4.12.** Recorded three-component ground accelerations, corresponding Fourier amplitude spectra (FAS) and response spectra (with 5% damping) in comparison with the most recent building code (TBEC, 2019) at selected station 4624 due to Pazarcik (Mw=7.7) event

Station 4624, located in Onikisubat, Kahramanmaraş on a NEHRP site class D (site class ZD of TBEC, 2019) at a rupture distance of 13.7 km. The maximum horizontal PGA of 357 cm/s<sup>2</sup>, which is relatively lower than the values at other stations. However, the geometric mean of the

horizontal response spectra still exceeds the design spectrum for a return period of 475 years at periods longer than 0.7 seconds. The broadband content of the response spectra is consistent with the multiple wave packets observed in the accelerogram.

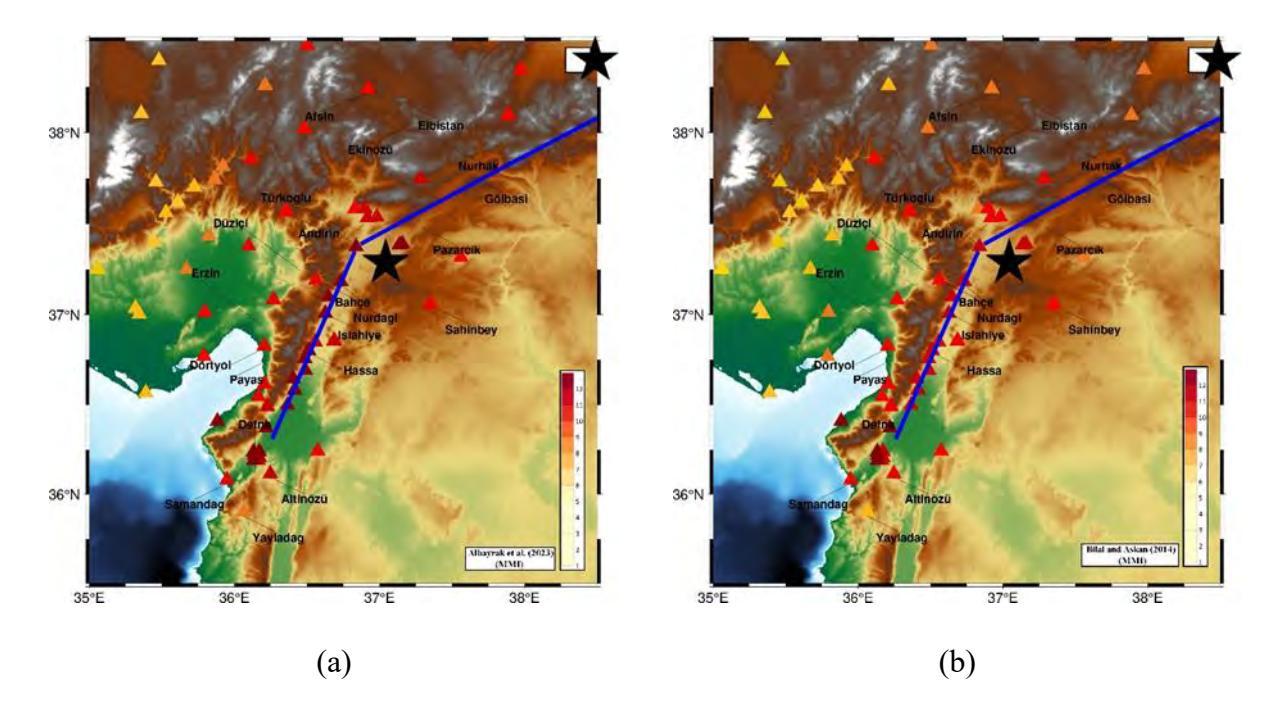
MMI levels can be related to anticipated damage levels. These damage levels are approximately moderate damage, moderate-to-severe damage and severe damage or total collapse as MMI levels of VI-VIII, VIII-X, and X-XII, respectively. Figure 4.13 shows the station-based MMI levels for Pazarcik Earthquake. Locations in the close vicinity of the epicenter exhibit MMI levels between X and XII. Figure 4.14 shows the station-based MMI levels for Elbistan earthquake. Locations in the close vicinity of the epicenter VIII and X.

It should be underlined that the Pazarcik earthquake had severe seismic effects not only around the epicenter but also along the surface rupture. In contrast, the MMI levels for Elbistan earthquake imply moderate-to-severe damage around the epicenter. It is important to note that MMI levels presented here express the effects of these two events independently. However, the occurrence of two large consecutive earthquakes in a relatively short time undoubtedly increased the damage levels in the structures located in the region. Finally, for regions with mid- and high-rise flexible reinforced concrete structures, PGV-based ground motion to intensity conversion equations should also be examined (Albayrak et al. 2023; Erberik, 2008a; Erberik, 2008b).

**Figure 4.13.** Station based MMI levels for Pazarcik earthquake using recorded PGA values for (a) Equation 4.1 and (b) Equation 4.2.

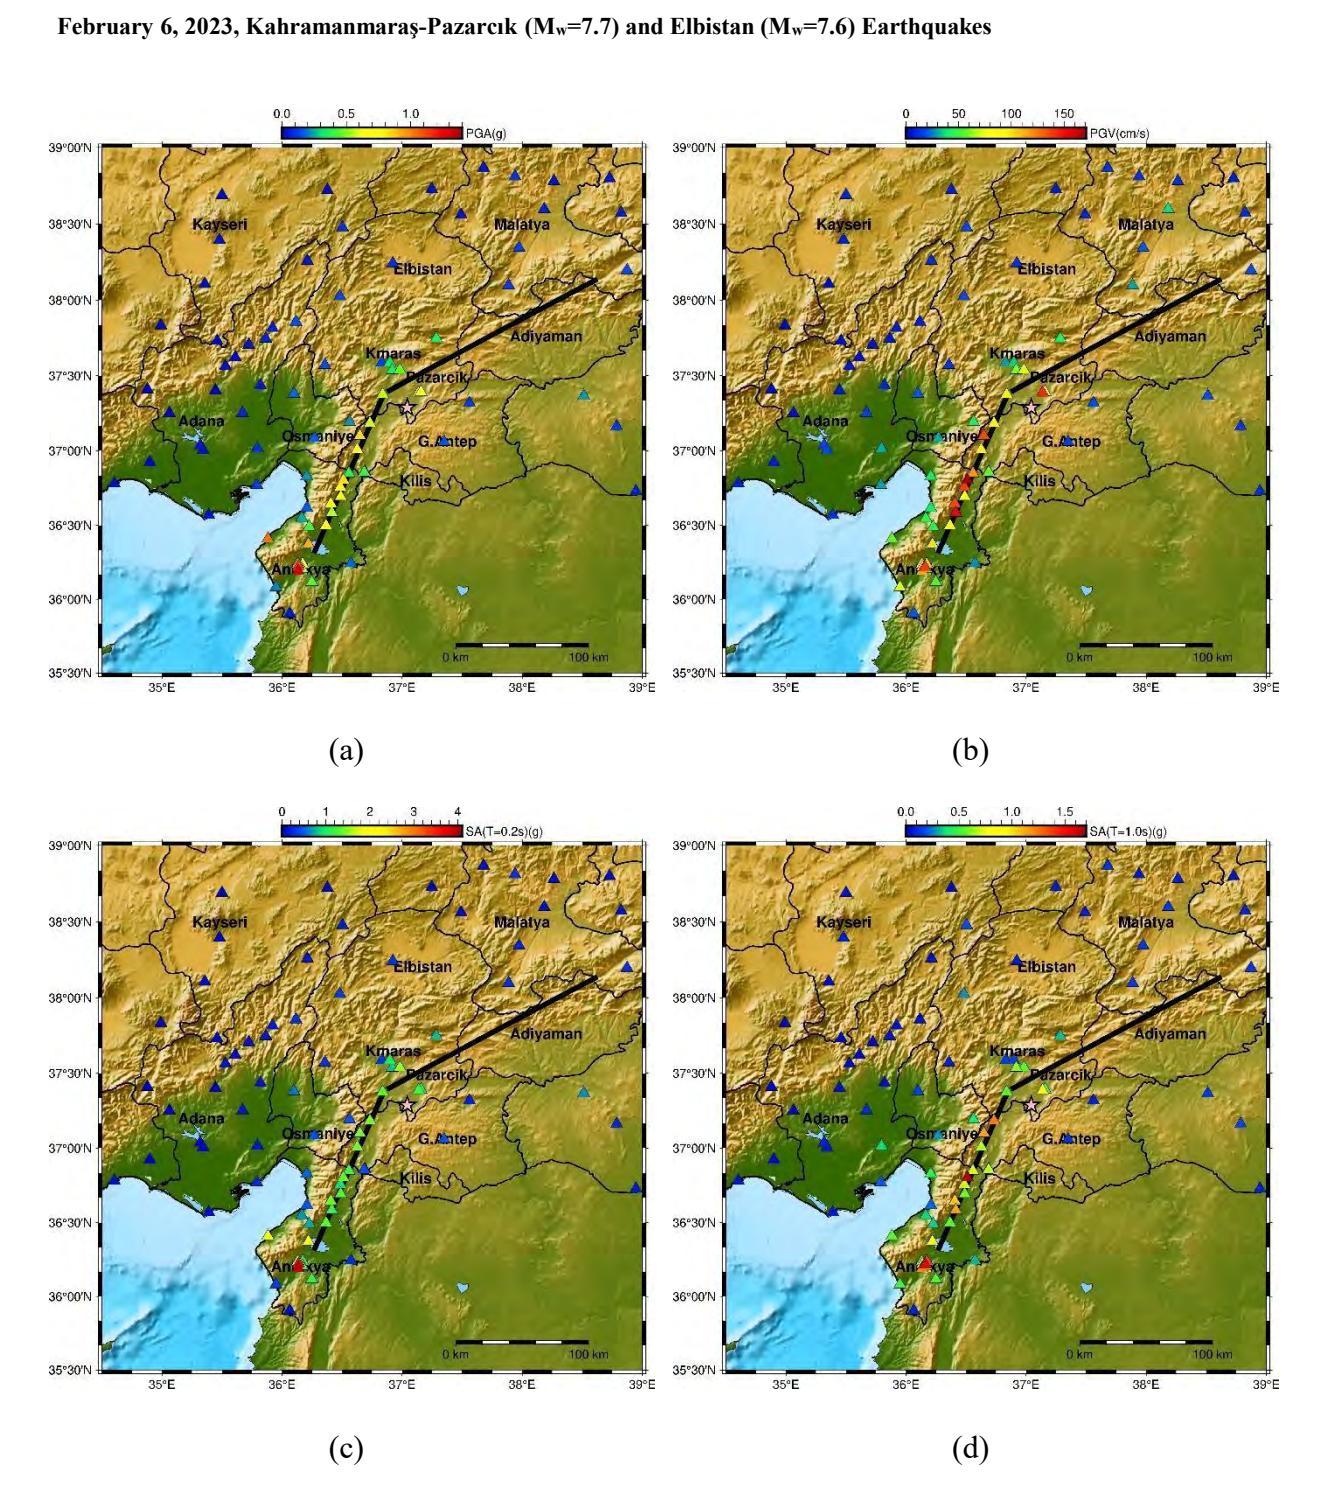
The spatial distribution of peak and spectral accelerations for the Pazarcik and Elbistan earthquakes is shown in Figures 4.15 and 4.16, respectively. Upon investigation of Figure 4.15, it becomes apparent that the highest PGA values are recorded in Antakya. In addition, very high PGA values between 500-1000 cm/s<sup>2</sup> are observed generally in the North-South direction, covering the provinces of Kahramanmaraş, Gaziantep, Osmaniye, Kilis and Hatay. The distribution of PGV and short-period spectral acceleration (at T=0.2 s) values are more homogeneous compared to the PGA, with very high intensities at all stations close to the rupture. Finally, the higher long-period spectral acceleration values (at T=1 s) observed in Antakya indicate potential forward directivity effects. As for the Elbistan earthquake (M<sub>w</sub>=7.6), it is not as densely-recorded as the Pazarcik (M<sub>w</sub>=7.7) event. As the rupture is located to the north of the first event (Figure 4.16), the effects of this event are felt more noticeably in the northern provinces, in addition to Kahramanmaraş, such as Adıyaman, Malatya and Kayseri. The highest ground motion intensities are generally observed in Kahramanmaraş.

**Figure 4.15.** Spatial distribution of intensity measure of Pazarcik earthquake (a) PGA, (b) PGV, (c) T=0.2 s PSA and (d) T=1.0 s PSA
