# Türkiye Earthquake

## **RECONNAISSANCE REPORT**

February 6, 2023 Kahramanmaraş-Pazarcık ( $M_w$ =7.7) and

Elbistan (M<sub>w</sub>=7.6) Earthquakes

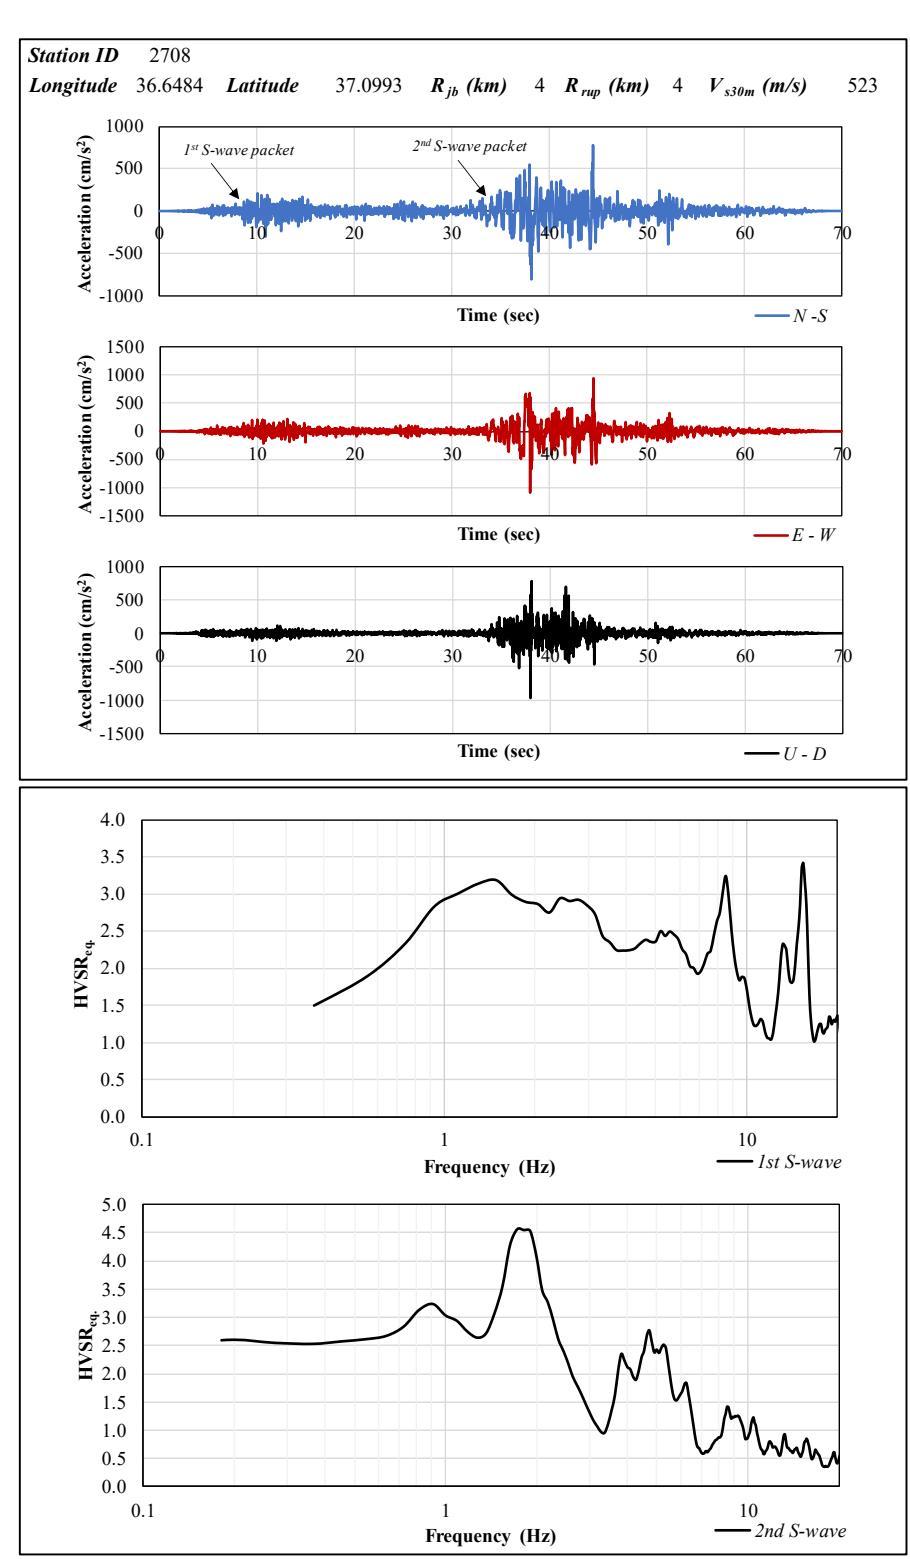
- Station 2708 (Figure 4.27) is located on either a very dense soil or a very soft rock site, where the V<sub>s,30m</sub> is 523 m/s and HVSR indicates peaks around 1.5 Hz (T=0.67 sec) and 7.5 Hz (T=0.13 sec) for the 1<sup>st</sup> S-wave portion and relatively low frequency 1.9 Hz (T=0.53 sec) and 5.0 Hz (T=0.2 sec) peak for the 2<sup>nd</sup> S-wave portion.

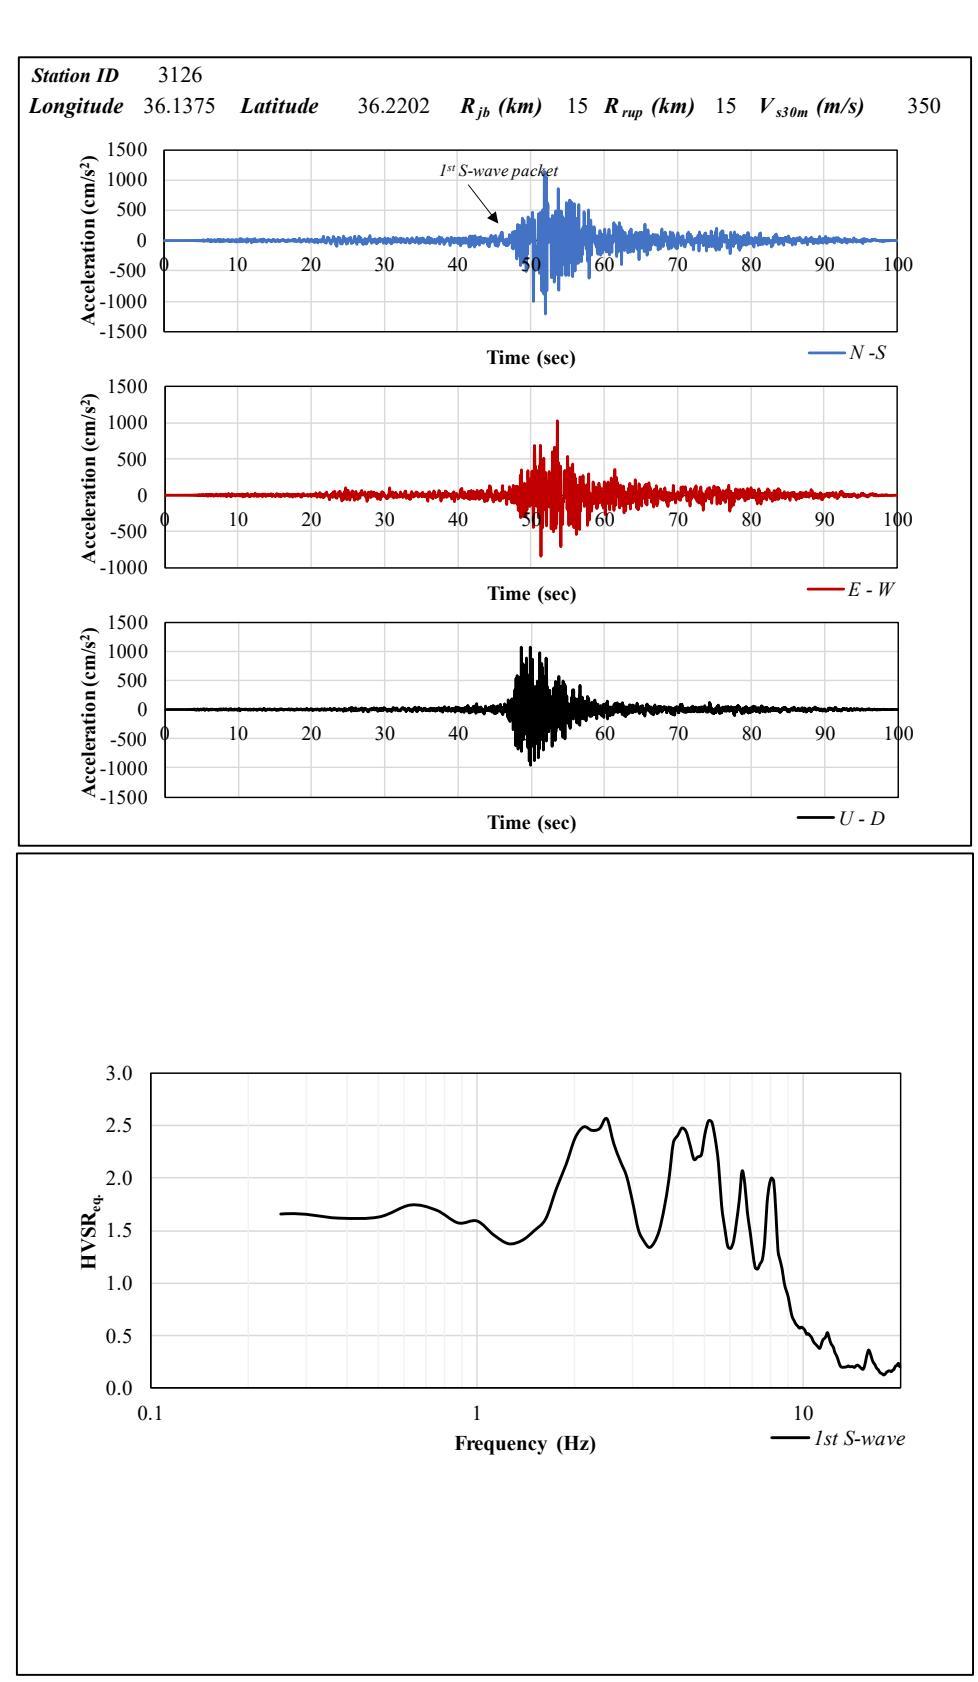
Figure 4.28. Resulting HVSR curve for station 3126

- Station 3126 (Figure 4.28) is located on a stiff soil site, where the V<sub>s,30m</sub> is 350 m/s and HVSR indicates peaks around 2.4 Hz (T=0.42 sec) and 5.3 Hz (T=0.19 sec).

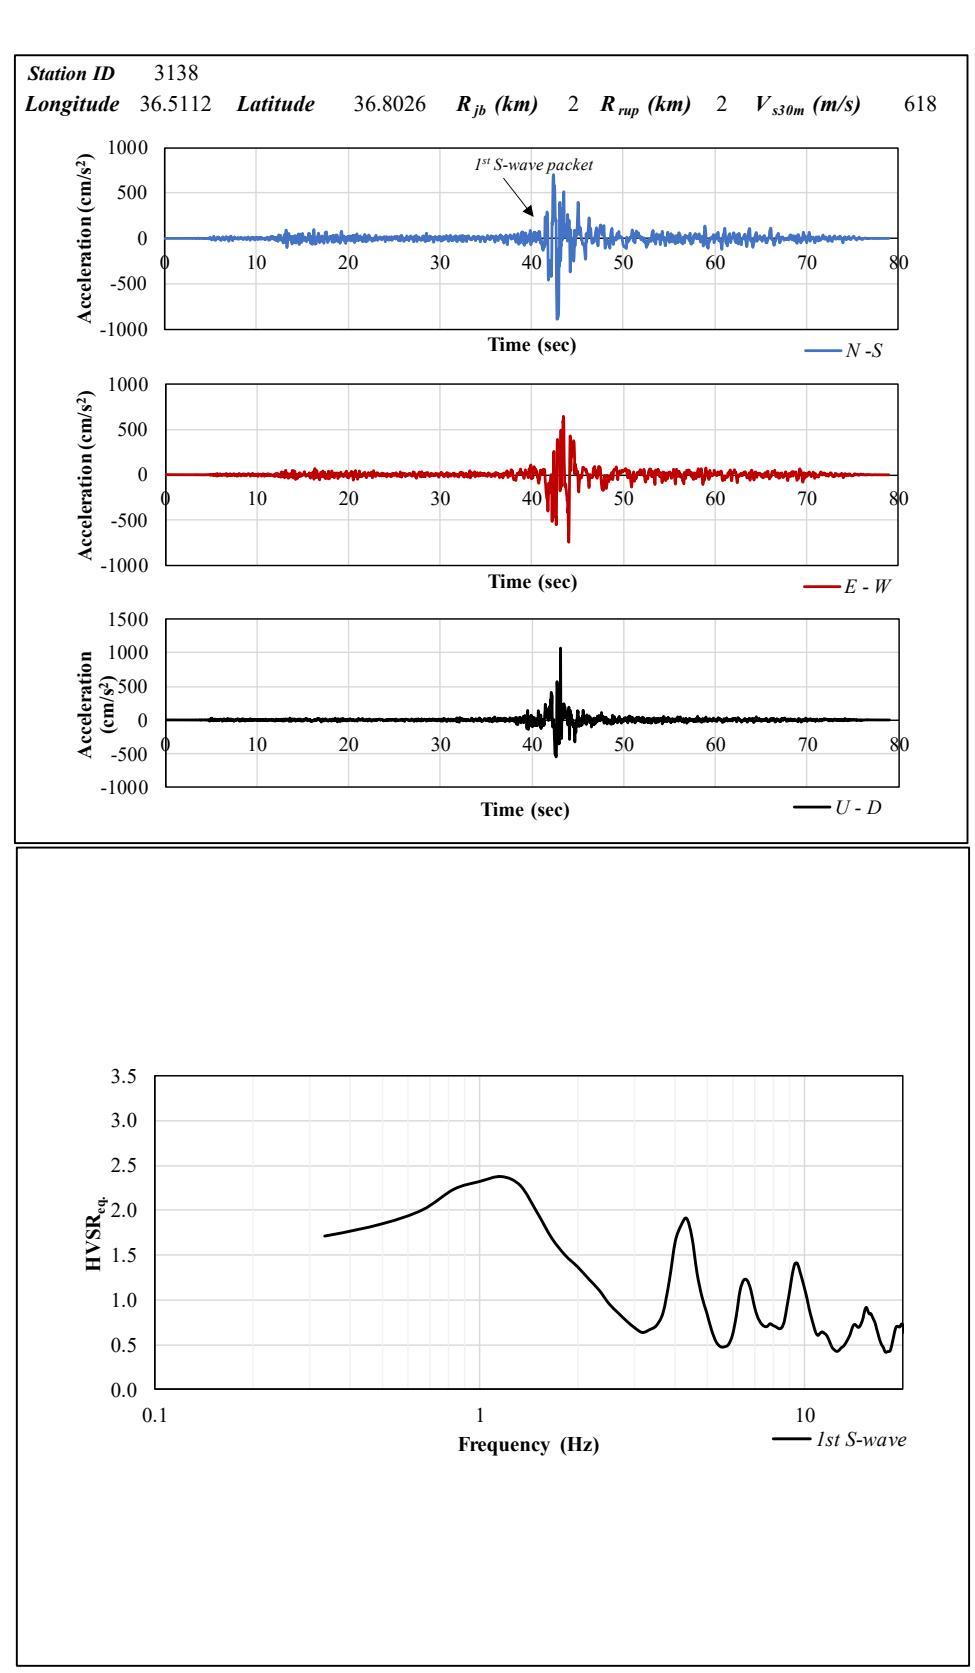
Figure 4.29. Resulting HVSR curve for station 3138

- Station 3138 (Figure 4.29) is located on either a very dense soil or a very soft rock site, where the V<sub>s,30m</sub> is 618 m/s and HVSR indicates peaks around 1.2 Hz (T=0.83 sec) and 4.3 Hz (T=0.23 sec).

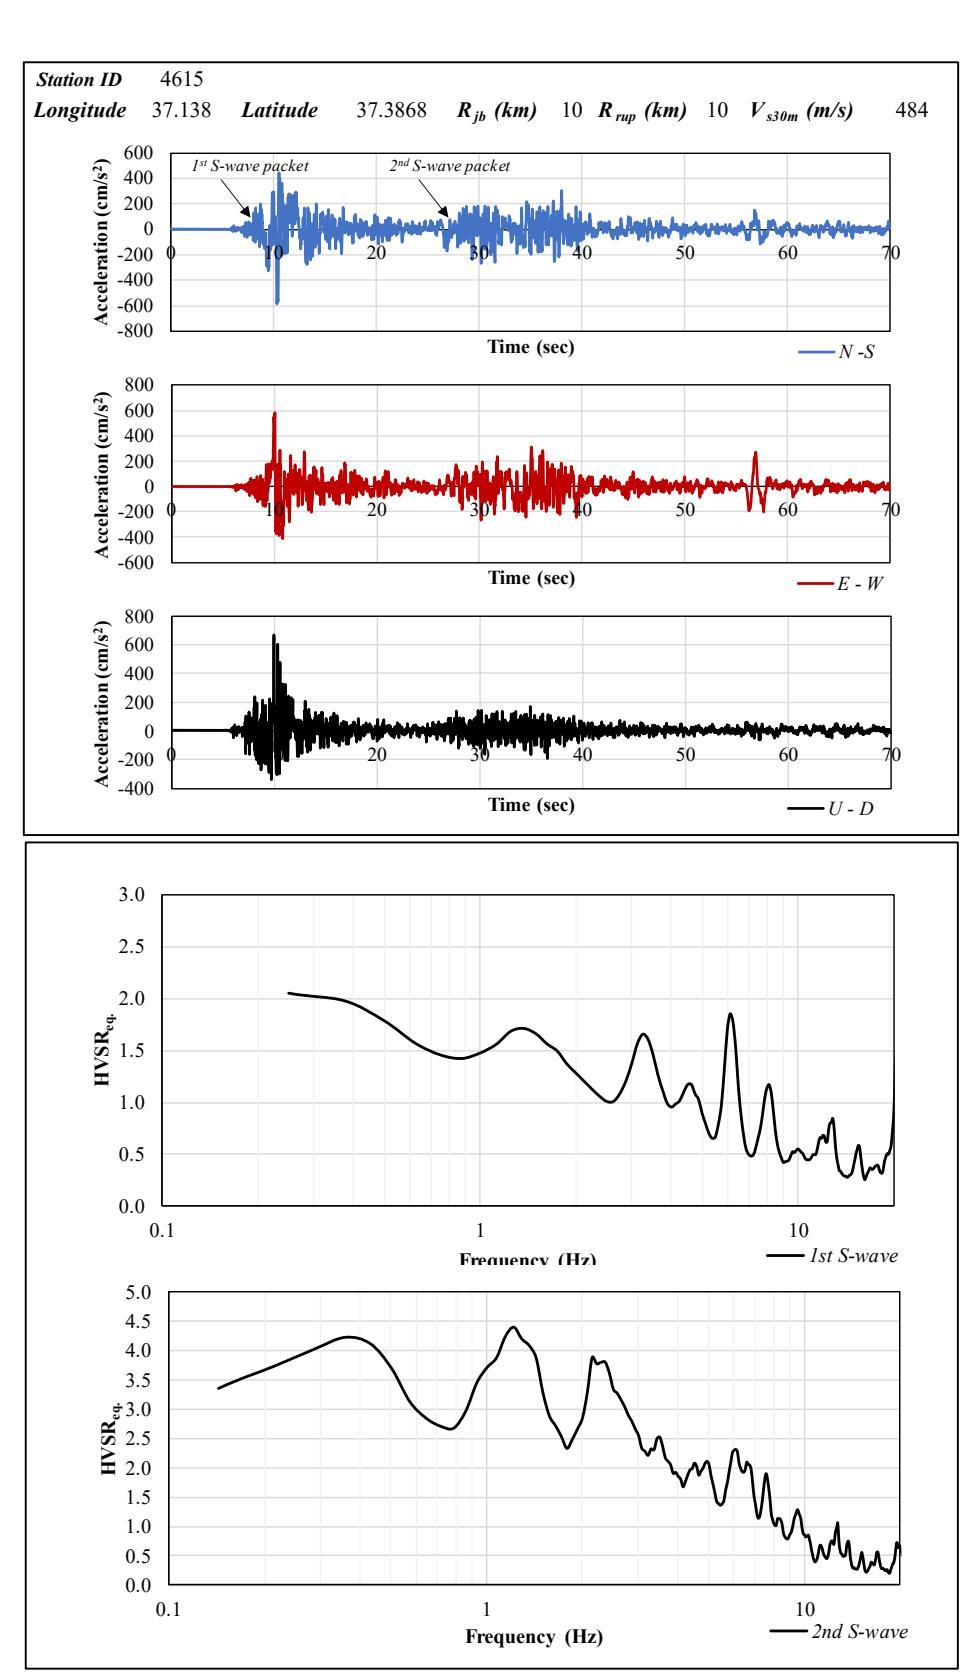
Figure 4.30. Resulting HVSR curve for station 4615

- Station 4615 (Figure 4.30) is located on either a very dense soil or a very soft rock site, where the V<sub>s,30m</sub> is 484 m/s and HVSR indicates peaks around 1.5 Hz (T=0.67 sec) and 2.5 (T=0.4 sec) Hz for the 1<sup>st</sup> S-wave portion and relatively low frequency 0.4 Hz (T=2.5 sec) and 1.2 Hz (T=0.83 sec) peak for the 2<sup>nd</sup> S-wave portion.

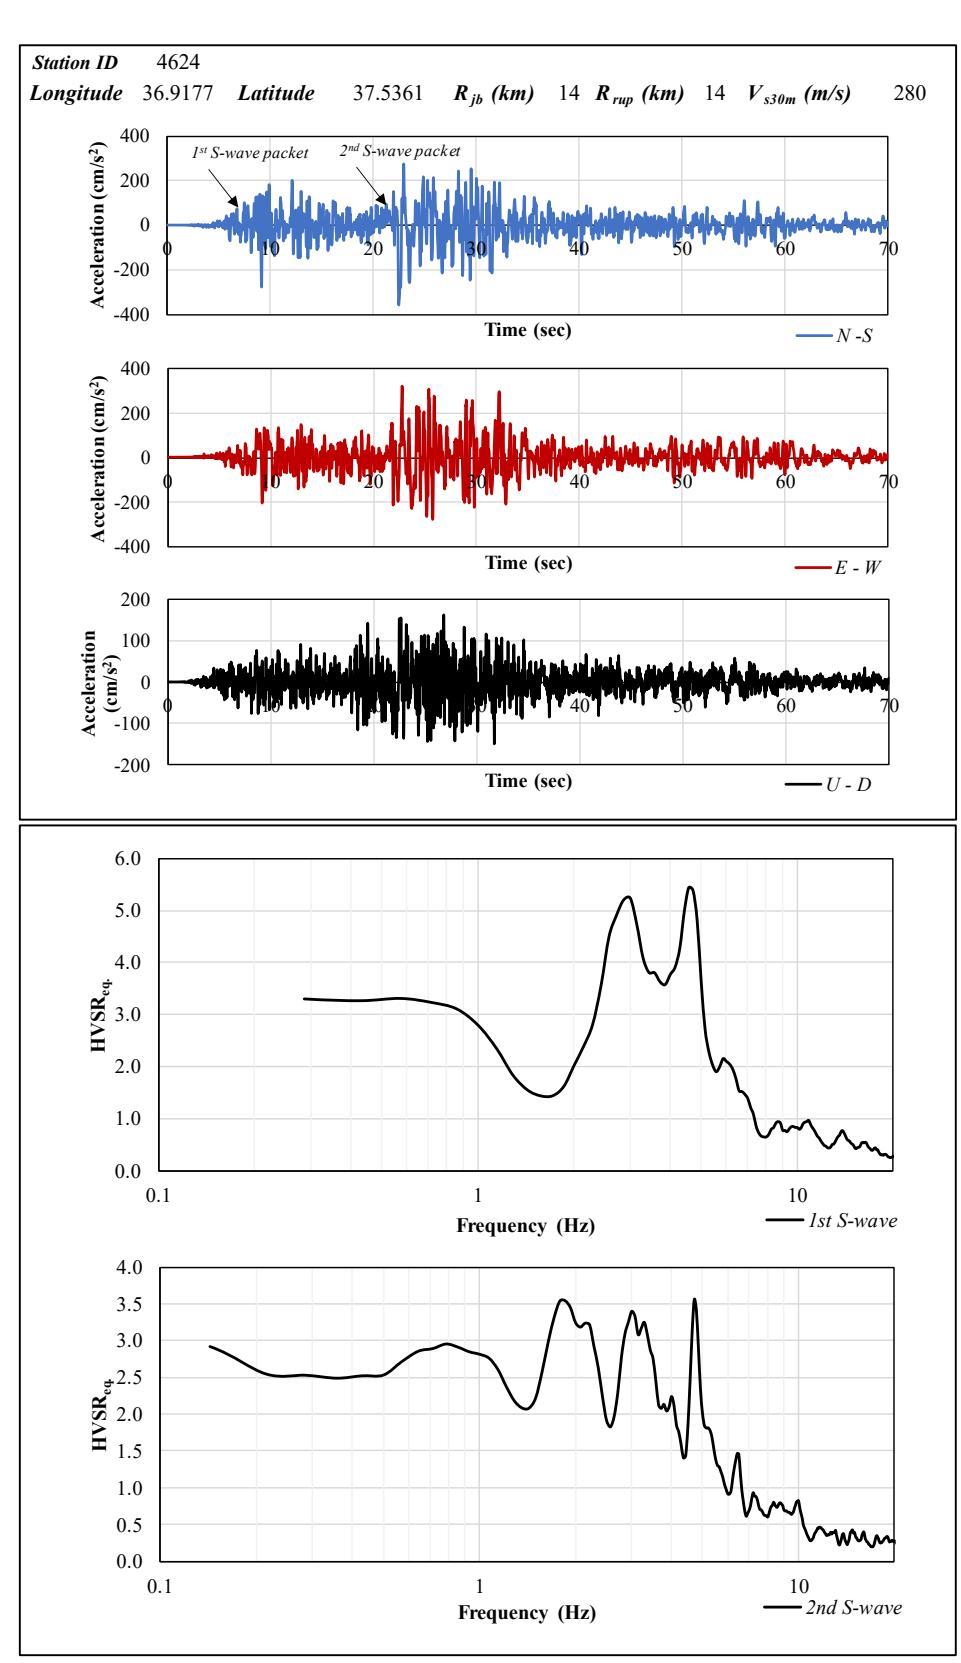
Figure 4.31. Resulting HVSR curve for station 4624

- Station 4624 (Figure 4.31) is located on a stiff soil site, classified as a NERHP Site Class D (V<sub>s,30m</sub> = 280 m/s) and HVSR indicates peaks around 3 Hz (T=0.33 sec) and 5 Hz (T=0.2 sec) for the 1<sup>st</sup> S-wave packet and relatively low frequency 0.8 Hz (T=1.25 sec) and 2 Hz (T=0.5 sec) peak for the 2<sup>nd</sup> S-wave packet.

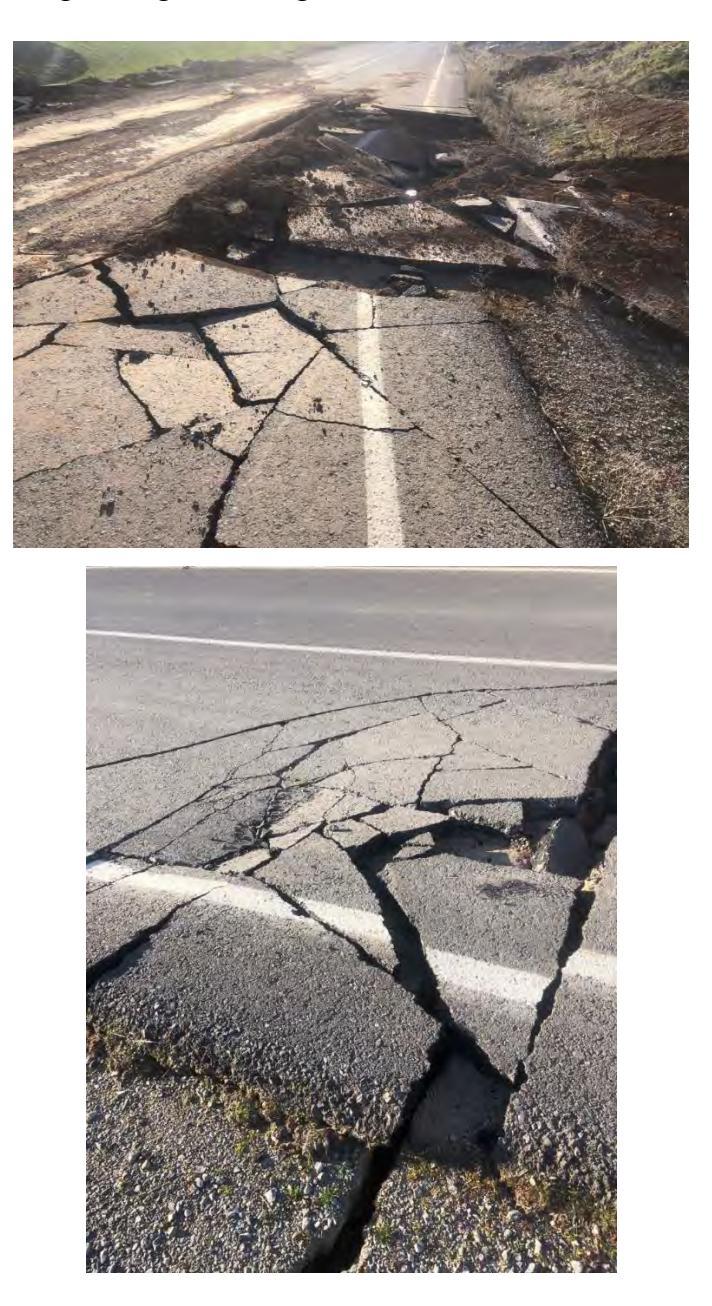
In Kahramanmaraş city center, no significant geotechnical-related damage was reported. The totally collapsed buildings were concentrated in the southern parts of the city. Many deep cracks were observed in the road route along the villages of Kocalar, Öksüzlü, Tevekkeli and Kapıçam (Fig. 5.1). Many buildings in the villages were either damaged with manifestations of severe cracking or collapsed. Electric poles on the same road routes were folded (Fig. 5.2).

Figure 5.1. Cracks on the roads along Tevekkeli village photo by Dr. Eyyüb Karakan

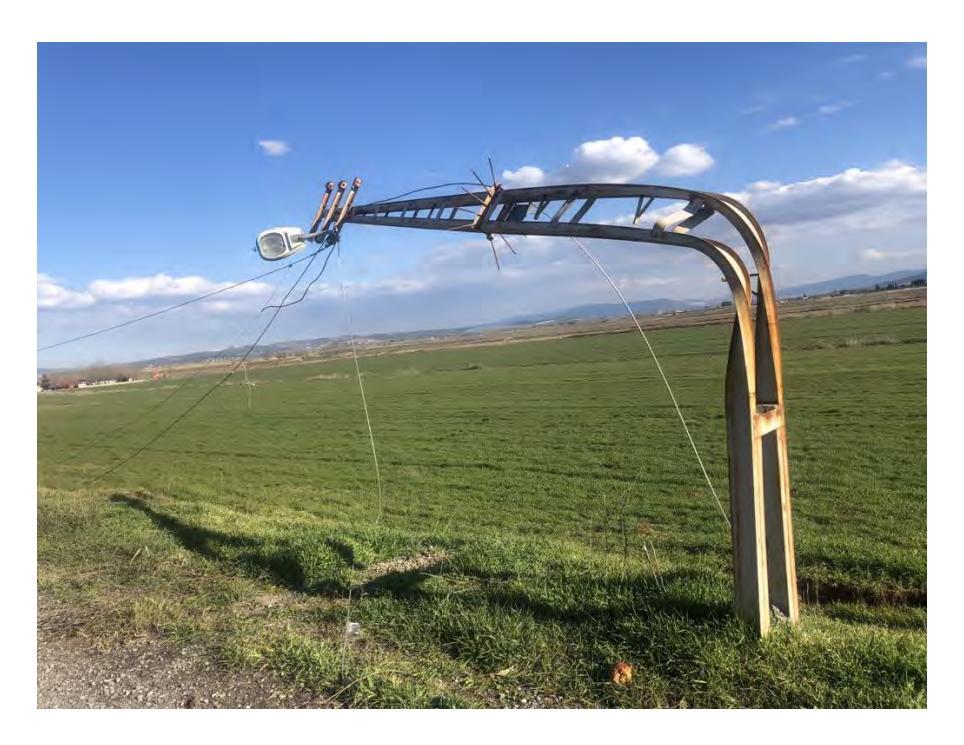
Figure 5.2. Electric poles on the roads folded by Tevekkeli village photo by Dr. Eyyüb Karakan

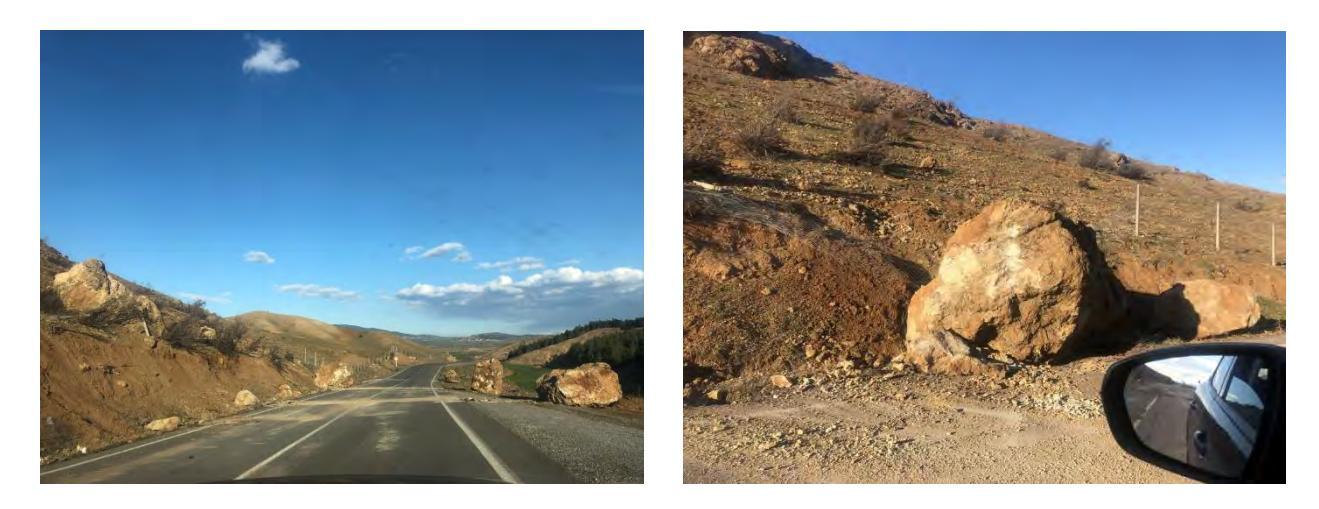
Rock falls were also observed on the same road (Fig. 5.3). Some pictures from geotechnical and road structure damages are given in Fig. 5.4-5.8.

Figure 5.3. Rockfalls observed in Tevekkeli village photo by Dr. Eyyüb Karakan

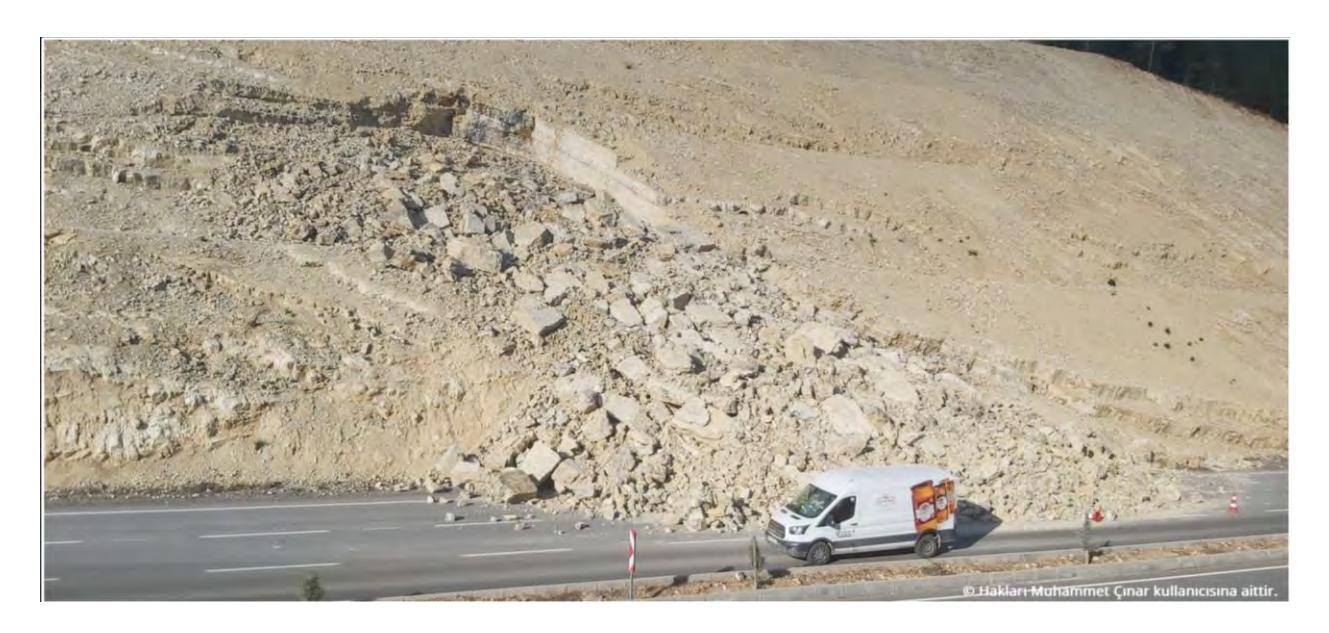
**Figure 5.4.** Translational slides observed on northern highway in Kahramanmaraş city center photo by Dr. Muhammet Çınar

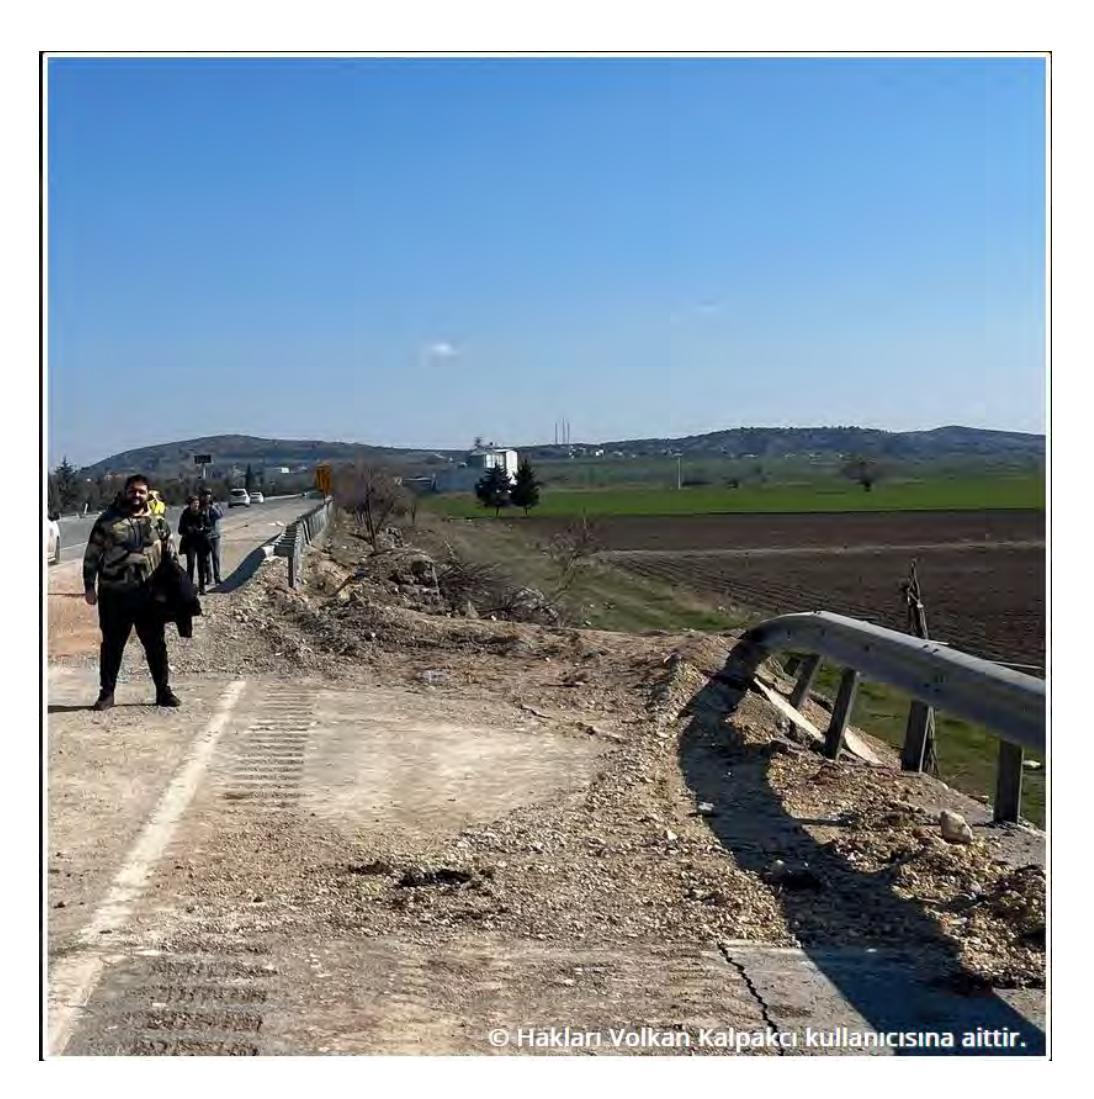
Figure 5.6. Fault offset on Kahramanmaraş – Gaziantep Road photo by Dr. Volkan Kalpakçı

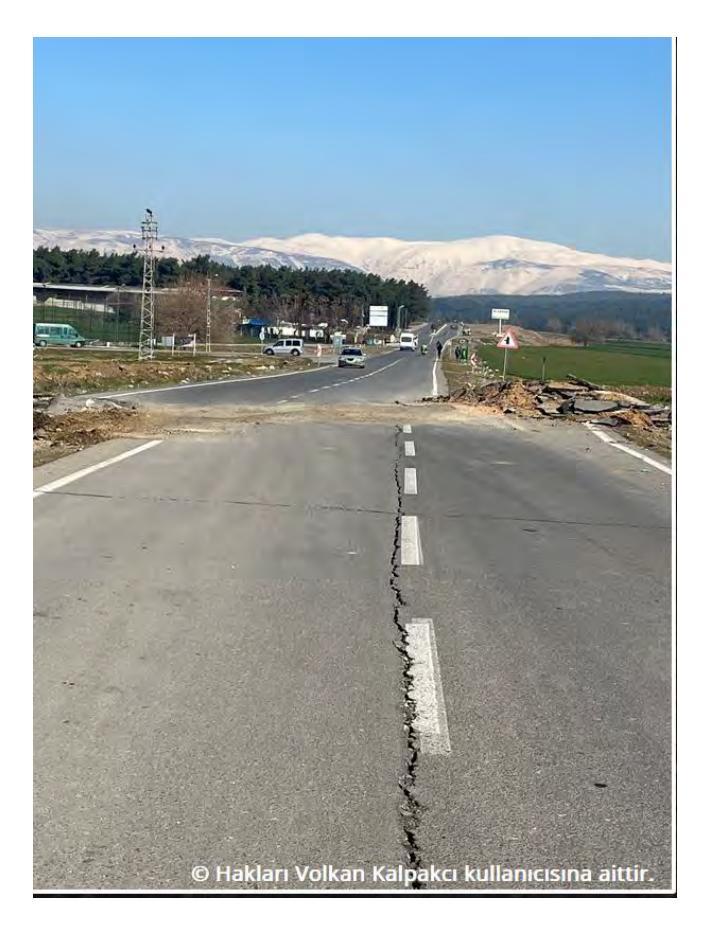
Figure 5.7. Fault offset on Kahramanmaraş – Gaziantep Road photo by Dr. Volkan Kalpakçı

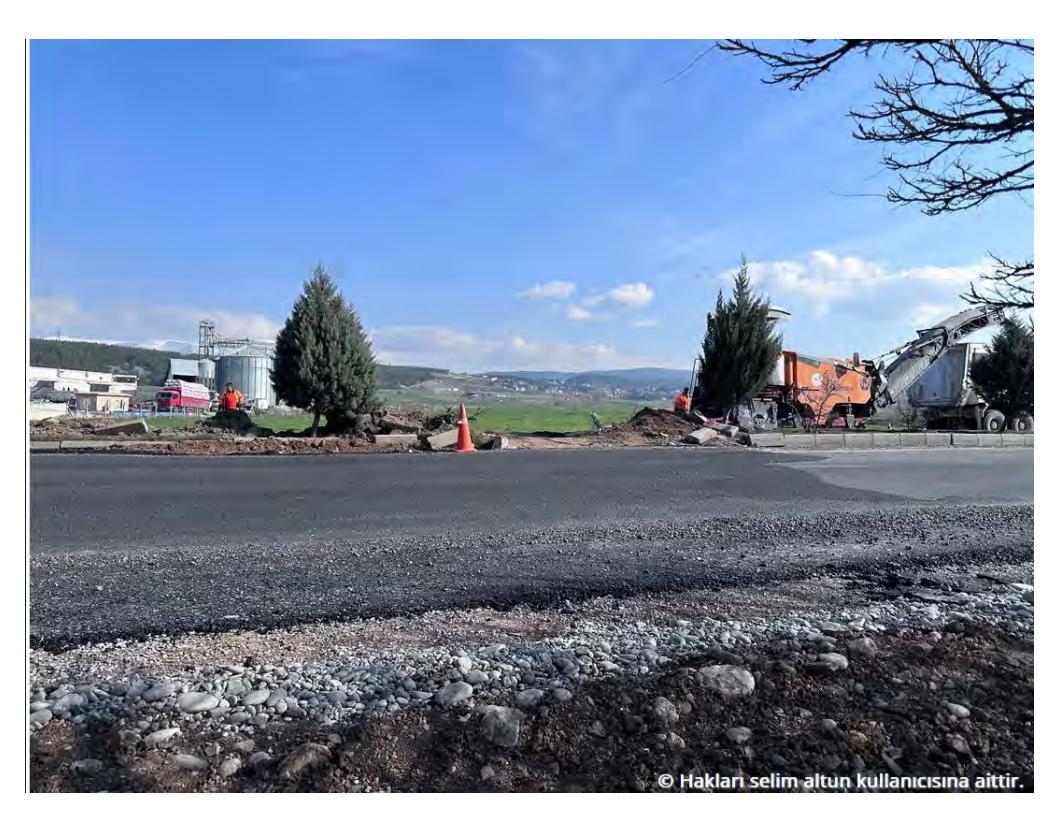
Figure 5.8. Fault offset on Kahramanmaraş – Gaziantep Road photo by Prof. Dr. Selim Altun

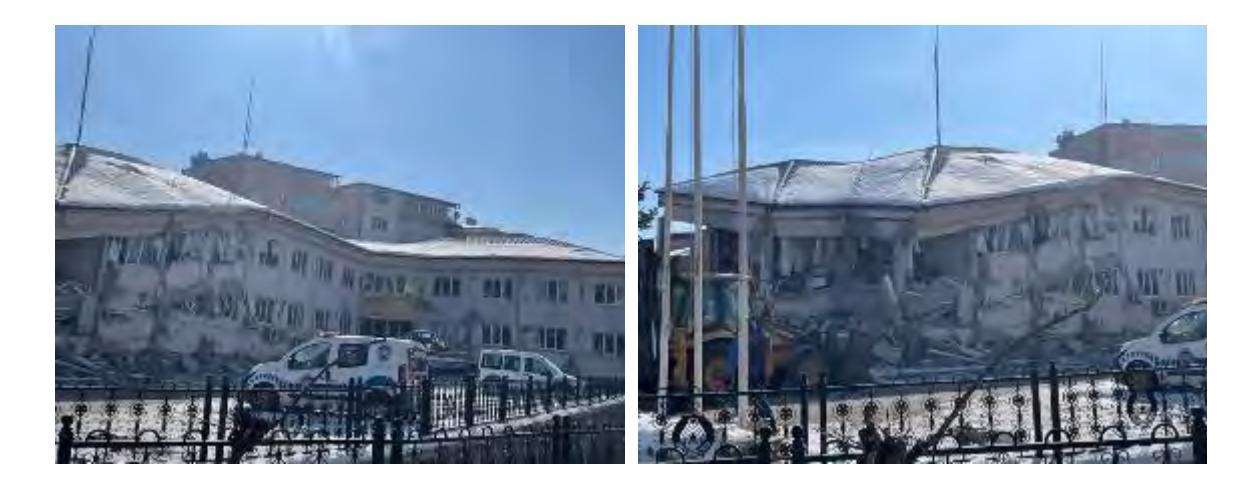
No major geotechnical-induced damage features were observed in the Afşin city center. The damage was mainly due to poor construction quality and lack/inadequacy of structural element lateral capacity. Some examples of partially collapsed buildings are shown in Figures 5.9 and 5.11 in Afşin city center.

Figure 5.9. Heavily damaged buildings – Afşin city center

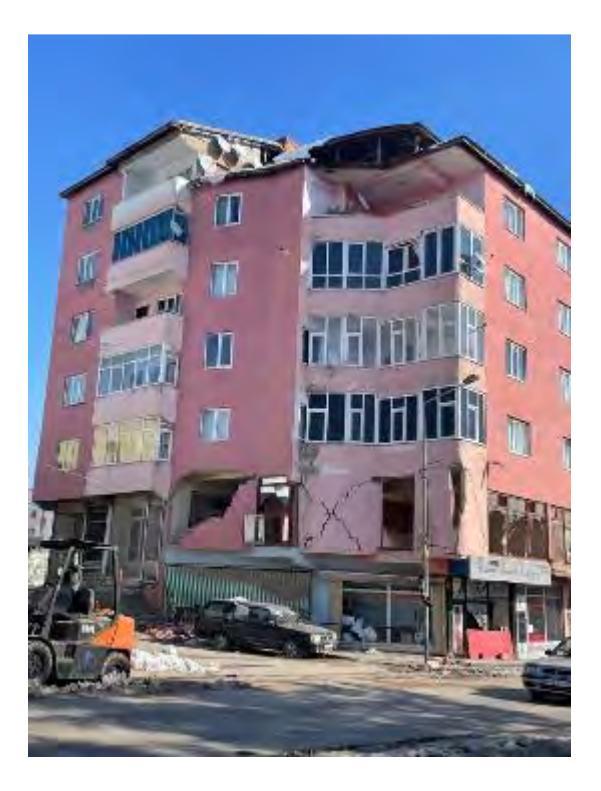
Figure 5.10. Shear cracks on partition walls- Afşin city center

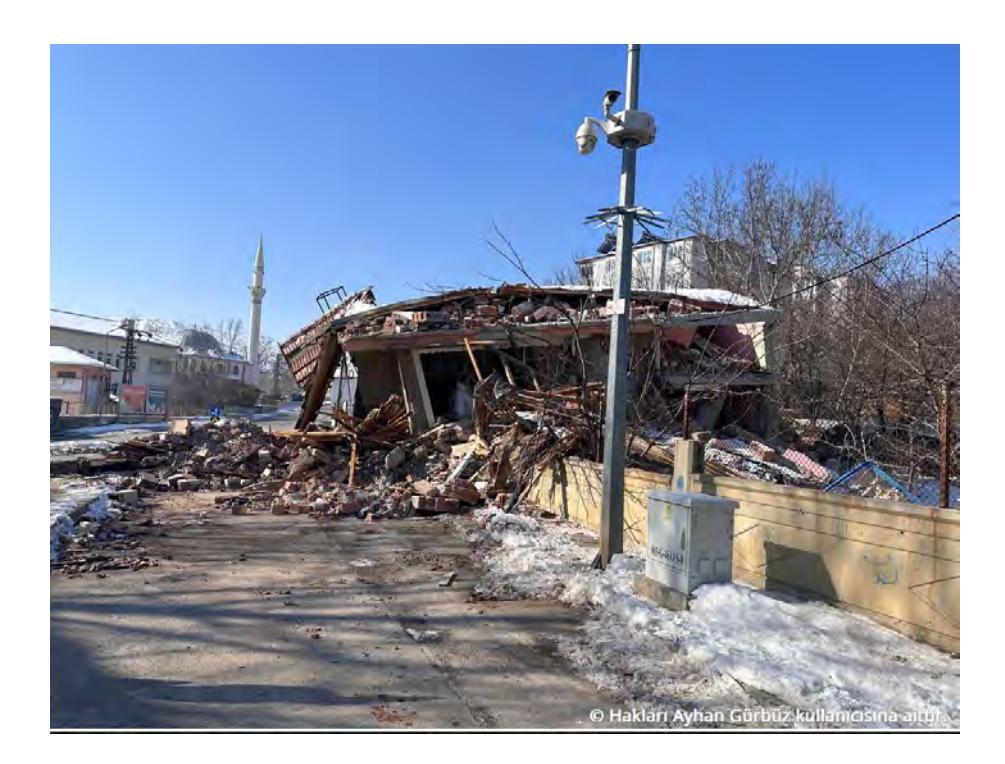
Figure 5.11. Heavily damaged buildings – Afşin city center

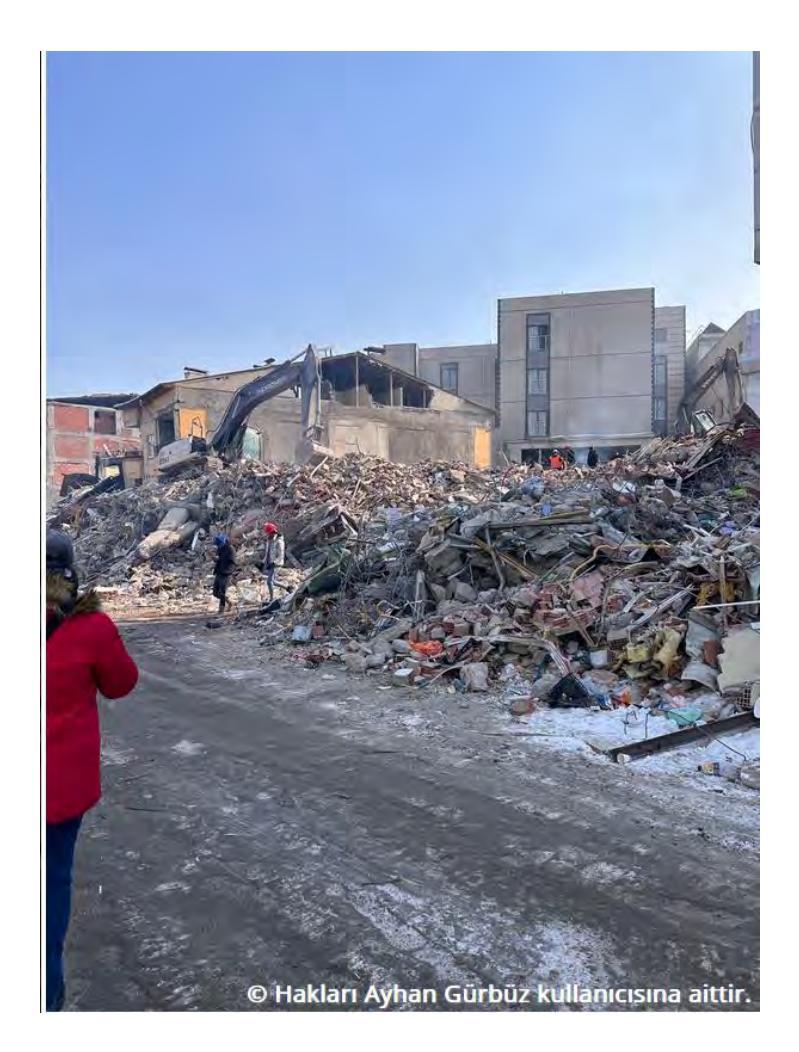
No geotechnical damage was observed in and around Elbistan. This is mostly due to the snow covering the area. The surface manifestations of lateral spread and/or liquefaction were covered by snow. The damage was mainly due to poor construction quality and lack/inadequacy of structural elements, some examples are presented in Figures 5.12-5.15.

Figure 5.12. Collapsed buildings – Elbistan city center.

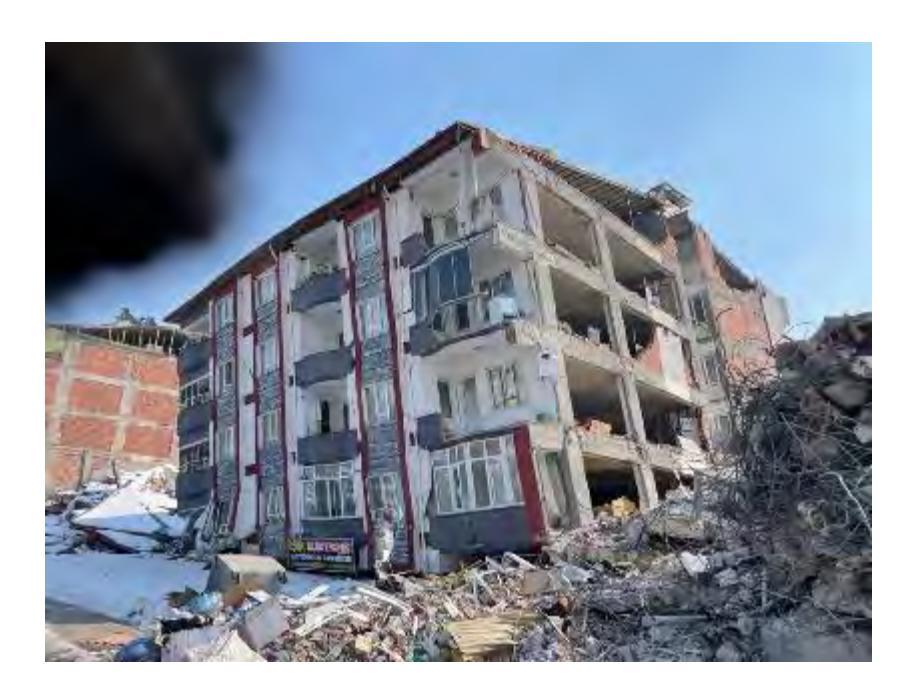
Figure 5.13. Collapsed building – Elbistan city center.

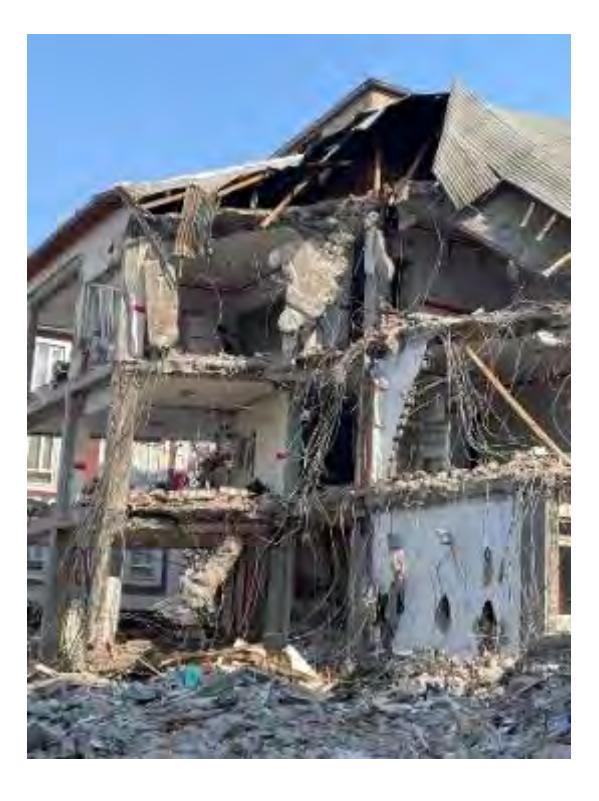
Figure 5.14. Heavily damaged residential building – Elbistan city center

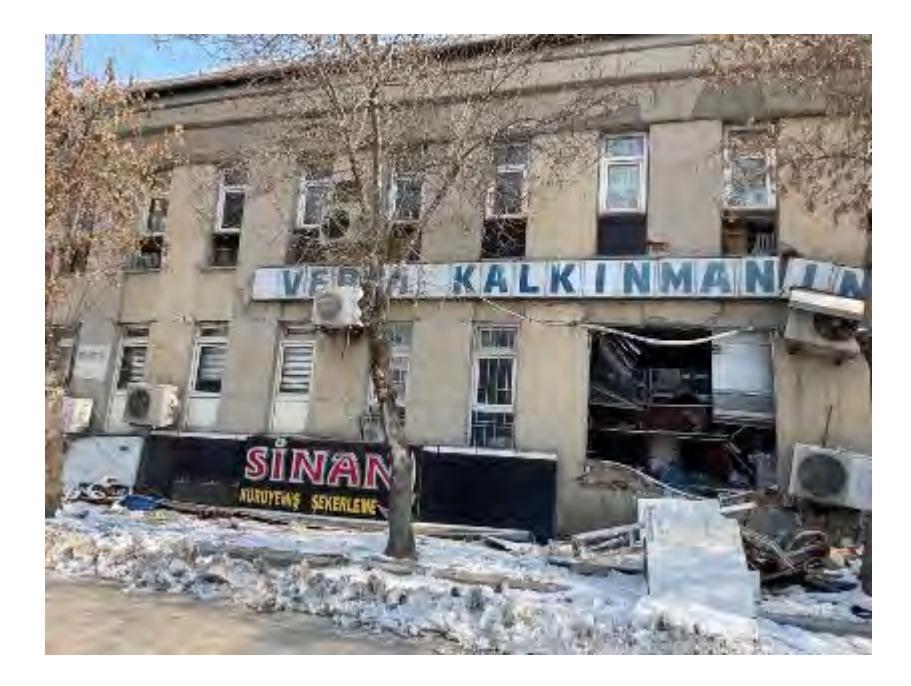
Figure 5.15. Pancaked ground floor – Elbistan city center.

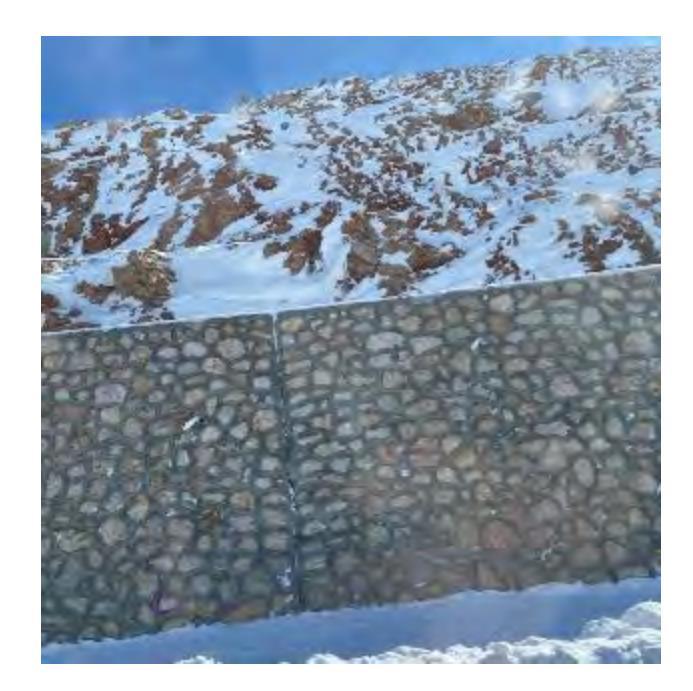
On the road from Elbistan to Malatya, there were no significant manifestation of geotechnicalinduced failures or features. No ground cracks, no slope failures, etc. were observed along the road. The retaining walls by the benches of (about 5 m high), and the slopes behind the walls were not damaged as can be seen in Figure 5.16.

Figure 5.16. Stable retaining wall – Elbistan-Malatya Road

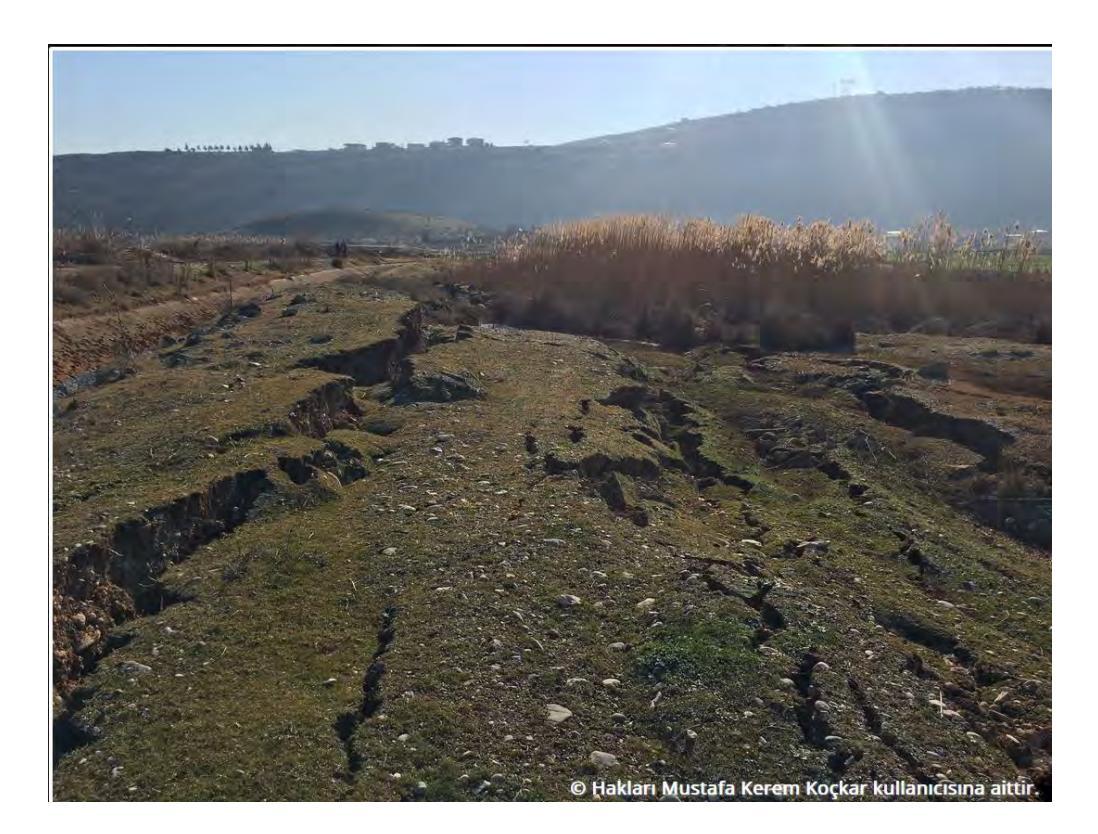
Lateral spreading is observed on alluvial soils along the stream bed in Çöçelli district, Adana-Şanlıurfa highway Narlı entrance location (Fig. 5.17). In addition, ground deformations were apparent along the access road pavements on alluvial sediments (Fig. 5.18). The bridge crossing was affected due to large lateral spreading (Fig. 5.19).

Figure 5.17. Lateral spreading observed in Pazarcık

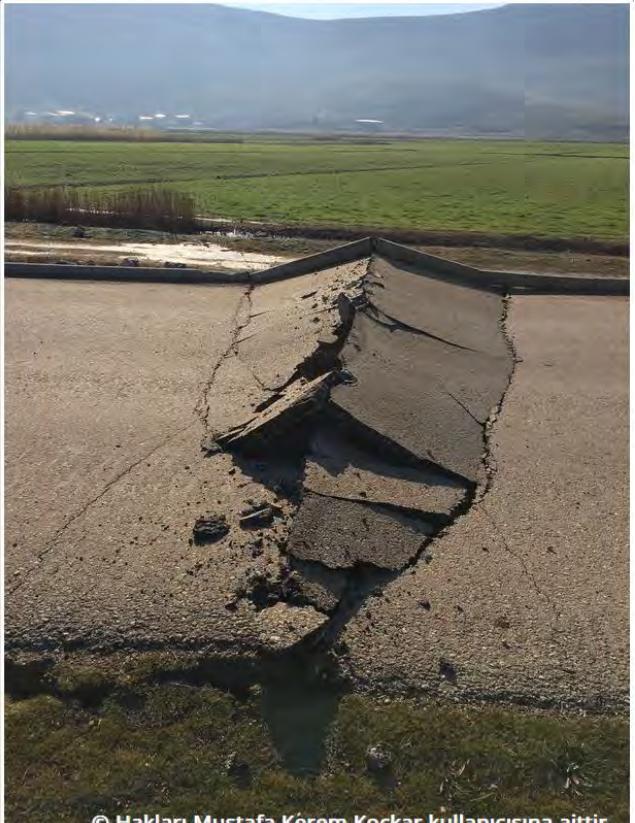
Figure 5.18. Compression cracks observed in Pazarcık

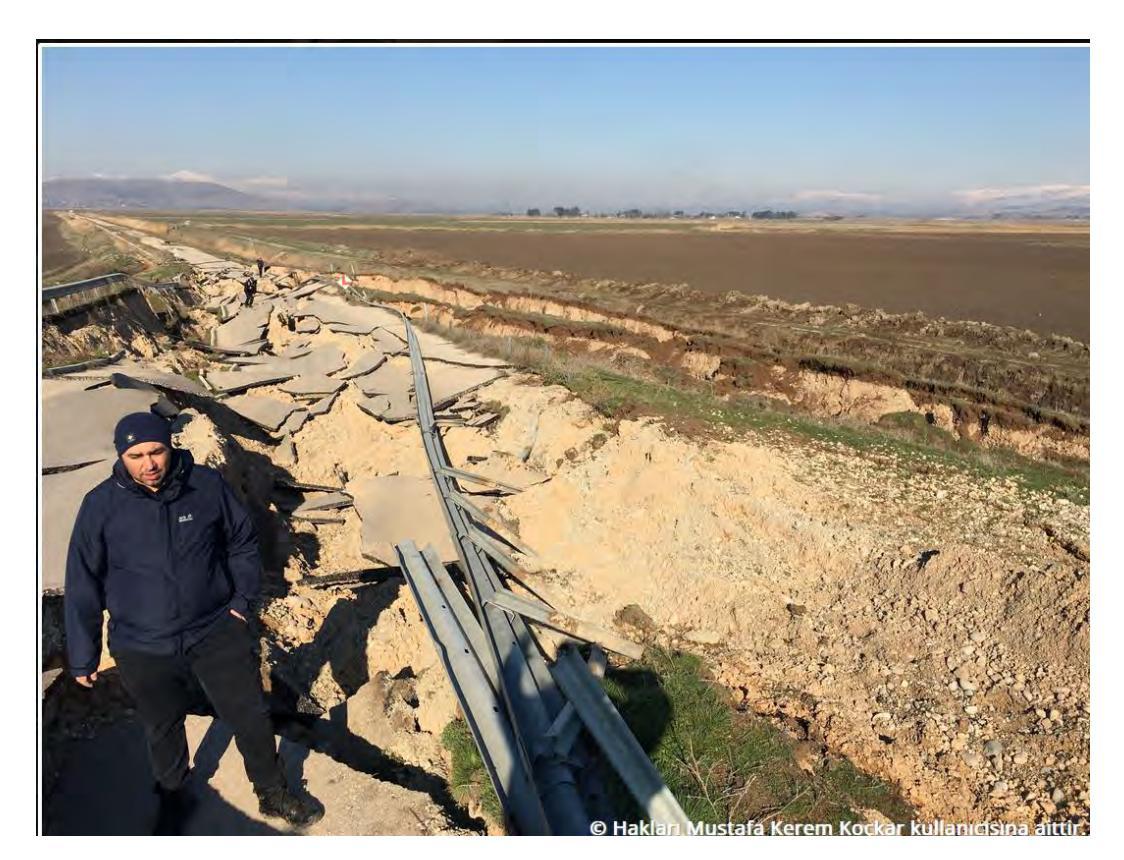
Figure 5.19. Lateral spreading along the road in Pazarcık
