# Türkiye Earthquake

## **RECONNAISSANCE REPORT**

February 6, 2023 Kahramanmaraş-Pazarcık ( $M_w$ =7.7) and

Elbistan (M<sub>w</sub>=7.6) Earthquakes

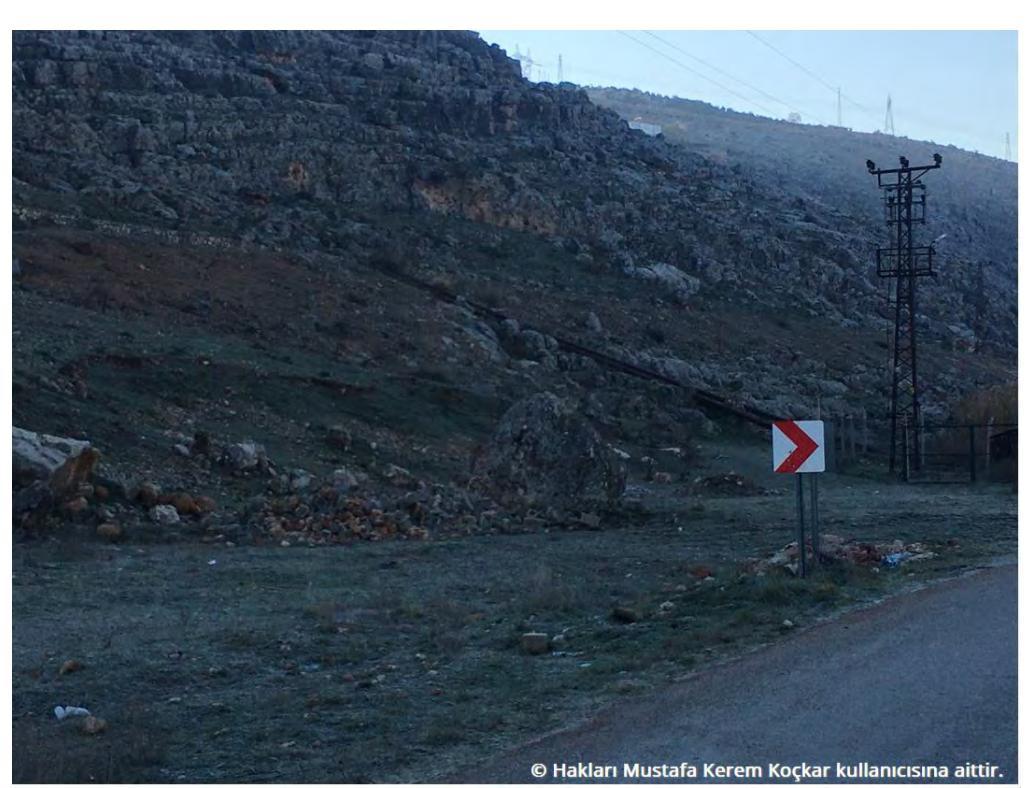
Rock mass failures due to rockfall were observed on the slopes along the road crossings in the Çöçelli neighborhood, which is close to the epicenter of the February 6, 2023 ( $M_w$ :7.7) earthquake (Fig. 5.20).
In the city center, the damage was mainly due to poor construction quality and lack/inadequacy of structural elements. Some examples of partially collapsed buildings are shown in Figure 5.21 in the Pazarcık city center. Some geotechnical structures protected its stability during earthquakes (Figure 5.22).

Figure 5.20. Rock falls observed in Pazarcık

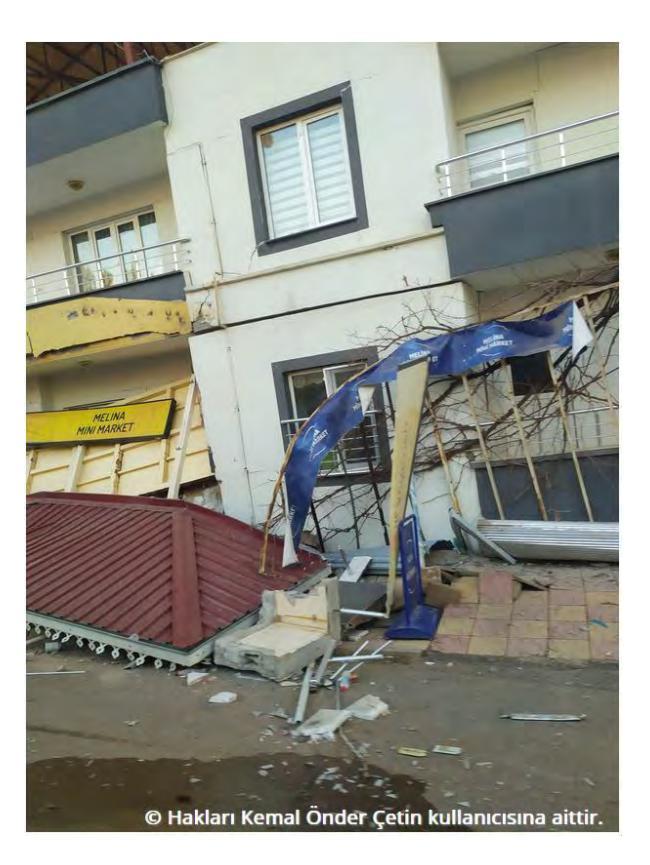
Figure 5.21. A partially collapsed building in Pazarcık

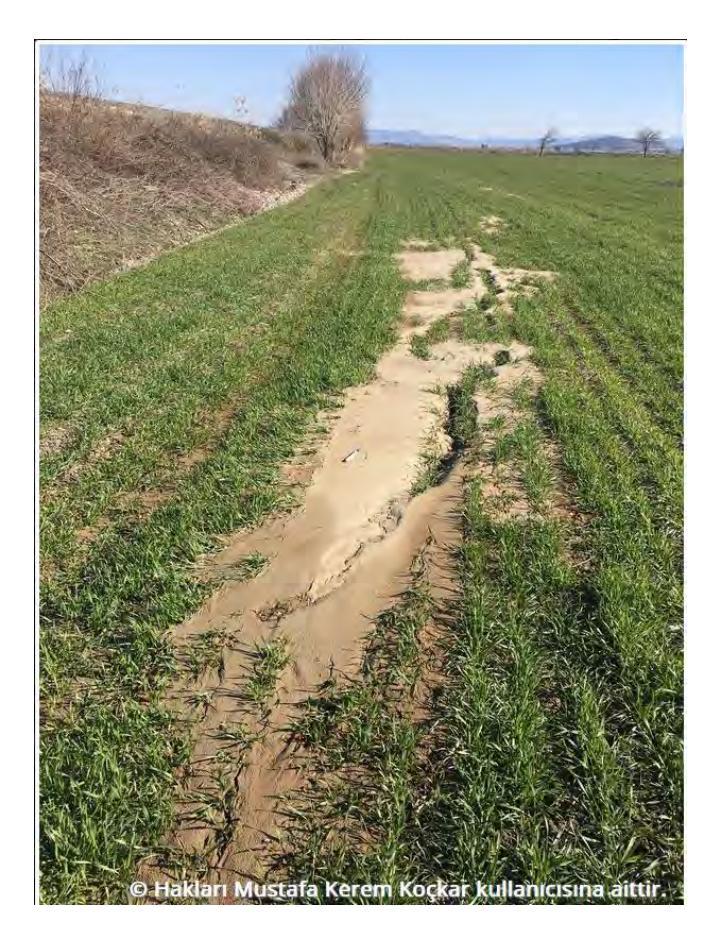
Lateral spreading (Fig. 5.23) and liquefaction manifestations (Fig. 5.24) were observed at the irrigation dam road crossing located on the Aksu Stream in the northeast of the district,

Figure 5.23. Liquefaction in free field

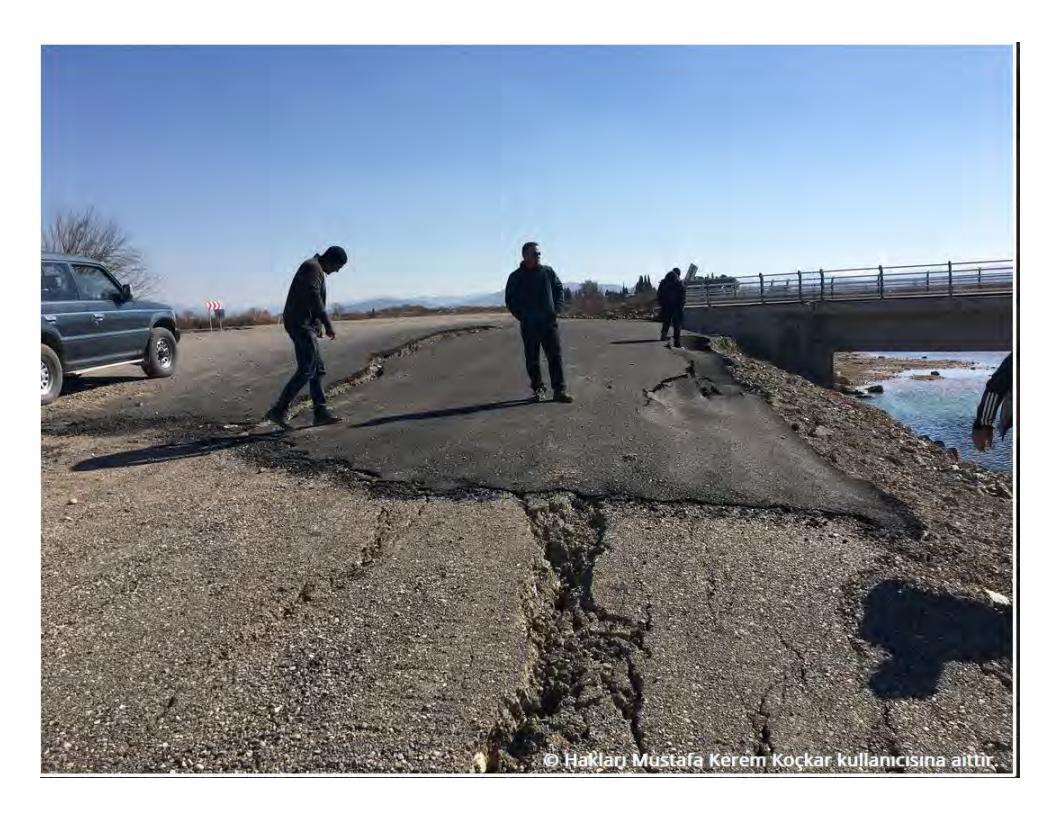
Figure 5.24. Lateral spreading

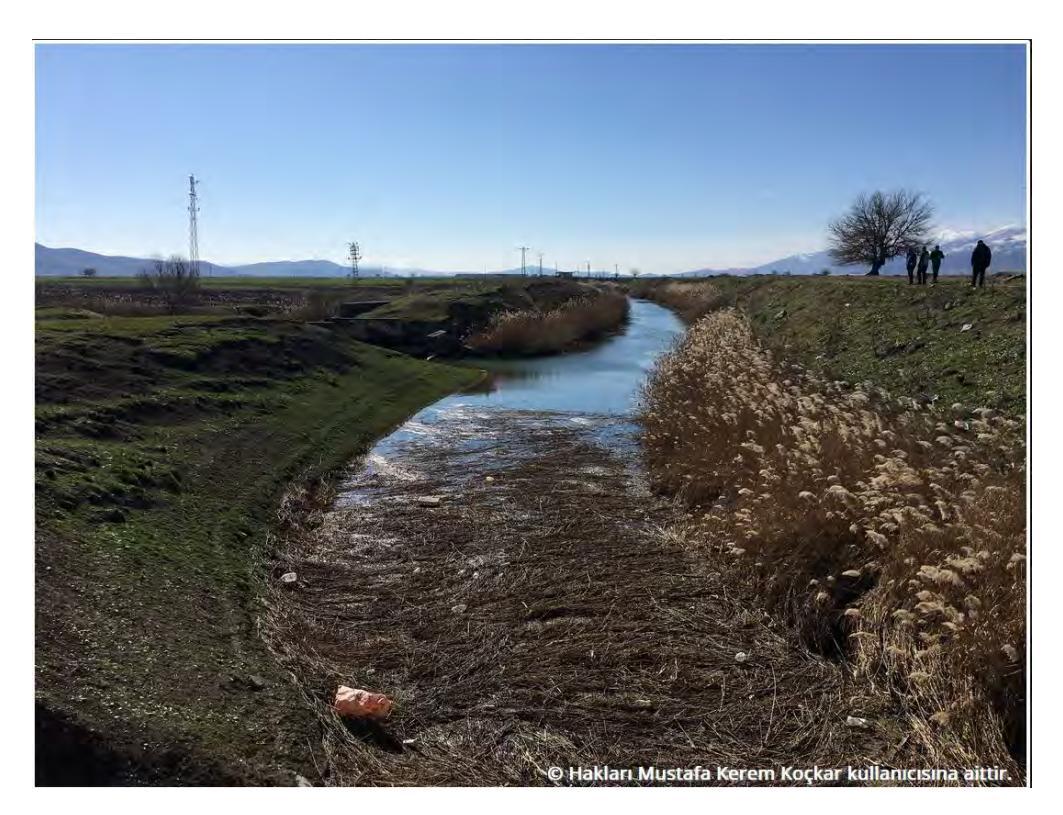
respectively. Lateral spreading was also encountered at the railway crossing on the east side of the river (Fig. 5.25). Damages also occurred in the retaining structure of the water channel passing through the district (Fig. 5.26).

Figure 5.25. Lateral spreading

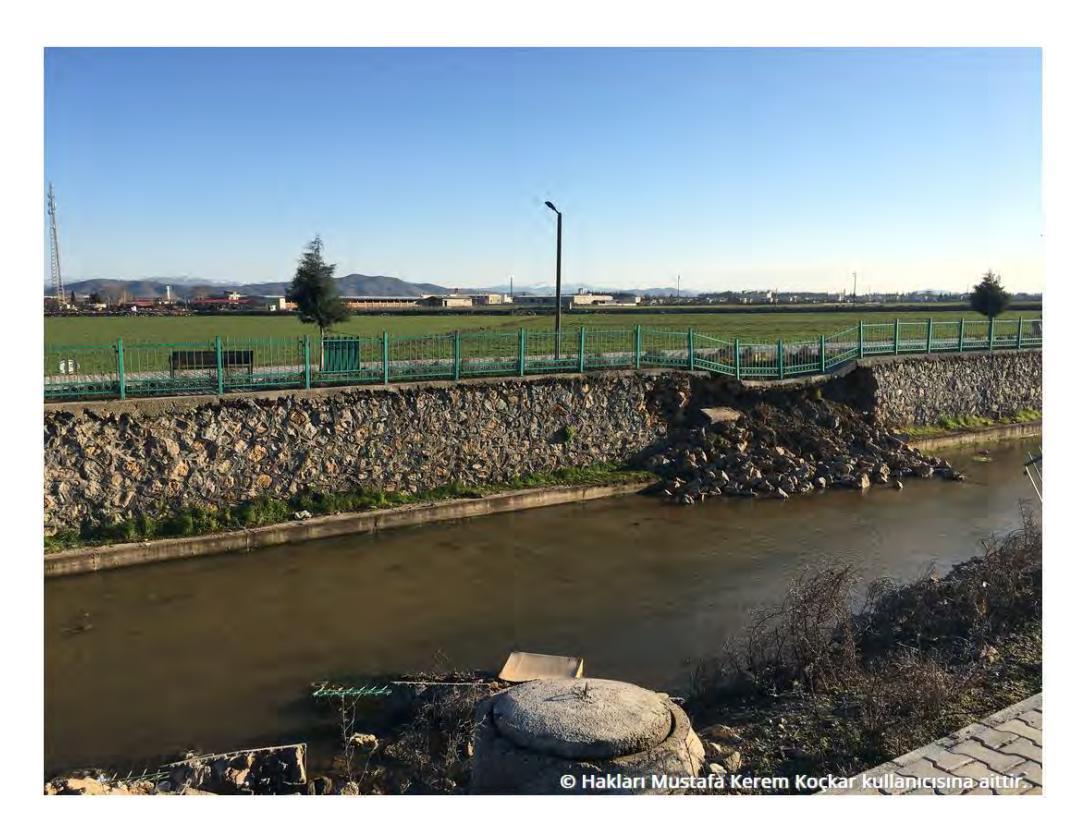
Figure 5.26. Lateral spreading

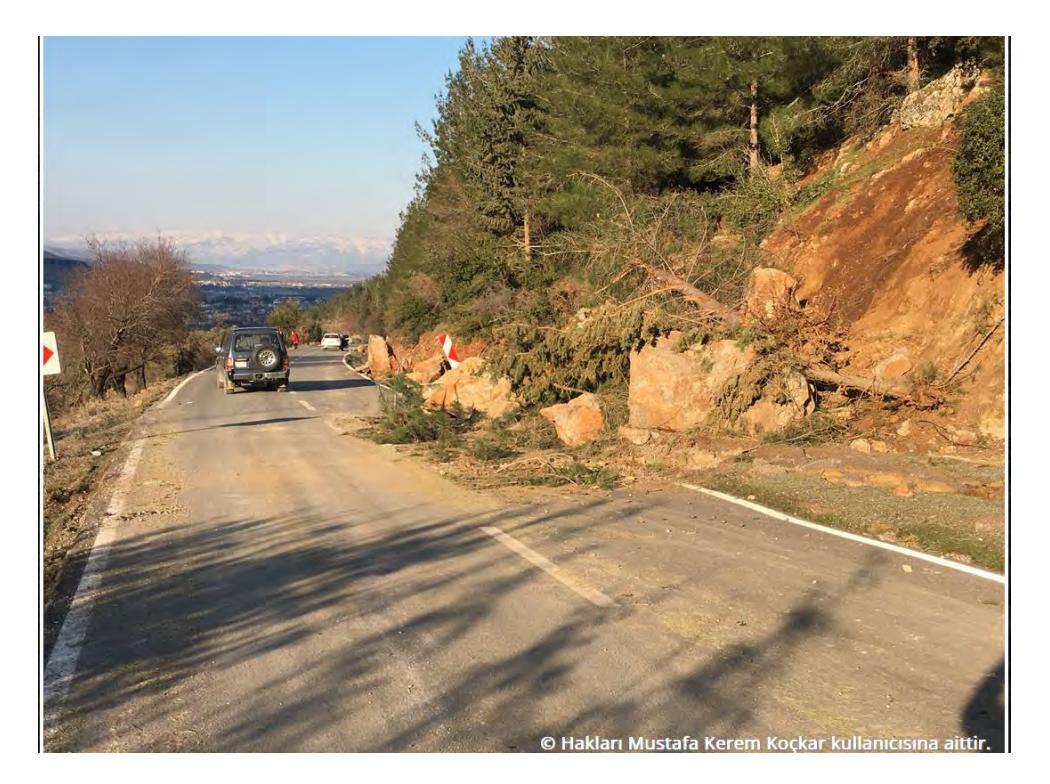
Along the road crossing connecting the Yeşilyurt neighborhood of the Türkoğlu district to the Şekeroba neighborhood, rockfalls on the side slopes and structural damage along the highway were observed (Fig. 5.27).

Figure 5.27. Landslide

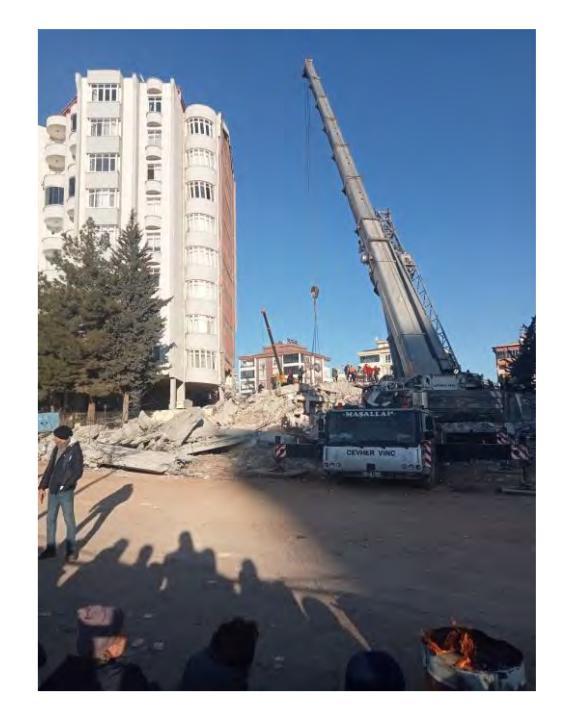
Local authorities have recently stated that at least 25 multi-story buildings collapsed in the city center due to the consecutive earthquakes (Fig. 5.28). A few collapsed one-story buildings in the villages close to the city center were observed (Fig. 5.29). Slope failures caused by the earthquakes were observed both in the city center (Fig. 5.30) and its vicinity area (Fig. 5.31). Liquefaction was not observed in the areas, where liquefaction was likely expected due to the presence of high groundwater level and silt/sand/gravel with low density (Fig. 5.32). Walls of the Gaziantep Castle, whose history dates back to the Hittite Empire, was severely damaged by the two consecutive earthquakes. However, no serious damage was observed on the slopes (greater than about 45°) carrying the castle walls. This gave the impression that the geogrid application made a few years ago on the slopes was found to be quite successful (Fig. 5.33).

**Figure 5.28.** An 8-storey building collapsed in the city (Coordinates; 37.0824, 37.3269). Photo by Prof. Dr. Ali Fırat Çabalar

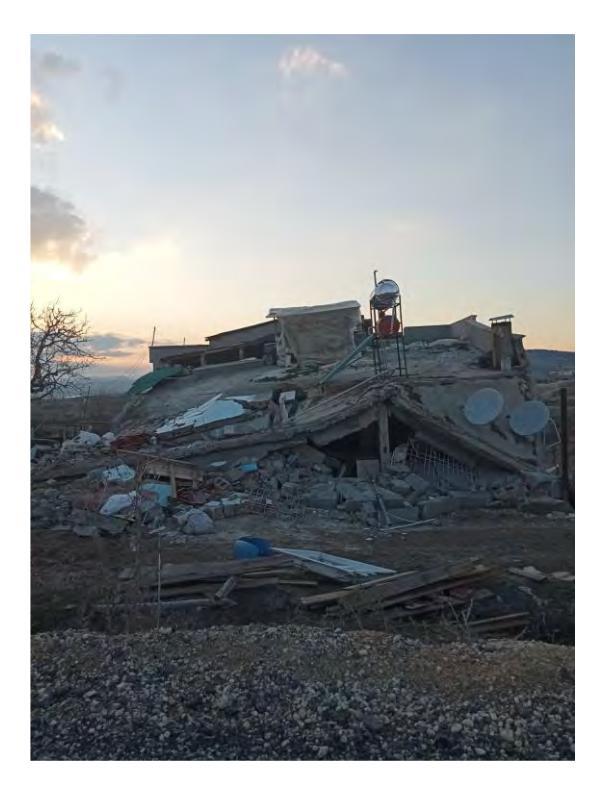
**Figure 5.29.** A 1-storey building collapsed in the village Akpinar (Coordinates; 37.0370, 37.1767). Photo by Prof. Dr. Ali Fırat Çabalar

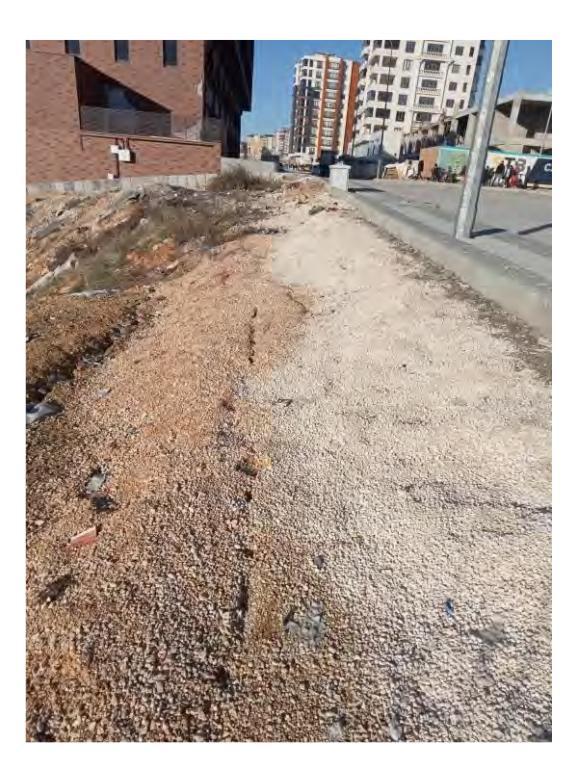
**Figure 5.30.** A slope failure in the city center (Coordinates; 37.0793, 37.3237). Photo by Prof. Dr. Ali Fırat Çabalar

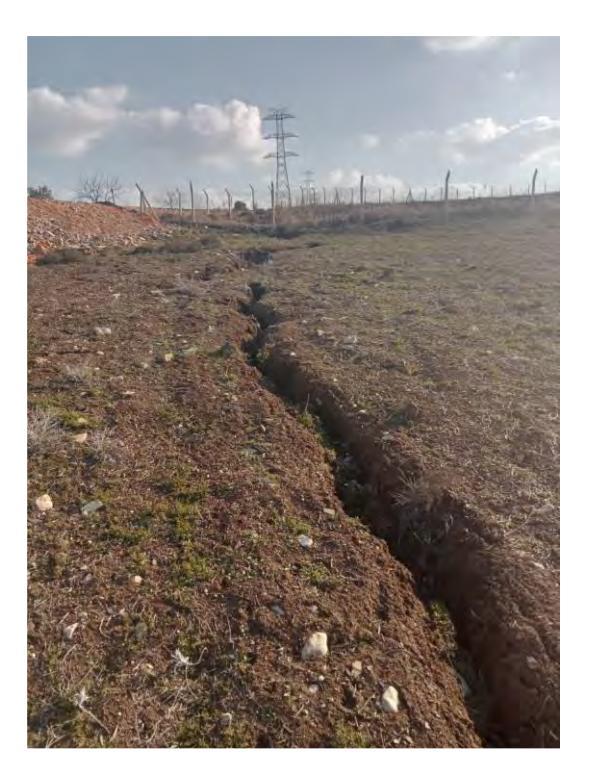
**Figure 5.31.** A slope failure in the vicinity area (Coordinates; 37.0209, 37.1509). Photo by Prof. Dr. Ali Fırat Çabalar

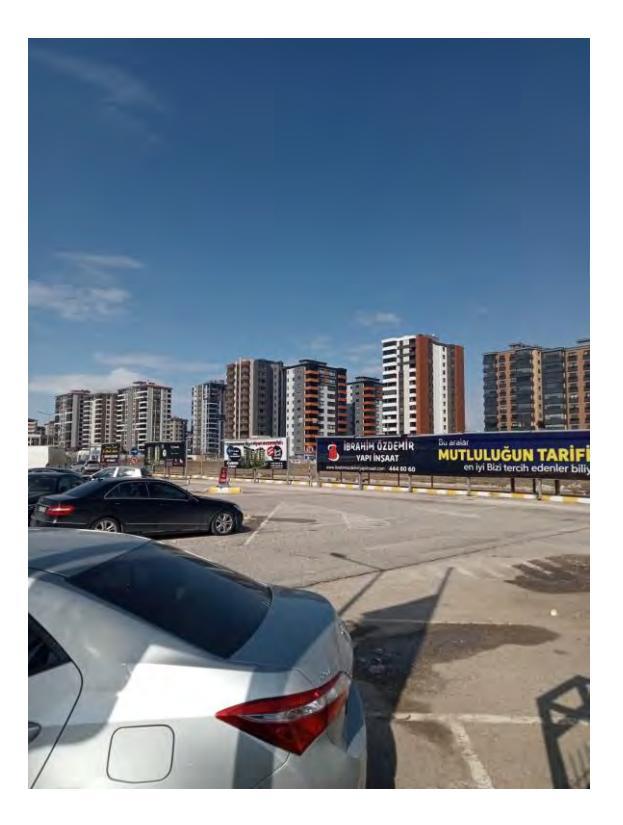
**Figure 5.32.** Non-liquefied area (Coordinates; 37.0628, 37.3363). Photo by Prof. Dr. Ali Fırat Çabalar

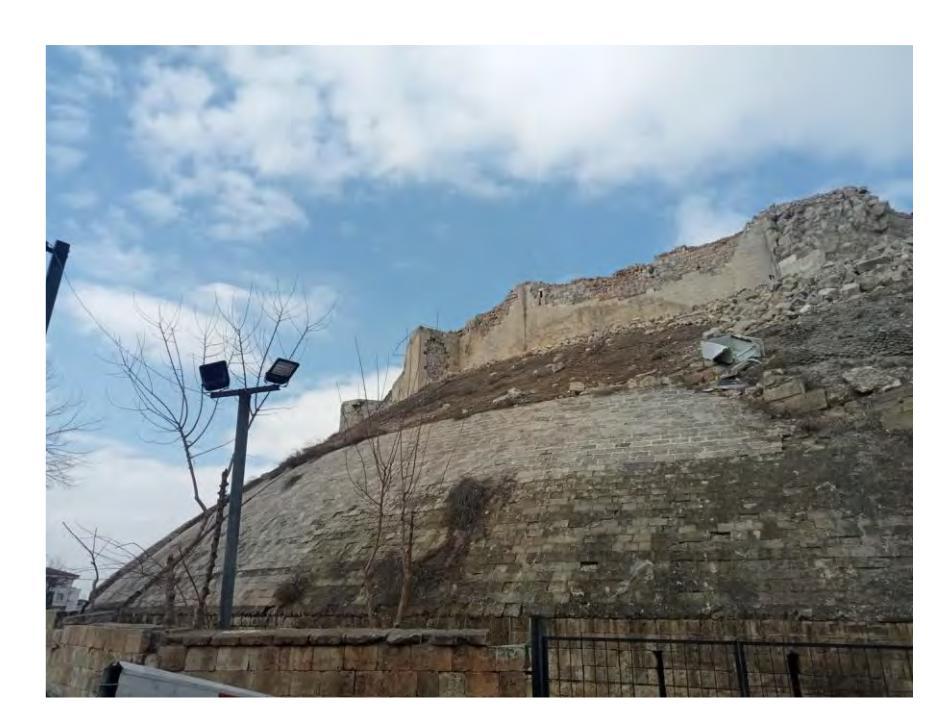
Figure 5.33. Gaziantep castle (Coordinates; 37.0665, 37.3832). Photo by Prof. Dr. Ali Fırat Çabalar

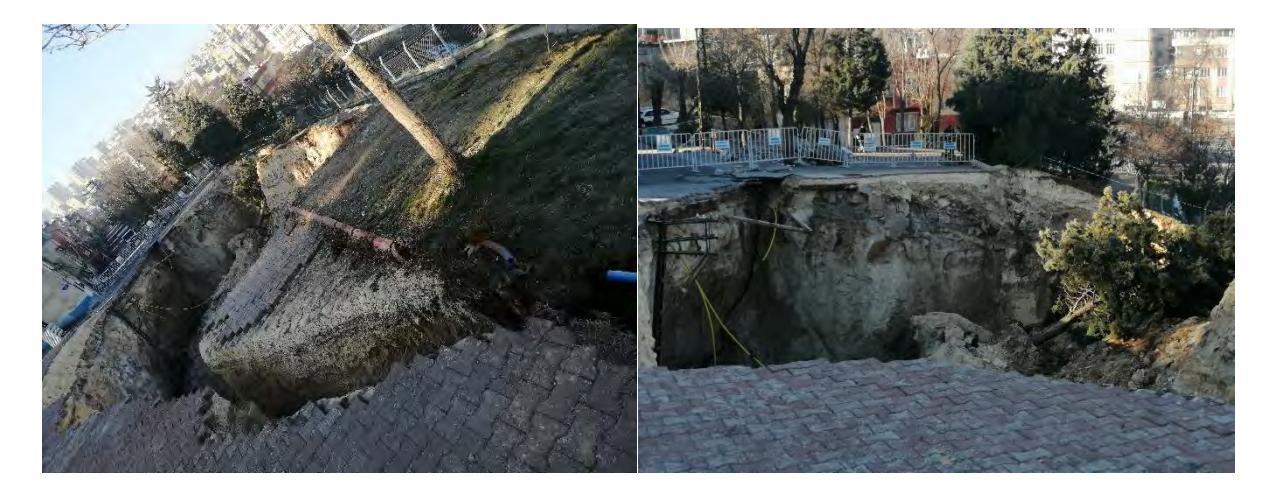
In Gaziantep, one of the cities most affected by the 7.7 and 7.6 magnitude earthquakes that occurred in Kahramanmaraş and affected 11 provinces, a giant sinkhole was formed in Aydın Baba Park, located in Şenyurt suburb, Derinçukur street in Şahinbey district. As the park collapsed with the force of the earthquake, the surrounding houses were also damaged. The sinkhole in the park is approximately 30 meters long, 8 meters wide and 10 meters deep (Fig. 5.34).

**Figure 5.34.** Sinkhole in Aydınbaba park, Derinçukur Street, Şahinbey district in Gaziantep Photo by Assist. Prof. Dr. Eyyüb Karakan

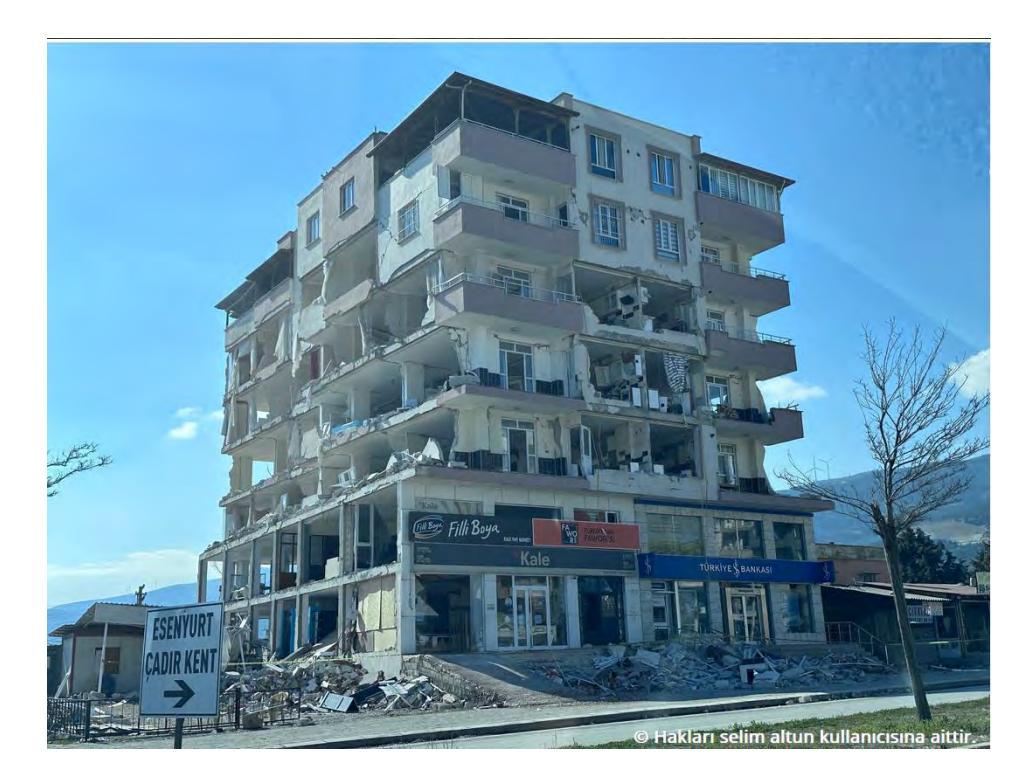
The damage was mainly due to poor construction quality and lack/inadequacy of structural elements in City center of Nurdağı. Some geotechnical damage was observed surrounding the city center. An example of partially collapsed buildings are shown in Figures 5.35 in the Nurdağı city center.

Figure 5.35. Heavily damaged building

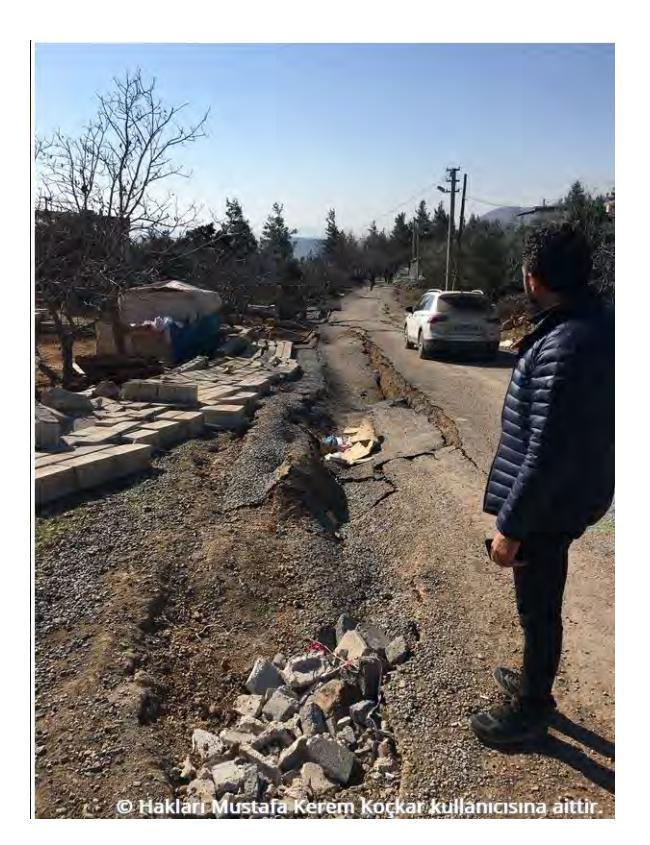
Large deformations and settlements occurred in the access road pavements on the rock units due to surface rupturing in the Nurdağı district (Figure 5.36).

Figure 5.36. Surface rupture in Nurdağı

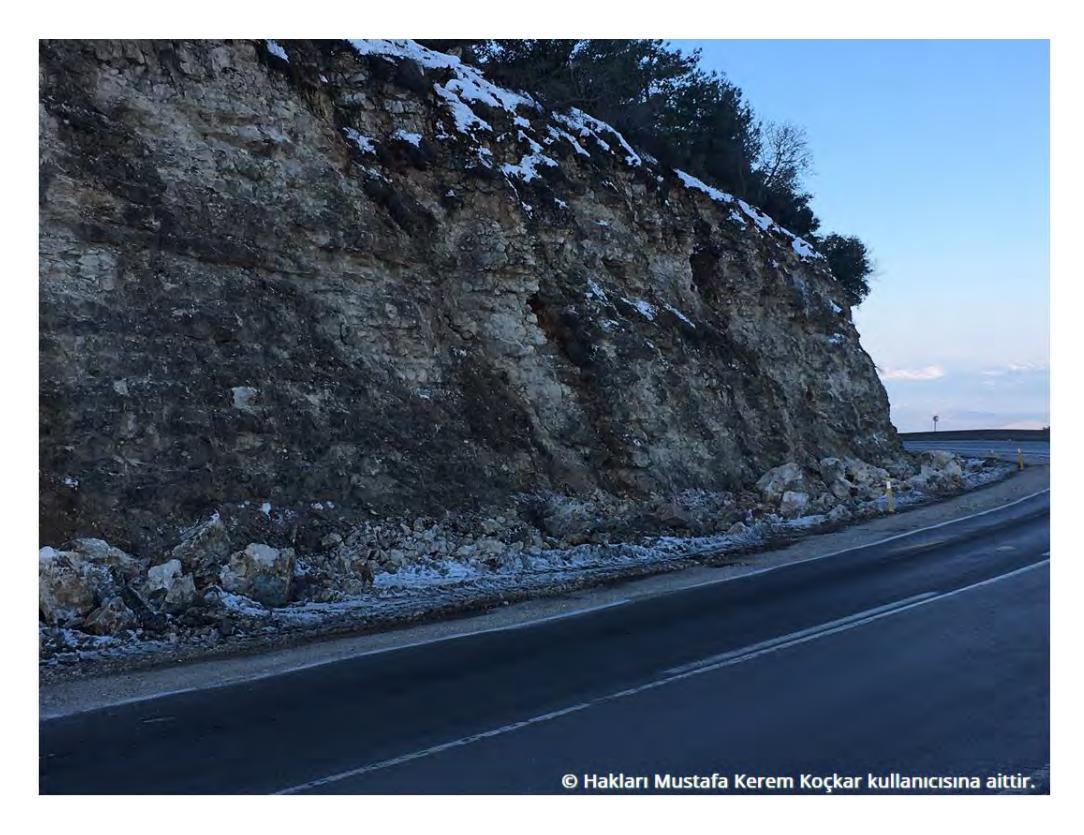
Rock mass failures due to rockfalls were observed along the slopes on the Gaziantep Osmaniye Road (D400) to the east of Nurdağı (Figure 5.38).

Figure 5.38. Rockfalls in the Nurdağı

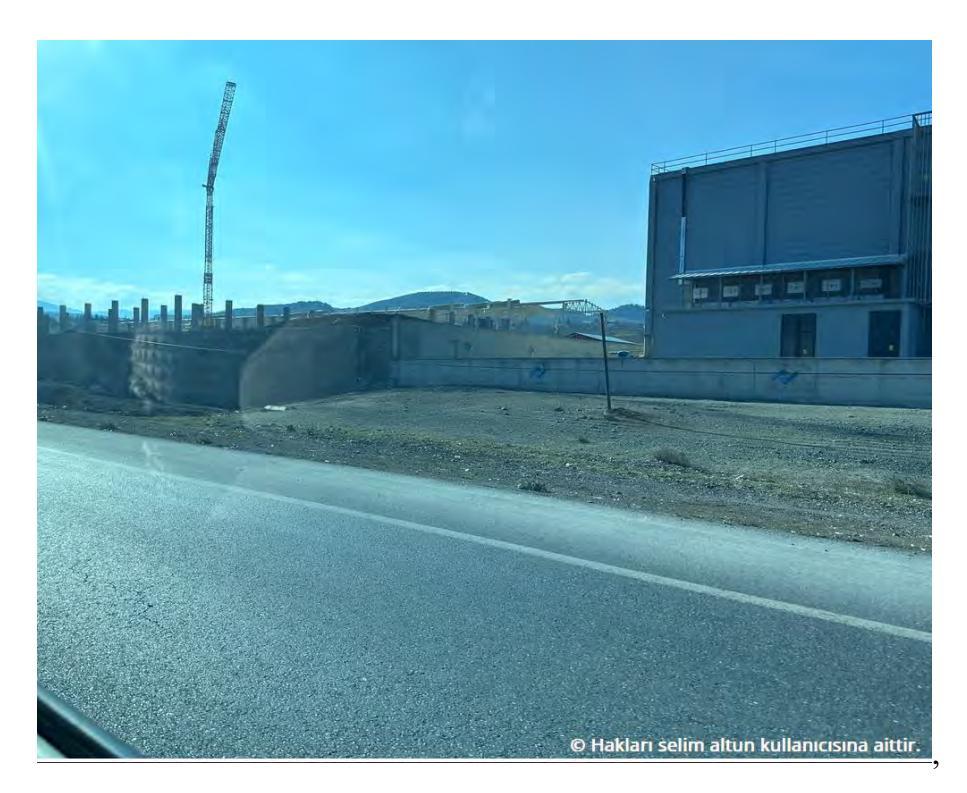
Figure 5.40. Retaining structure failure

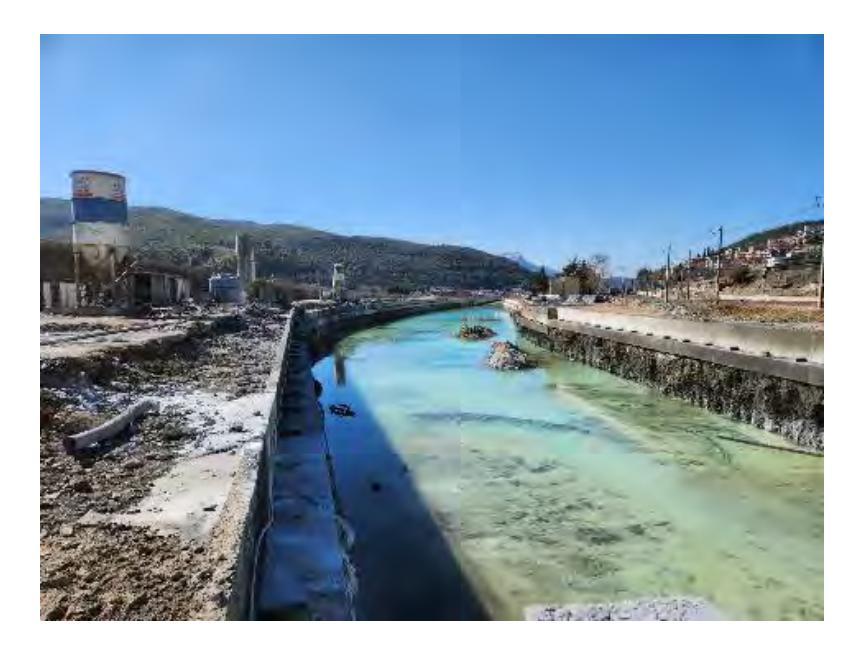
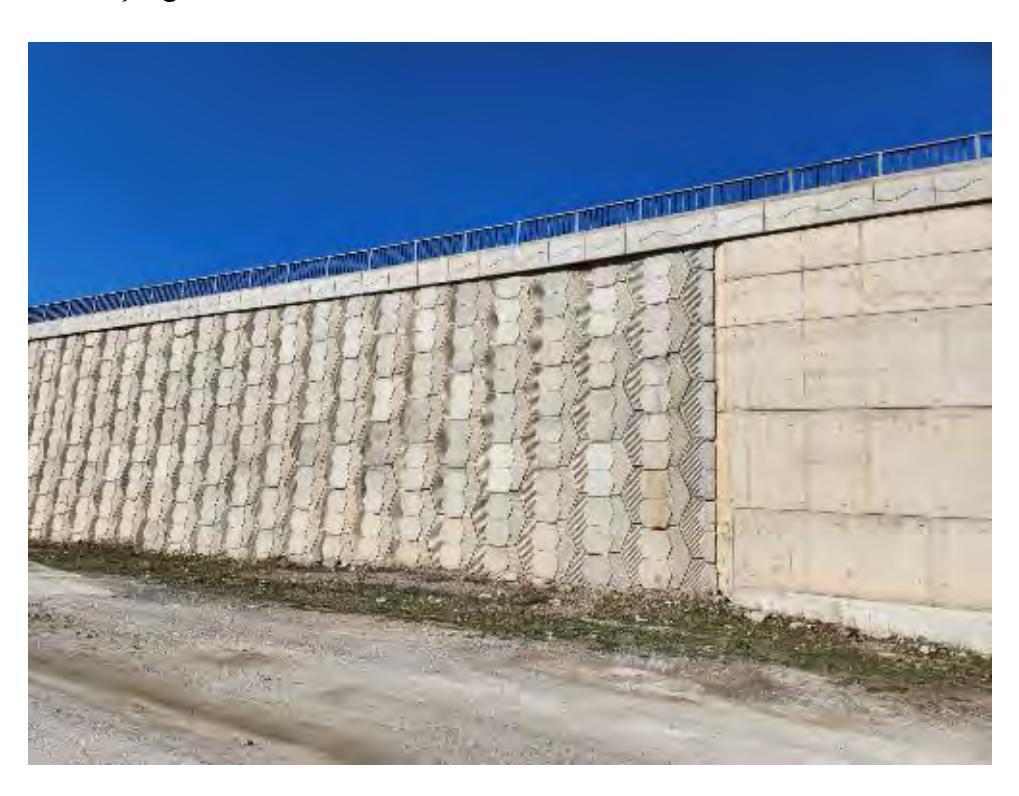
Observations at Bahçe Railway Underpass: The construction of the underpass that will connect the Osmaniye Bahçe district to the Osmaniye - Gaziantep Road continues. Although the construction works are not completed yet, no damage was observed in the piled excavation support system. A jet grout base curtain was designed and under construction during earthquakes. No significant deformations or failures was observed in the reinforced earth wall and panels, built for the main road embankments (Figs. 5.41& 5.42).

**Figure 5.41.** Bahçe Railway Underpassage Photo by Prof. Dr. Kemal Önder Çetin and Prof. Dr. Candan Gökçeoğlu

**Figure 5.42.** The reinforced earth wall. Photo by Prof. Dr. Kemal Önder Çetin and Prof. Dr. Candan Gökçeoğlu

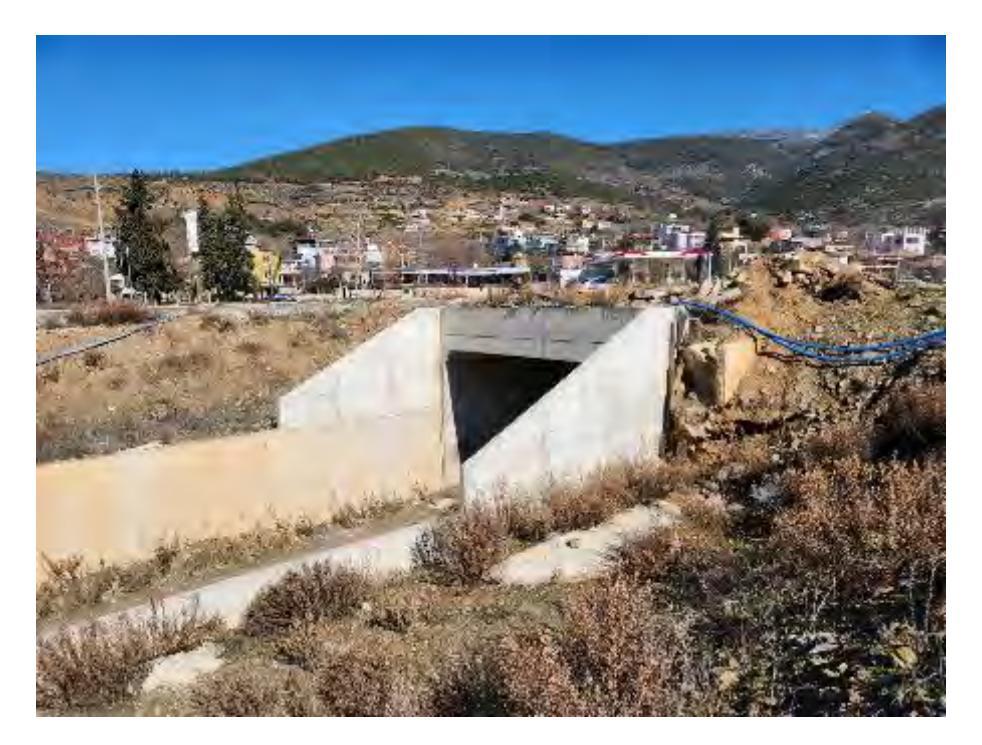
As can be seen from the Figure 5.43, no damage was observed at cut-and-cover tunnel exit section and the reinforced concrete support walls.

**Figure 5.43.** Cut-and-cover tunnel Photo by Prof. Dr. Kemal Önder Çetin and Prof. Dr. Candan Gökçeoğlu

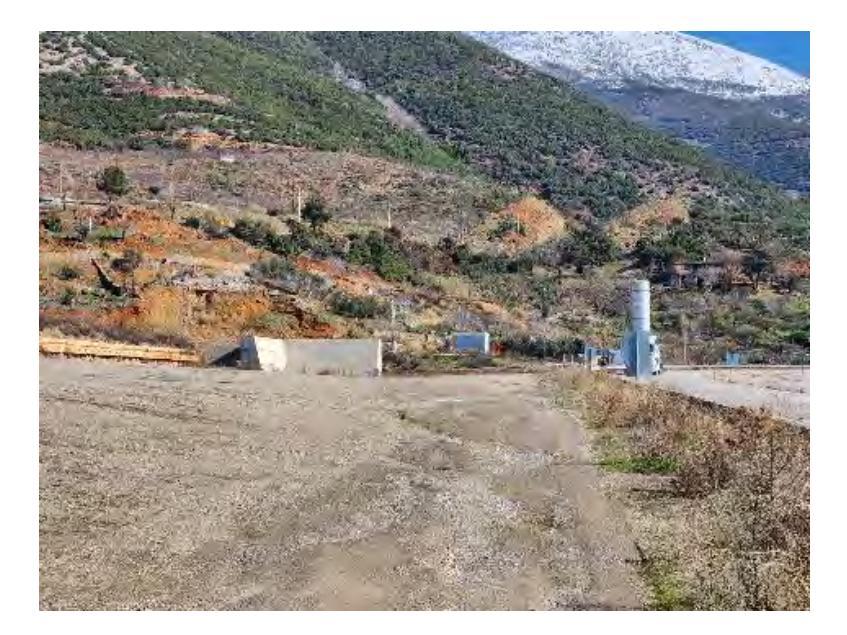
The photo in Figure 5.44, is taken from an angle extending from west to east, showing the TBM exit portal, the conventional railway line is running just above it. An L-shaped retaining wall was constructed between the top of the portal and the conventional railway. A small landslide

occurred, but the retaining wall prevented the landslide from continuing, preventing damage to both the portal and the conventional railway (Fig. 5.44).

**Figure 5.44.** A small landslide occurred. Photo by Prof. Dr. Kemal Önder Çetin and Prof. Dr. Candan Gökçeoğlu

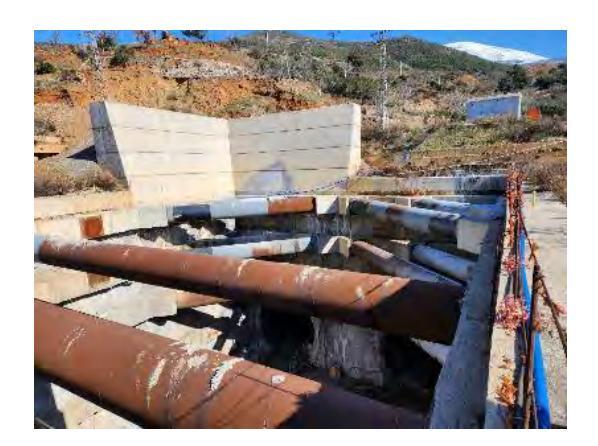
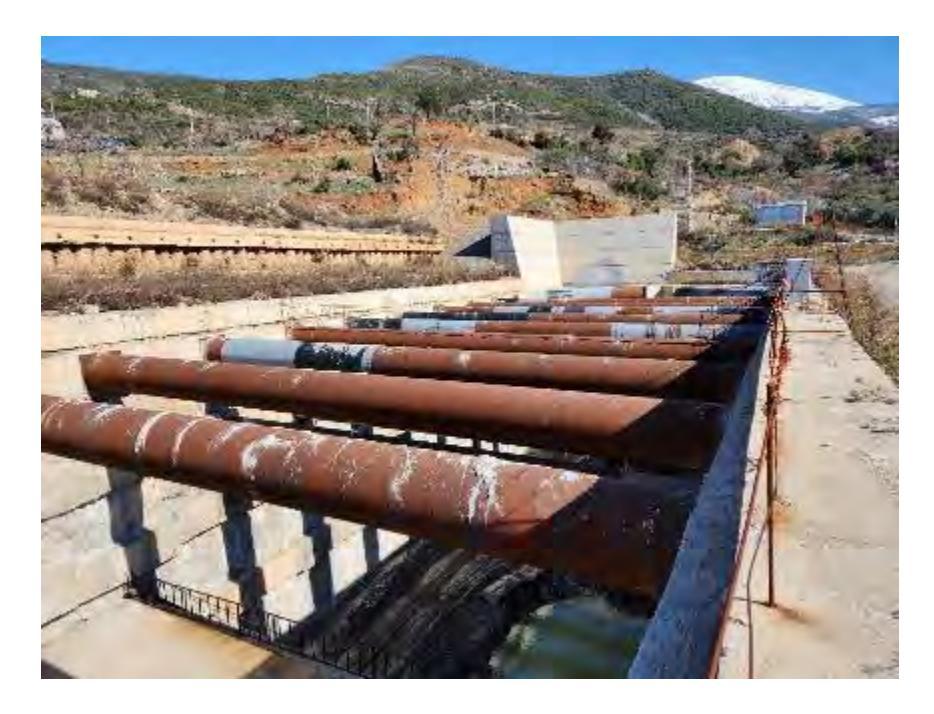
Struts (steel pipes) were designed to support pile elements in Bahçe. A certain section of the cut-and-cover tunnel built right in front of the garden portal is temporarily supported by struts and kept open for the removal of the TBM, which is currently being excavated in the tunnel. As can be seen from the photos below, all struts performed well as designed and no damage was occurred (Figs. 5.45 & 5.46).

**Figure 5.45.** A certain section of the cut-and-cover tunnel Photo by Prof. Dr. Kemal Önder Çetin and Prof. Dr. Candan Gökçeoğlu

**Figure 5.46.** Cut-and-cover tunnel supported by struts. Photo by Prof. Dr. Candan Gökçeoğlu and Prof. Dr. Kemal Önder Çetin

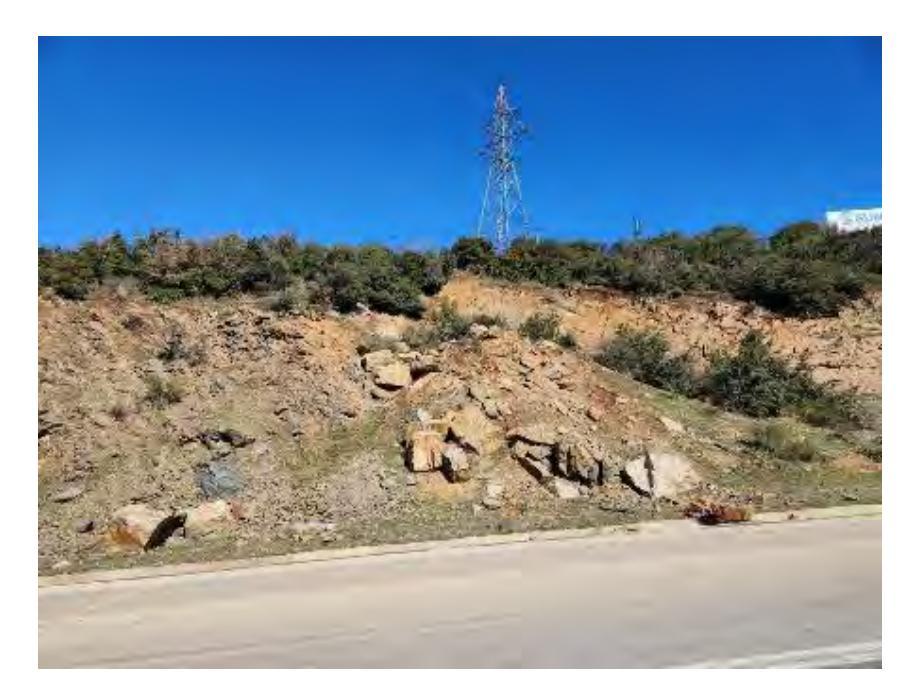
Various rockfalls and failures caused by local discontinuity were observed in the metamorphic blocky rock masses on the slopes of the State Highway between Bahçe and Nurdağı. In the photo below, the block falls observed on the northern slope of Bahçe-Nurdağı Highway can be observed (Fig. 5.47).

**Figure 5.47.** Rockfall at Bahçe-Nurdağı Highway. Photo by Prof. Dr. Candan Gökçeoğlu and Prof. Dr. Kemal Önder Çetin

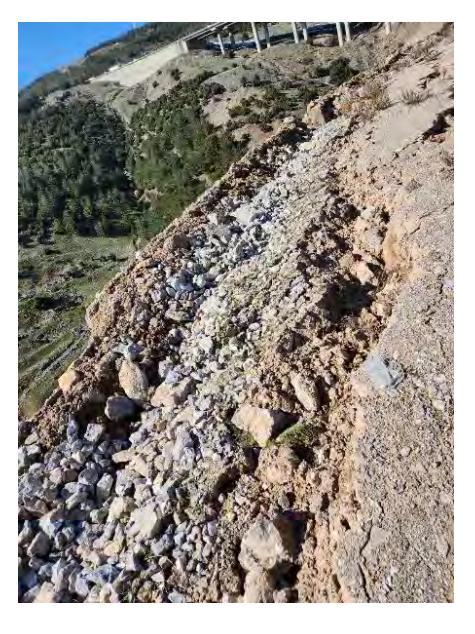
Failures were observed in the road embankment and the stone wall supporting the embankment between Bahçe and Nurdağı. These changes can be seen in the photos below (Figs. 5.48-5.49).

Figure 5.48. Failures in the road embankment and the stone wall supporting the embankment between Bahçe and Nurdağı. Photo by Prof. Dr. Kemal Önder Çetin and Prof. Dr. Candan Gökçeoğlu

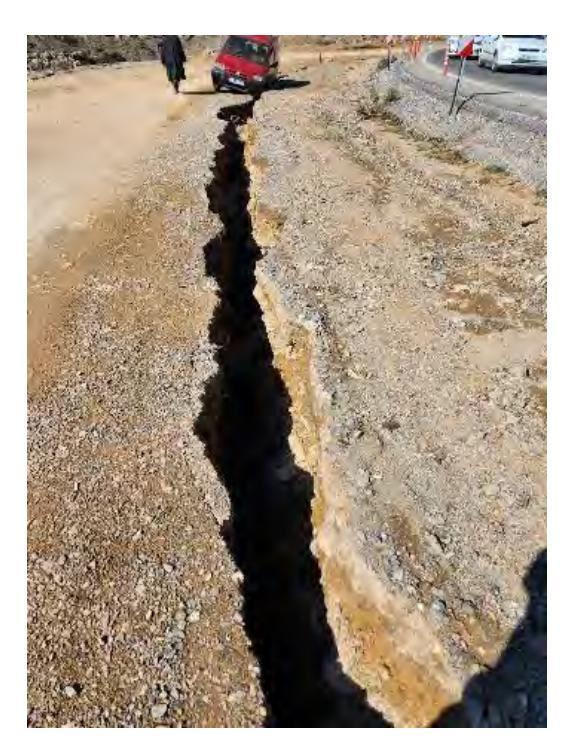
**Figure 5.49.** Failures in the road embankment and the stone wall supporting the embankment between Bahçe and Nurdağı. Prof. Dr. Candan Gökçeoğlu and Prof. Dr. Kemal Önder Çetin

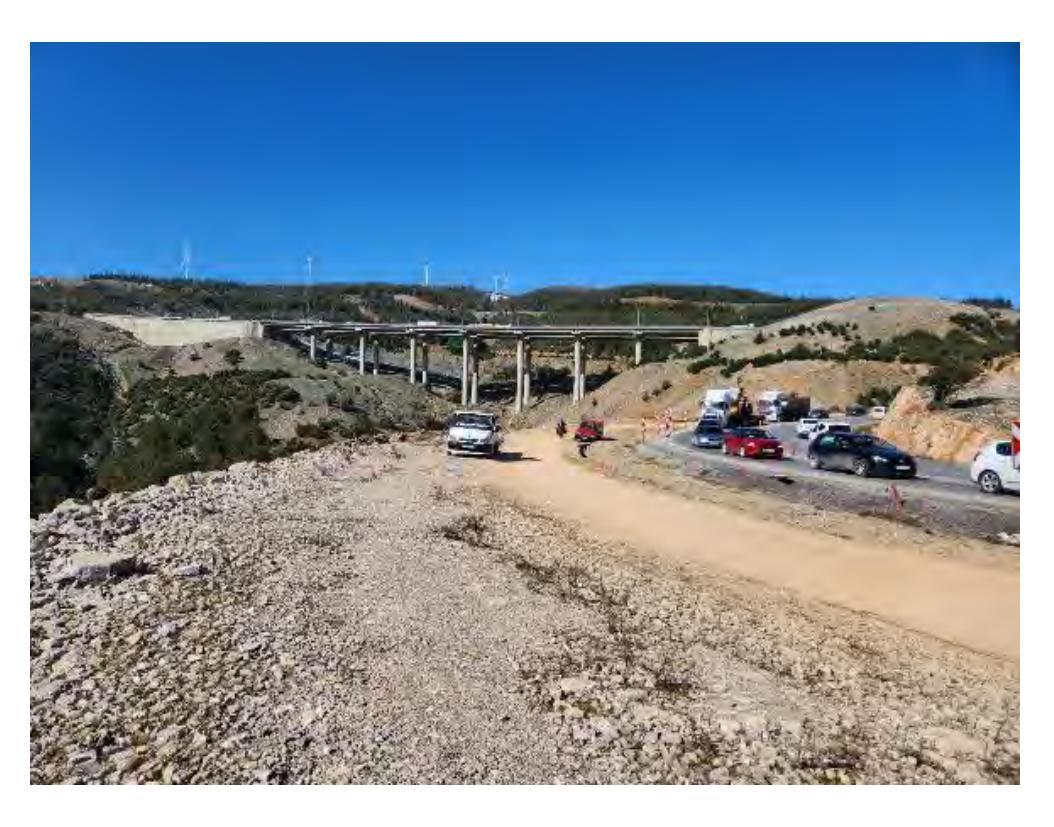
**Figure 5.50.** Failures in the road embankment and the stone wall supporting the embankment between Bahçe and Nurdağı. Photo by Prof. Dr. Kemal Önder Çetin and Prof. Dr. Candan Gökçeoğlu

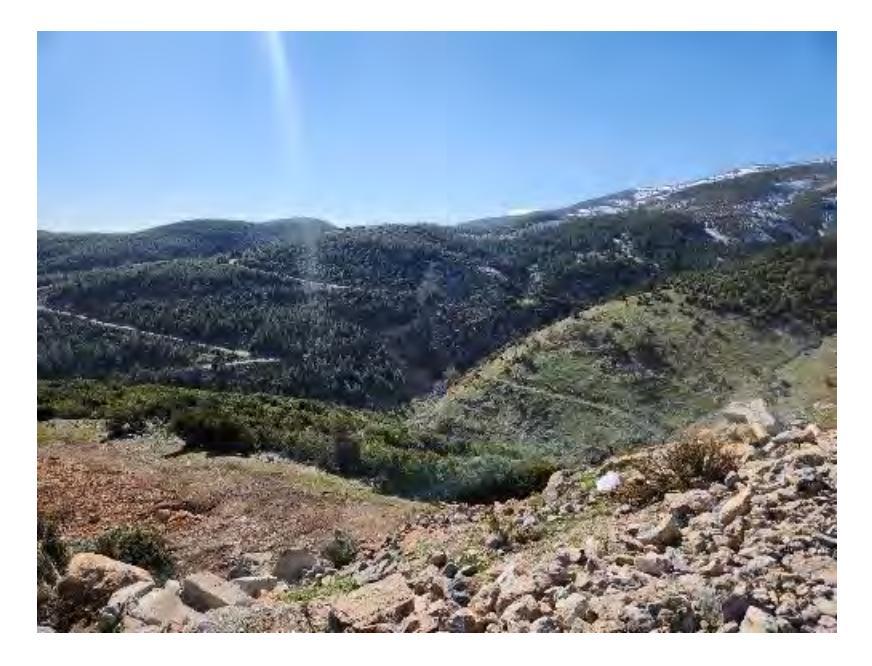
Surface ruptures and landslides triggered by many landslides were observed around Gökçedere village of Nurdağı district (Figs. 5.51-5.54).

**Figure 5.51.** Surface ruptures and landslides around Gökçedere. Prof. Dr. Candan Gökçeoğlu and Prof. Dr. Kemal Önder Çetin

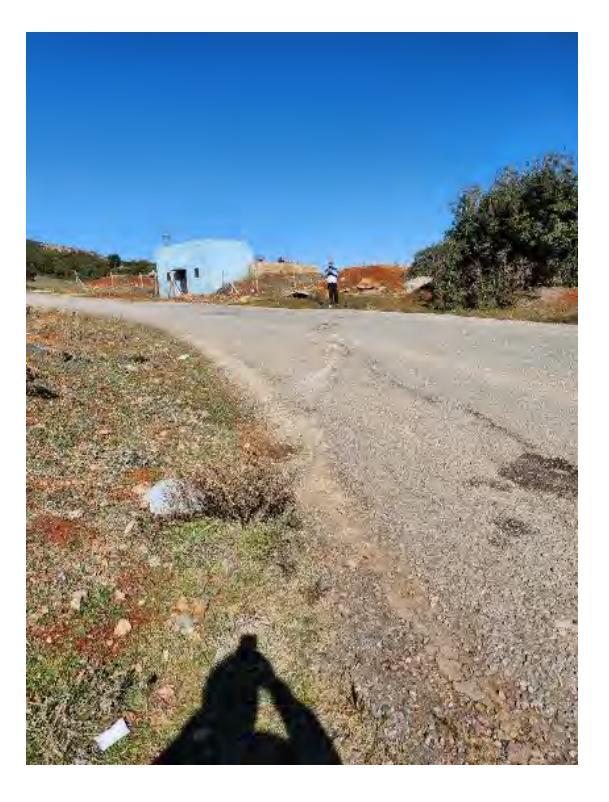
**Figure 5.52.** Minor surface ruptures around Gökçedere. Prof. Dr. Candan Gökçeoğlu and Prof. Dr. Kemal Önder Çetin

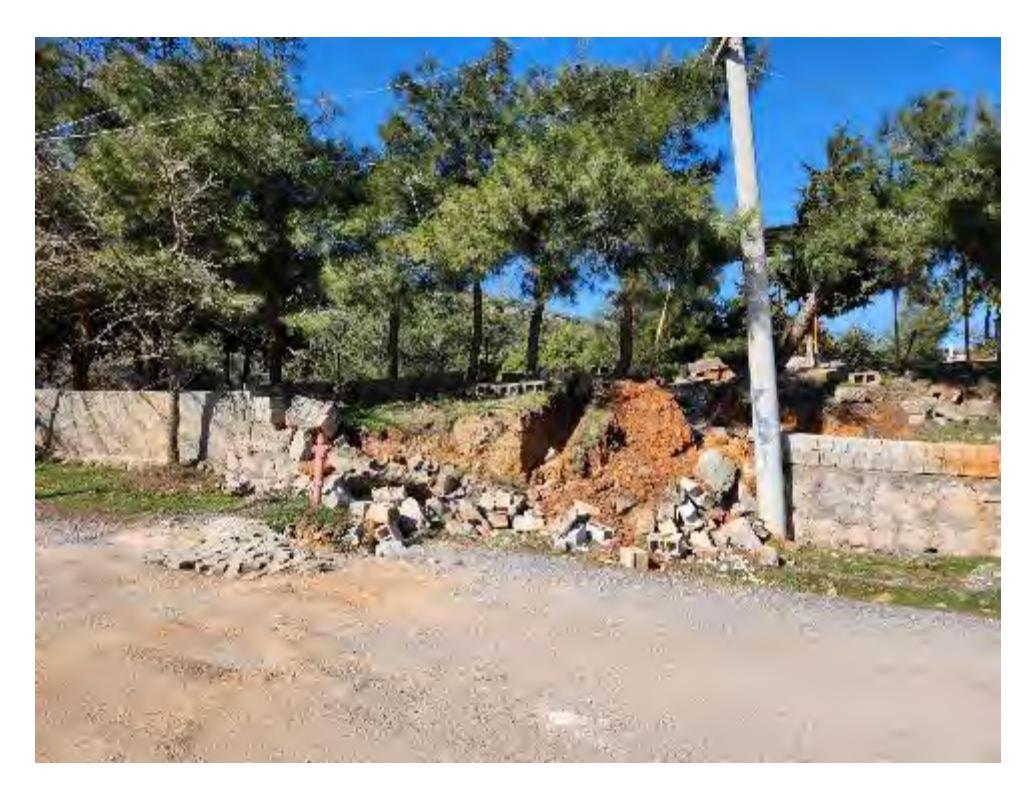
**Figure 5.53.** Fault ofsett across a village graveyard. Photo by Prof. Dr. Kemal Önder Çetin and Prof. Dr. Candan Gökçeoğlu

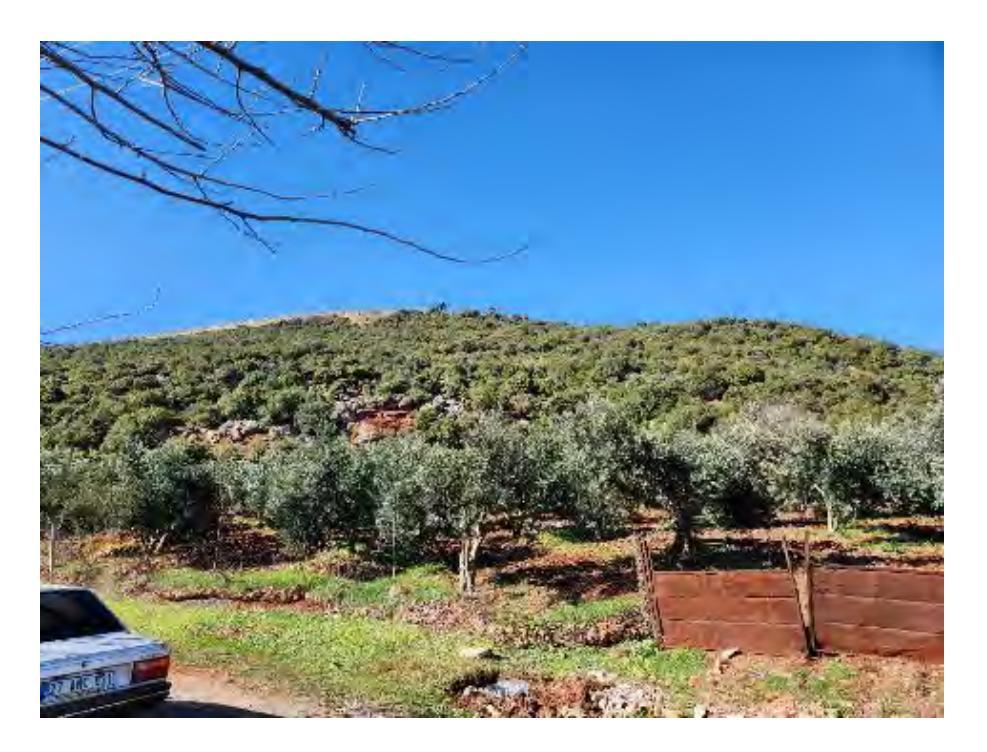
**Figure 5.54.** Minor surface ruptures around Gökçedere. Photo by Prof. Dr. Candan Gökçeoğlu and Prof. Dr. Kemal Önder Çetin
