# Türkiye Earthquake

## **RECONNAISSANCE REPORT**

February 6, 2023 Kahramanmaraş-Pazarcık ( $M_w$ =7.7) and

Elbistan (M<sub>w</sub>=7.6) Earthquakes

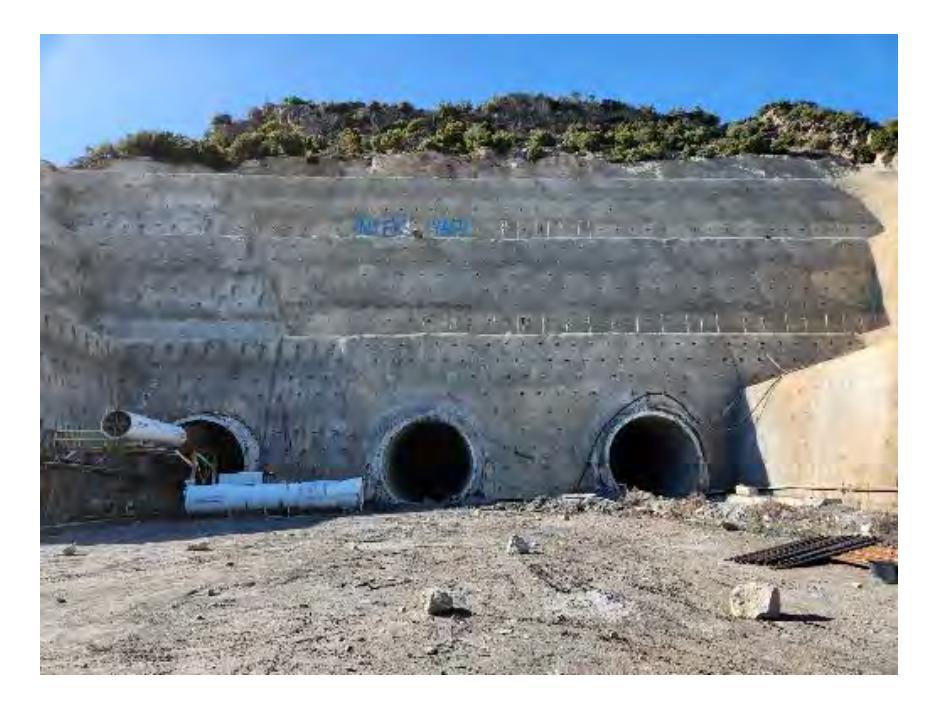
No damage was observed at the portal of the Bahçe-Nurdağı tunnels. However, some rockfalls are observed. However, the surface fracture passes approximately 50 m in front of the portal (Fig. 5.55).

**Figure 5.55.** The portal of the Bahçe-Nurdağı tunnels. Photo by Prof. Dr. Candan Gökçeoğlu and Prof. Dr. Kemal Önder Çetin

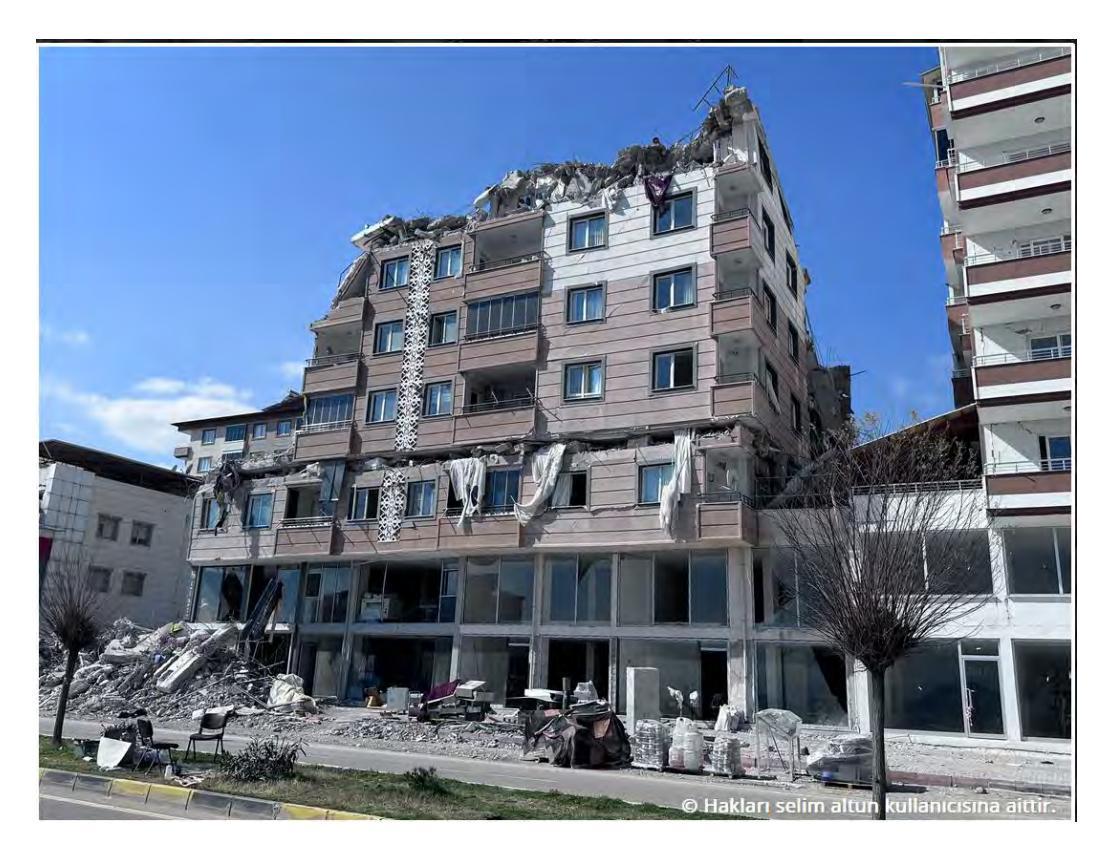
The damage was mainly due to poor construction practices and inadequacy of lateral structural element capacity in city center of Islahiye. Some geotechnical damage was observed surrounding the city center. Some examples of partially collapsed buildings are shown in Figures 5.56 and 5.57 in the Islahiye city center.

Figure 5.56. Partially collapsed building in Islahiye

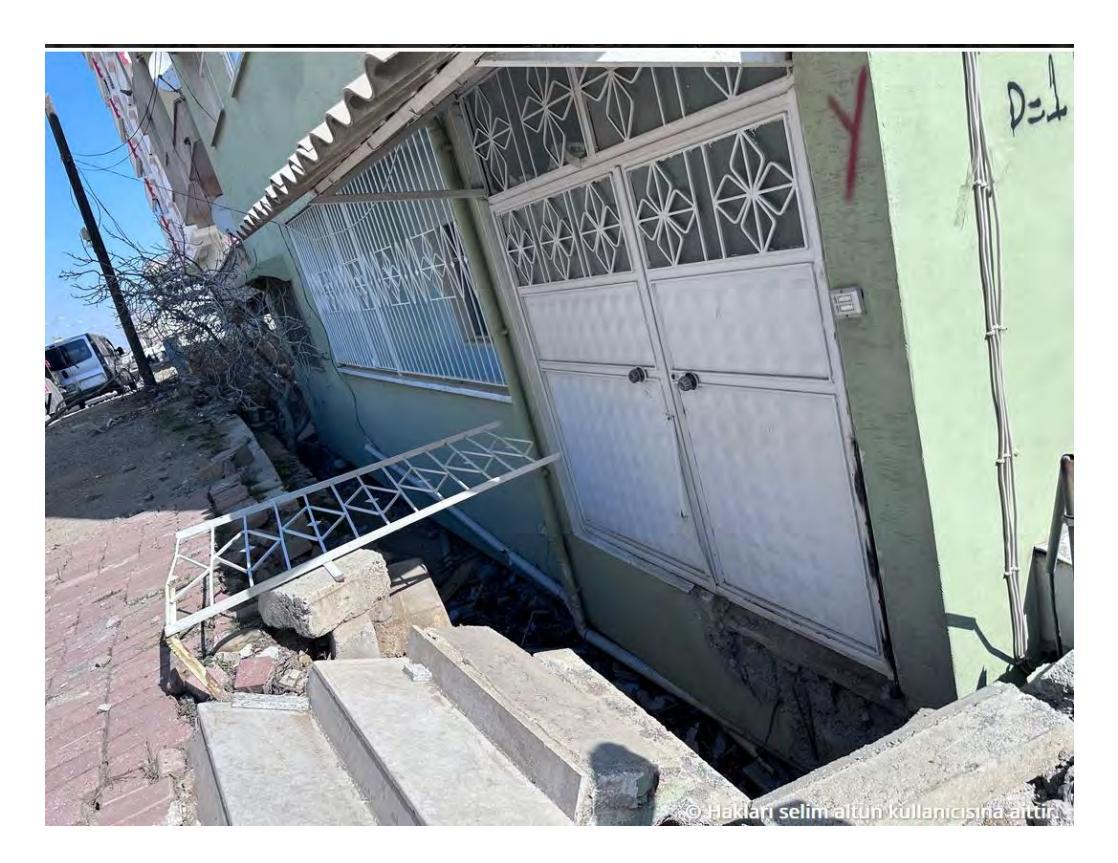
Figure 5.57. Settled building in Islahiye

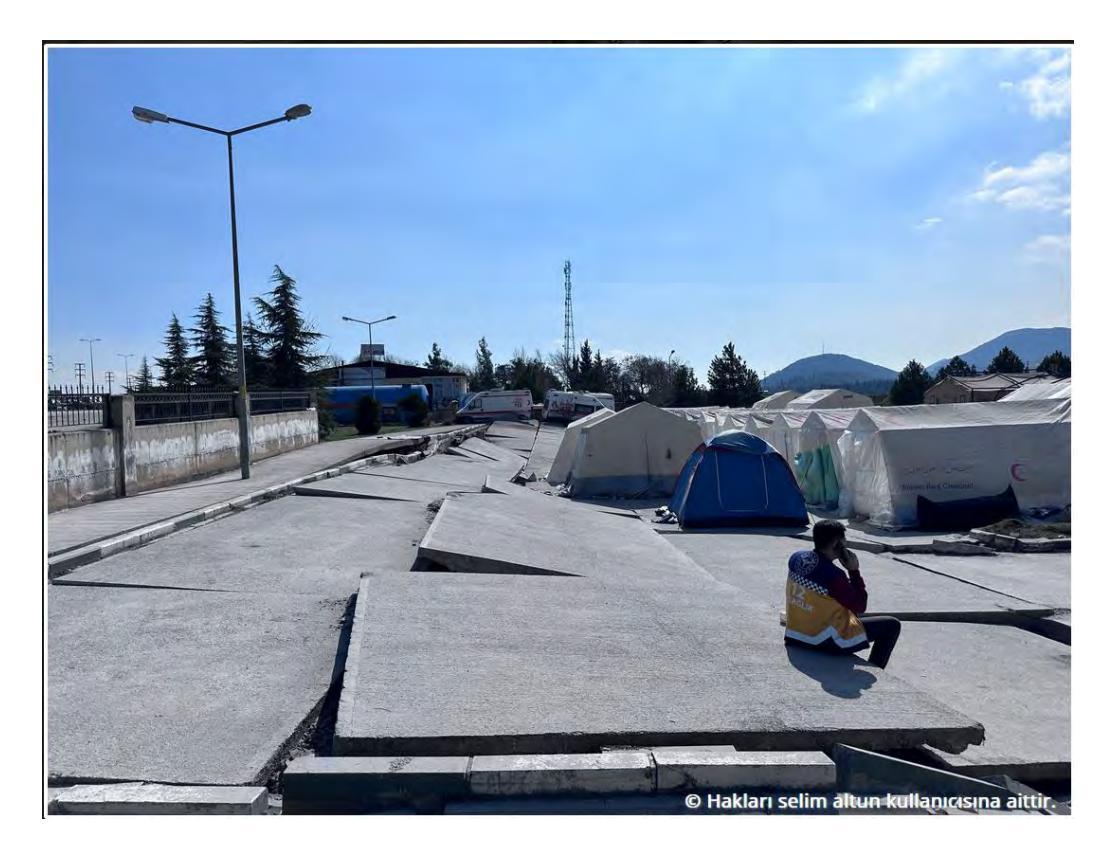
Islahiye State Hospital did not suffer from damage during earthquake despite it is proximity to the fault rupture (Fig. 5.58-5.59)

Figure 5.58. Deformed surface concrete panels in front of Islahiye State Hospital

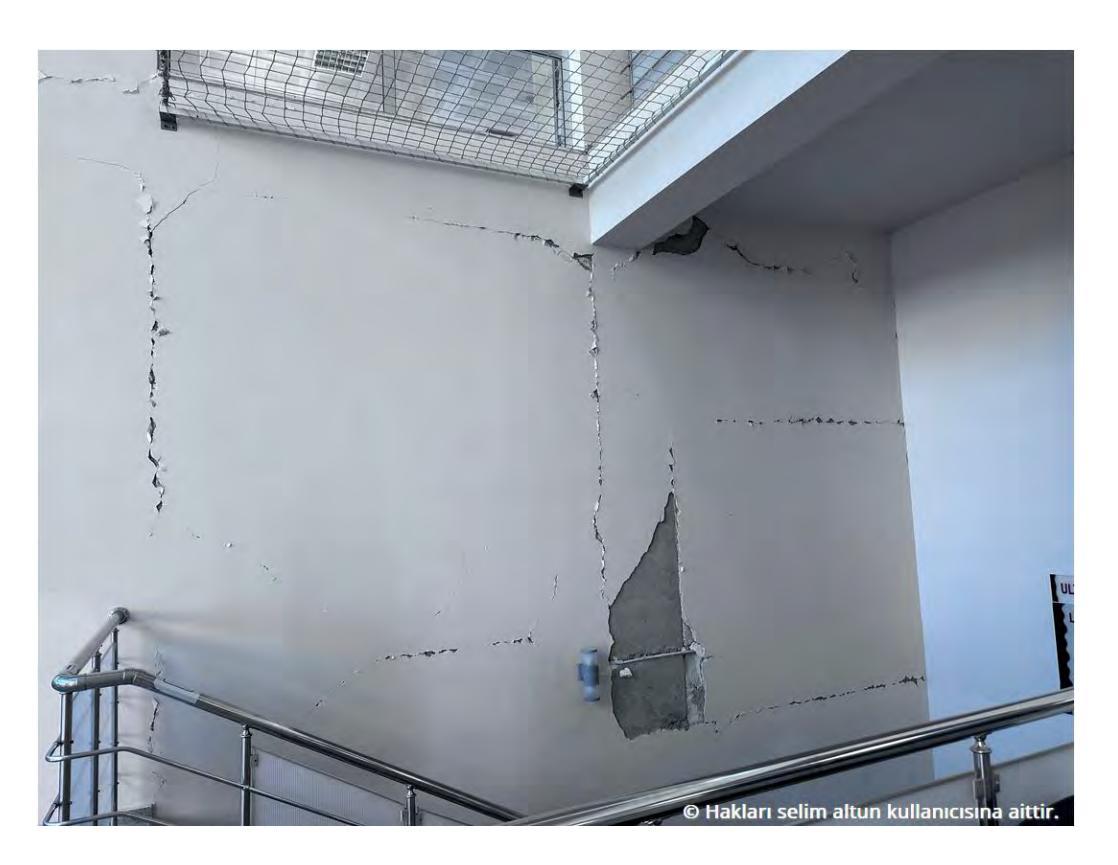
Figure 5.59. No structural damage in Islahiye State Hospital. Minor cracks at infill walls

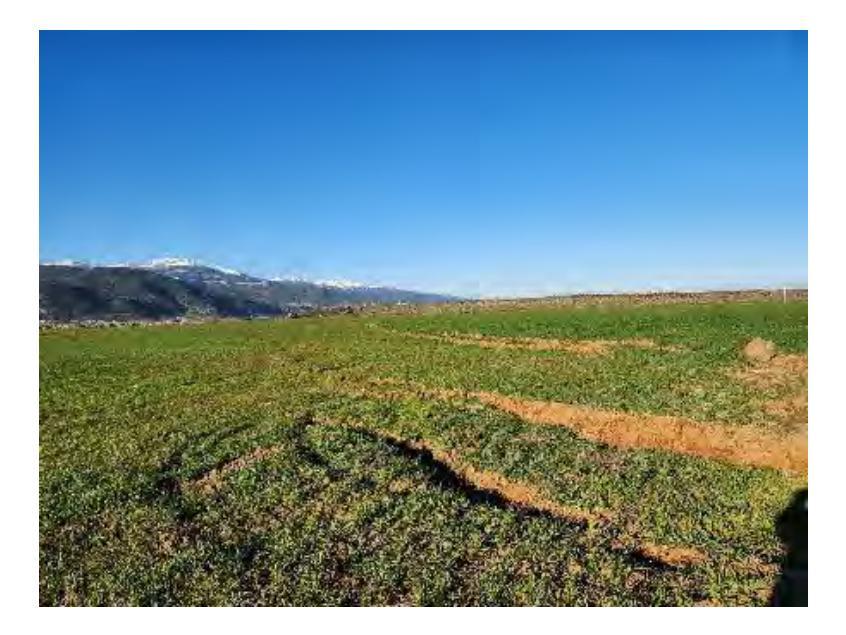
Approximately north-south trending surface ruptures are commonly observed in Islahiye district. The rupture passing in front of the Islahiye State Hospital cuts the railway to the south. In addition, flowering was observed on the natural ground. Left lateral displacement was clearly observed in the surface fractures (Figs. 5.60-5.63).

**Figure 5.60.** Surface rupture Photo by Prof. Dr. Candan Gökçeoğlu and Prof. Dr. Kemal Önder Çetin

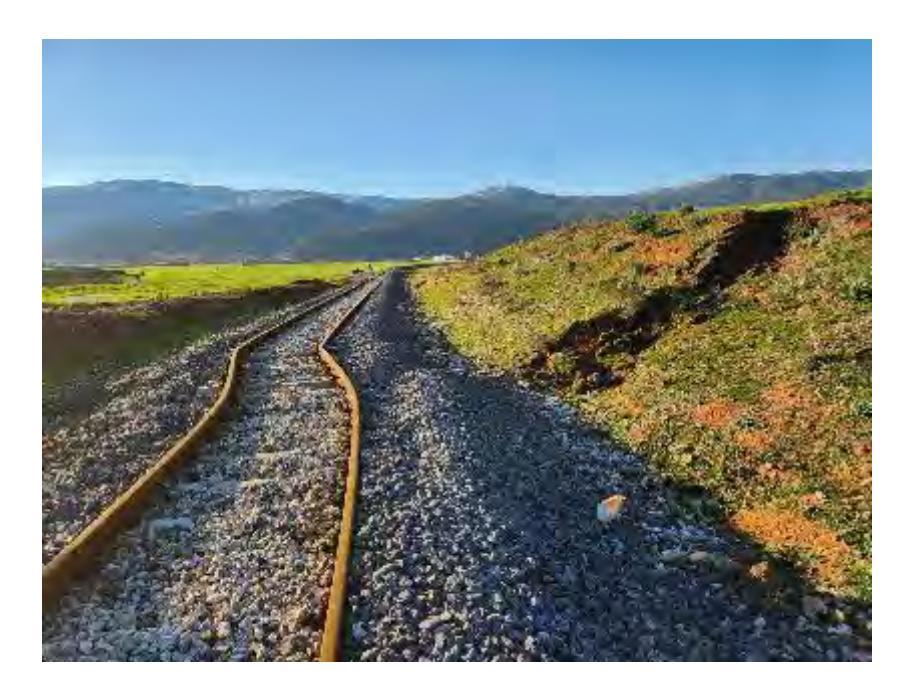
**Figure 5.61.** Fault rupture. Photo by Prof. Dr. Candan Gökçeoğlu and Prof. Dr. Kemal Önder Çetin

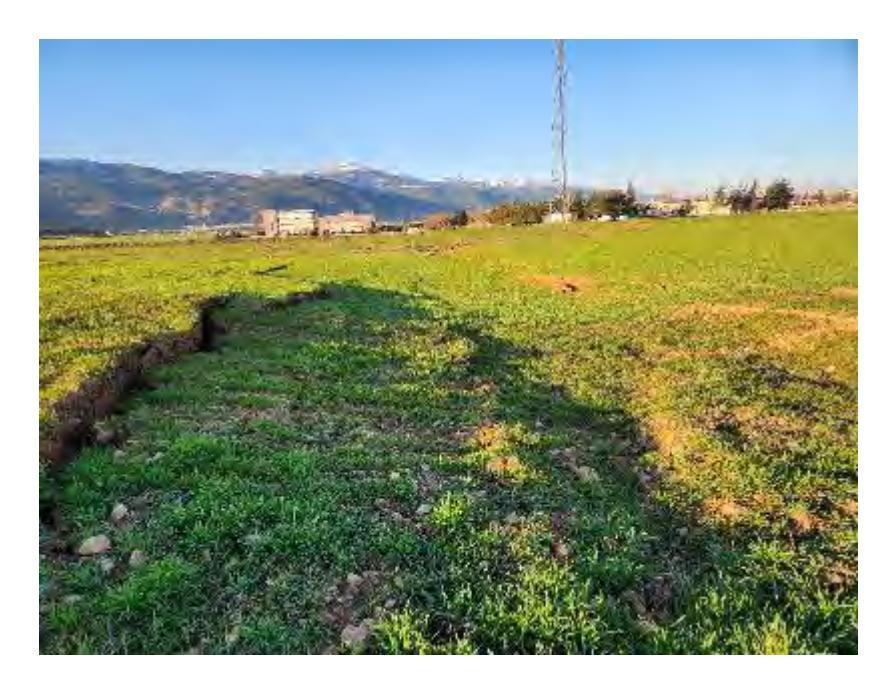
**Figure 5.62.** Fault rupture and flowering surface manifestations. Photo by Prof. Dr. Kemal Önder Çetin and Prof. Dr. Candan Gökçeoğlu

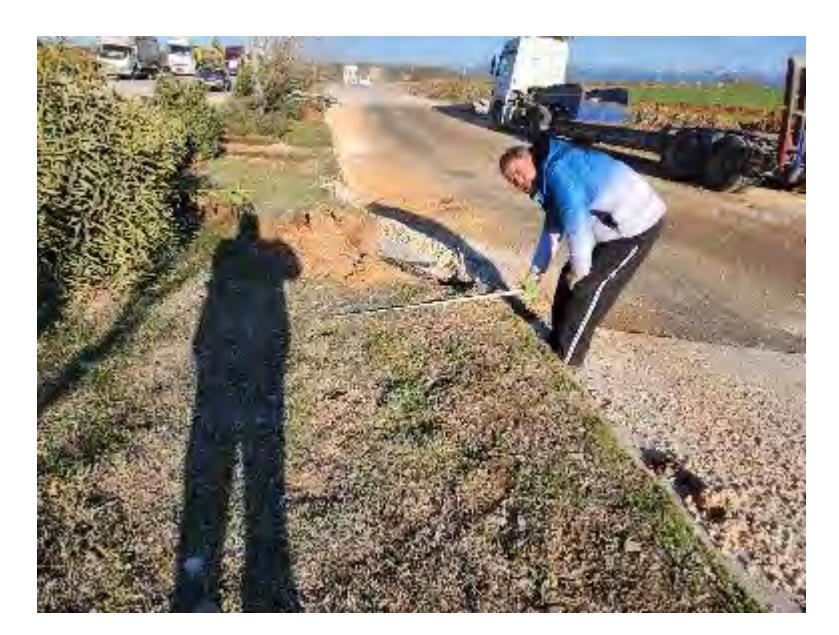
Figure 5.63. Fault offset. Photo by Prof. Dr. Candan Gökçeoğlu and Prof. Dr. Kemal Önder Çetin

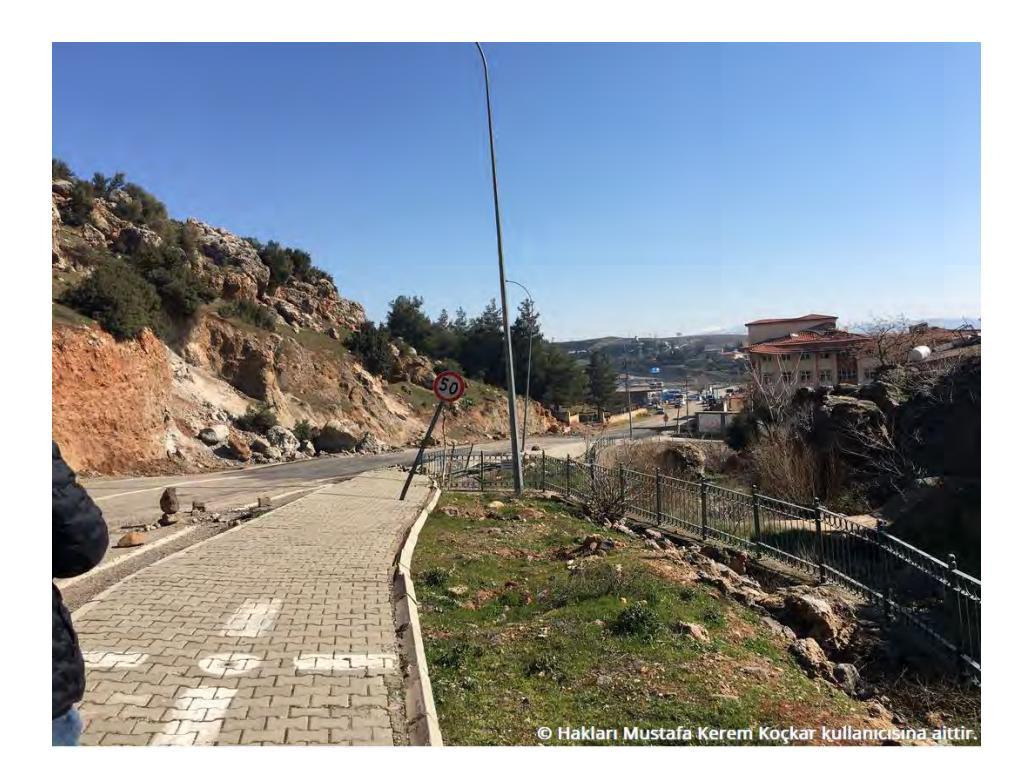
Mass failures due to rockfall were observed on the slopes parallel to the railway in the Fevzipaşa neighborhood of the Islahiye district (Fig. 5.64). In addition, along the water channel on the same route, the retaining structure collapsed towards the channel for approximately 150 m due to lateral spreading (Fig. 5.65).

Figure 5.64. Rockfalls in Islahiye

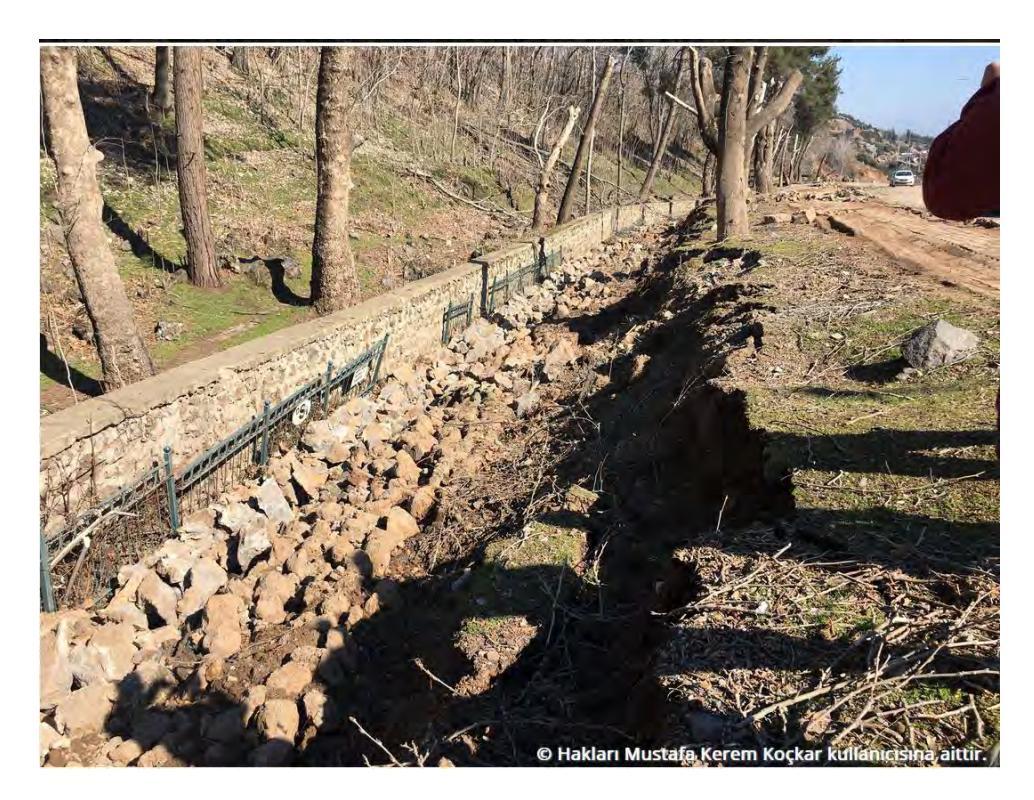
Figure 5.65. Lateral spreading in Islahiye

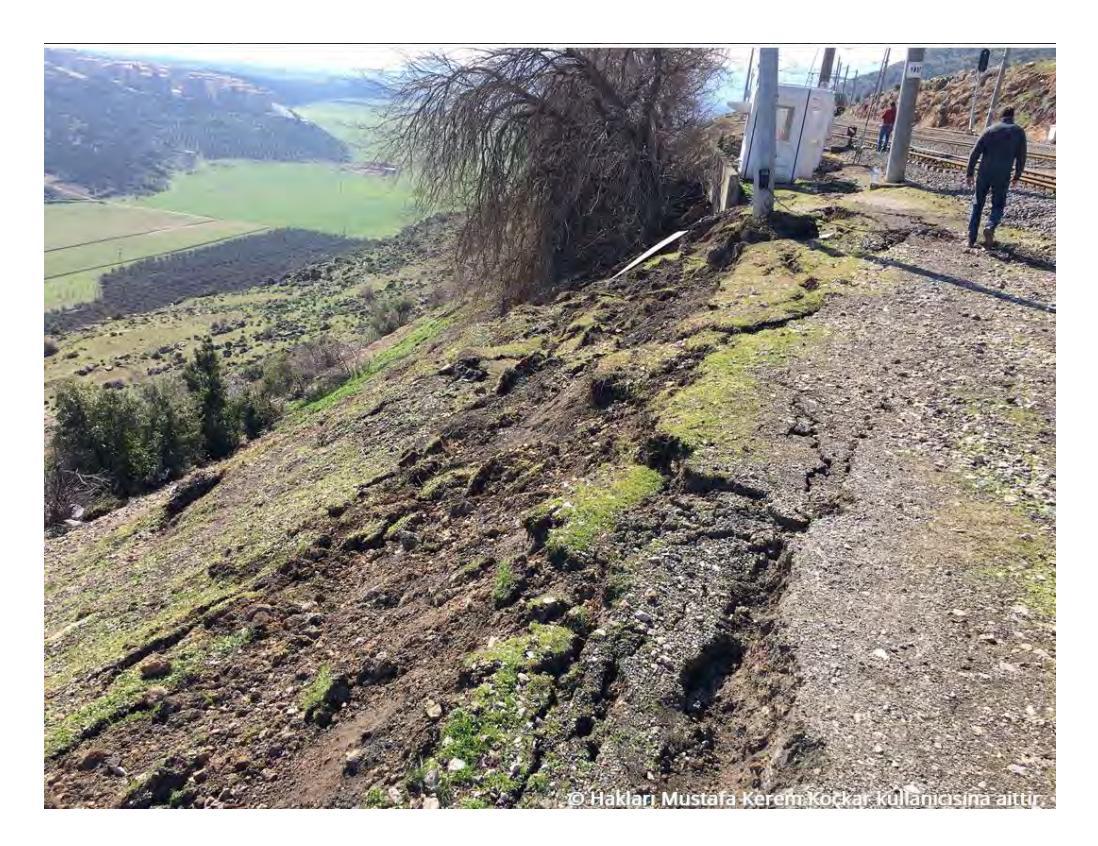
Large deformations occurred on the railway in the Fevzipaşa region due to surface rupturing. Large tension cracks at the crown of the landslide were encountered along the cut slope to the east of the station (Fig. 5.66). In a certain section, the retaining structure along this landslide was also destroyed and tilted due to the sliding movement.

### Figure 5.66. Slope slides in Islahiye

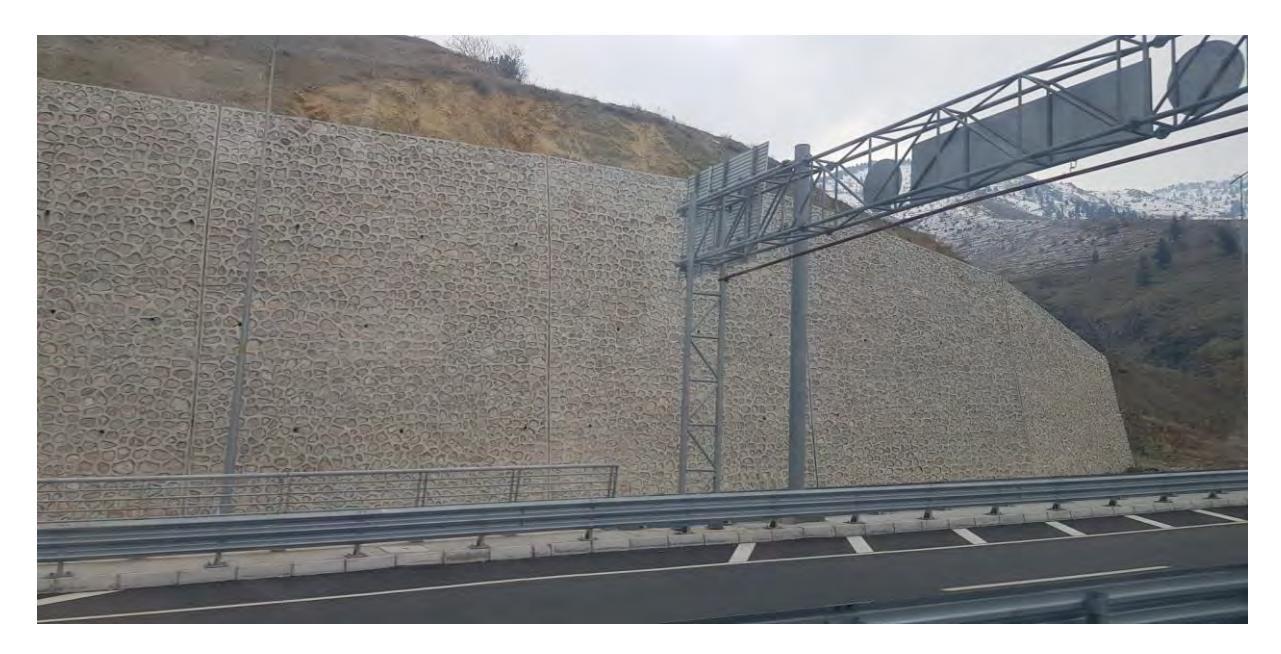
There was no damage to the retaining structures located on the Elazığ and Malatya highway as seen in Figure 5.67. Also, insignificant slope stability was seen (Figure 5.68). Large cracks were not observed on the Elazığ-Malatya highway and in the Malatya city center. Only small cracks were observed in the roads of Malatya, as seen in Figure 5.69. It can be said that geotechnical problems such as submersion, swelling, liquefaction etc., were not observed in the Malatya city center. Due to the old building stocks, structural design and material defects, some residential structures were heavily damaged or collapsed.

Figure 5.67. Elazığ-Malatya highway (Kömürhan Bridge-Photo by Erkut Sayın)

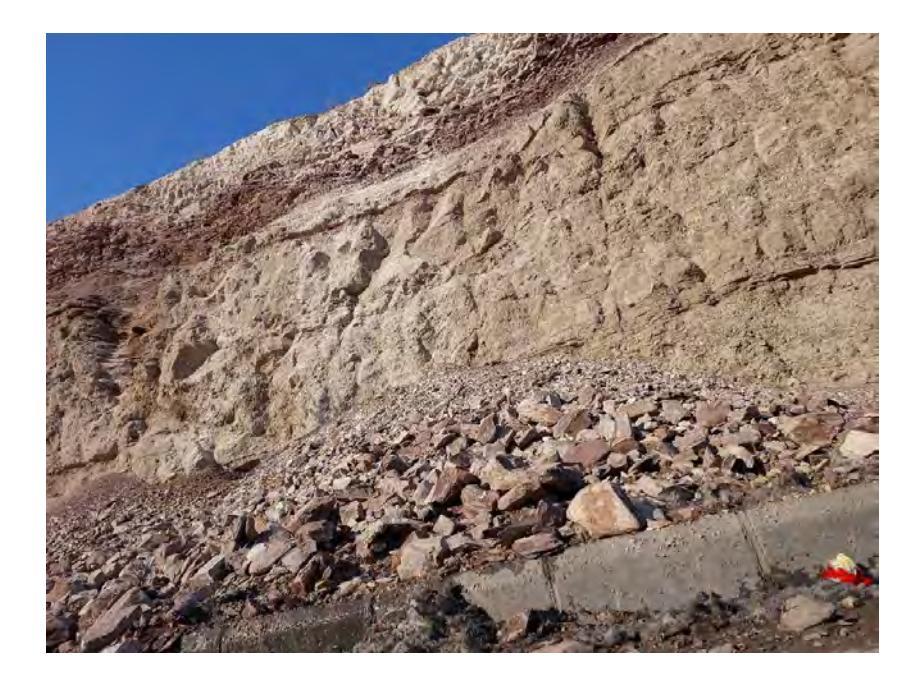
Figure 5.68. Elazığ-Malatya highway (Photo by Mesut Gör)

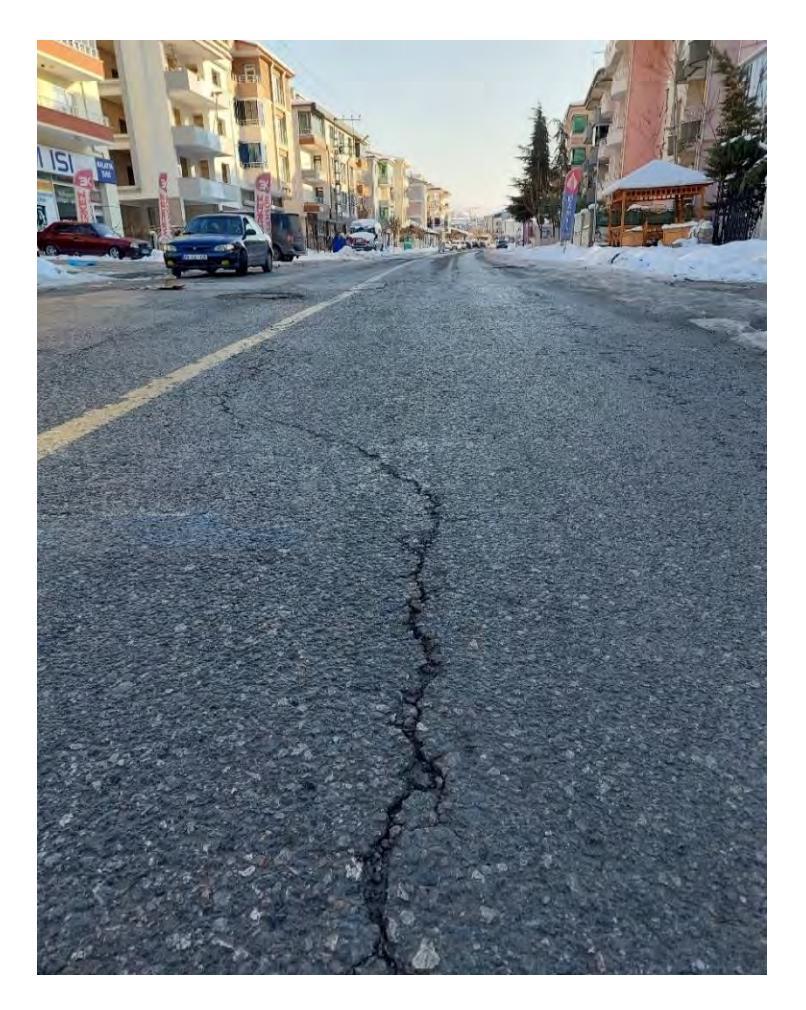
Figure 5.69. Road conditions in Malatya city center (Photo by Mesut Gör)

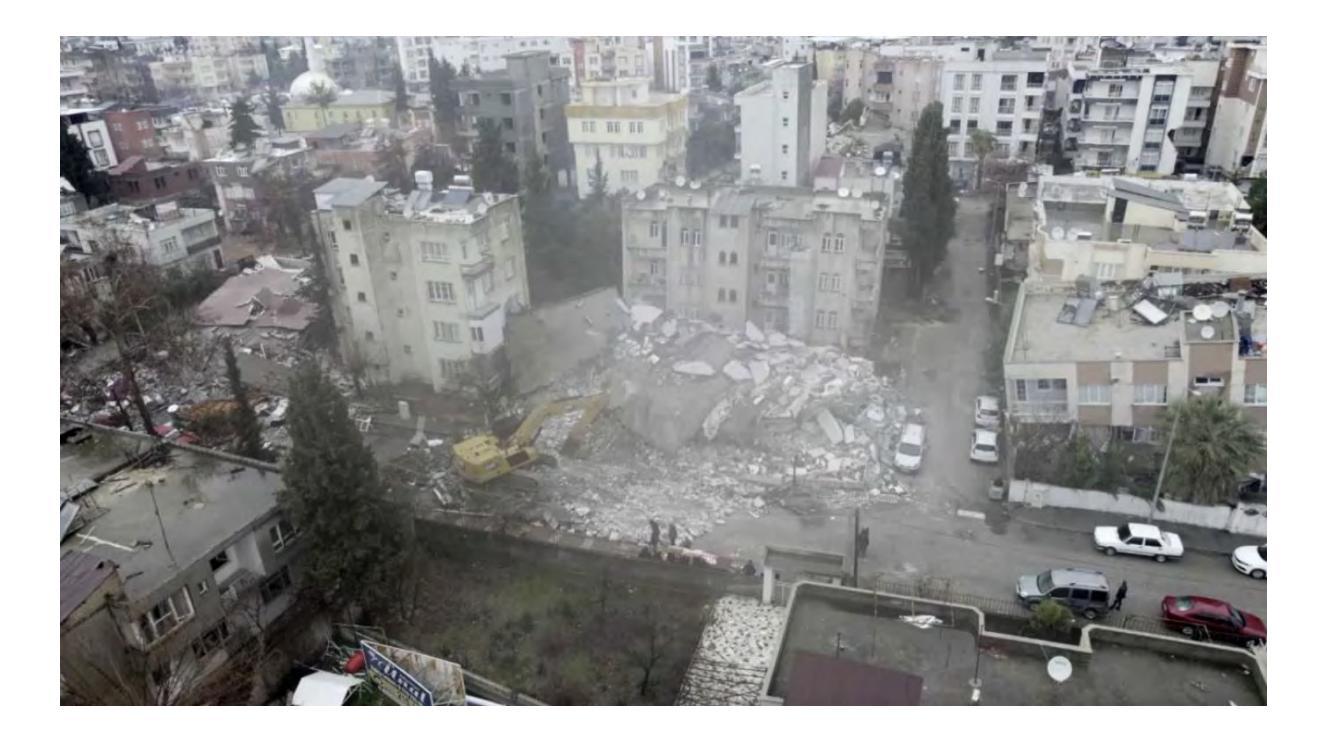
Approximately 45 % of the buildings in the central district collapsed during the first earthquake  $(M_w=7.7)$  and 15 % collapsed during the second earthquake  $(M_w=7.6)$ . The majority of the remaining structures were heavily damaged (Figure 5.70, 71, 72, 73). Most of the buildings constructed after 2016 are inhabitable, their elevator reinforced concrete walls are damaged. Liquefaction phenomenon was not observed in the Adıyaman central district. The number of totally collapsed buildings in the Pazarcık and Gölbaşı districts are less compared to the central

**Figure 5.70.** Photograph taken in the Adıyaman central district showing earthquake damage (https://www.gazeteduvar.com.tr/depremden-etkilenen-Adıyamandaki-hasar-havadan-goruntulendi-galeri-16020839.

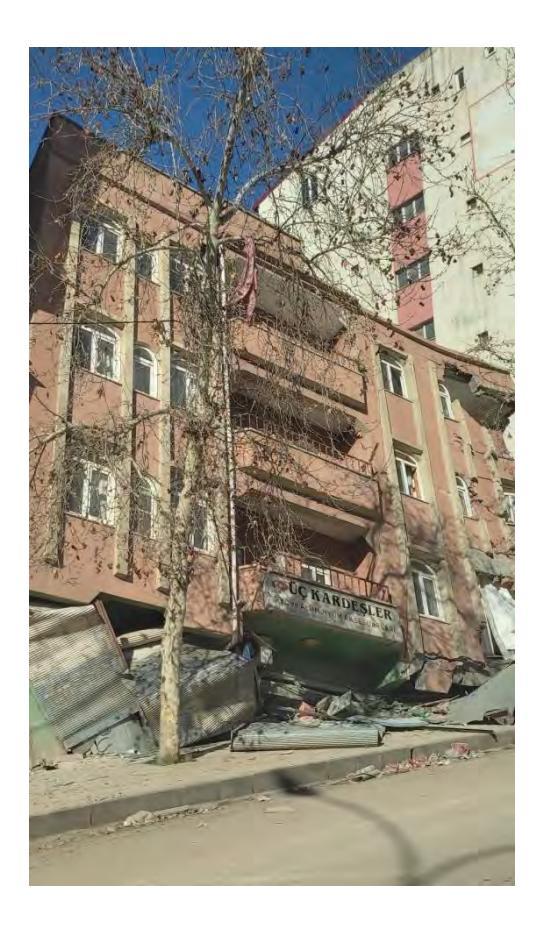
**Figure 5.71.** Collapsed building in the Adıyaman central district (photo taken by Dr. Senem Tekin).

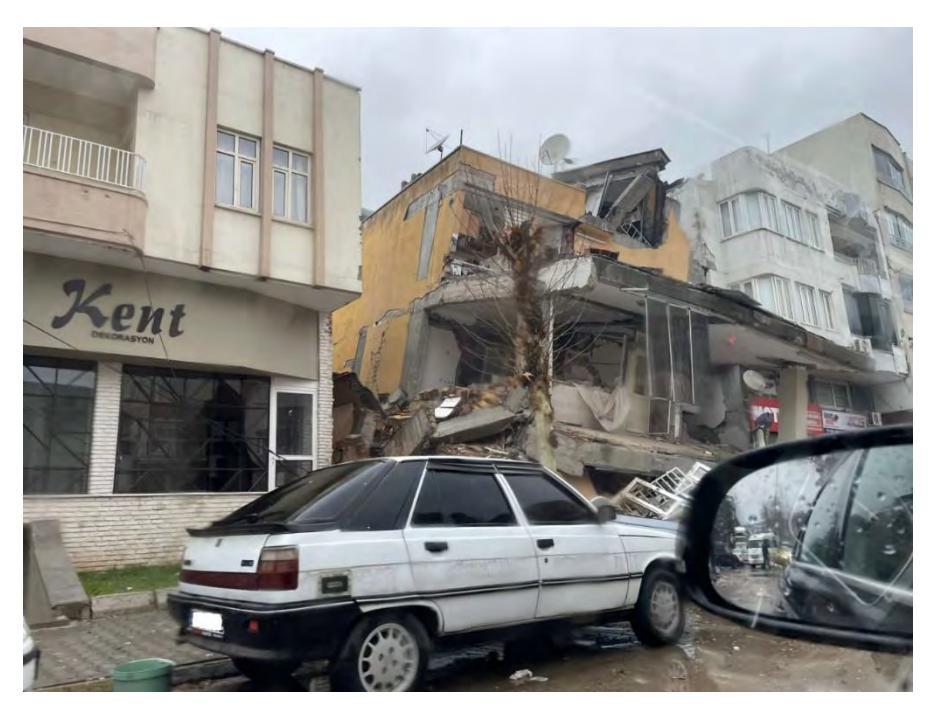
**Figure 5.72.** Partially collapsed building in the Adıyaman central district (photo taken by Dr. Senem Tekin).

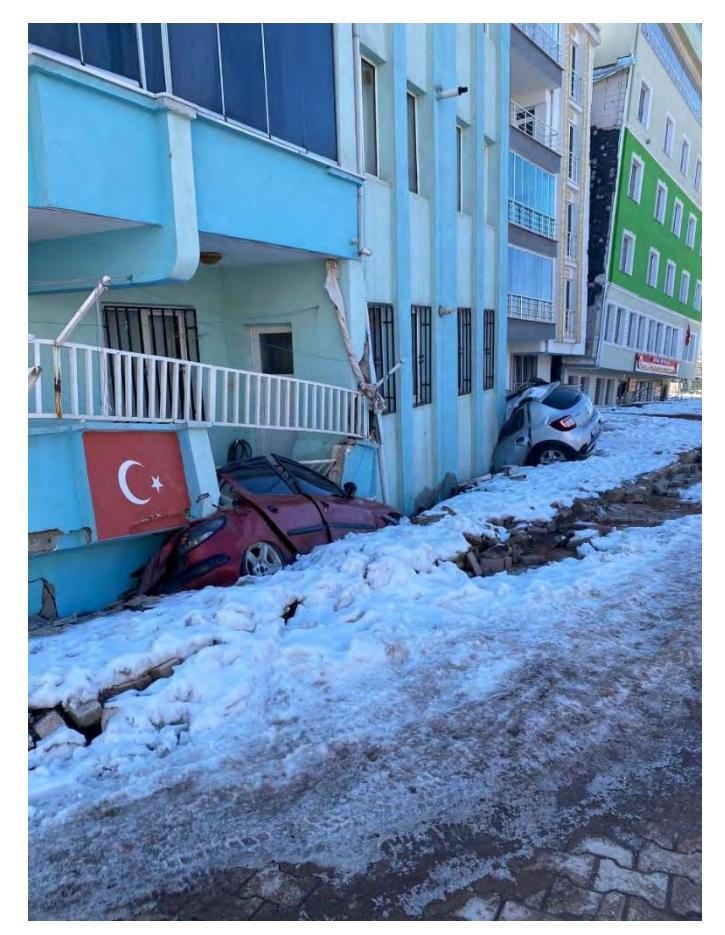
The Gölbaşı basin is a depression formed by pull-apart mechanism. Main geological unit observed in the district is Quaternary gravelly sandy soils with clay – silt intercalations (Akıl et. al., 2008). Observations made in the Gölbaşı district, revealed very intense structural damage and ground deformations, such as total and differential settlements due to liquefaction (Figures 5.74 and 5.75). In addition to settlement, lateral spreading was also observed in some areas (Figure 5.78).

**Figure 5.74.** Settlement due to liquefaction in the Adıyaman Gölbaşı district (photo taken by Dr. Müge Akın).

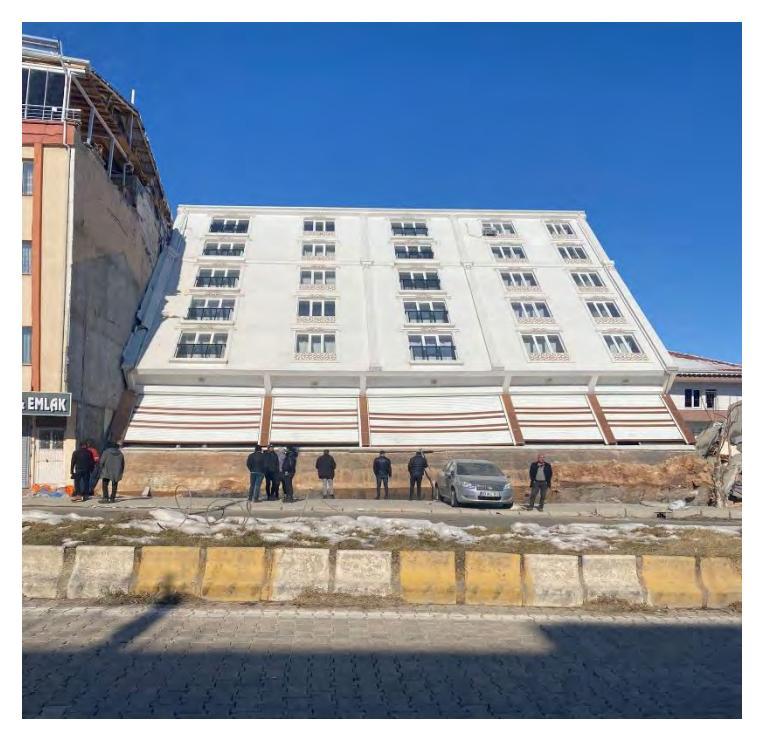
Some of the building tilted and overturned due to bearing capacity losses after seismic soil liquefaction. Widespread sand boils with water outlets were observed in some places (Figure 5.79). In addition, rockfalls involving large blocks were also encountered around the Karamağara locality (Figure 5.80). No loss of life due to the rockfall was reported, but the road was closed, and transportation was disrupted.

**Figure 5.75.** Overturned building without structural damage in the Adıyaman Gölbaşı district (photo taken by Dr. Müge Akın).

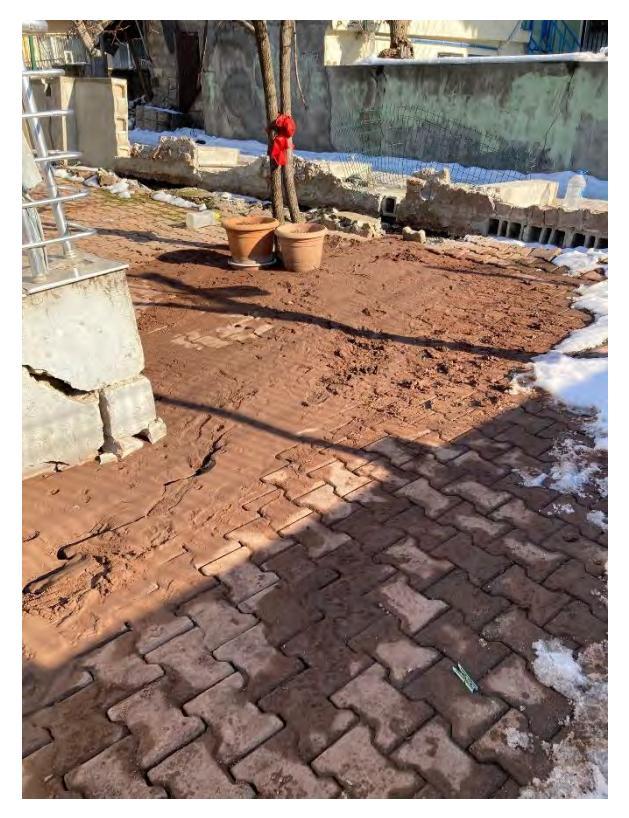
**Figure 5.76.** Sand boils observed in the Adıyaman Gölbaşı district (photo taken by Dr. Müge Akın).

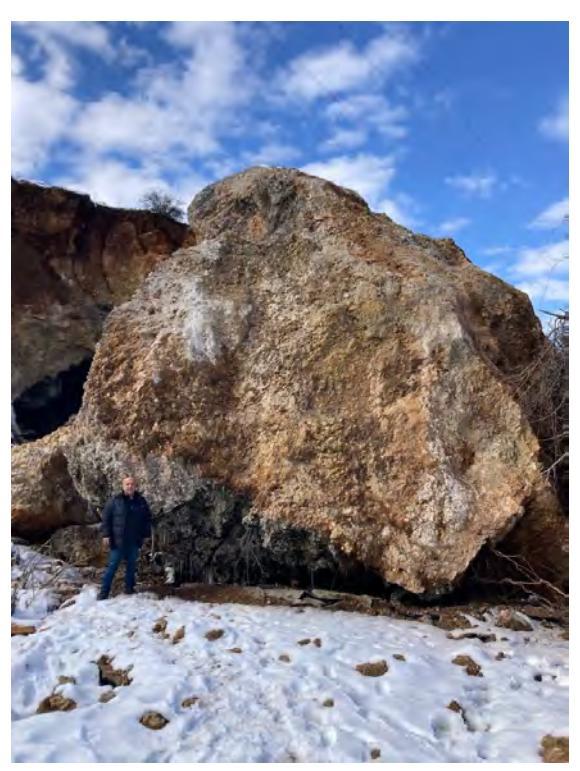
**Figure 5.77.** Large rockfall observed in the Adıyaman Gölbaşı district, Karamağara locality (photo taken by Dr. Müge Akın).

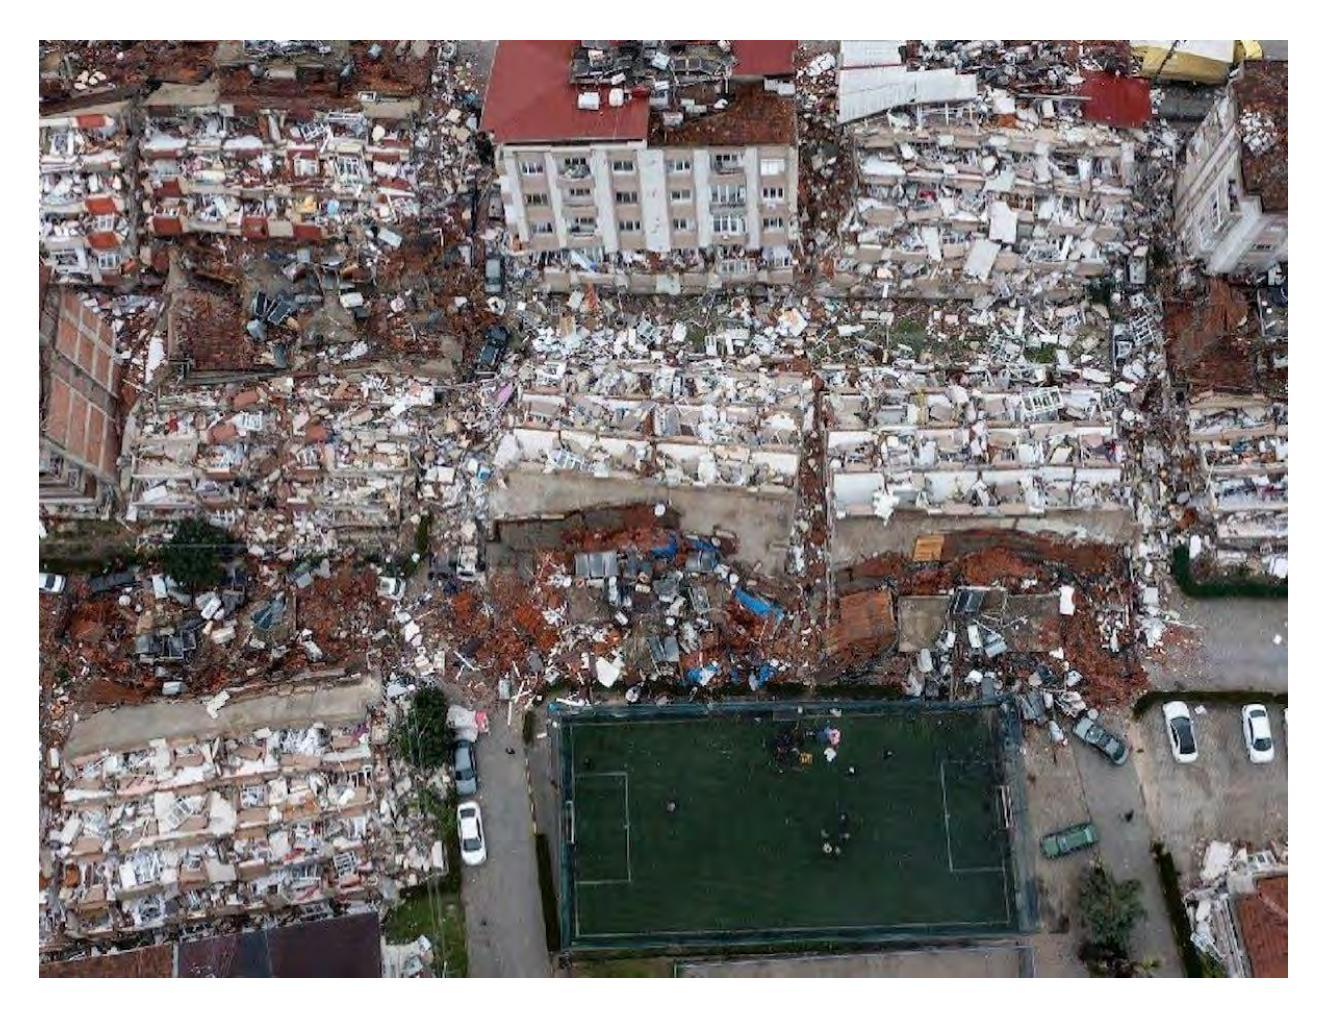
**Figure 5.81.** A view from the great destruction in Antakya after the great earthquakes in Pazarcık and Elbistan on February 6, 2023, <u>https://www.sozcu.com.tr</u>.

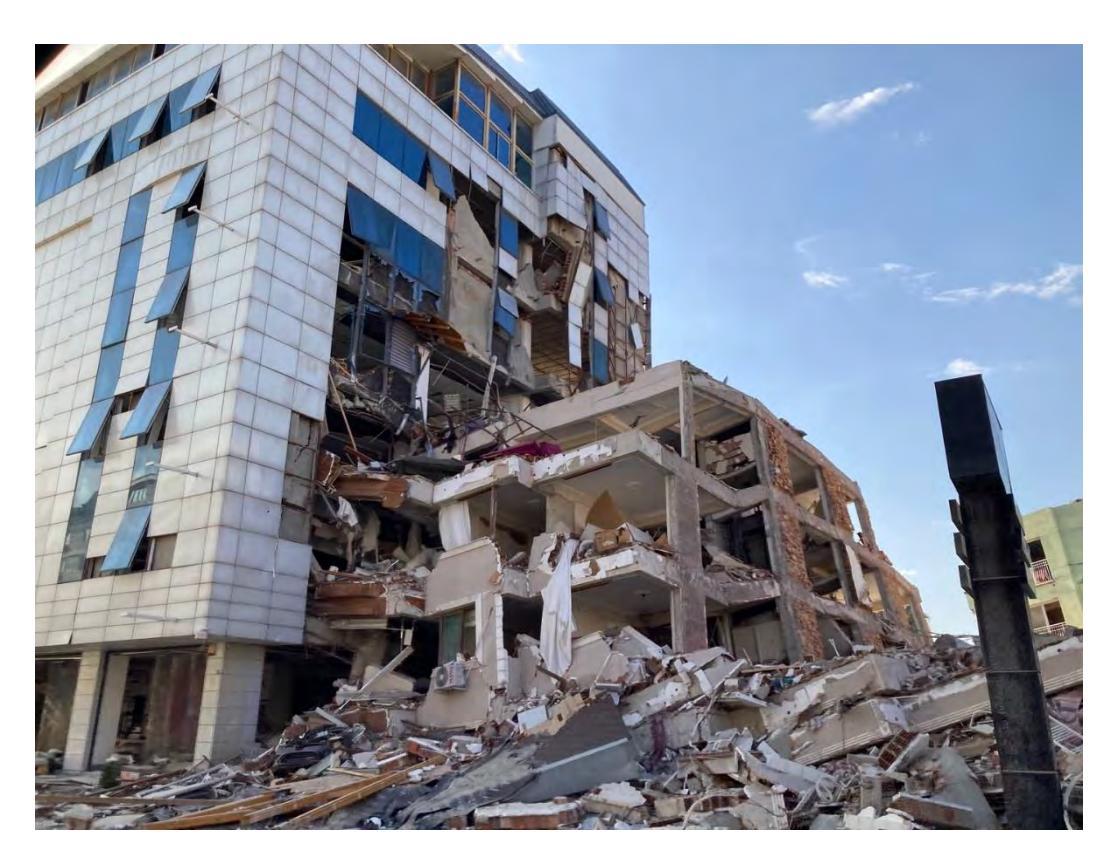
**Figure 5.86.** Collapsed building in Hatay (photo by Müge Akın)

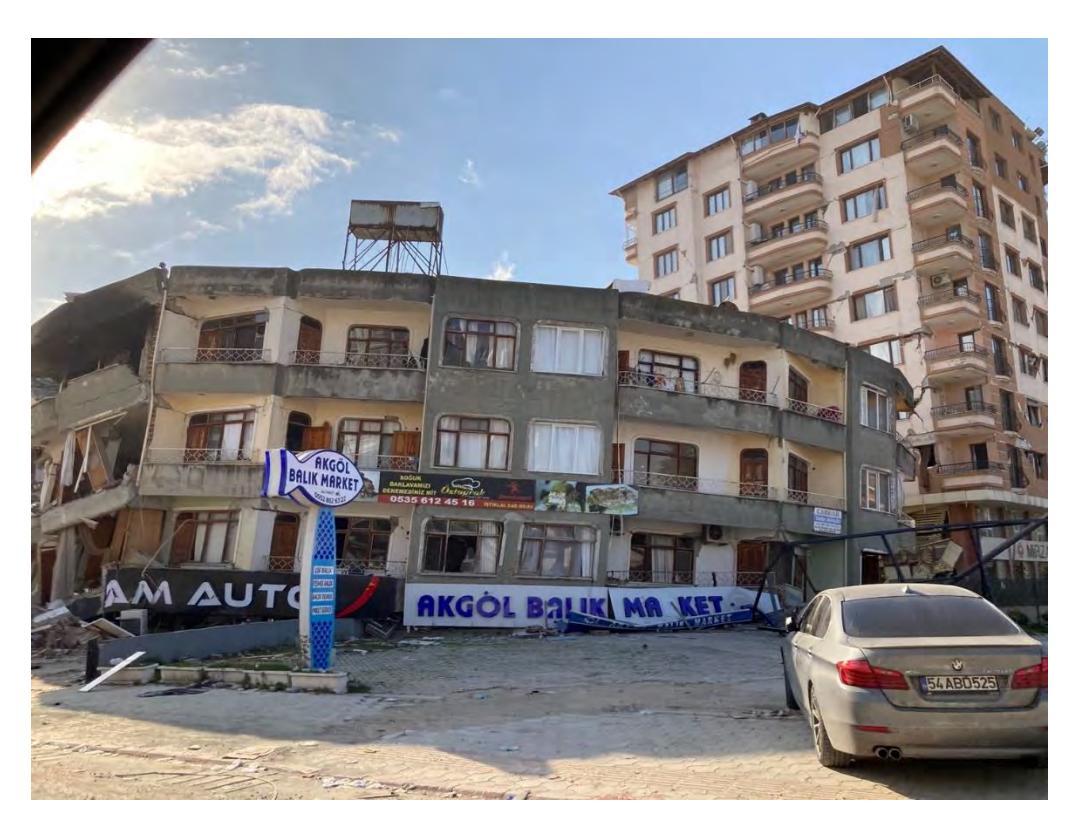
**Figure 5.87.** Damaged building in Hatay (photo by Müge Akın)

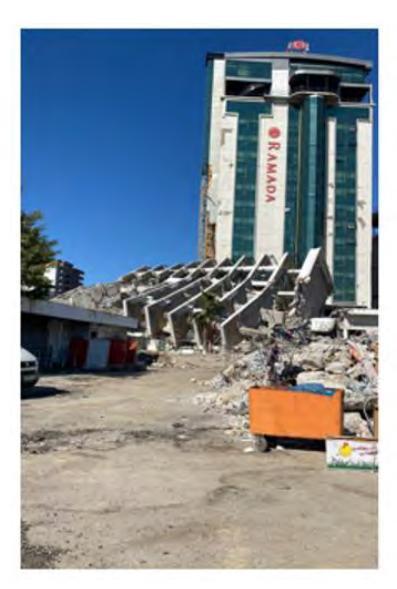
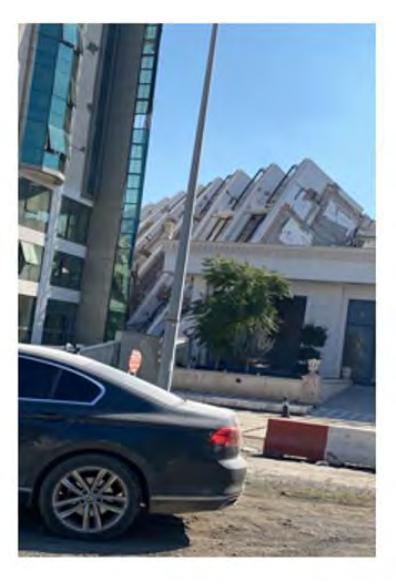
February 6, 2023, Kahramanmaraş-Pazarcık (Mw=7.7) and Elbistan (Mw=7.6) Earthquakes heavily affected the city of İskenderun. There were many totally collapsed and heavily damaged 2-6 stories residential buildings in the province of Hatay-Iskenderun center as shown in Figure 5.88. Some of the damaged buildings were tilted or settled probably due to a foundation bearing capacity failure. Some of them had structural damage from the first or second story. The number of buildings collapsed at the city center is reported to be approximately 300. Main roads and street along Atatürk Boulevard The major findings of the reconnaissance studies performed immediately after the earthquake by Turkish teams are discussed in the below sections under the titles of performance of building foundations, seismic soil liquefaction and performance of retaining structures.

**Figure 5.88.** Collapsed and overturned buildings in İskenderun/Hatay (36°35'22.0 "N/ 36° 10'37.5"E, Photo by: Ece Eseller Bayat, Yaren Birşen)
