# Türkiye Earthquake

## **RECONNAISSANCE REPORT**

February 6, 2023 Kahramanmaraş-Pazarcık ( $M_w$ =7.7) and

Elbistan (M<sub>w</sub>=7.6) Earthquakes

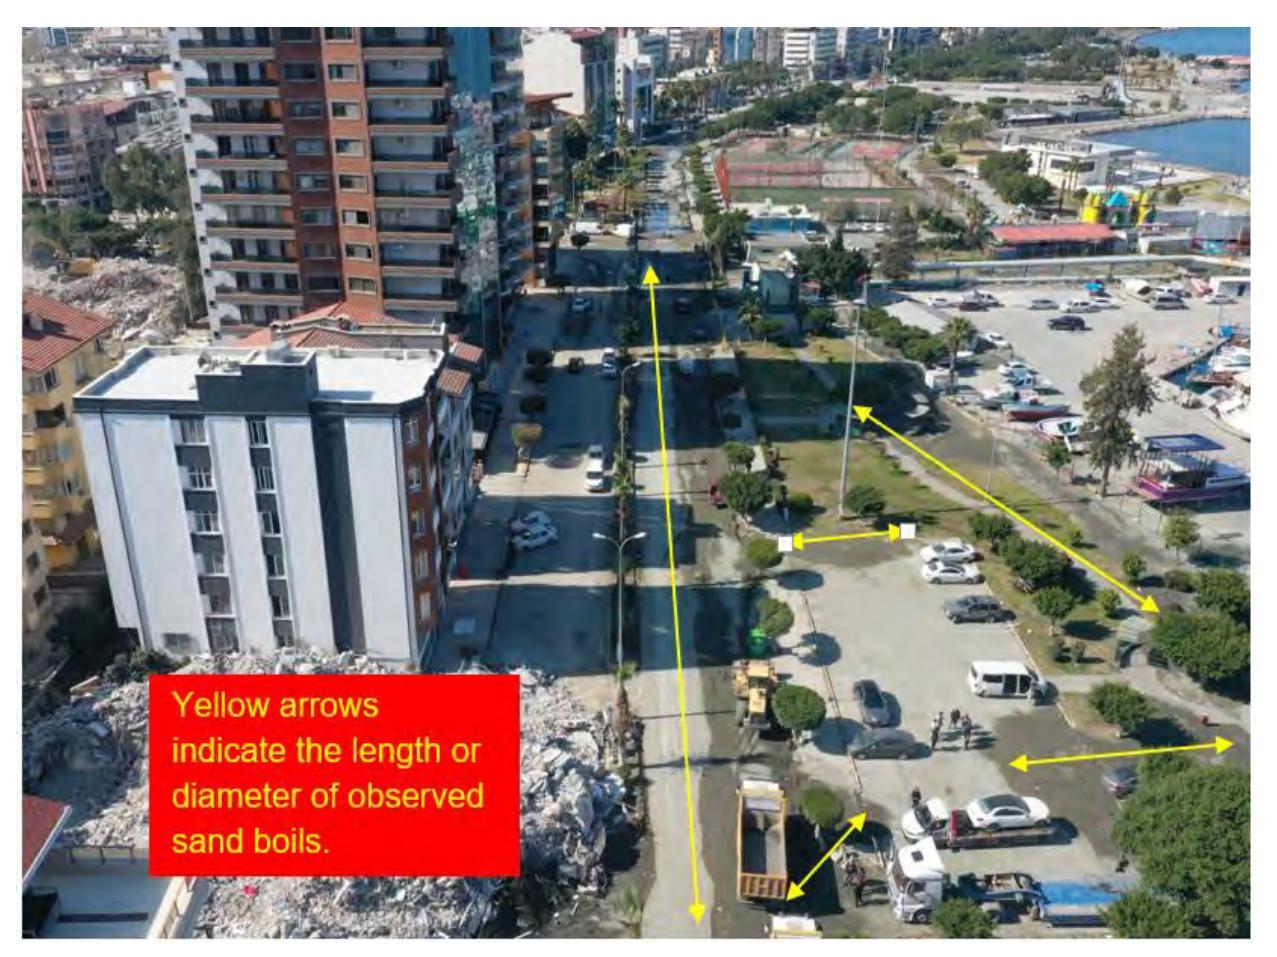
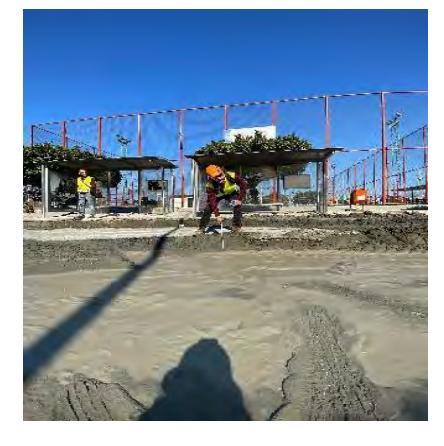
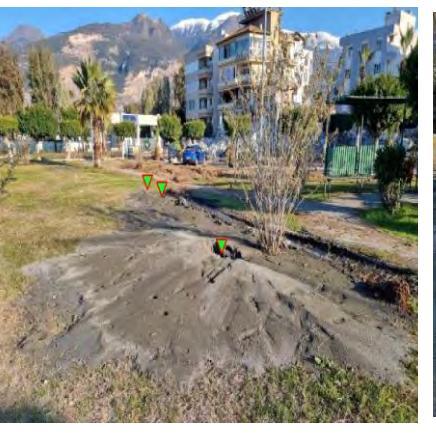
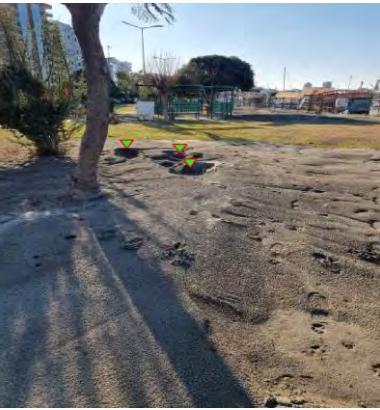
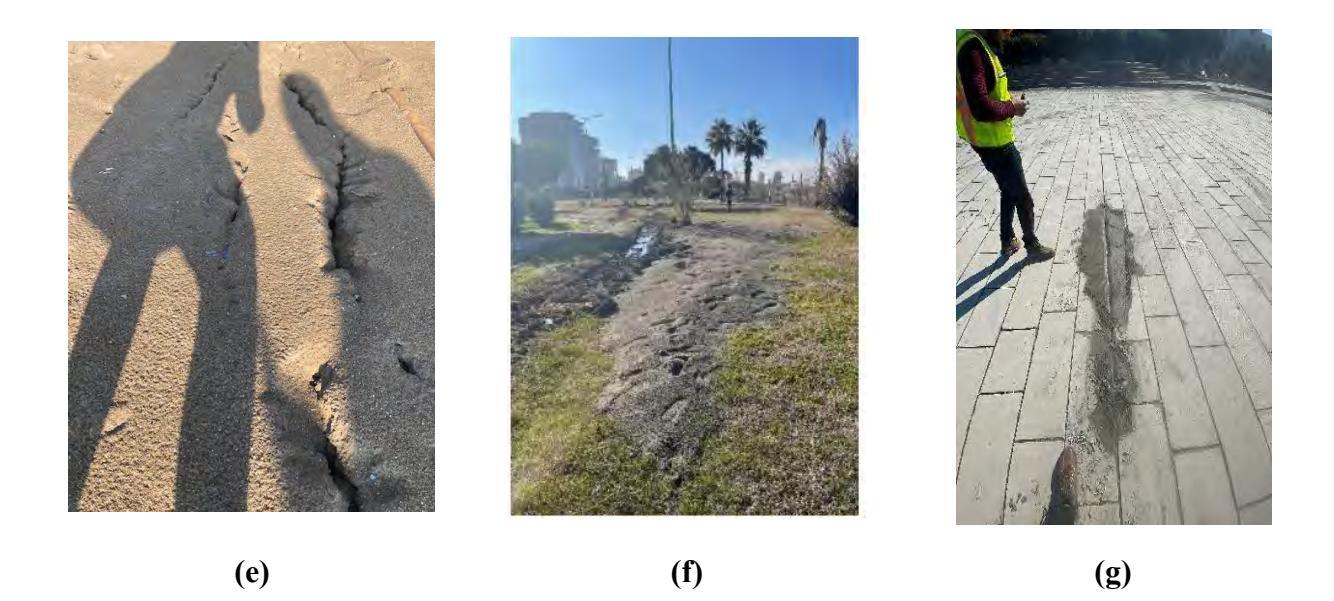
Consistent with the subsoil conditions and geology of the region, surface manifestations of seismic soil liquefaction including lateral spreading, sand boils, soil ejecta, and subsidence were observed in İskenderun region as shown in Figure 5.90 through Figure 5.92.

**Figure 5.90.** Seismic soil liquefaction-induced surface manifestation: sand boils in free field conditions: a) Ataturk Boulevard/İskenderun/Hatay (36°35'26.86"N/ 36° 10'40.39"E, Photo by: Tugce Baser, Ozgun Numanoglu, Serhat Erinmez) b) Tennis Courts on Ataturk Boulevard İskenderun/Hatay (36°35'26.95"N/ 36° 10'28.39, Photo by: Tugce Baser, Ozgun Numanoglu, Serhat Erinmez) c) Çay District / İskenderun /Hatay (36.591334°N, 36.178781°E, Photo by: Ertan Bol, Aşkın Özocak, Sedat Sert, Eylem Arslan) d) Çay District / İskenderun /Hatay (36.591326°N 36.178147°E, Photo by: Ertan Bol, Aşkın Özocak, Sedat Sert, Eylem Arslan) d) Çay District / İskenderun /Hatay (36.591326°N 36.178147°E, Photo by: Ertan Bol, Aşkın Özocak, Sedat Sert, Eylem Arslan) e) İskenderun Port / İskenderun /Hatay (36.73221°N 36.19618°E, Photo by: Pelin Özener, M. Murat Monkul) f) Çay District / İskenderun / Hatay (36.59133°N, 36.17888°E, Photo by: Kemal Önder Çetin, Elife Çakır) g) Ataturk Boulevard/İskenderun/Hatay (36°35'29.50"N, 36° 10'20.23"E, Photo by: Tugce Baser, Ozgun Numanoglu, Serhat Erinmez)

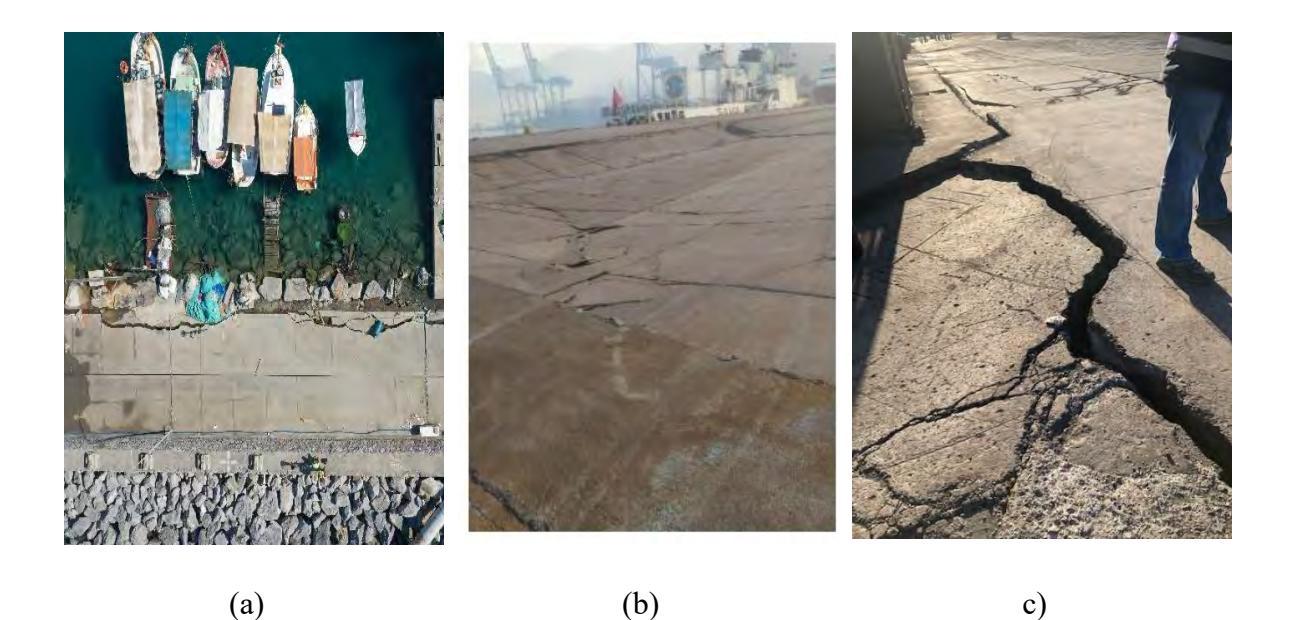
**Figure 5.91.** Seismic soil liquefaction induced lateral spreadings **a)** Iskenderun Dock/İskenderun/ Hatay (36°35'40.67"N/, 36° 10'38.69"E, Photo by: Tugce Başer, Özgun Numanoglu, Serhat Erinmez) b) İskenderun Port Area /İskenderun/ Hatay (36.59991°N, 36.19274°E, Photo by: Kemal Önder Çetin) c) İskenderun Port Area/İskenderun/Hatay (36.73011°N, 36.19681°E, Photo by: Pelin Özener, M. Murat Monkul)

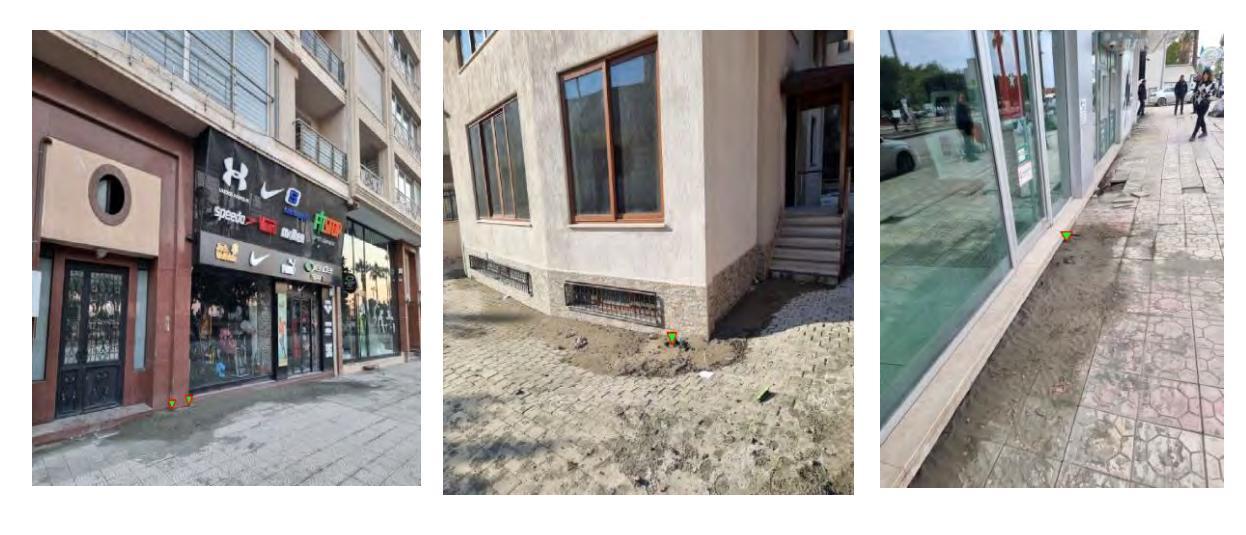
**Figure 5.92.** Seismic soil liquefaction induced bearing capacity and settlement problems in **a**) Çay District / İskenderun.

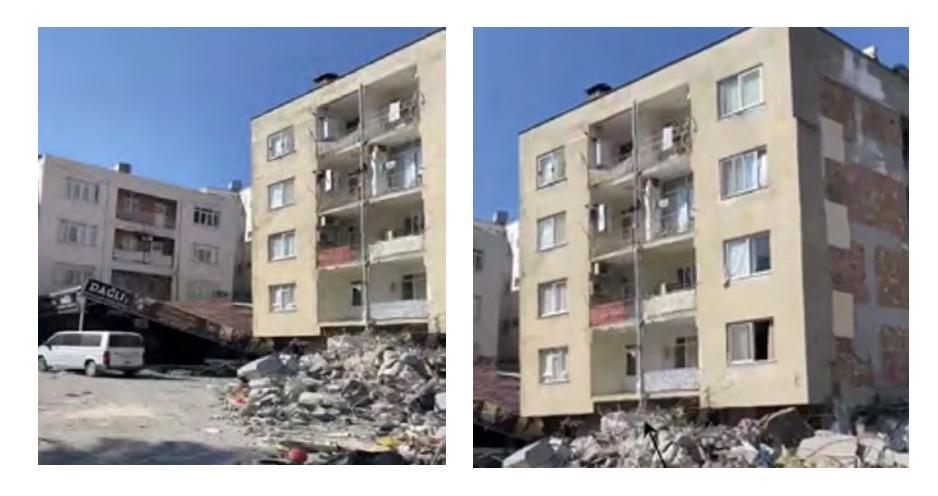
Many foundations of residential buildings in İskenderun region were subjected liquefaction induced settlements and bearing capacity failures The foundation settlements are observed to vary within 3 cm to 15 cm in İskenderun city Center and reach approximately 30-35 cm in Karaağaç – Cumhuriyet Districts. Additionally, differential settlements that reach 30 cm were observed that caused the tilting of buildings as shown in Figure 5.93. On the other hand, no settlements were observed for high buildings that have pile foundation system, but damages attributed to inadequate structural design was observed in those buildings.

**Figure 5.93.** Tilted Buildings due to seismic soil liquefaction (36°35'11.4 N/, 36° 10' 27.5, Photo by: Ece Eseller Bayat, Yaren Birşen)

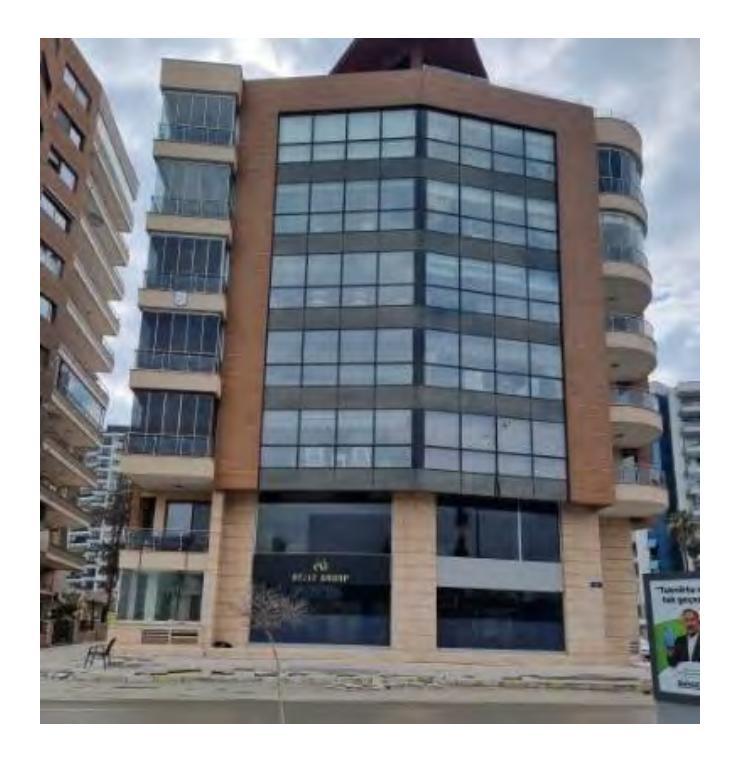
Moreover, performance of improved sites was observed to perform well during earthquake with no severe damage although the neighboring buildings collapsed. Çivisöken building shown in Figure 5.94 is surrounded by diaphragm wall penetrating to 12m depth from the ground surface and improved with jet grout columns of 3m in length and 60cm in diameter.

**Figure 5.94.** Performance of Çivisöken building with no damage resting on improved soil conditions in Çay District / İskenderun /Hatay (36.590761°N, 36.175848°E, Photo by: Ertan Bol, Aşkın Özocak, Sedat Sert, Eylem Arslan)

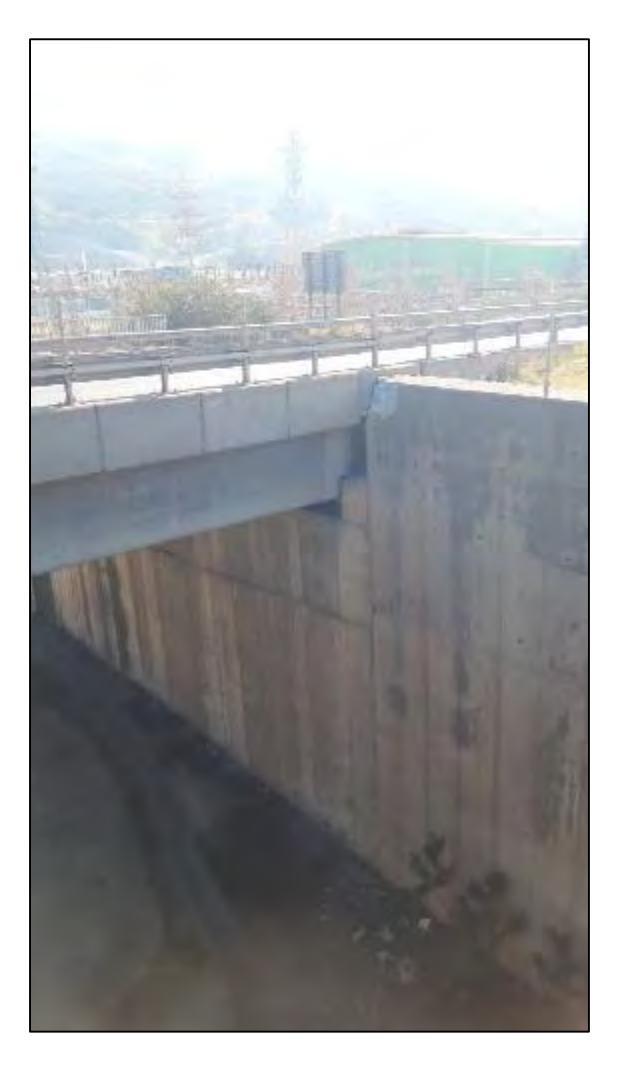
Performance of viaducts at Çankaya-Belen and Payas-İskenderun intersections were inspected. Seismic shear keys were mainly observed to be damaged as shown in Figure 5.95. But in general, elastomeric bearings were observed to perform well up to a certain acceleration level and the displacement bridge deck was observed to be restrained by shear keys and parapet walls of abutment (Figure 5.96). These damages mainly indicate that shear keys functioned well and prevent the excess displacement and fall of bridge deck.

**Figure 5.96.** Bridge deck restrained by the performance of shear keys and paraphet at İskenderun-Payas Intersection (36.740734°N, 36.224845°E, Photo by: Pelin Özener)

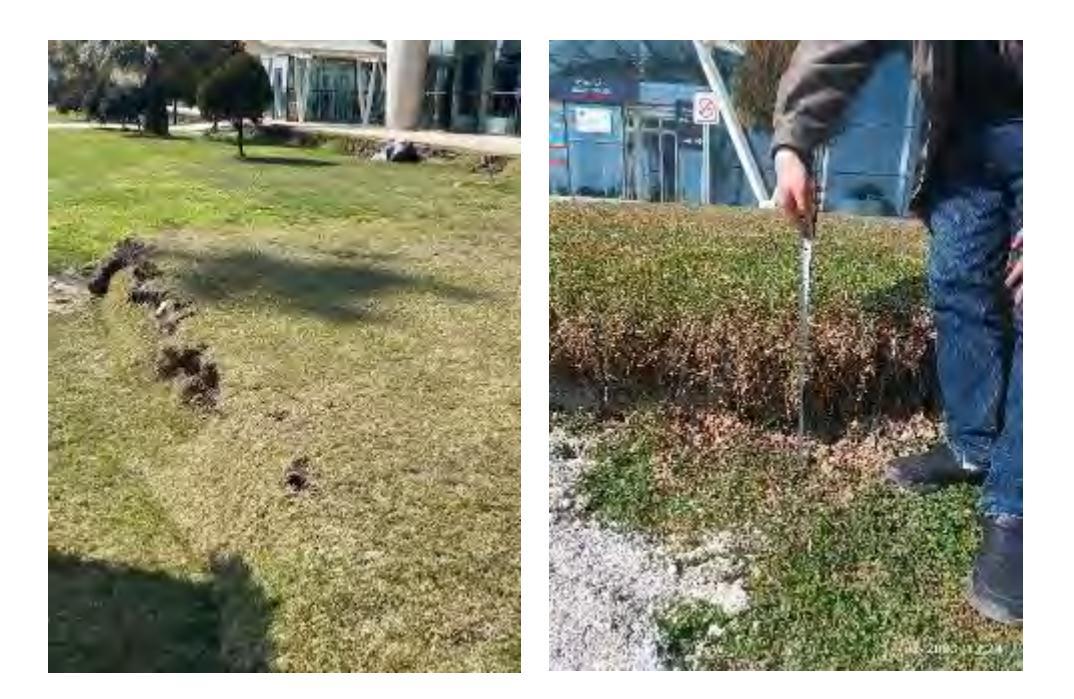
Deformation cracks and signs of vertical settlement were observed at the entrance of domestic arrivals lounge as shown in Figure 5.97. The vertical settlement was observed to be in the order of 35-40 cm, but no severe structural damage was observed in Airport building.

**Figure 5.97.** Settlements observed at the entrance of domestic arrivals lounge (Hatay Airport, 36.366025°N, 36.272742°E, Photo by M. Murat Monkul and Pelin Özener)

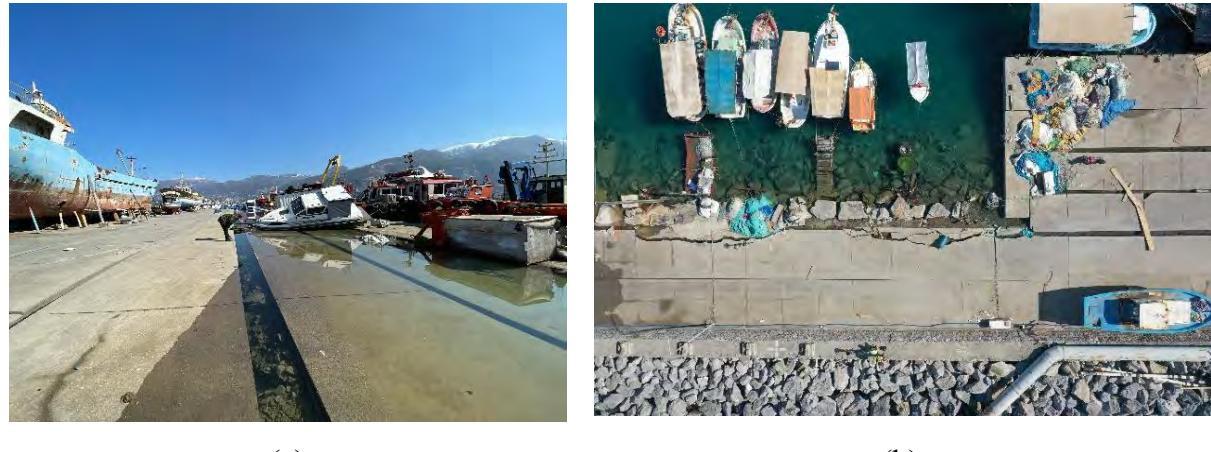
İskenderun fishery port and an industrial port located in Payas were observed to be severely damaged during the earthquake. Ground Settlements and Lateral displacements were also observed at Iskenderun Fishery Port indicating liquefaction induced type of deformations (Figure 5.98).

**Figure 5.98.** Ground Settlements and Lateral Displacements at Iskenderun Fishery Port (36°35'40.67"N/ 36° 10'38.69"E, Photo by: Tugce Baser, Ozgun Numanoglu, Serhat Erinmez)

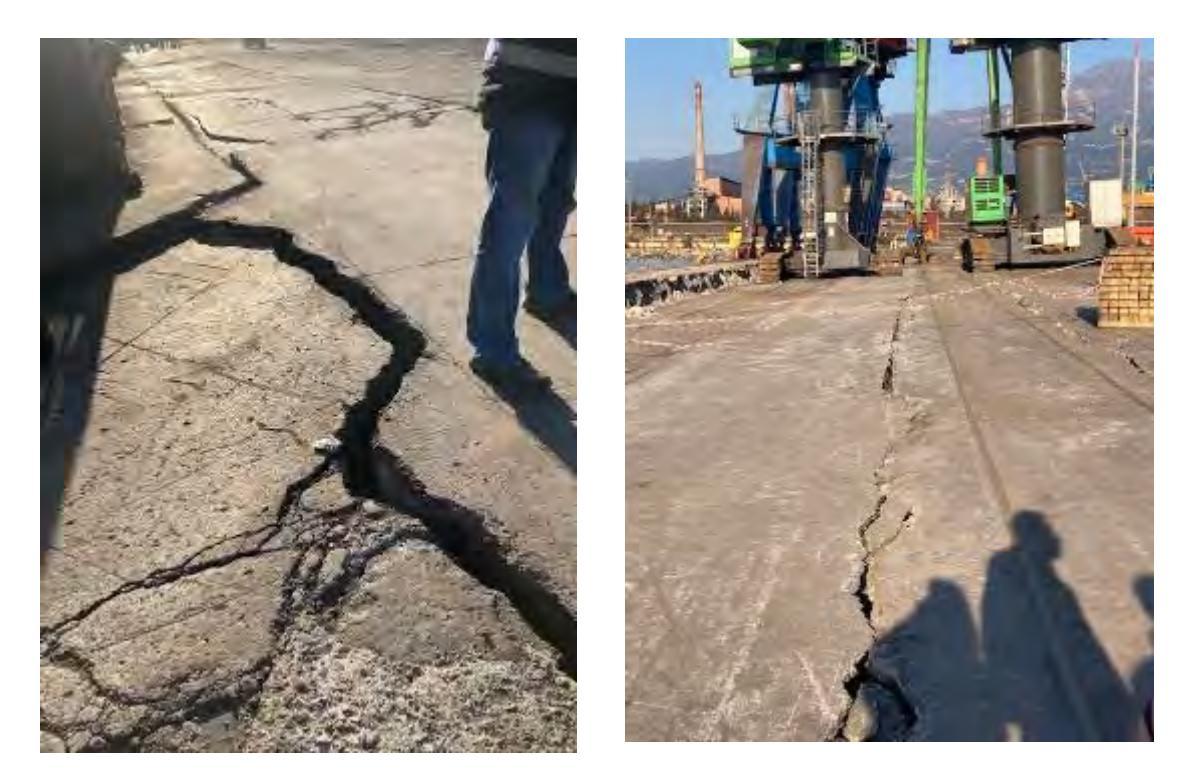
The port located in Payas was mainly constructed as block type gravity quay wall and in 2006 after a modernization study, a new port was constructed which is founded on driven steel piles. Deformation cracks were observed in block type gravity quay wall part during the February 6, 2023, Earthquake as shown in Figure 5.99. Due to the damages occurred at the port, cranes and weighbridges were reported to be tilted (Figure 5.99).

**Figure 5.99.** Deformation cracks in block type gravity quay wall and tilted cranes (36.73011°N, 36.19681°E, Photo by: Pelin Özener, M. Murat Monkul)

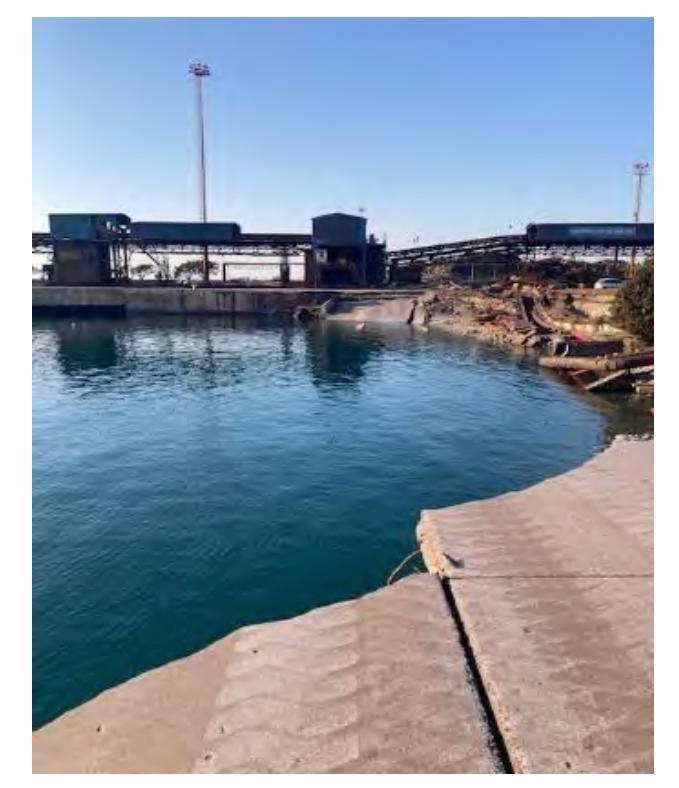
Vertical and lateral displacements were also observed and documented in the vicinity of sand ejecta most probably due to lateral spreading of the quay wall. The vertical and lateral displacements were observed to be in the order of 85 cm and 57 cm, respectively (Figure 5.100). The port way over No.2 and No.3 ports collapsed as shown in Figure 5.101 most probably due to lateral spreading that took place during earthquake and this part of the port is not in service now.

**Figure 5.101.** The collapse of Port way over No.2 and No.3 ports due to liquefaction induced lateral spreading (36.73208°N, 36.19735°E, Photo by: Pelin Özener, M. Murat Monkul)

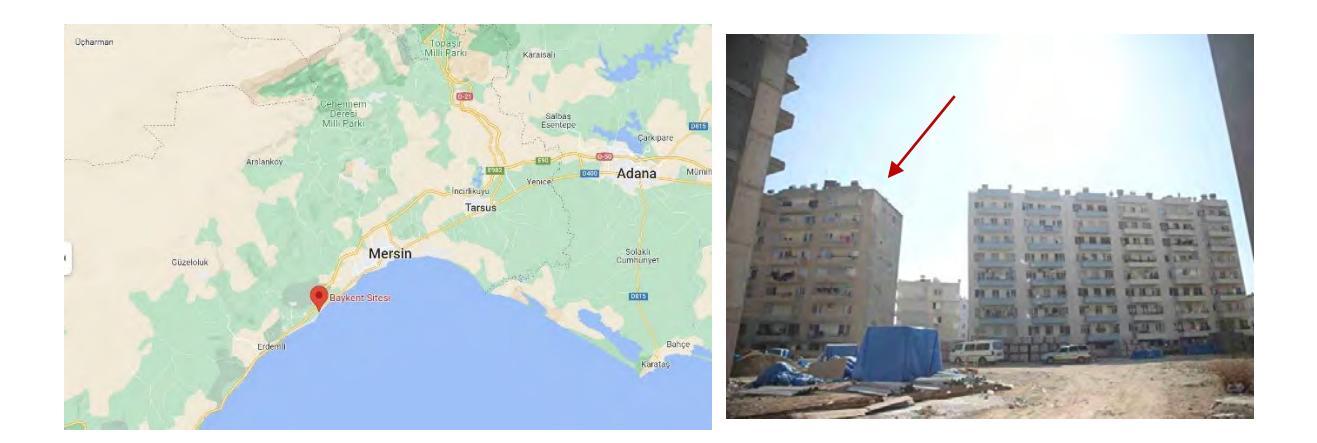
There are three buildings in the Baykent complex, which was built in 1995, and only one of them was damaged. The locals reported that there were several structural problems with the building even before the earthquake. The subsurface profile in the coastal strip of Mersin mainly consists of loose alluvial deposits. Considering that the majority of the urban development (multistory buildings) is in the coastal strip of Mersin, this area deserves a further attention.

**Figure 5.104.** Tilted building (Baykent complex) in Mezitli, Mersin (36.68888N, 34.44277E): (a) Location; (b) Overview; (c) Cracks in the concrete panels in the parking lot; (d) column cracks Photo by (Ozgun Numanoglu, Tugce Baser, Serhat Erinmez)

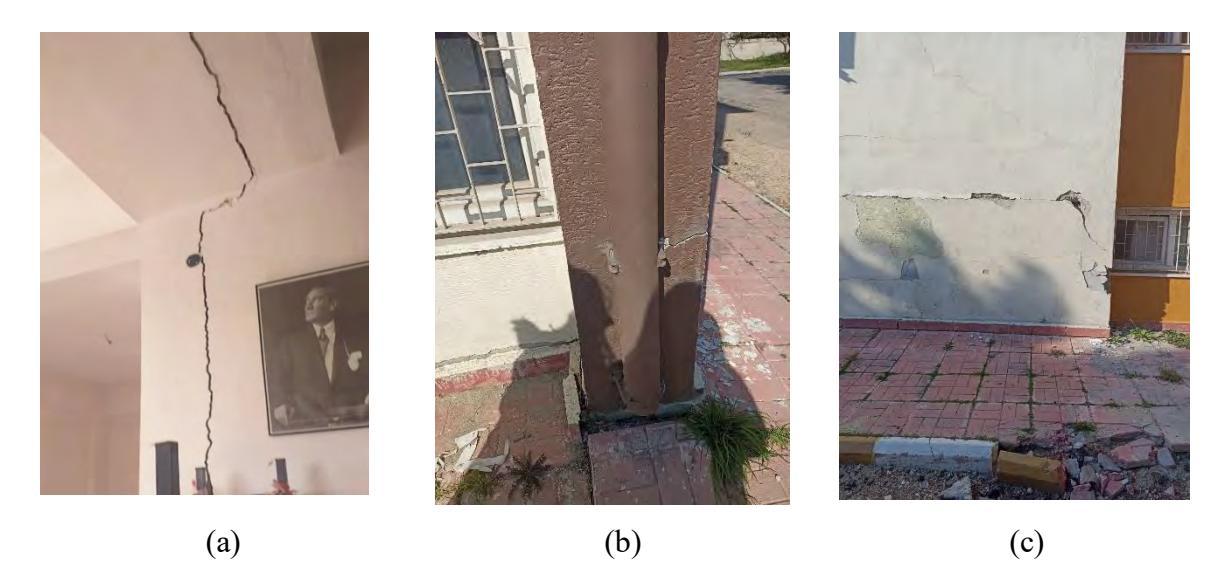
Five of school buildings in Tarsus are evacuated the right after the Kahramanmaraş earthquakes mainly because of the cracks in the load carrying columns and beams in addition to the walls. Our conversations with locals and authorities revealed that the evacuations are prevention at this stage. The map overview of the impacted buildings is given in Figure 5.105.

**Figure 5.106.** Damages in several school buildings in Tarsus: (a) Interior cracks in Hayrunnisa Koylugil (36.90946, 34.87914); (b) Column cracks in AKBAL (36.92016, 34.87463); (c) Sidewalk and wall damages in AKBAL Photo by (Ozgun Numanoglu, Tugce Baser, Serhat Erinmez)

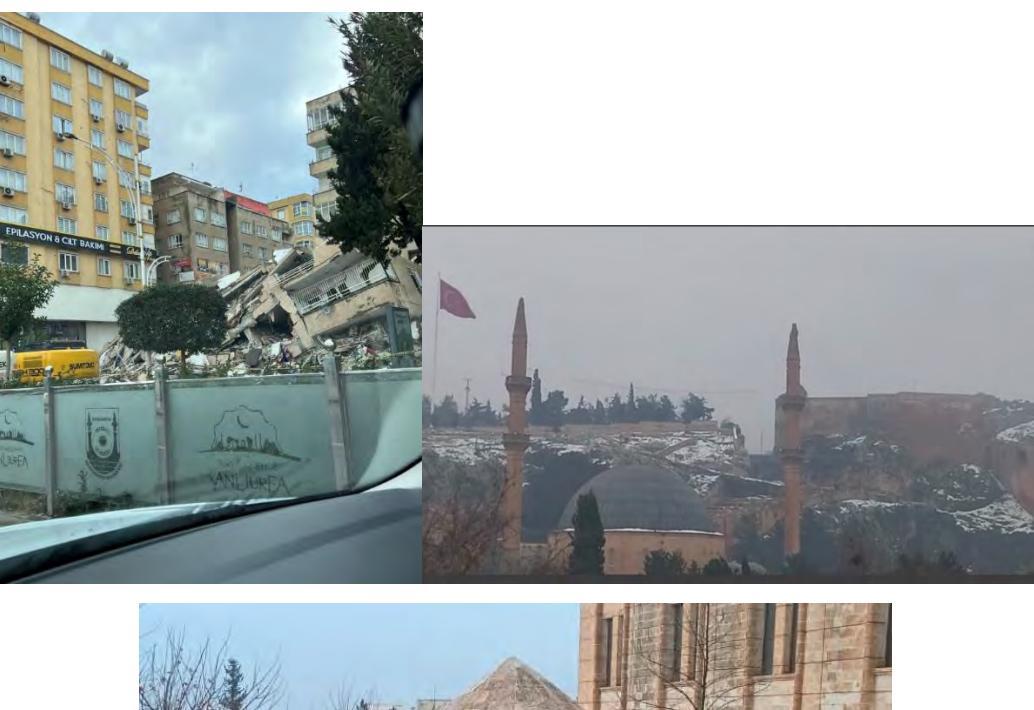
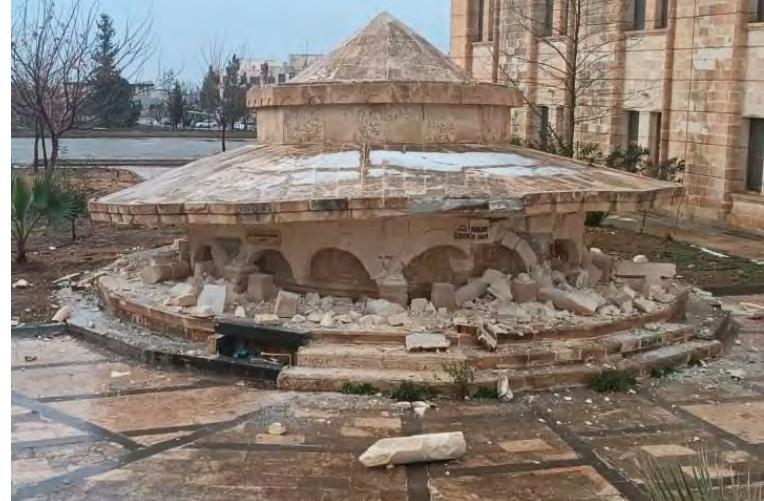
Figure 5.107. Collapsed building at Bahçelievler (top left), damaged minaret of the Balıklıgöl Mosque (top right), Fountain of Harran University Mosque (bottom)

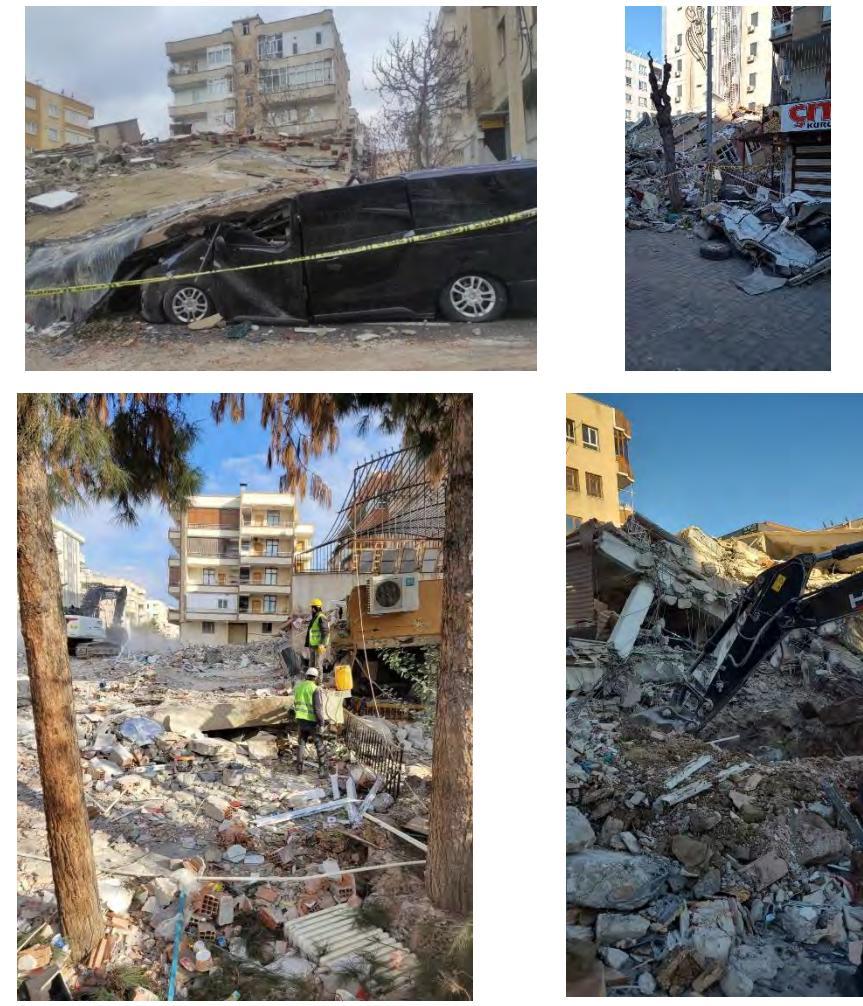
Figure 5.108. Some of the collapsed buildings

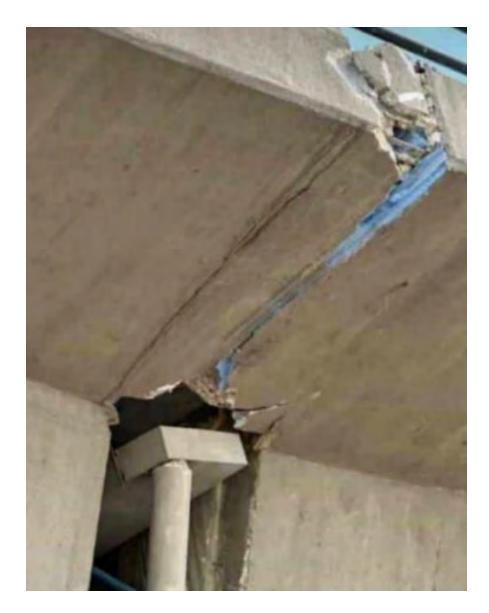
**Figure 5.109.** Damage at the newly constructed bridge on Abide Junction located between the İpekyol and Bahçelievler districts.

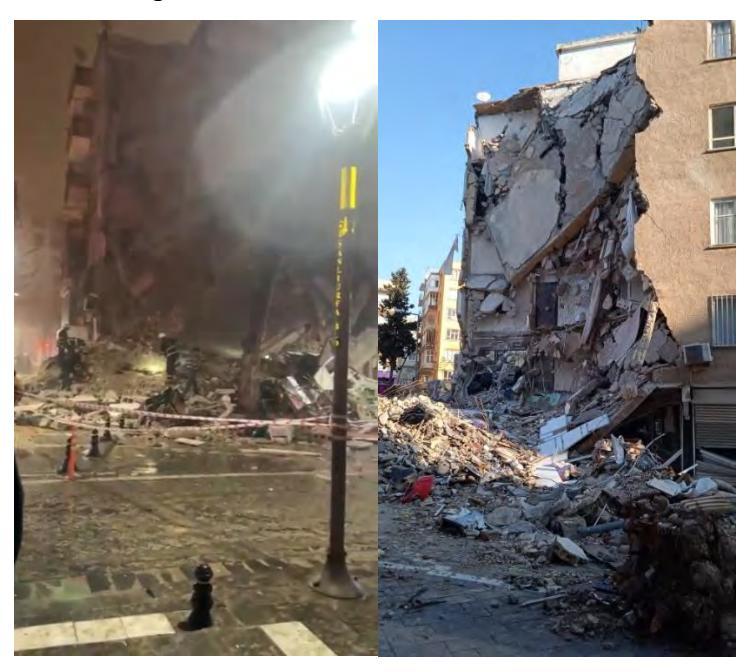
In the Bahçelievler district, the general reinforced concrete building profile is quite old, typically 40-50 years of age. The ground profile generally has low-quality (RQD 0.25-0.30) and slightly weathered rock formations. The groundwater table (gwt) varies excessively from 4 to 30 meters. This district has several collapsed buildings, but the number of damaged buildings is greater than the Yenişehir district. The structural damage at the newly constructed Abide Junction bridge is shown in Figure 5.109. Bahçelievler/ İpekyol districts are the most critical and severely damaged locations of the Şanlıurfa city center. There are many old structures in this district, and they are relatively more affected in terms of damage and collapse. Some of the collapsed buildings in this district are shown in Figure 5.110. Also, some tilted buildings were observed.

Figure 5.110. Collapsed buildings at Bahçelievler

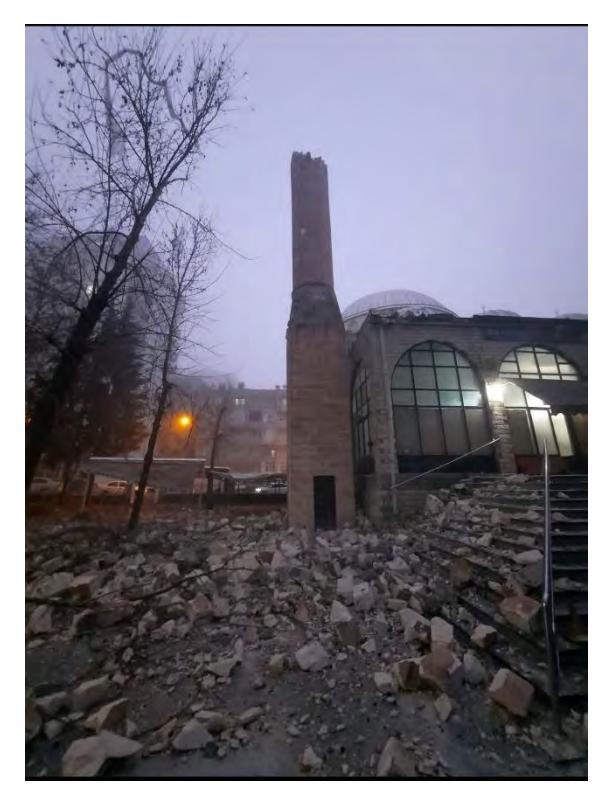
Figure 5.111. Damage at Eyüp el Ensari Mosque in Karaköprü district

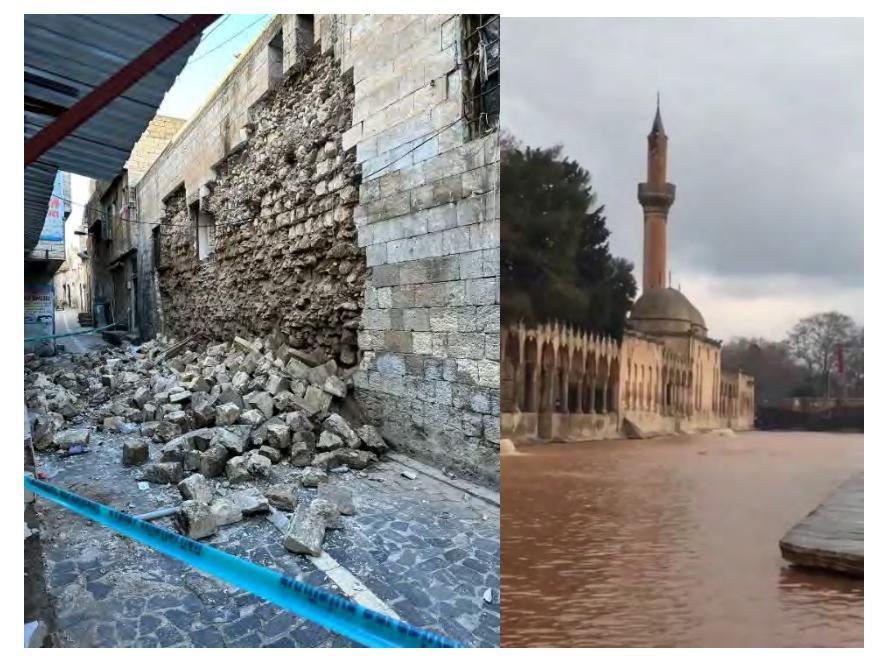
**Figure 5.112.** Damage to Urfa House at Eyyübiye (left) and brownish-colored water in the pool of Balıklıgöl with the fractured minaret of Dergah Mosque (right)

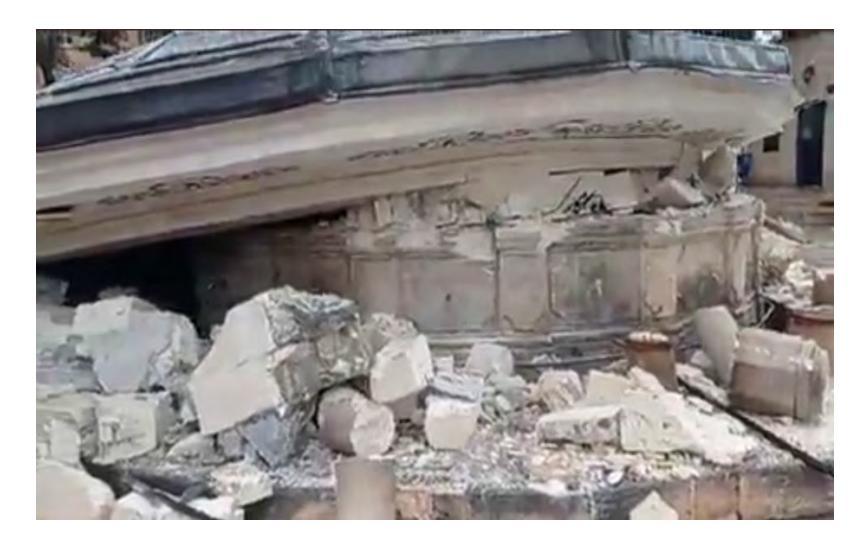
Figure 5.113. Damage at Ulu Mosque in Eyyübiye

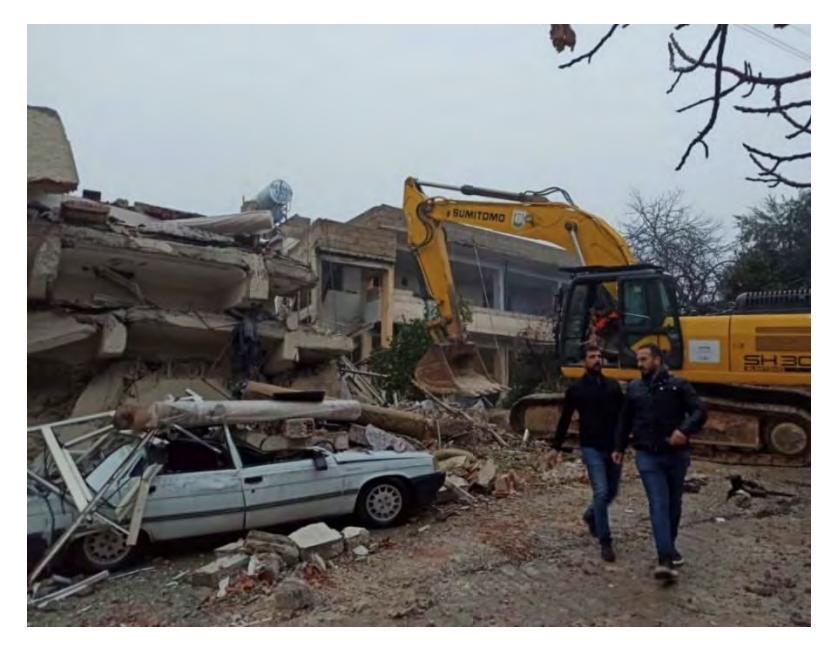
Figure 5.114. A collapsed building in Eyyübiye district

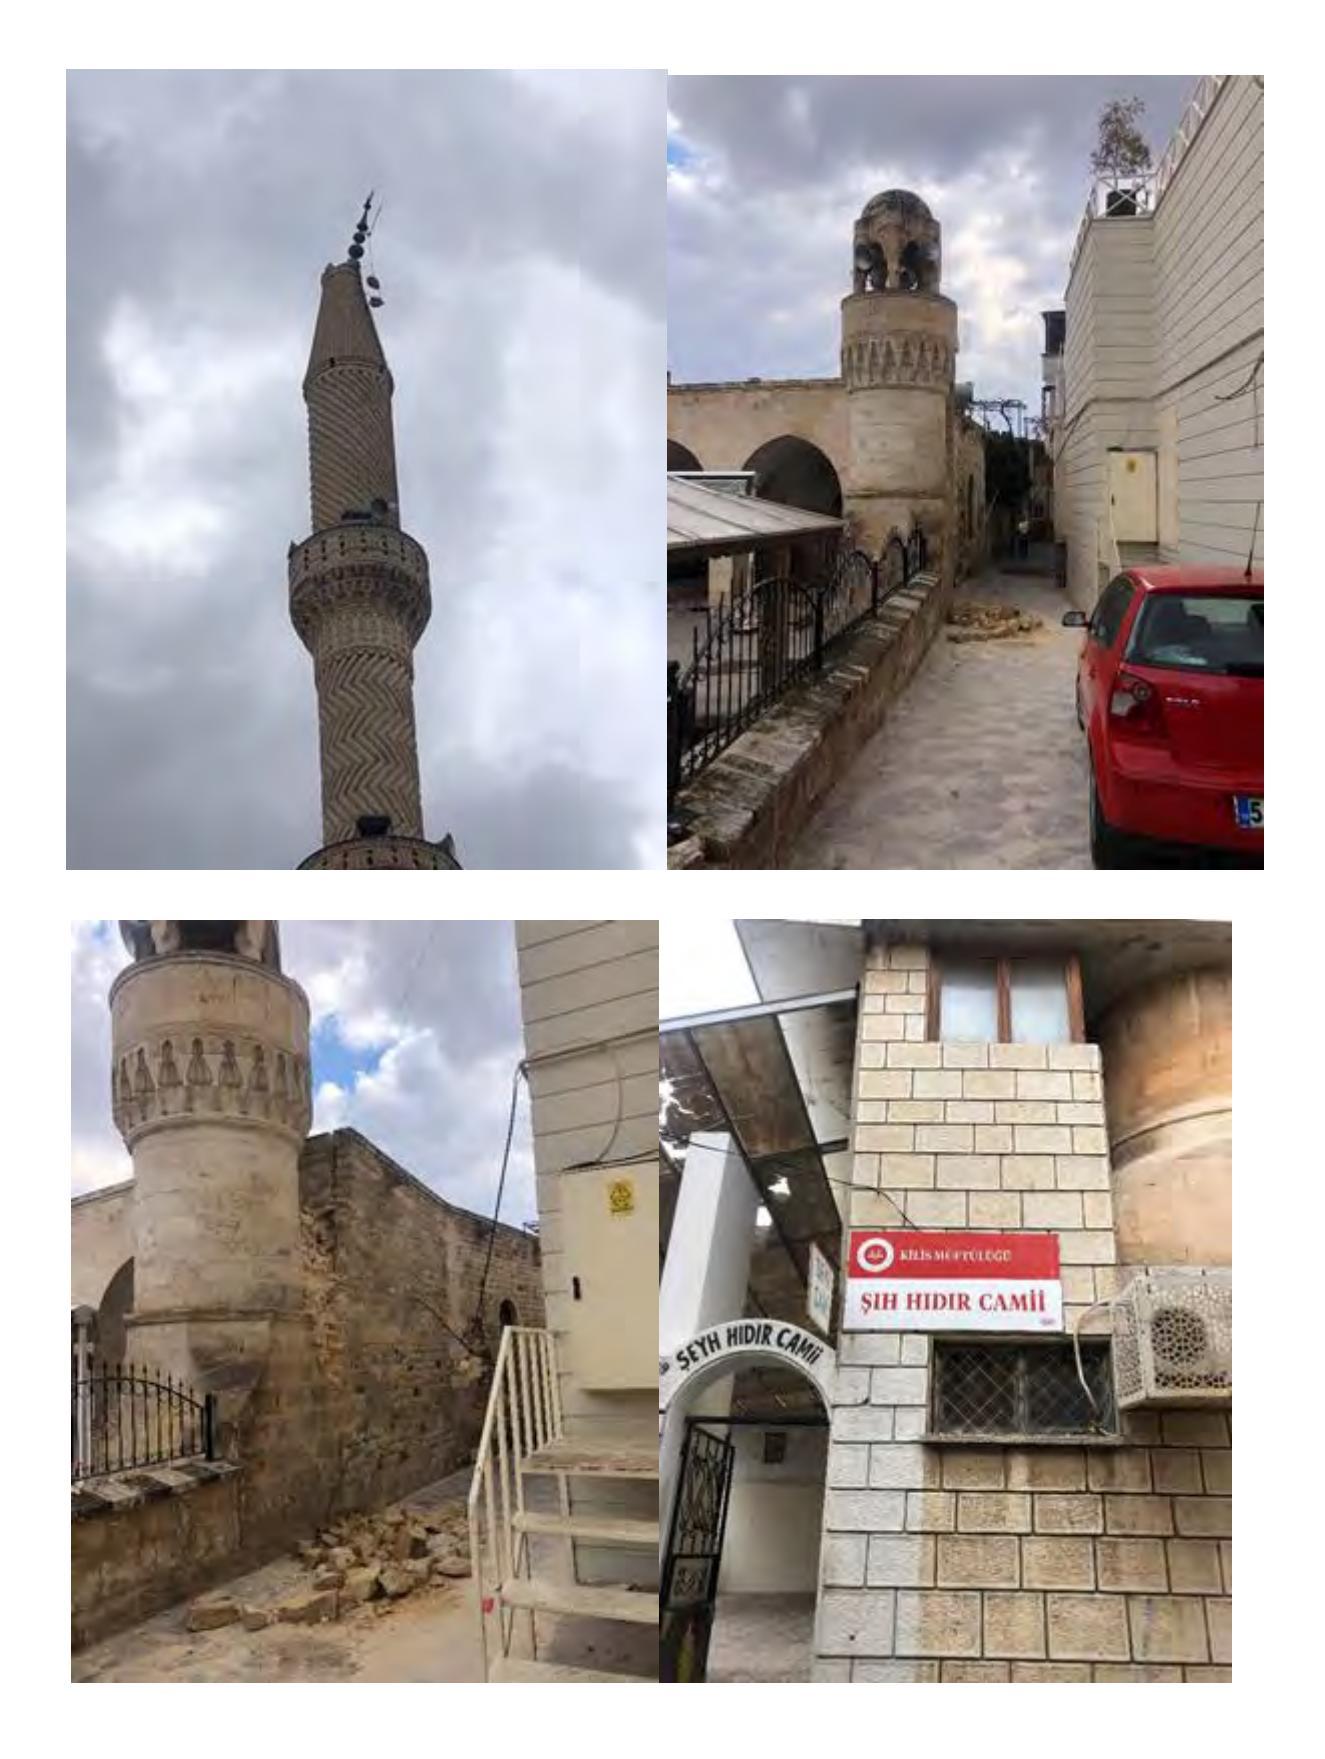
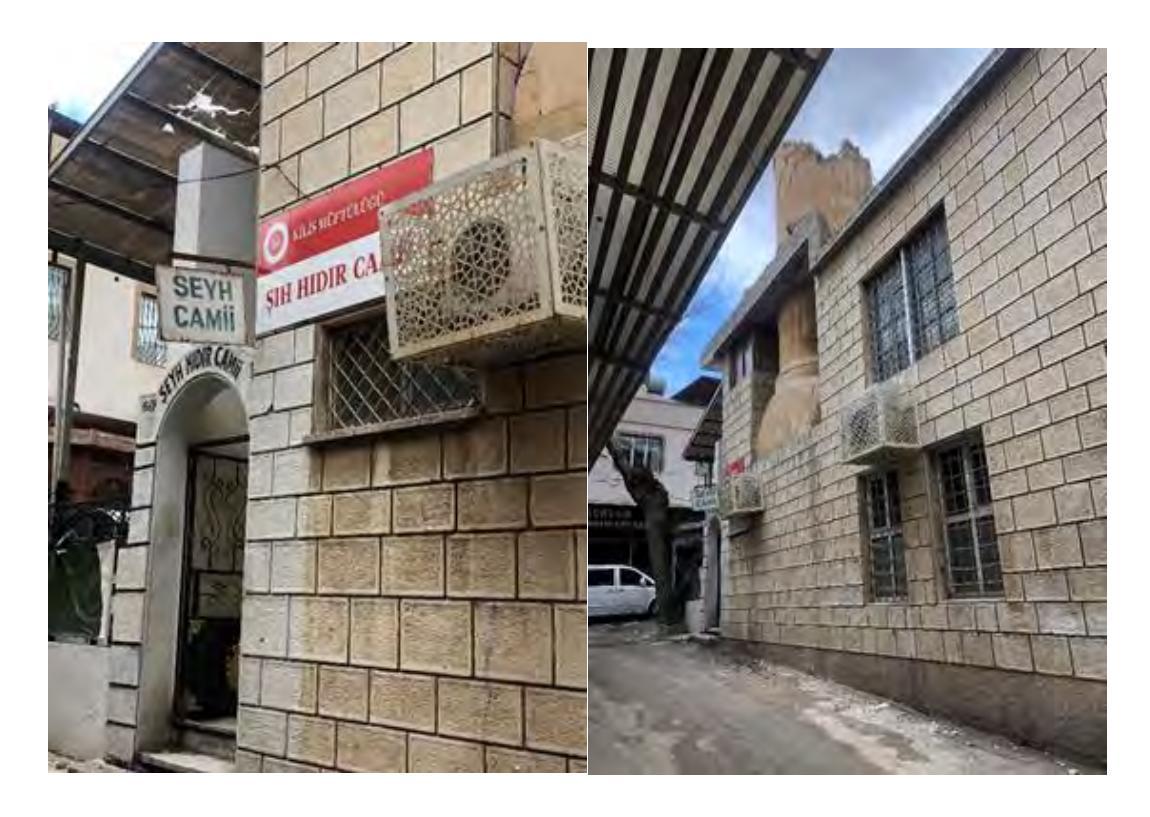
**Figure 5.117.** Şıh Hıdır Mosque (heavily damaged) Photo by Assist. Prof. Dr. Eyyüb Karakan and Prof. Dr. Alper SEZER

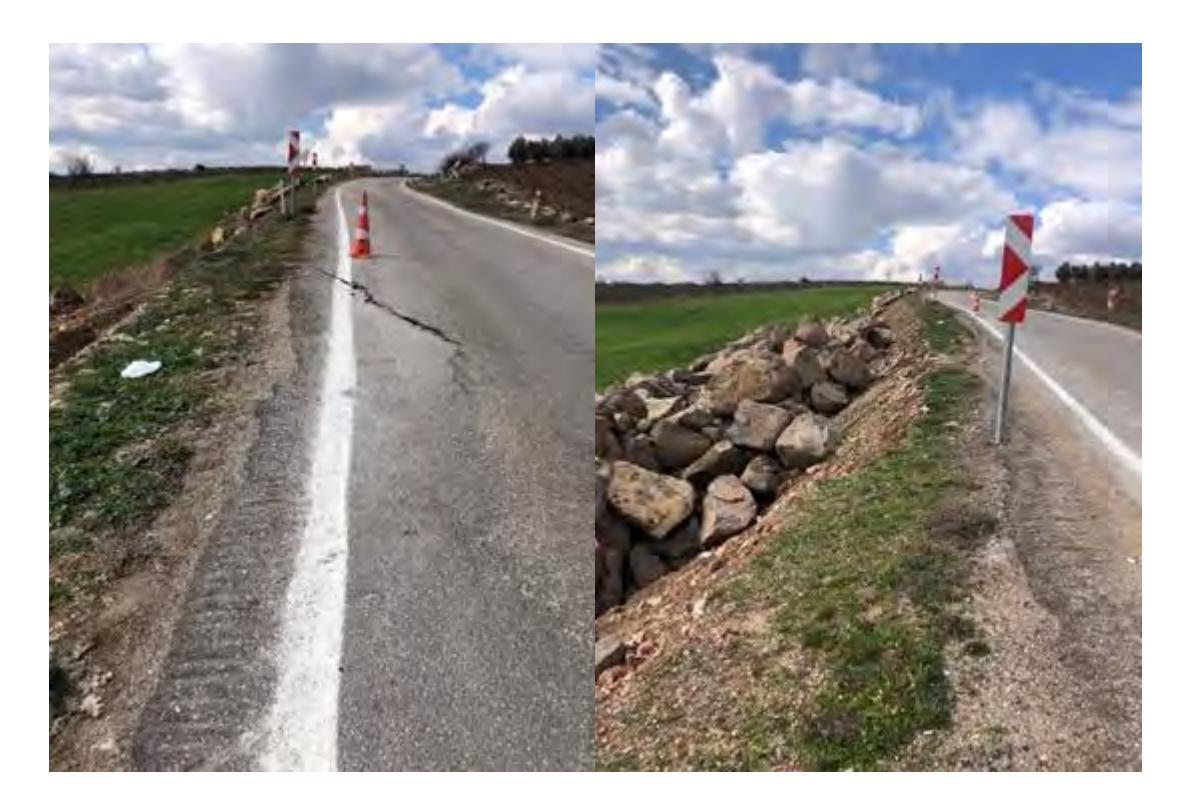
**Figure 5.118.** Limited cleavages and the stone fall in the vicinity of transportation structures between Kilis city center and Musabeyli town. Photo by Assist. Prof. Dr. Eyyüb Karakan and Prof. Dr. Alper SEZER
