# Türkiye Earthquake

## **RECONNAISSANCE REPORT**

February 6, 2023 Kahramanmaraş-Pazarcık ( $M_w$ =7.7) and

Elbistan (M<sub>w</sub>=7.6) Earthquakes

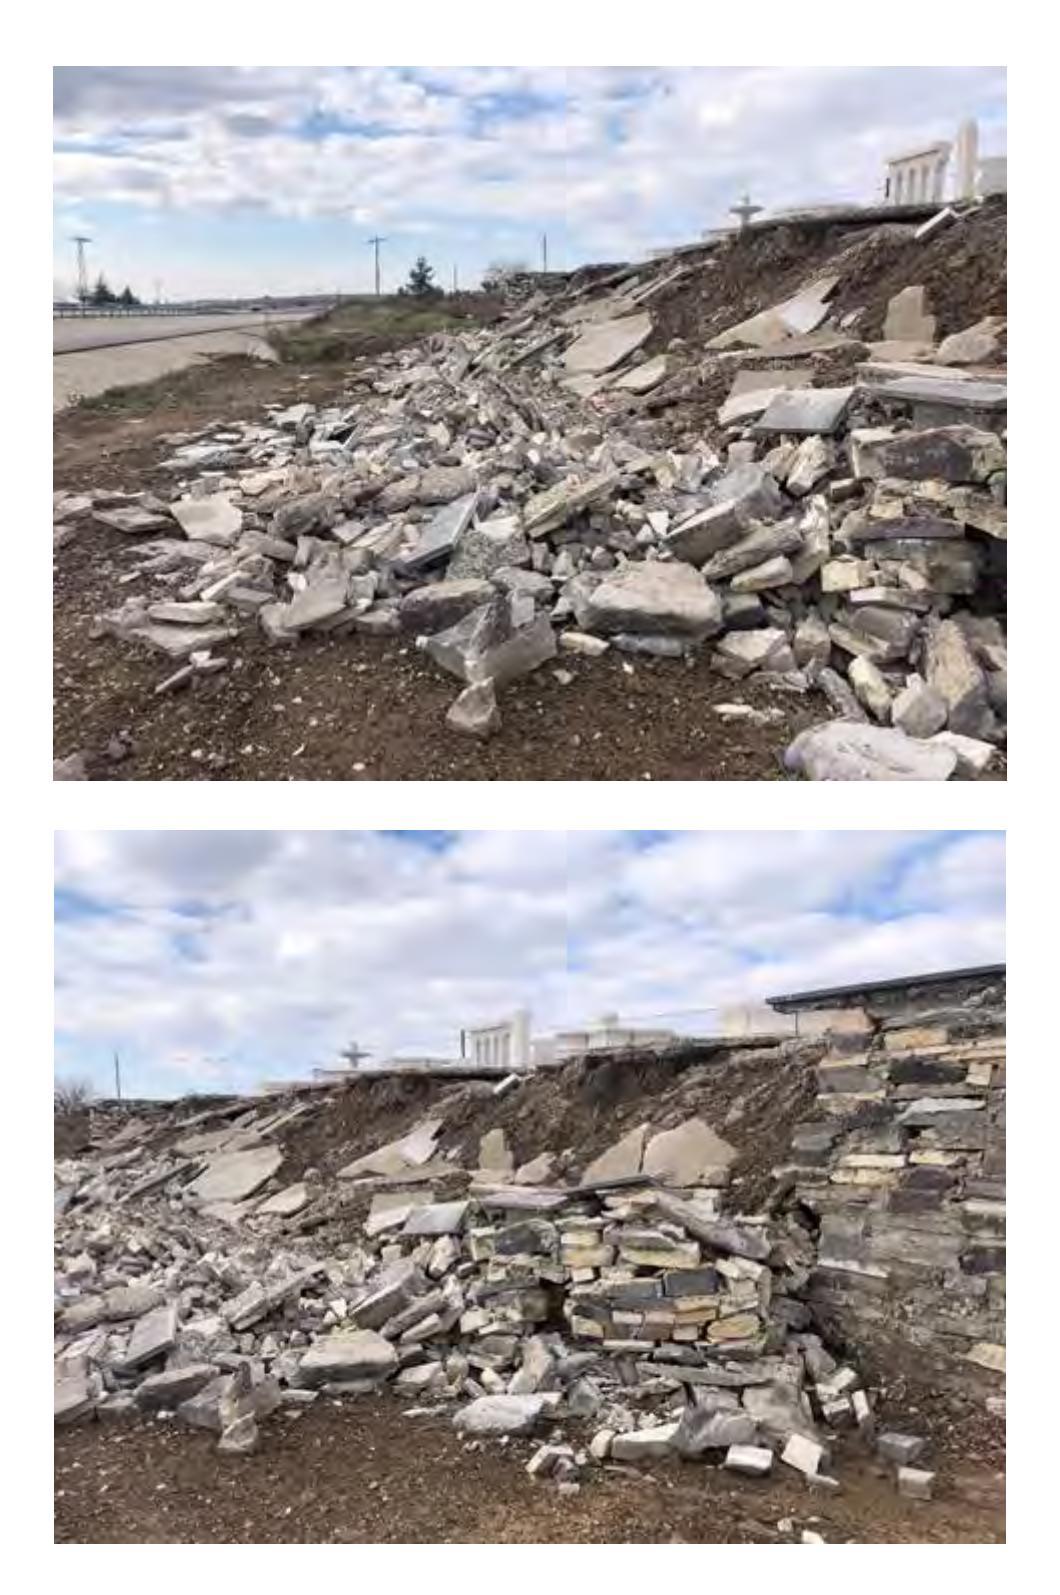
**Figure 5.119.** Briquettes have partially collapsed in the city center and also in the organized industrial zone of Kilis. Photo by Assist. Prof. Dr. Eyyüb Karakan and Prof. Dr. Alper SEZER

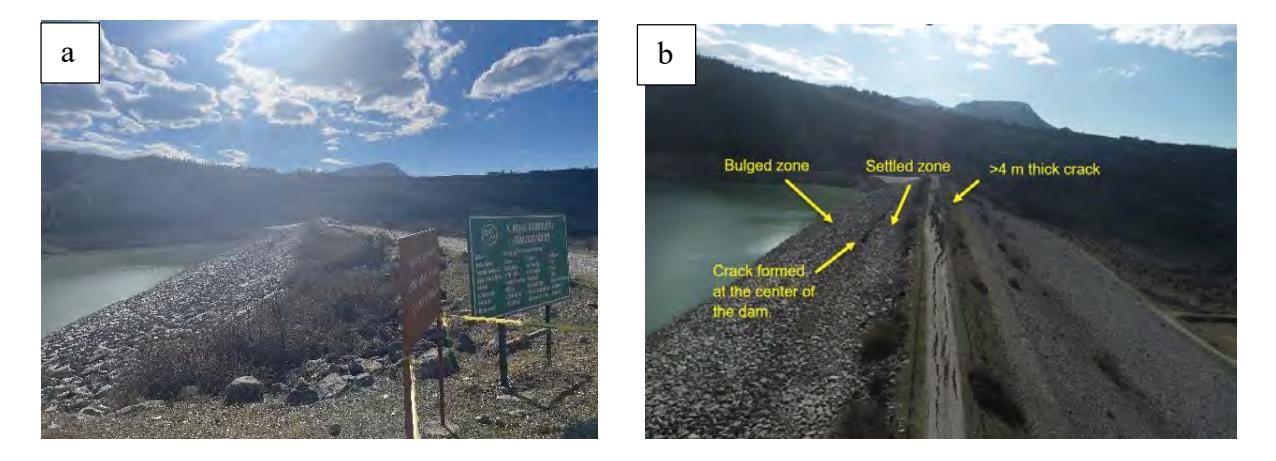
The documentation of performance of Ariklikas dam is presented in Figure 5.120. Figure 5.120b shows that the approximately 8-meter-wide crest has continuous cracks through the

longitudinal direction which intensifies towards the center of the dam more than 4 meters wide openings. Similarly, towards the center of the dam, upstream slope is observed to have settled significantly near the crest. In parallel to these settlements, toe of the upstream slope was observed to bulge significantly which indicates potentiall slope instability. Furthermore, D400 highway connecting Osmaniye to Nurdagi experienced several earthquake-induced rockfall hazards as shown in Figure 5.121. Moreover, several partial or complete collapse of the buildings at the city center of Osmaniye is documented in Figure 5.122.

Figure 5.120. a) Ariklikas Dam (side view); b) Ariklikas dam (bird's-eye view) (~37°09'25.70"N/ 36°30'55.96"E). (Photo by Ozgun Numanoglu, Tugce Baser, Serhat Erinmez)

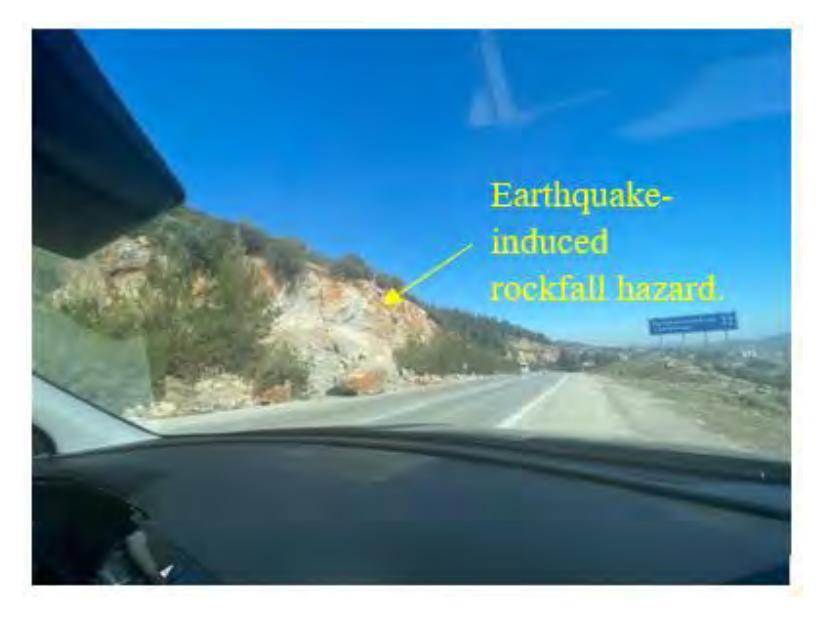
**Figure 5.121.** Earthquake-induced rockfall hazard at D400 connecting Osmaniye to Nurdagi(~37°10'48.17"N/ 36°42'45.62"E). (Photo by Ozgun Numanoglu, Tugce Baser, Serhat Erinmez)

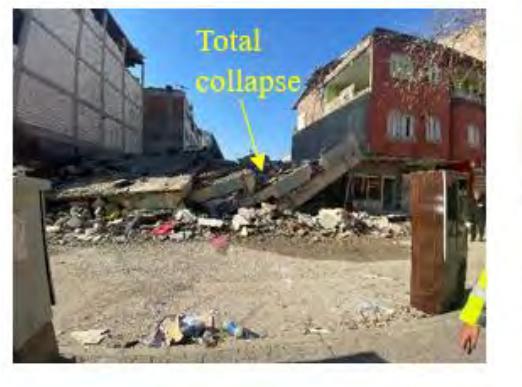
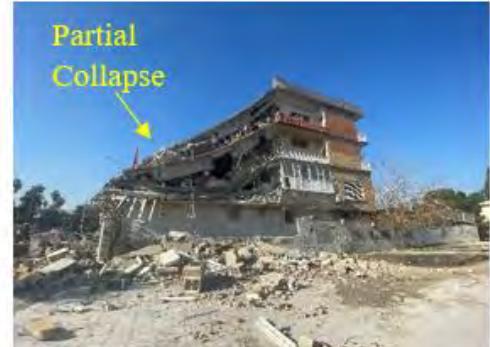
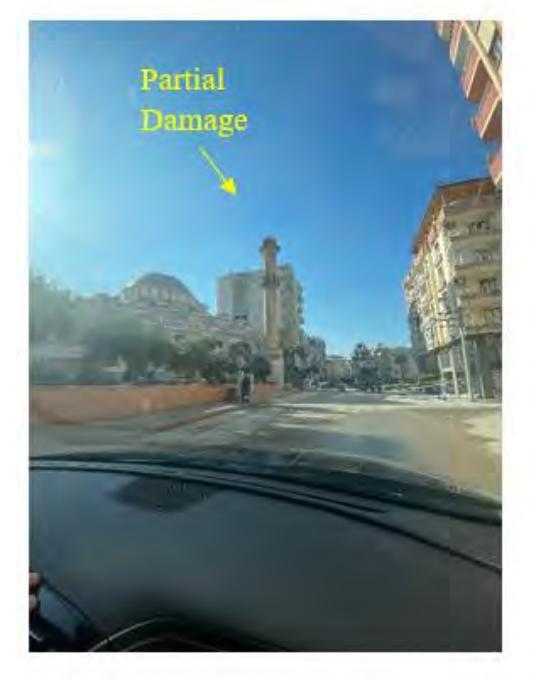
**Figure 5.122.** Total or partial collapse / damage documented fort the buildings in Osmaniye City Center: a) Total collapse case (~37°04'28.75"N/ 36°14'55.78"E); b) partial collapse case (~37°04'30.97"N/ 36°14'50.00"E); c) partial damage case (~37°04'15.08"N/ 36°14'46.00"E) (Photo by Ozgun Numanoglu, Tugce Baser, Serhat Erinmez)

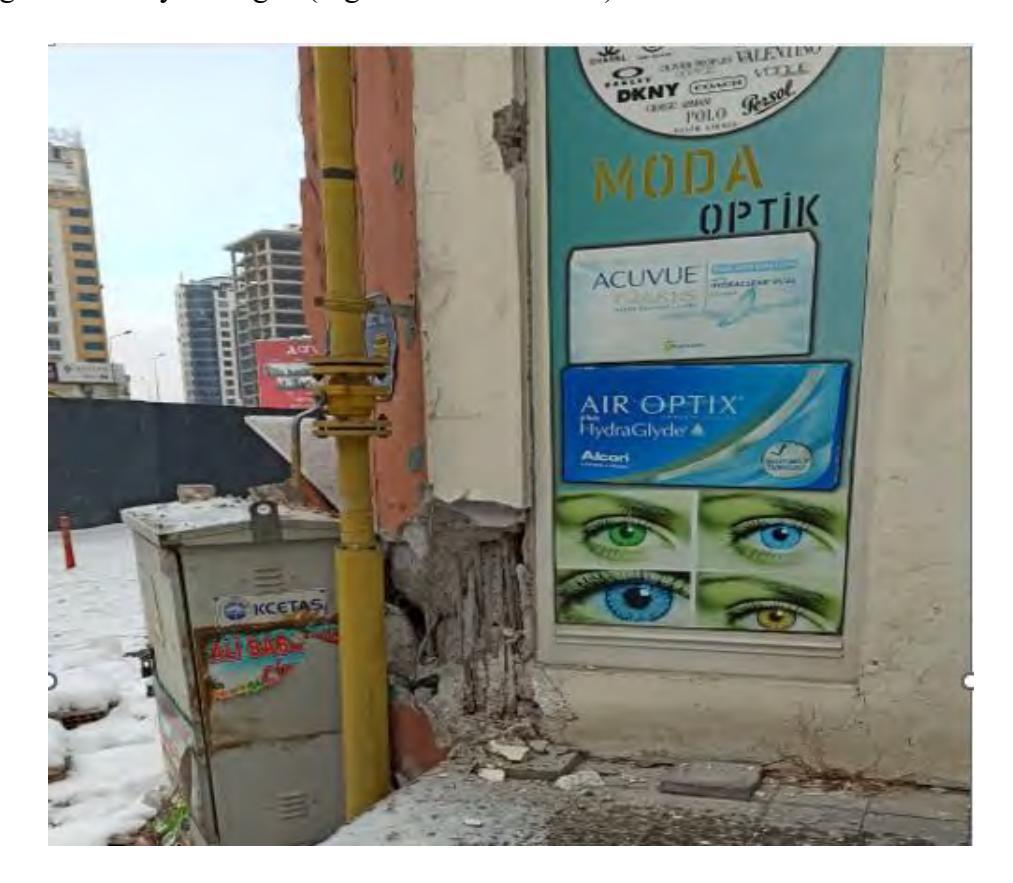
Considering the examinations performed after the earthquake, visible damage was found in some columns of the building (Figures 5.126 and 127). When the damage in the columns was examined closely, it was noticed that the reinforcement used was non-ribbed bar. In addition, when the facade of the building is examined, cracking in the plaster can be seen easily. In addition, cracks are evident on the walls of the business center and shop on the first four floors (Figures 5.128 and 129). In addition, diagonal breaks on the facade are also clearly visible. According to the evaluations of municipal officials, civil engineers it was concluded that the building was heavily damaged (Figures 5.130 and 131).

Figure 5.126. Column damage, plastic hinging

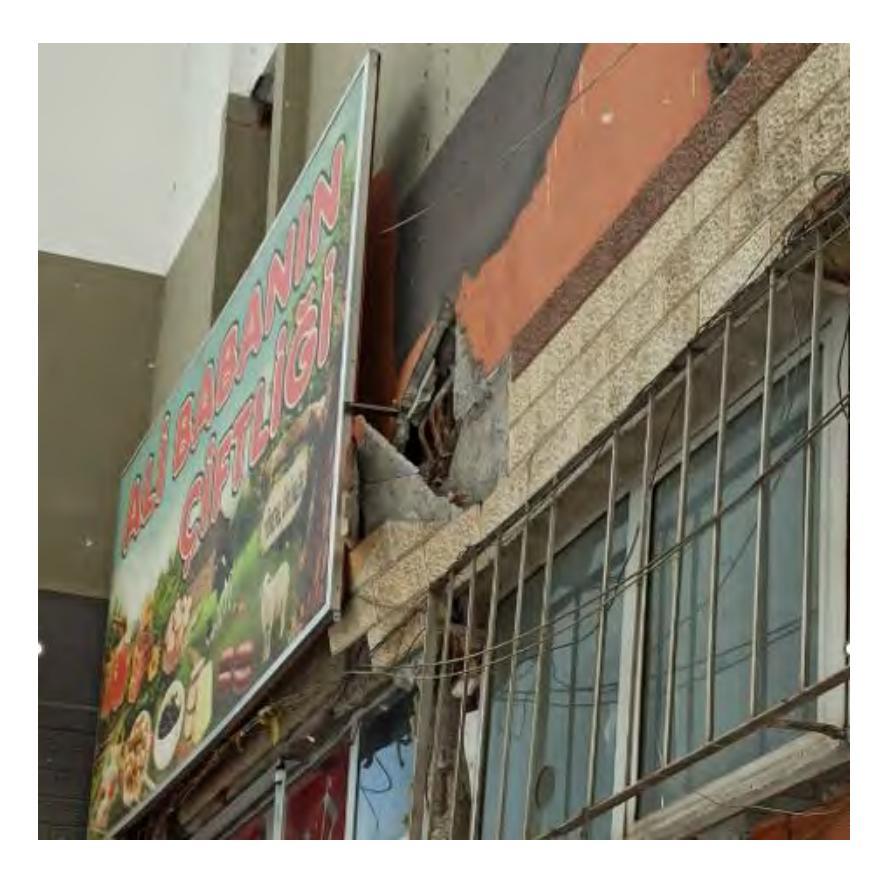
Figure 5.127. Damaged building, plastic hinging

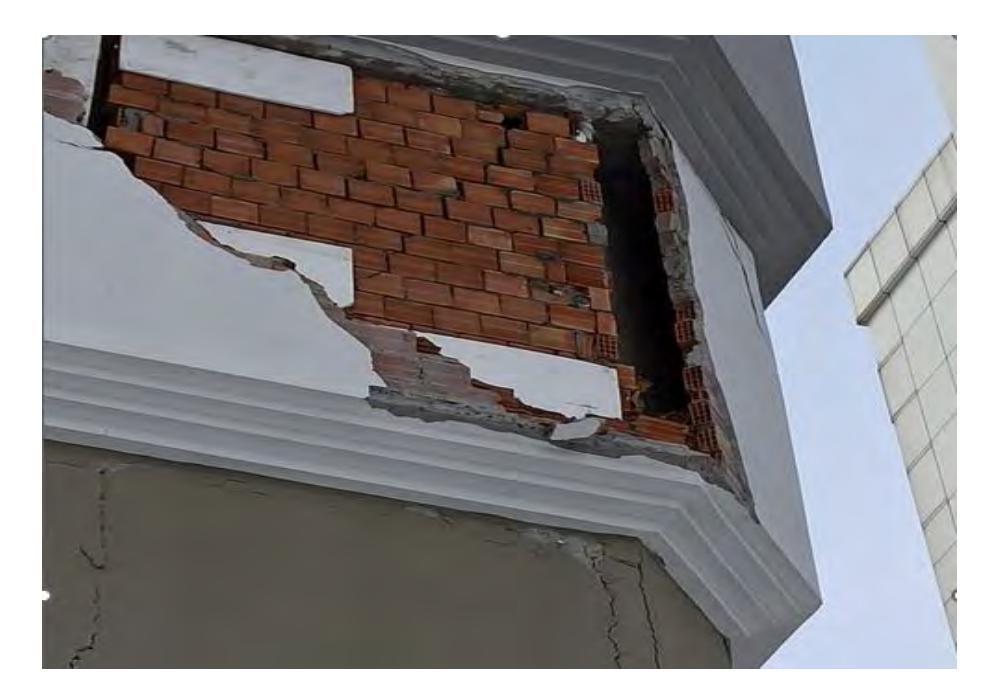
Figure 5.128. Partition wall damage

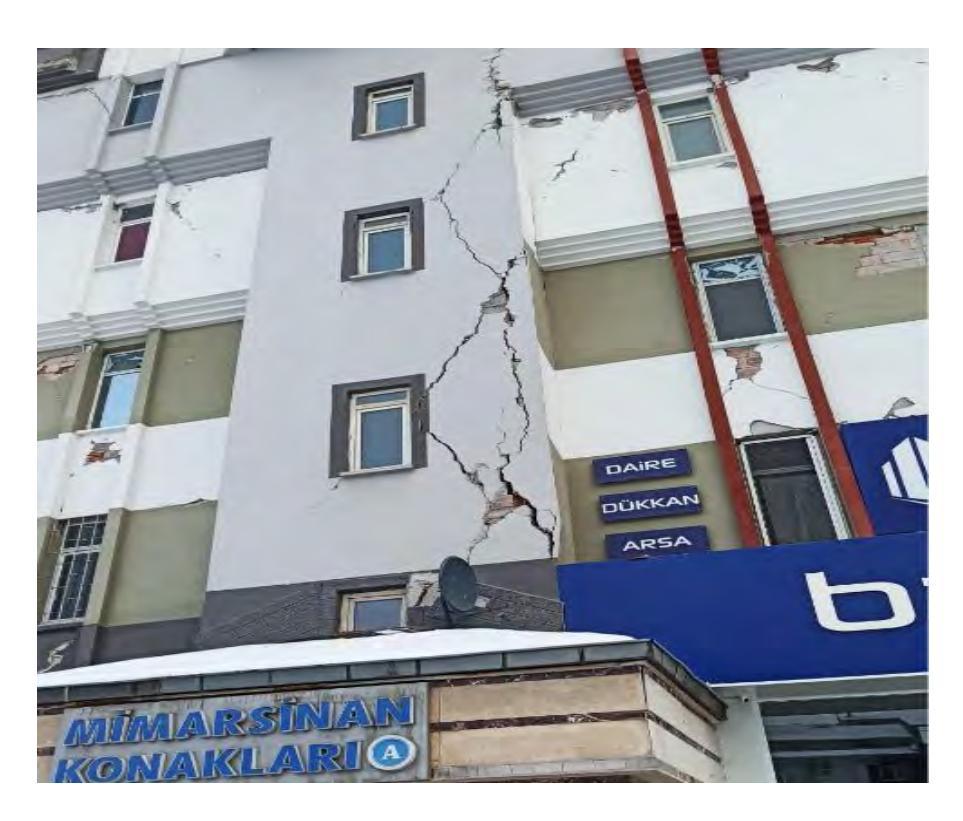
Figure 5.129. Shear cracking

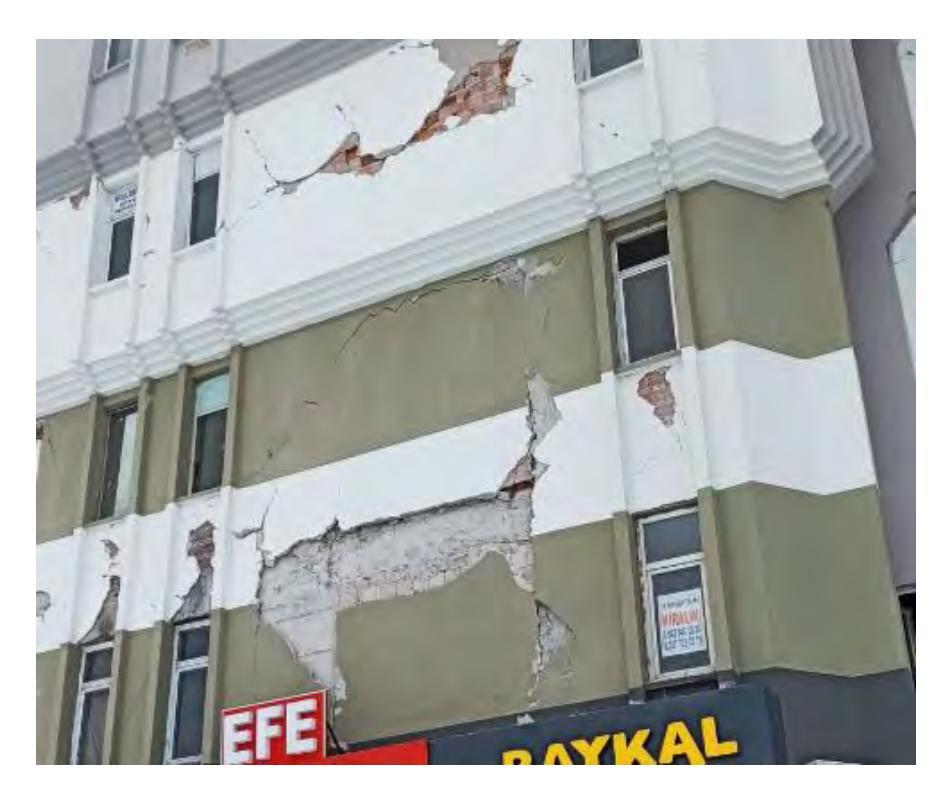
Figure 5.130. Facade damages

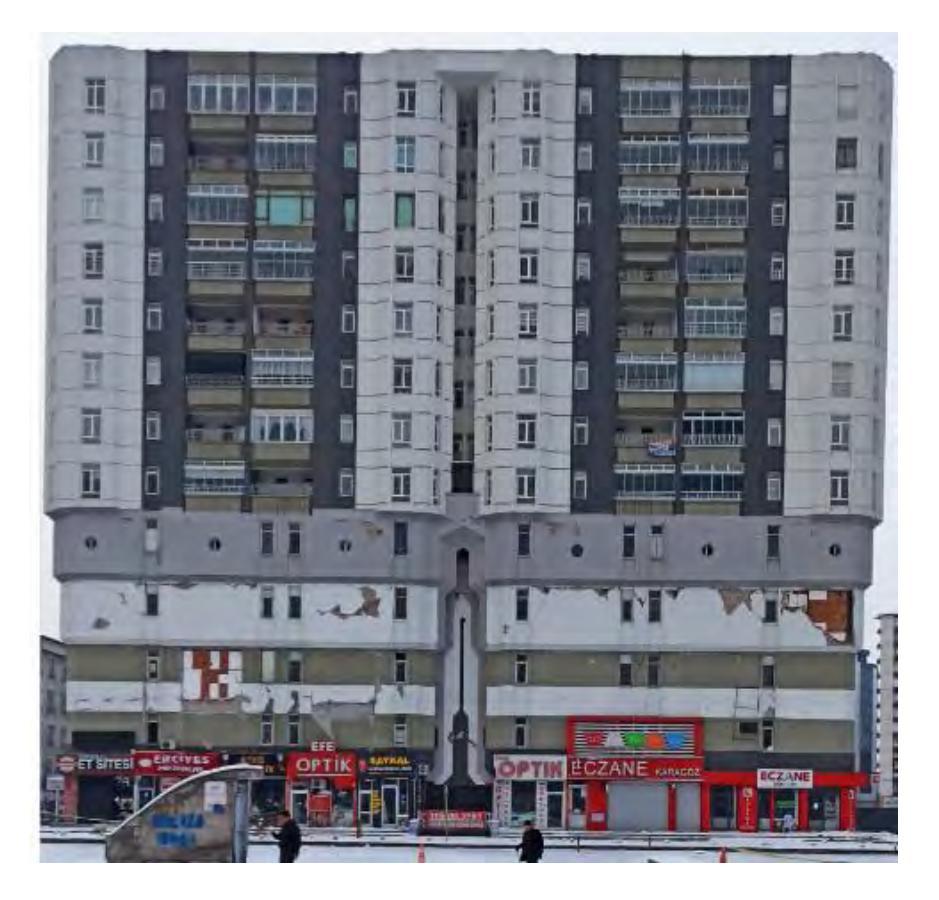
Figure 5.131. Front view of a damaged building complex

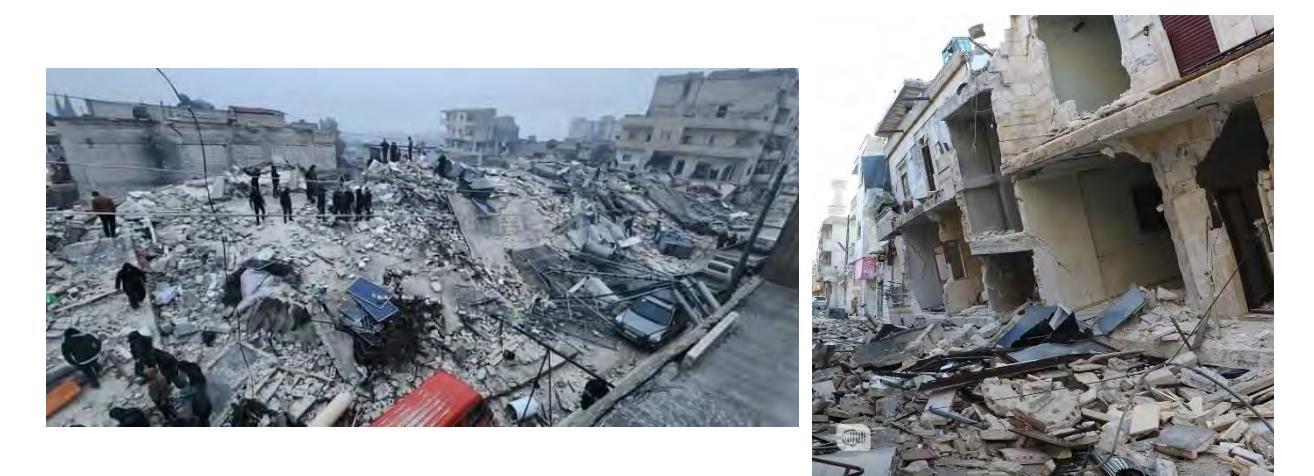
The greatest damage was in the city of Aleppo and its northwestern suburbs (Mostly in Jindires, Afrin, A'zaz, and Sawran). Figure 5.133 shows an example of the destruction in Jindires, where most of the buildings have been totally collapsed or damaged severely.

**Figure 5.133.** Destruction in Jindires – Afrin, Aleppo, approximate location (36°23'46.76"N, 36°41'14.26"E)

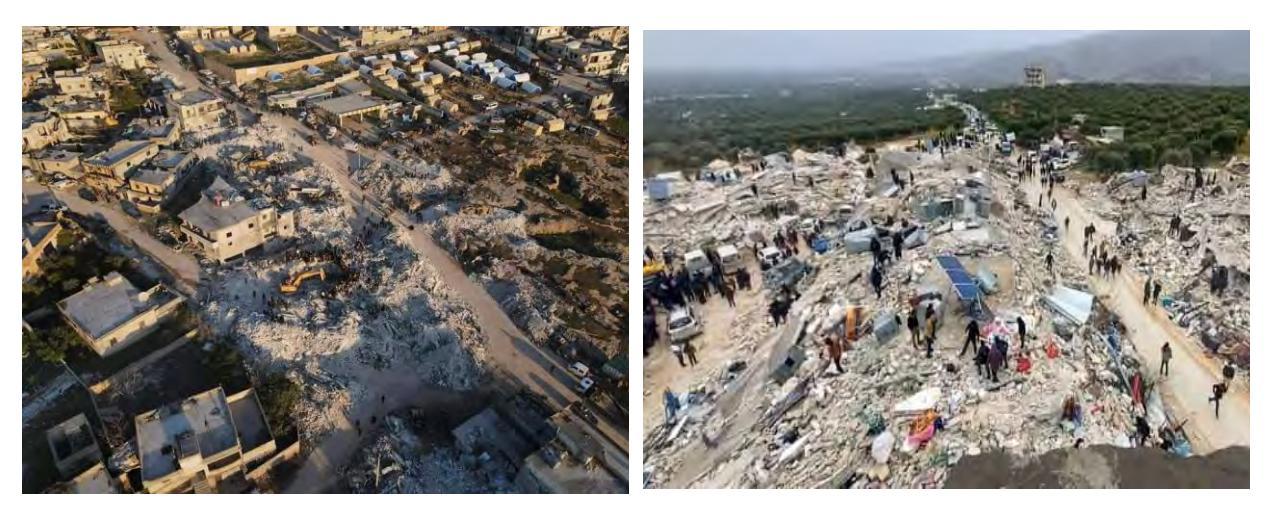
**Figure 5.134.** Destruction in Harem, Idlib, approximate location (36°12'45.01"N, 36°31'13.72"E)

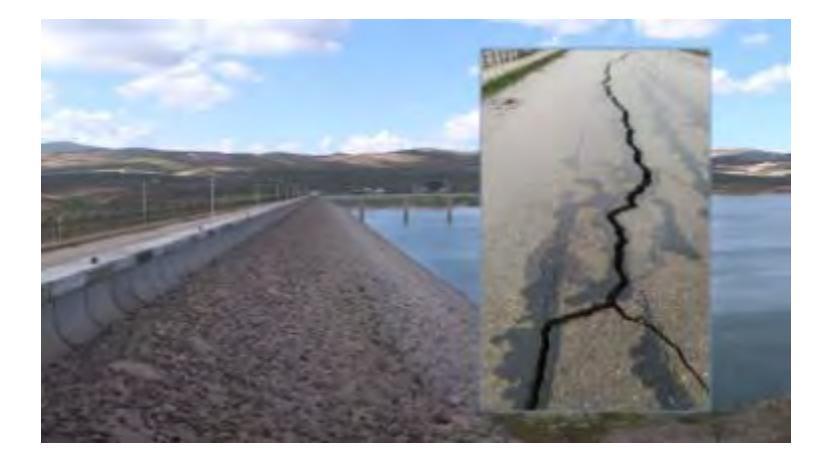
Regarding affected service structures, it was spoken of 17<sup>th</sup> April or Medanki dam in Afrin as being damaged due to the earthquake. But, as per reported by a committee of civil engineers who inspected the dam, there is no visible damage in the body of the dam and there is no water leakage observed. The seen cracks at the top road constructed over it are just in the asphalt layer of the road with a 4cm width and 40cm depth, Figure 5.135.

Figure 5.135. Medanki dam showing the cracks in the road at the crest, (36°37'18.56"N, 36°52'17.19"E), (syria.tv).

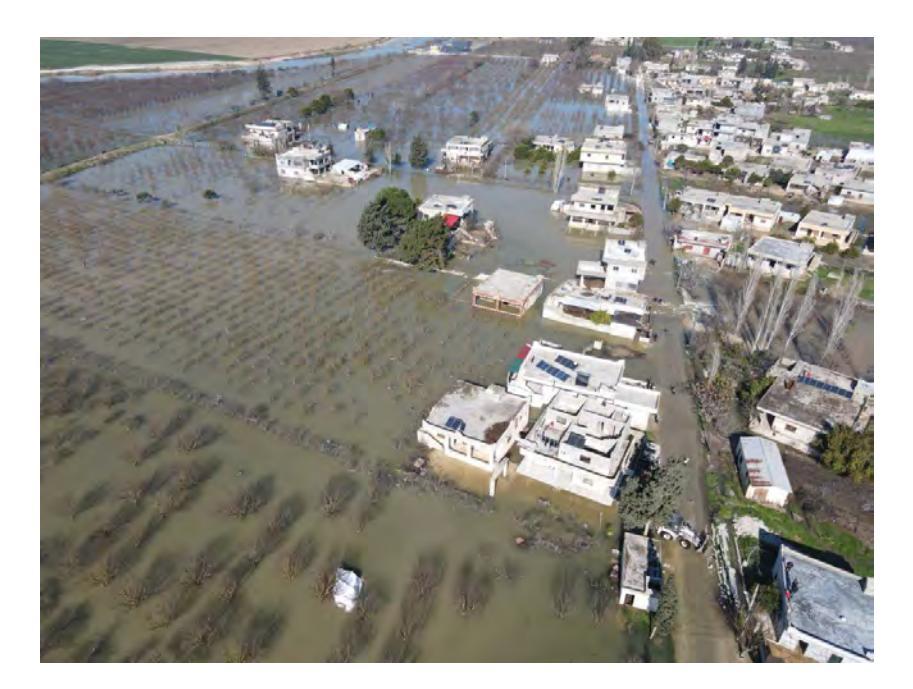
In the Tloul village in the subdistrict Salqin, Idlib, a flood occurred due to an increase in the AlAsi river water level due to the winter season and damage to the constructed mud shoulders on the sides of the river in the mentioned village and its neighborhood resulting in approximately 1000 home affected and evacuation of 7000 people, Figure 5.136.

Figure 5.136. Flooded village of Tloul in Salqin, Idlib, (36°12'42.82"N, 36°23'40.89"E), (nasnews.com).

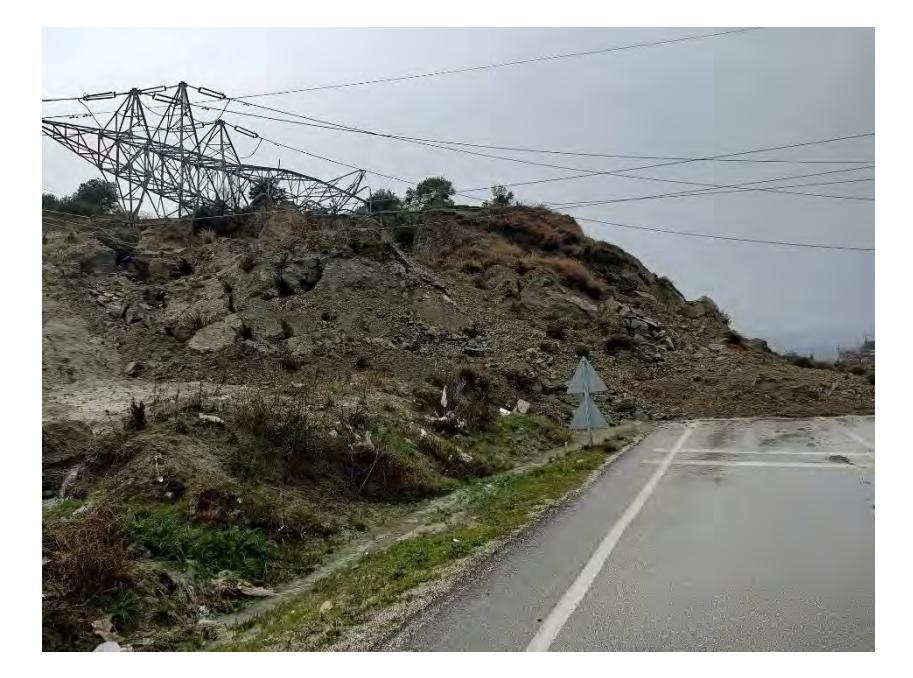
In the subdistrict of Afrin, collapsed electricity supply tower as a result of a stability problem in the foundation soil, Figure 5.137.

Figure 5.137. Slope failure in the proximity of the Afrin subdistrict.

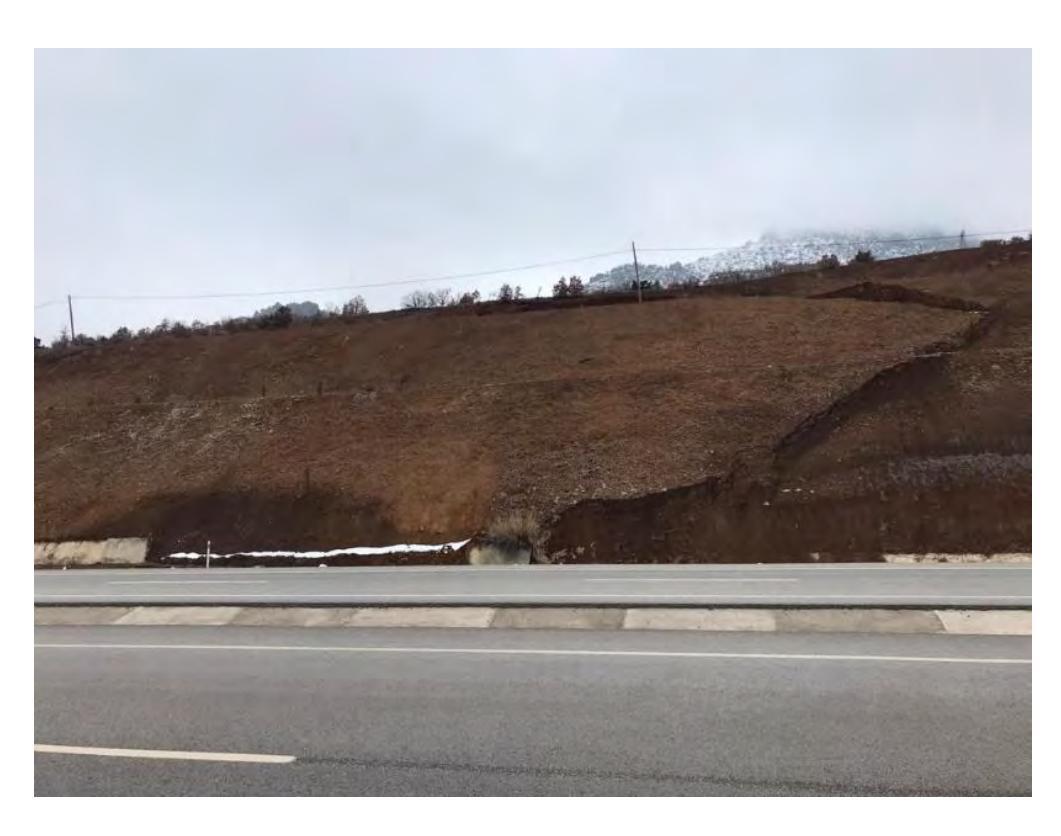
Figure 5.139. Planar sliding mass on the roadside (hekimhan-sivas Road)

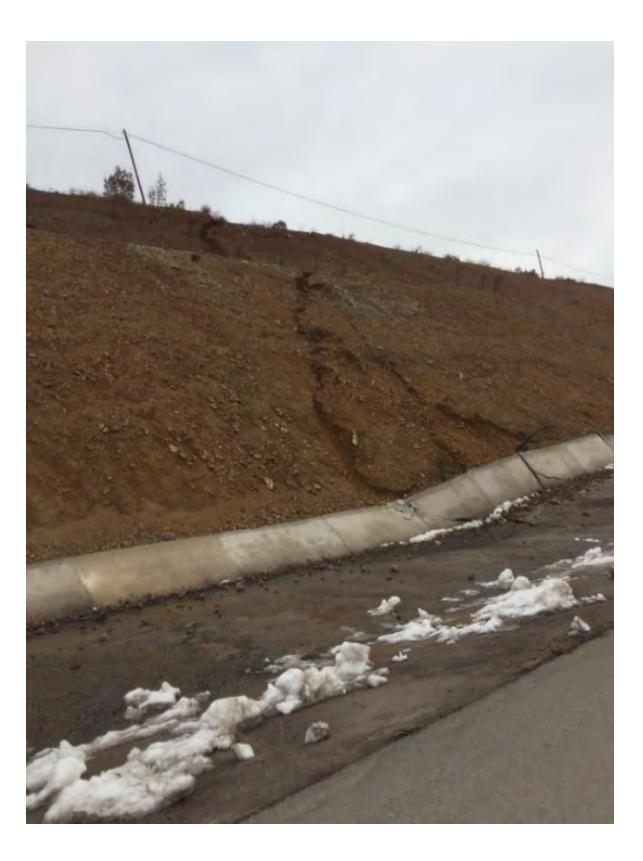
Figure 5.141. Shallow planar slips (hekimhan-sivas Road)

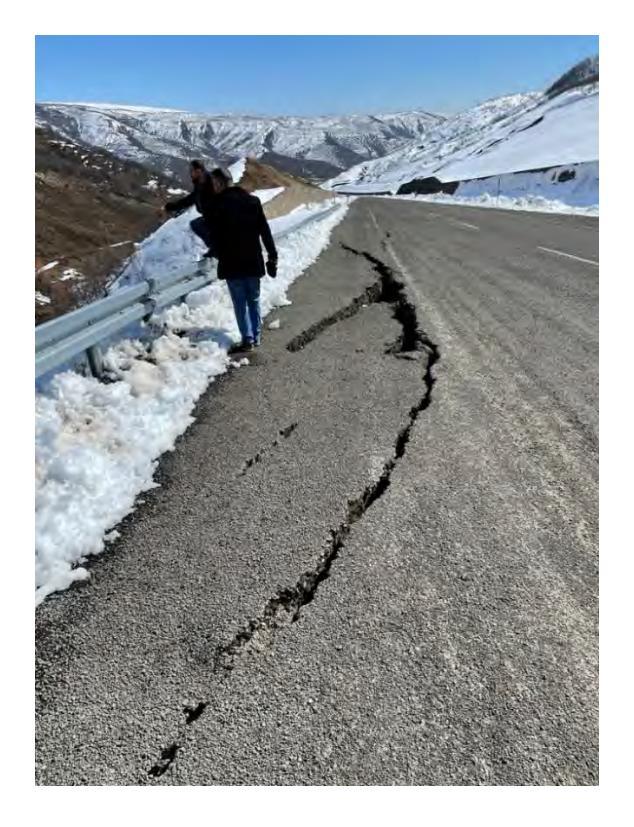
**Figure 5.142.** Partial landslide development due to earthquake at the roadside (bingol-elazig road junction)

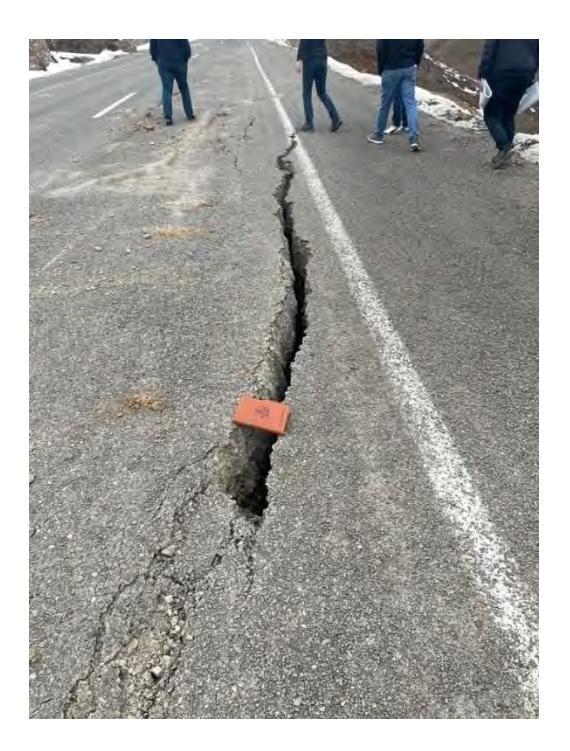
Figure 5.143. Earthquake-induced tension cracks in the road fill zone (bingol-elazig road junction)

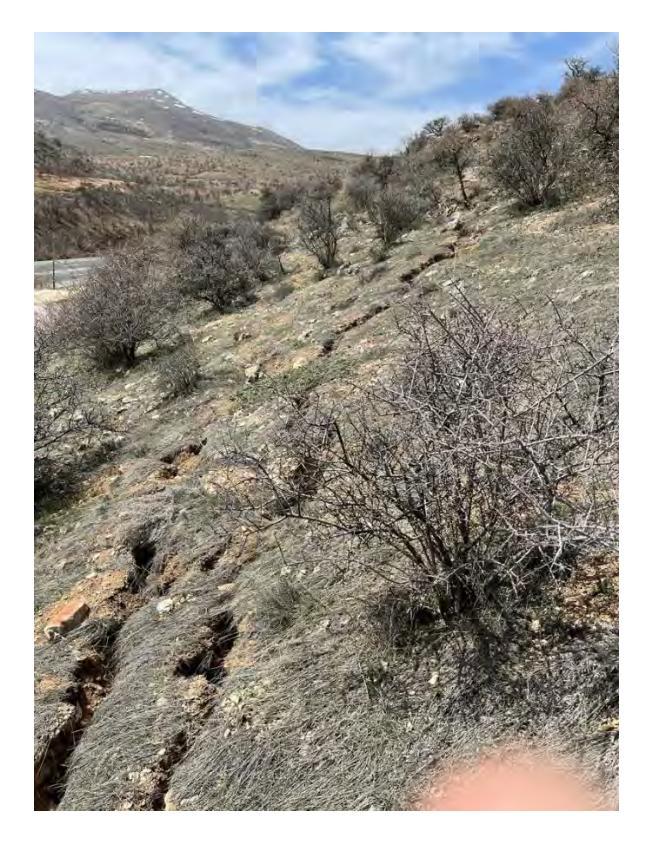
Figure 5.144. Landslide tension cracks on the roadside (bingol-elazig road junction)

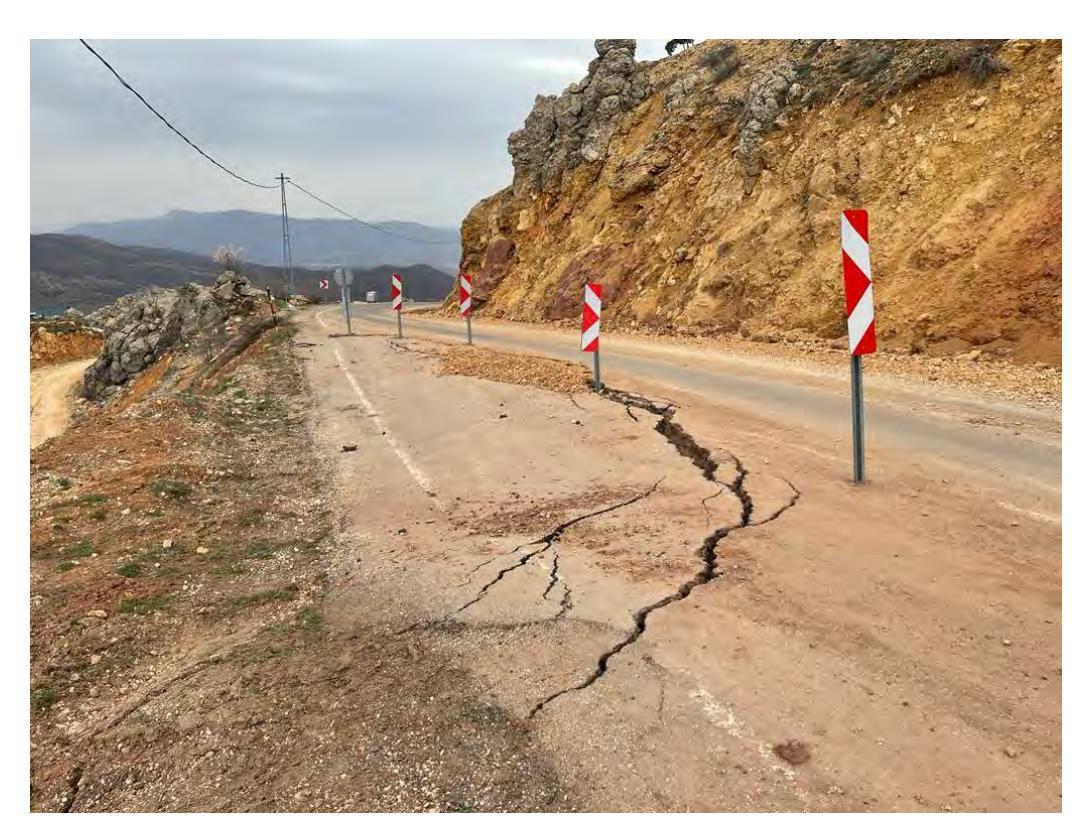
**Figure 5.145.** Development of tension cracks in the landslide crown zone, possibly on the mixed ground, on the roadside (bingöl-elazig road junction)

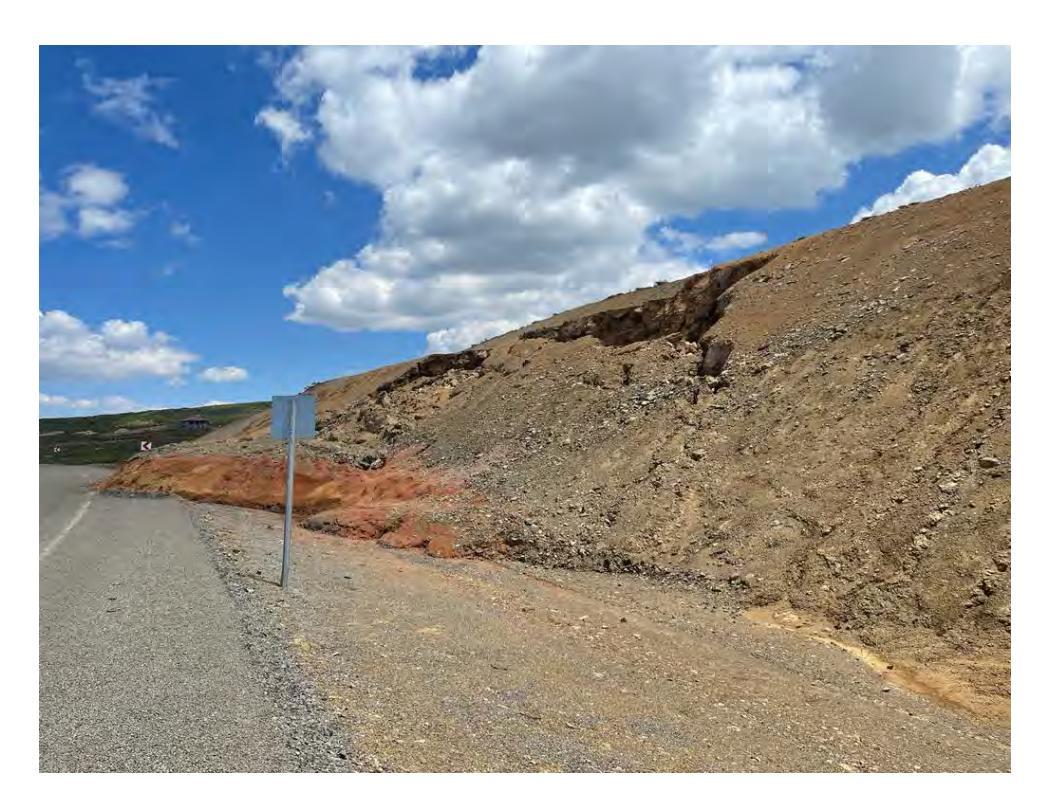
Figure 5.146. Landslide occured due to earthquake (Bingöl-Elazig road junction)

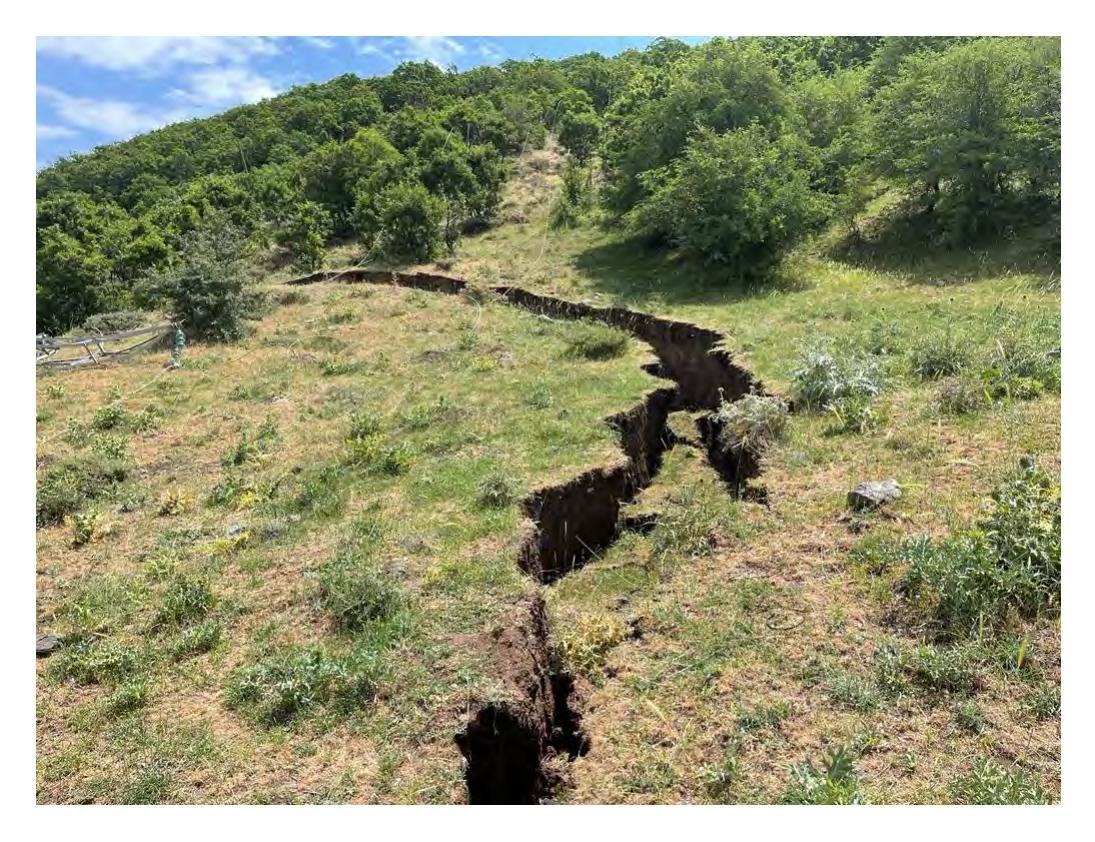
Figure 5.147. Landslide induced by earthquake (Bingöl-Karlıova road)

Due to the hihg level of accelaration it is observed that the displacement amount of slope become high

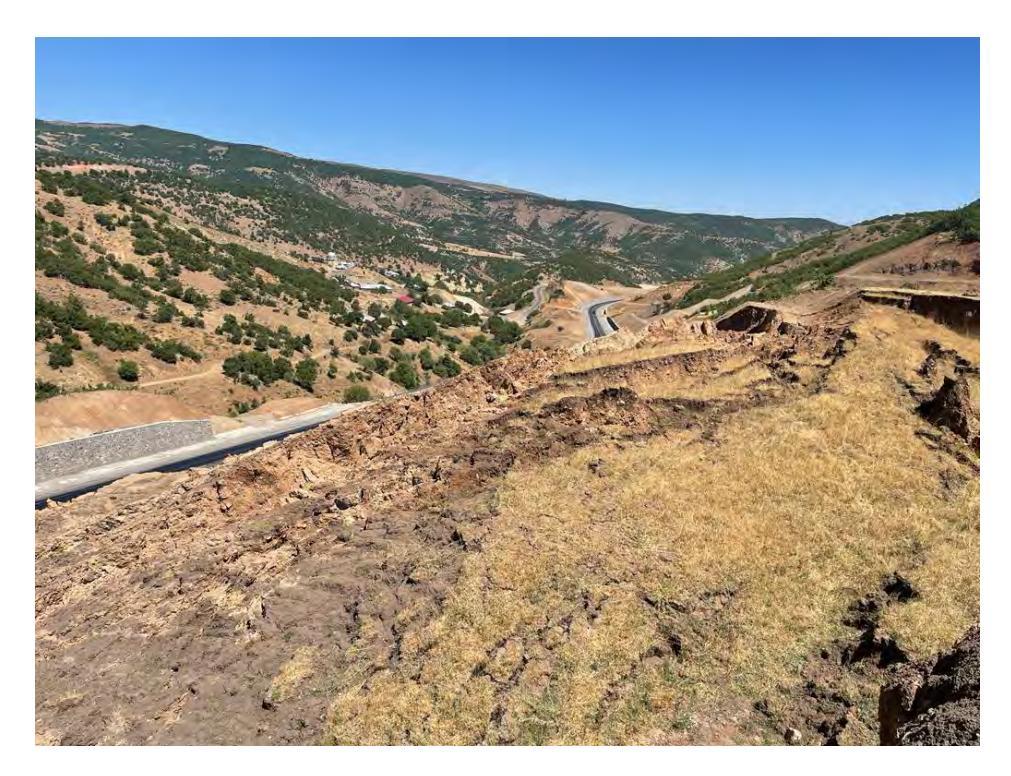
Figure 5.149. Earthquake induced Landslide occured at Sancak road

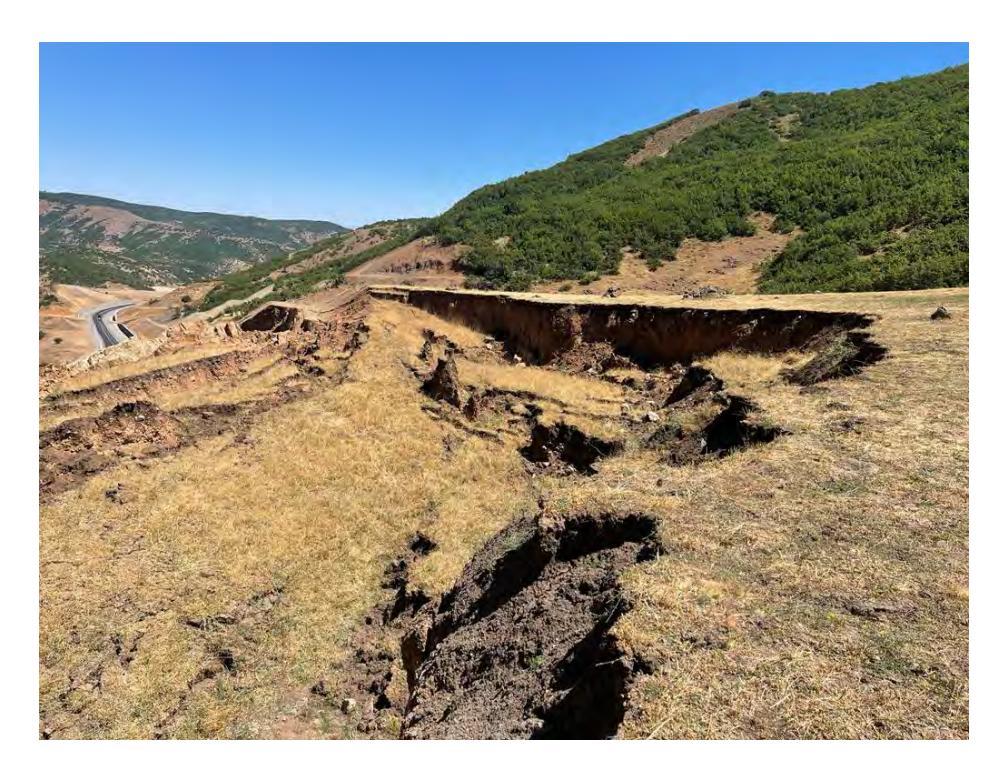
Figure 5.150. Earthquake induced Landslide occured at Sancak road

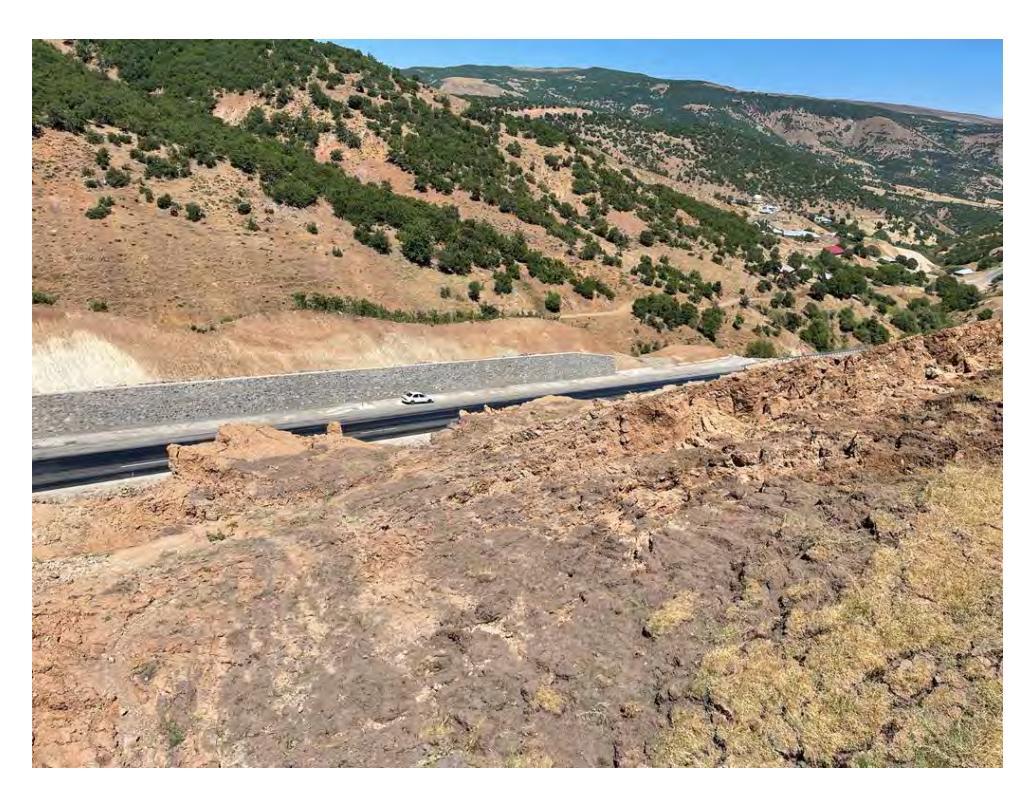
Figure 5.151. Earthquake induced Landslide occured at Sancak road

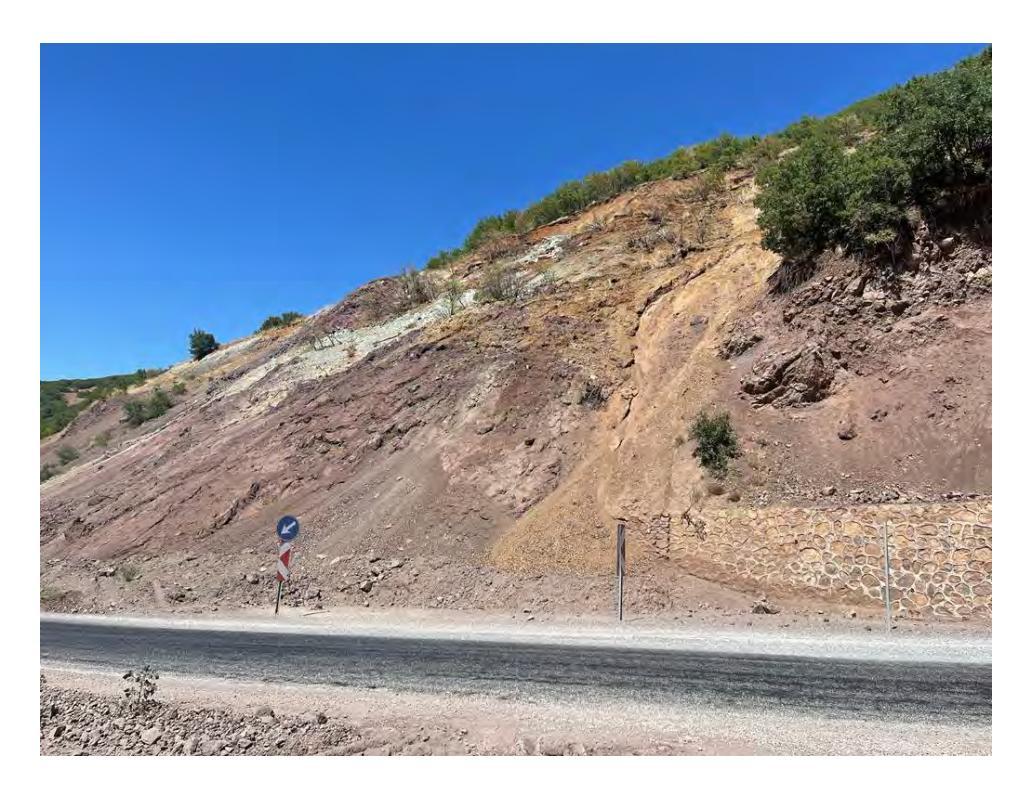
Figure 5.152. Flow and mass slides in the talus on the bedrock (Sancak road)

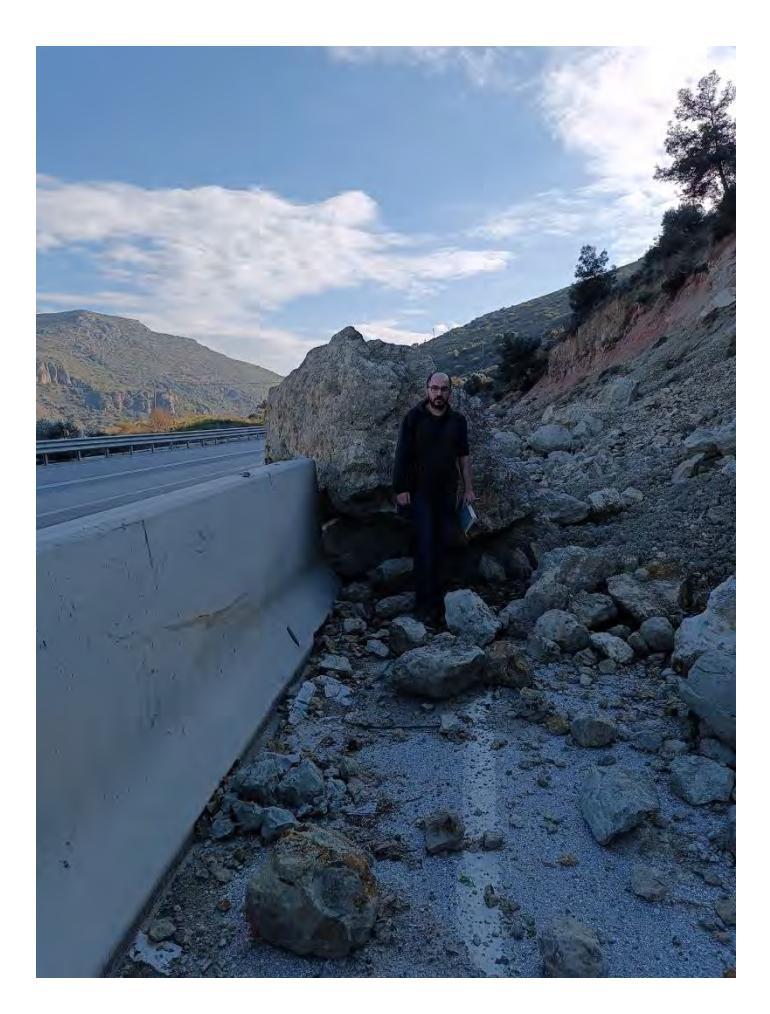
Figure 5.153. Hatay-Belen rockfall (Photo by Müge Akın)

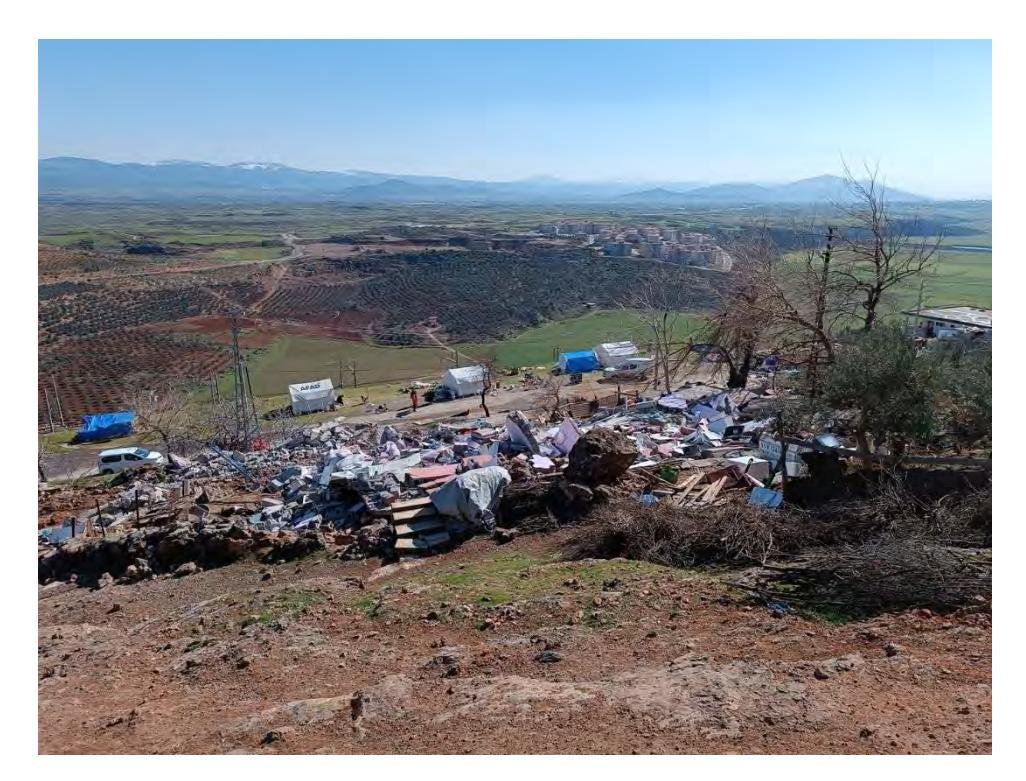
Figure 5.154. Gaziantep-Islahiye Fevzipaşa rockfall (Photo by Ogün Ozan Varol)
