# Türkiye Earthquake

## **RECONNAISSANCE REPORT**

February 6, 2023 Kahramanmaraş-Pazarcık ( $M_w$ =7.7) and

Elbistan (M<sub>w</sub>=7.6) Earthquakes

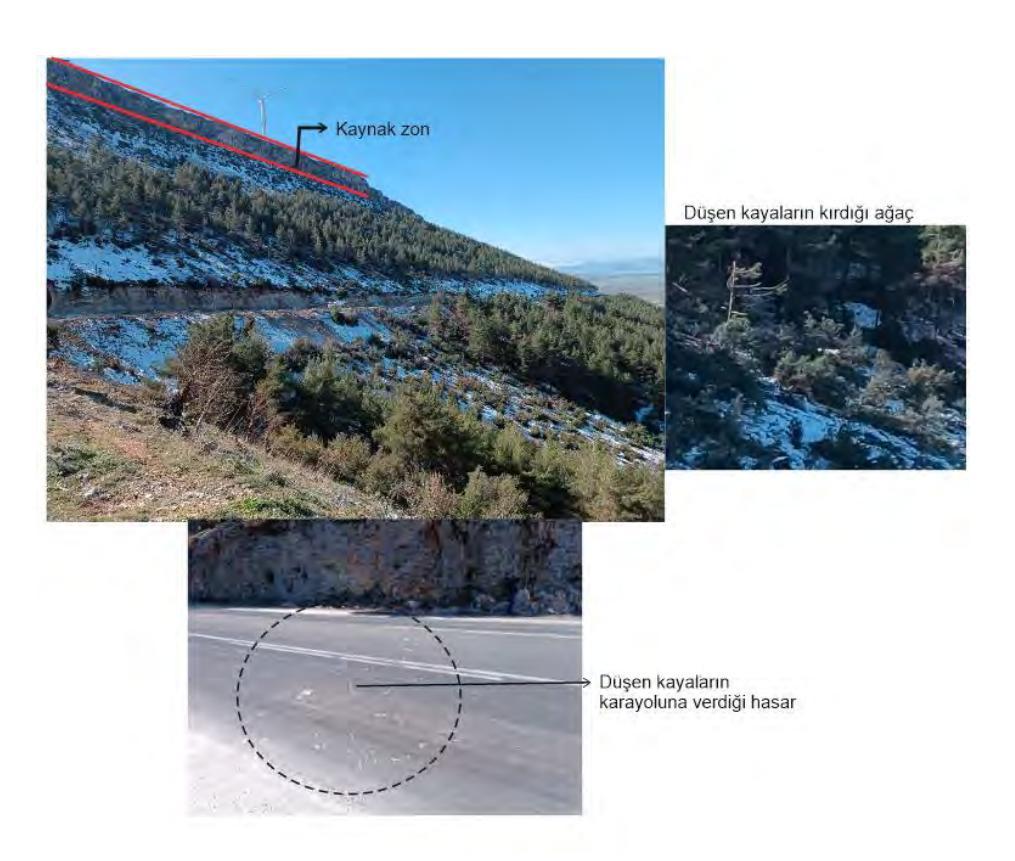
Figure 5.155. Gaziantep Nurdağ-Sakçagözü rockfall (Photo by Ogün Ozan Varol)

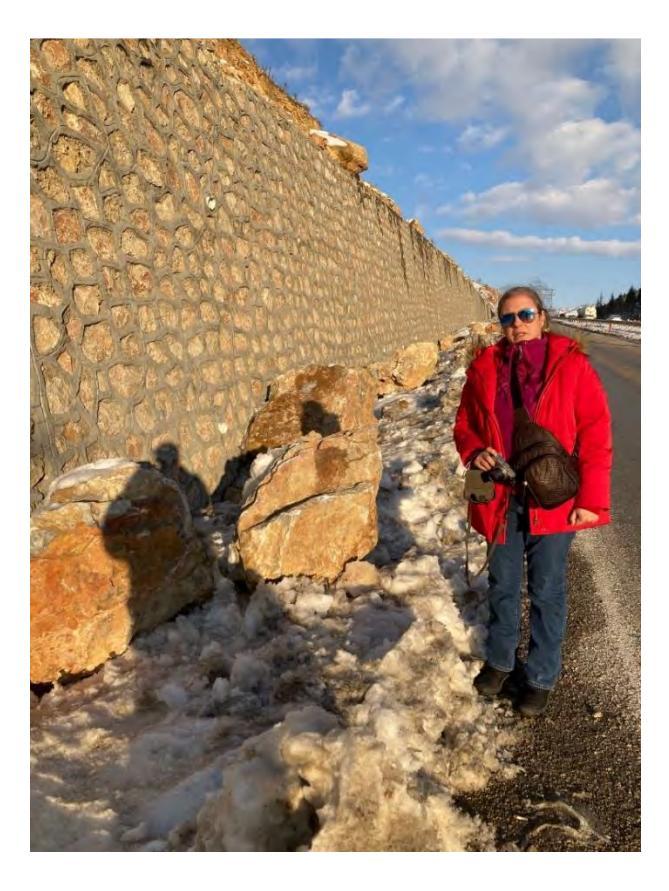
Figure 5.156. Malatya-Erkenek rockfall (Photo by Metehan Başer)

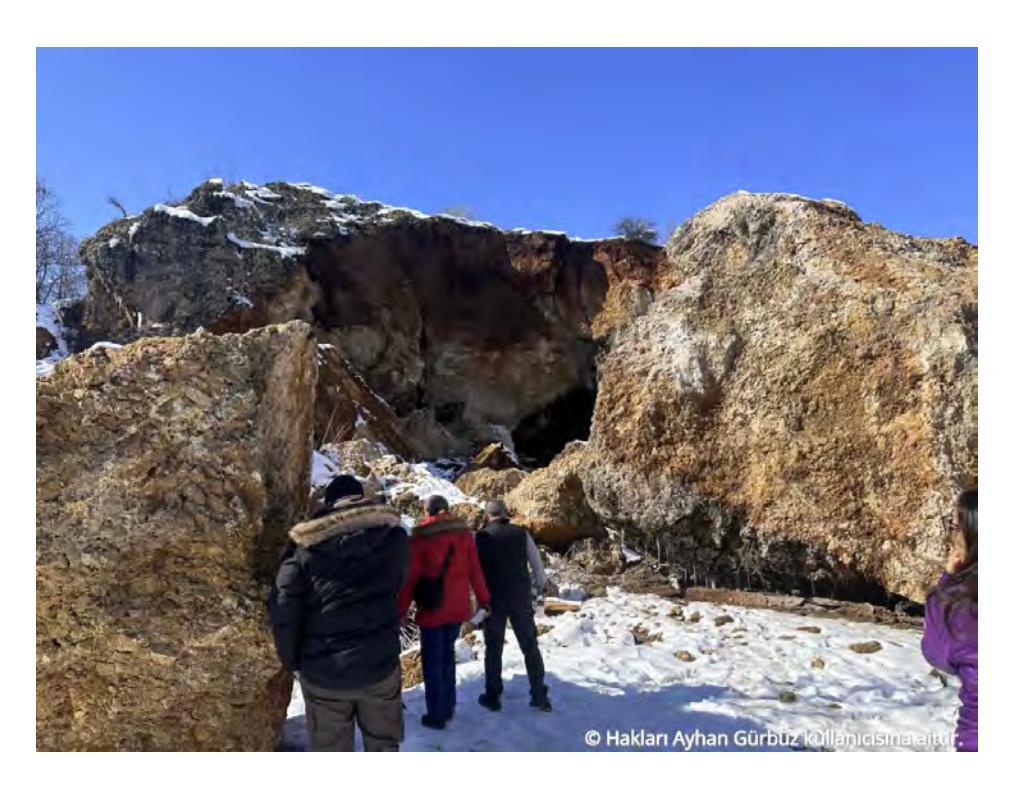
Figure 5.157. Adıyaman, Gölbaşı district Karamağara rockfall (Photo by Ayhan Gürbüz)

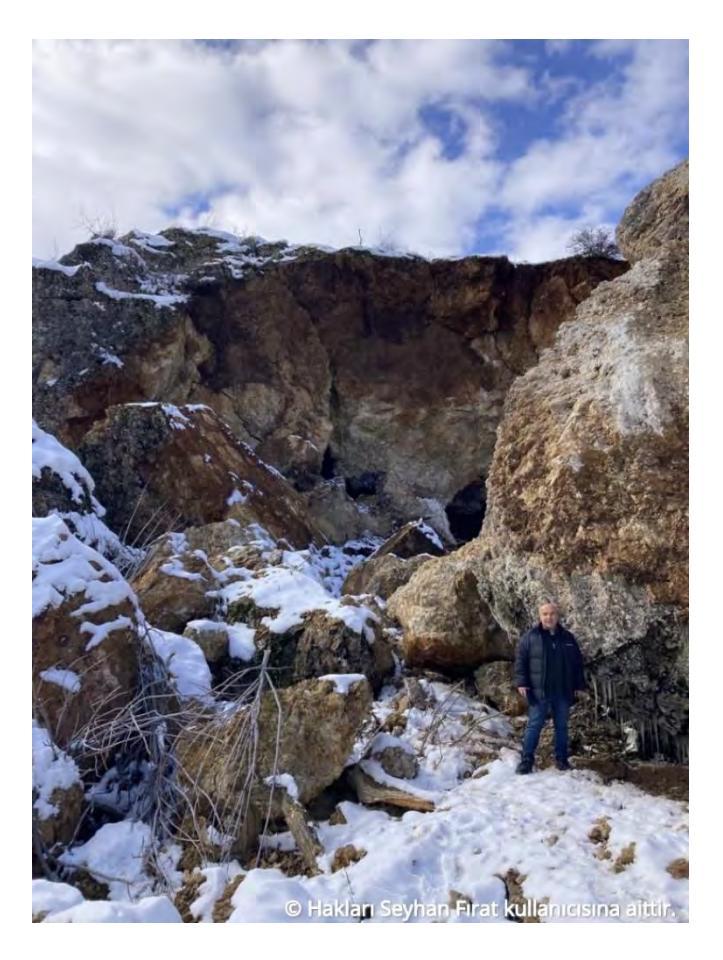
Figure 5.158. Another view of Adıyaman, Gölbaşı district Karamağara rockfall (Photo by Seyhan Fırat)

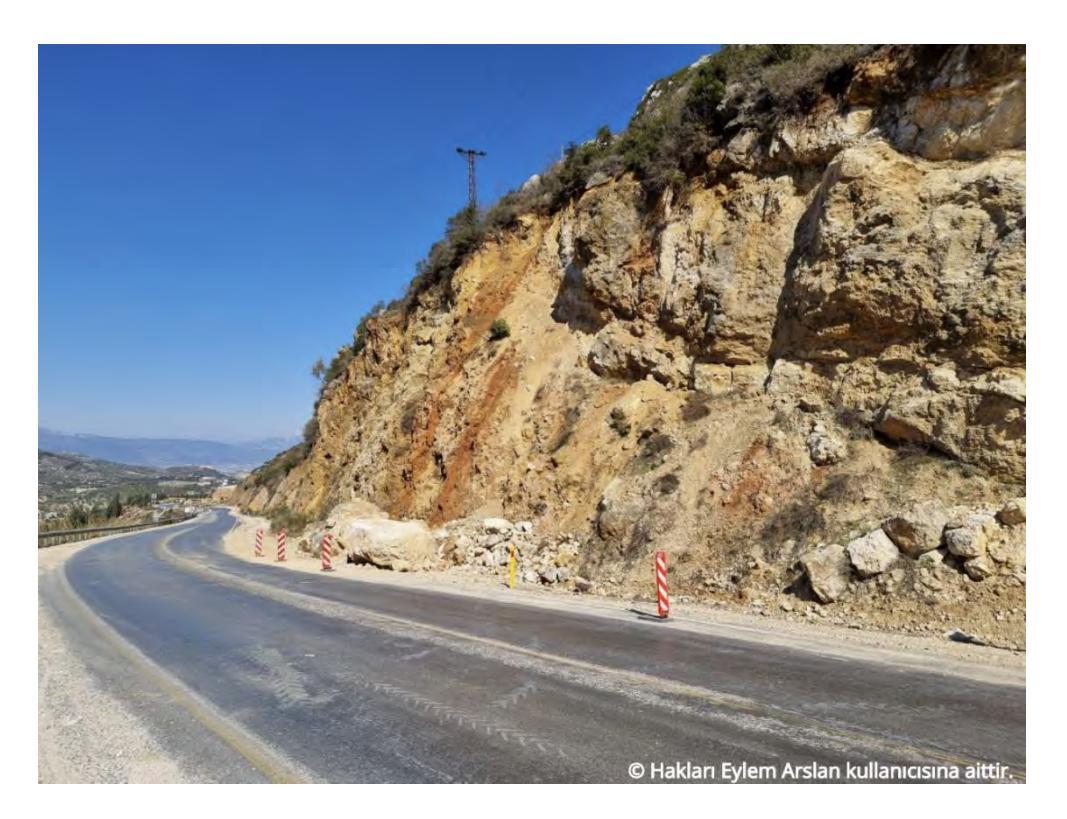
Figure 5.159. Rock falls along Altınözü road (Photo by Eylem Arslan)

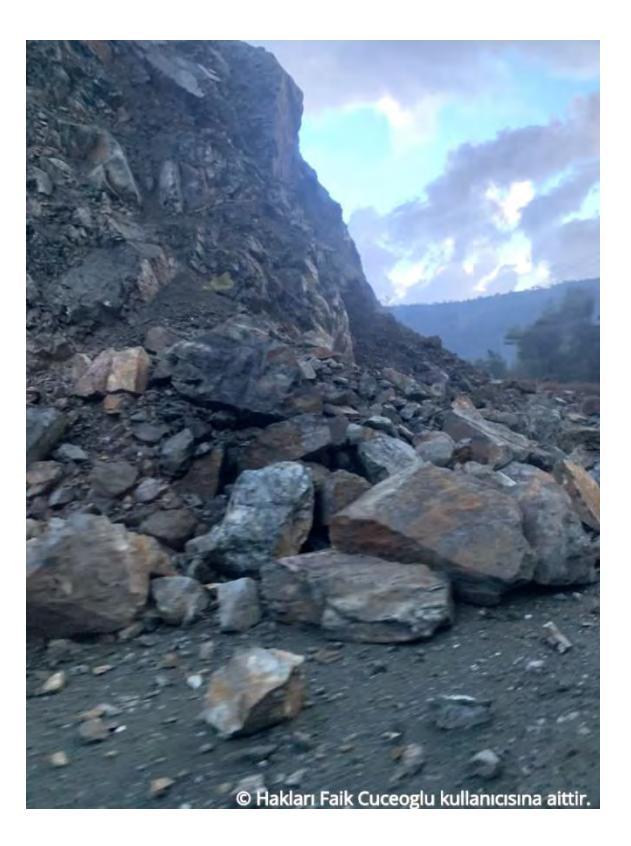
**Figure 5.160.** Rock falls and rockslides along Hatay Büyük Karaçay Dam Skirts, Power Plant transportation road (Photo by Faik Cüceoğlu)

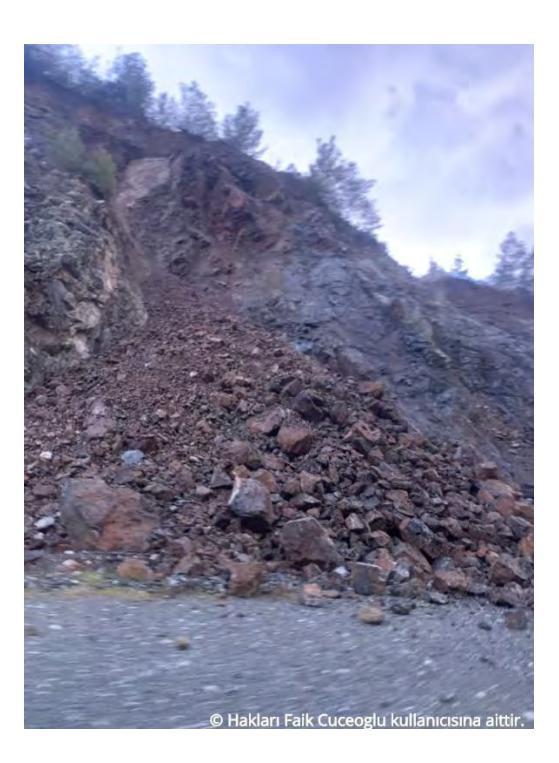
**Figure 5.161.** Rock falls and rockslides along Hatay Büyük Karaçay Dam Skirts, Power Plant transportation road (Photo by Faik Cüceoğlu)

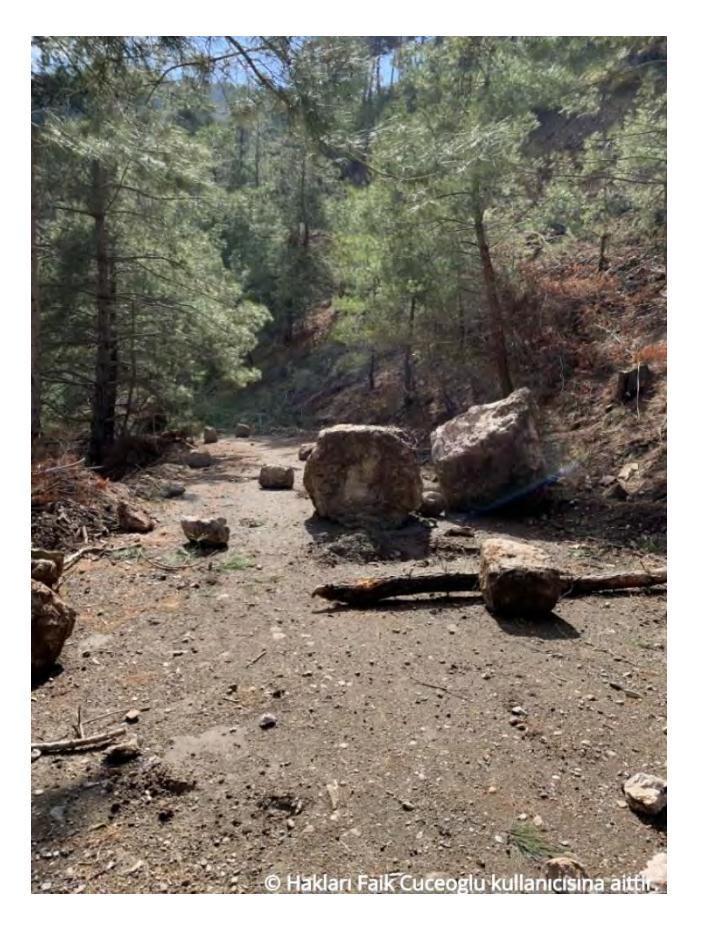
**Figure 5.162.** Rock falls along Osmaniye Kalecik Dam bottom sluice transportation road (taken by Faik Cüceoğlu)

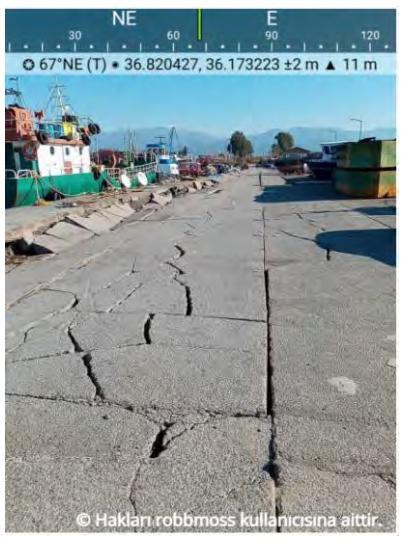
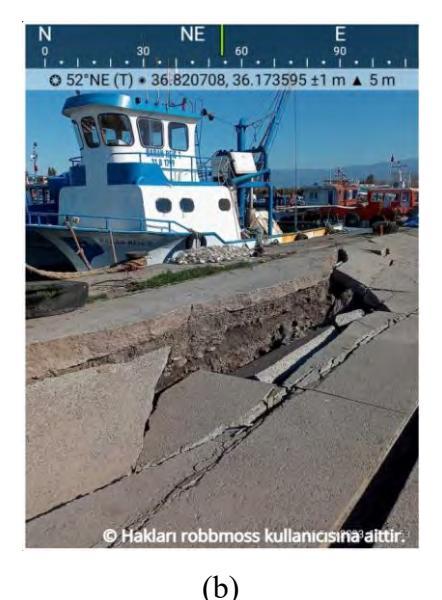
Seismic soil liquefaction-induced surface manifestations in the form of ejecta, lateral spreading, subsidence, and structural damage were accompanied to liquefaction triggering at these sites as displayed in Figure 5.165 to 168. Some of these manifestations were observed at free field sites. In addition to free field sites, liquefaction surface manifestations were also observed in the vicinity of building foundations.

**Figure 5.165.** Seismic soil liquefaction induced ground deformations in Dörtyol / Hatay a) 36.82043,36.17322 b) 36.82071, 36.17359 (photo taken by Dr. Robb Moss).

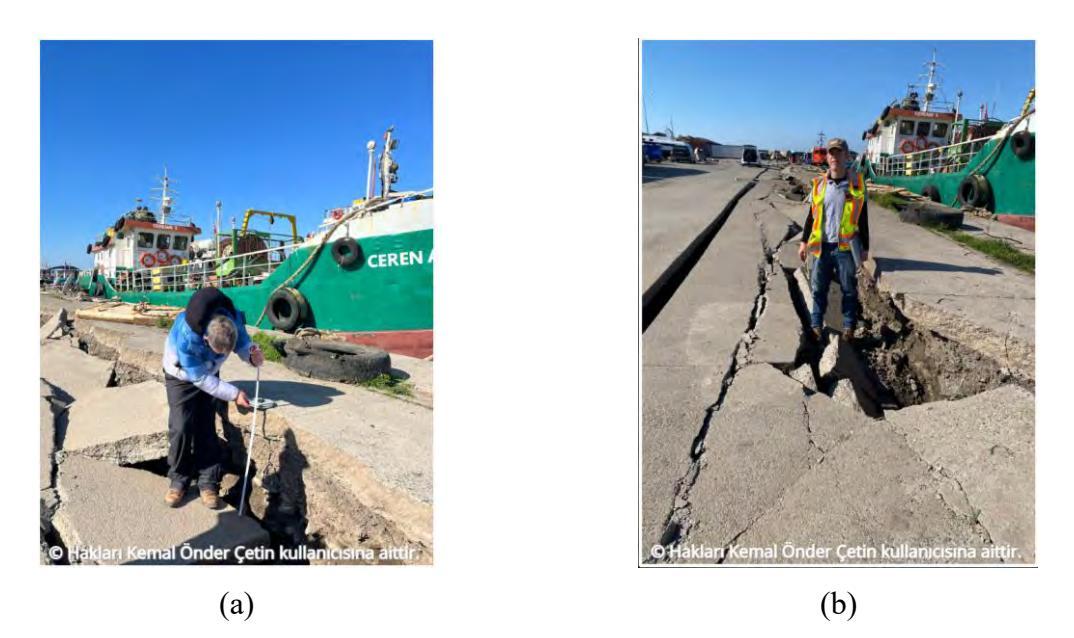
**Figure 5.166.** Seismic soil liquefaction induced lateral spreading in Dörtyol / Hatay a) 36.82067,36.17367, b) 36.82072,36.17372 (photo taken by Dr. Kemal Onder Cetin).

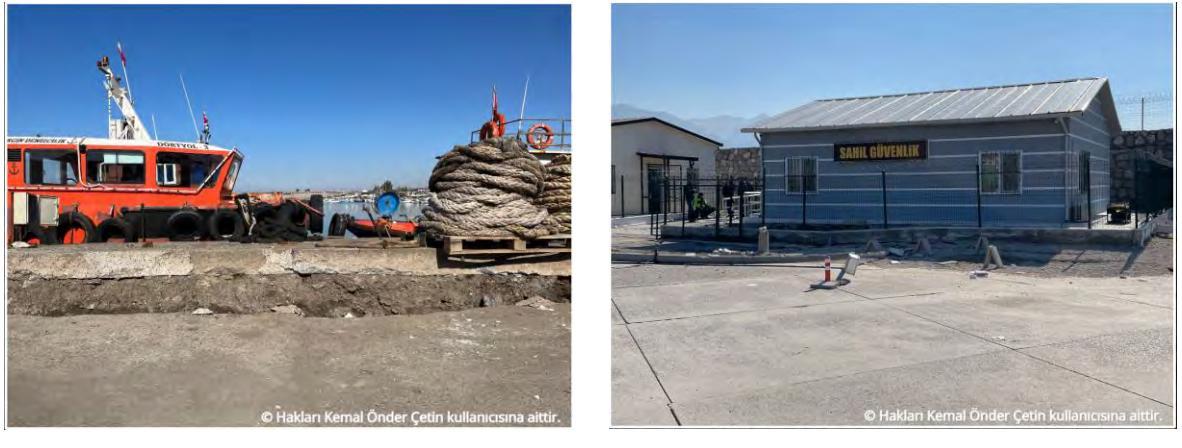
**Figure 5.167.** Seismic soil liquefaction induced settlements in Dörtyol / Hatay a) 36.82085,36.17402, b) 36.82117,36.17458 (photo taken by Dr. Kemal Onder Cetin).

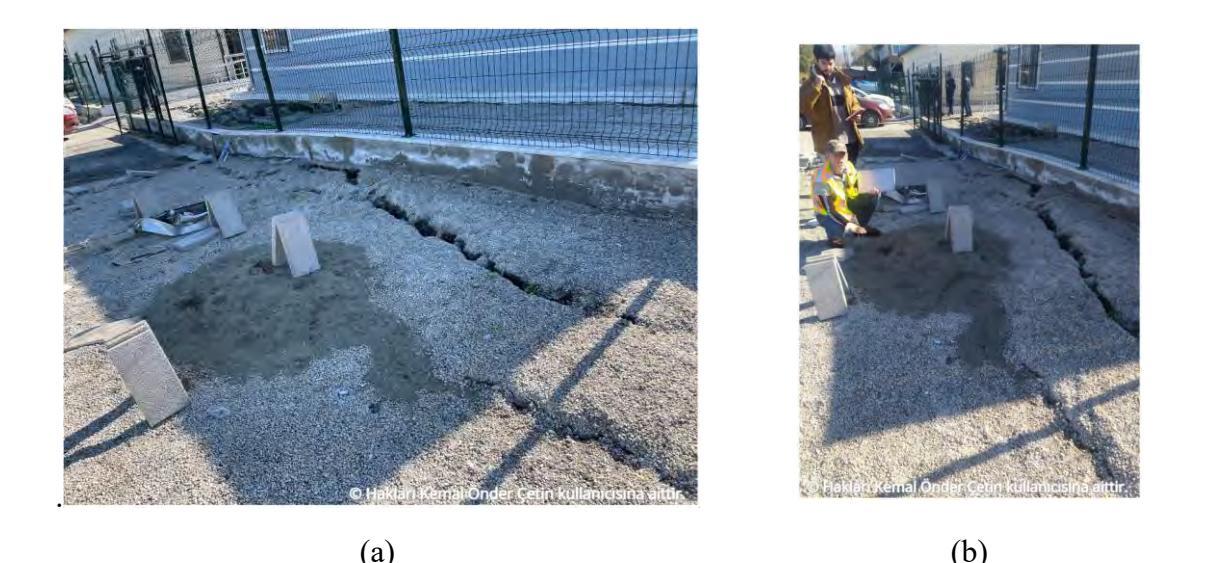
**Figure 5.168.** Seismic soil liquefaction induced surface manifestation in the form of soil ejecta in Dörtyol / Hatay a) 36.82108,36.17467, b) 36.82109,36.17468 (photo taken by Dr. Kemal Onder Cetin).

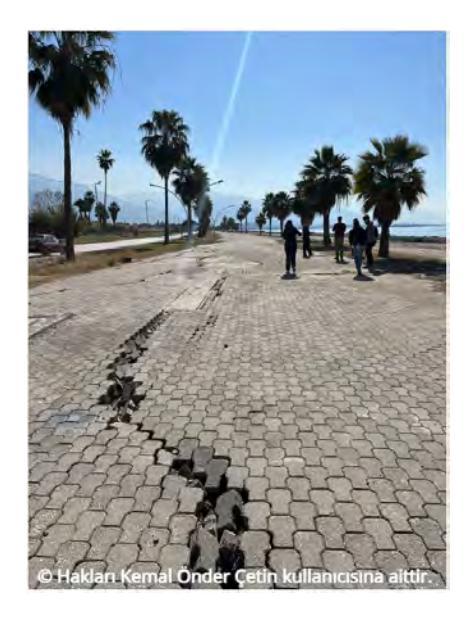
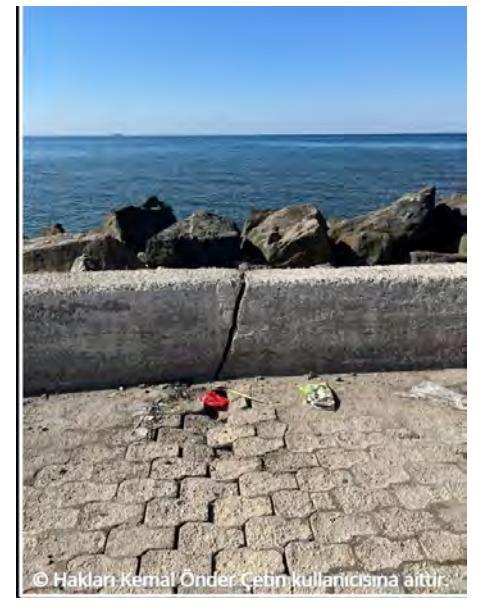
The second stop on the reconnaissance route was the coast of Dörtyol district. Like the municipality beach, several surface manifestations due to seismic soil liquefaction were observed in the form of ejecta, lateral spreading at the sites as displayed in Figure 5.169 and 170. Here the majority of the manifestations were observed at free field sites.

**Figure 5.169.** Seismic soil liquefaction induced surface manifestation in the form of soil ejecta in Dörtyol / Hatay a) 36.81295,36.18141, b) 36.81269,36.18138 (photo taken by Dr. Kemal Onder Cetin).

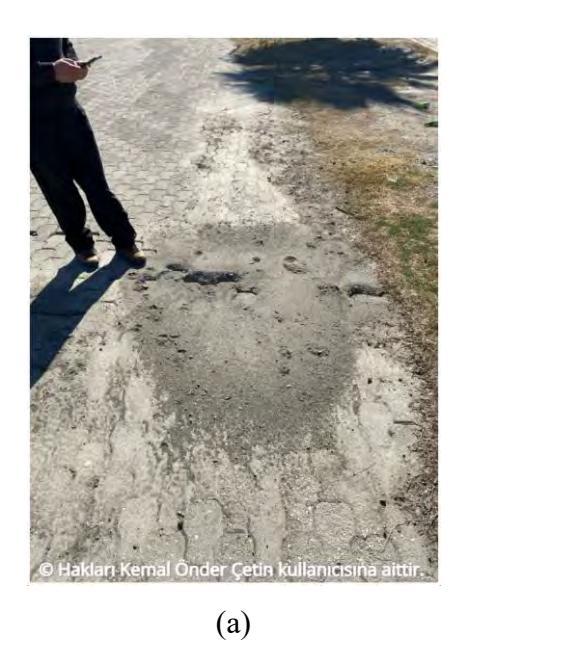
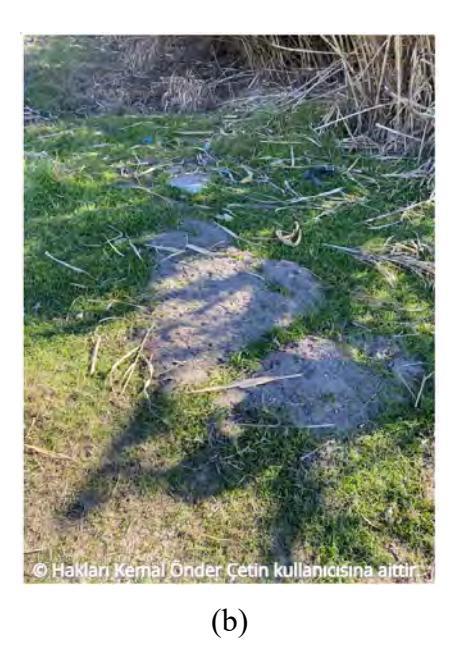
**Figure 5.170.** Seismic soil liquefaction induced surface manifestation in the form of soil ejecta in Dörtyol / Hatay a) 36.81274, 36.18147, b) 36.81283, 36.18182 (photo taken by Dr. Kemal Onder Cetin).

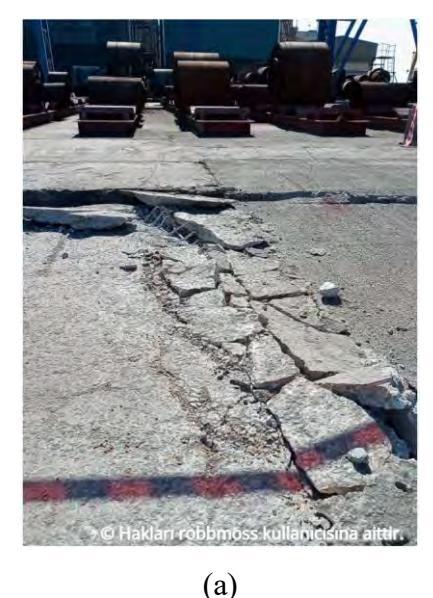
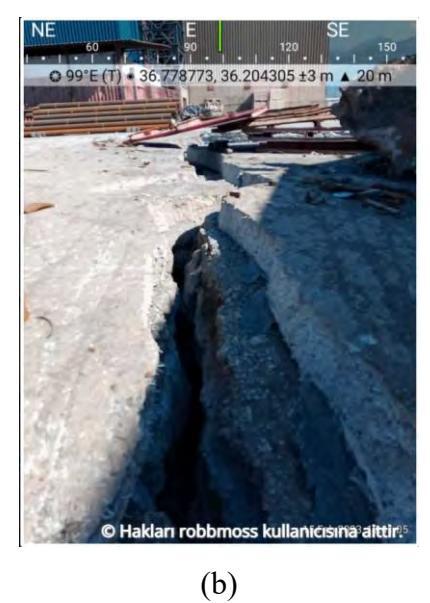
Seismic soil liquefaction-induced surface manifestations in the form of ejecta, lateral spreading, subsidence, and structural damage were accompanied to liquefaction triggering at these sites as displayed in Figure 5.171 to 175. Some of these manifestations were observed at free field sites. In addition to free field sites, liquefaction surface manifestations were also observed in the vicinity of building foundations.

**Figure 5.171.** Seismic soil liquefaction induced ground deformations in Iskenderun Bay a) 36.78337,36.20344 b) 36.77877,36.20430 (photo taken by Dr. Robb Moss).

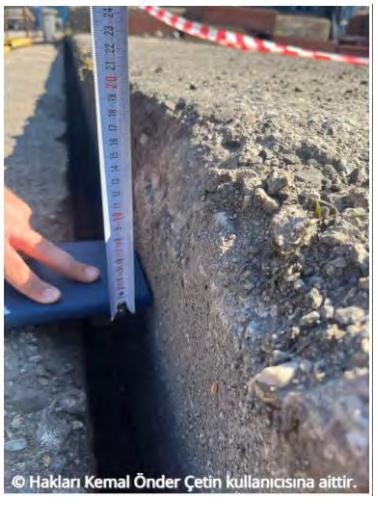
**Figure 5.172.** Seismic soil liquefaction induced lateral spreading in Iskenderun Bay a) 36.78331,36.20211, b) 36.78343,36.20270 (photo taken by Dr. Kemal Onder Cetin).

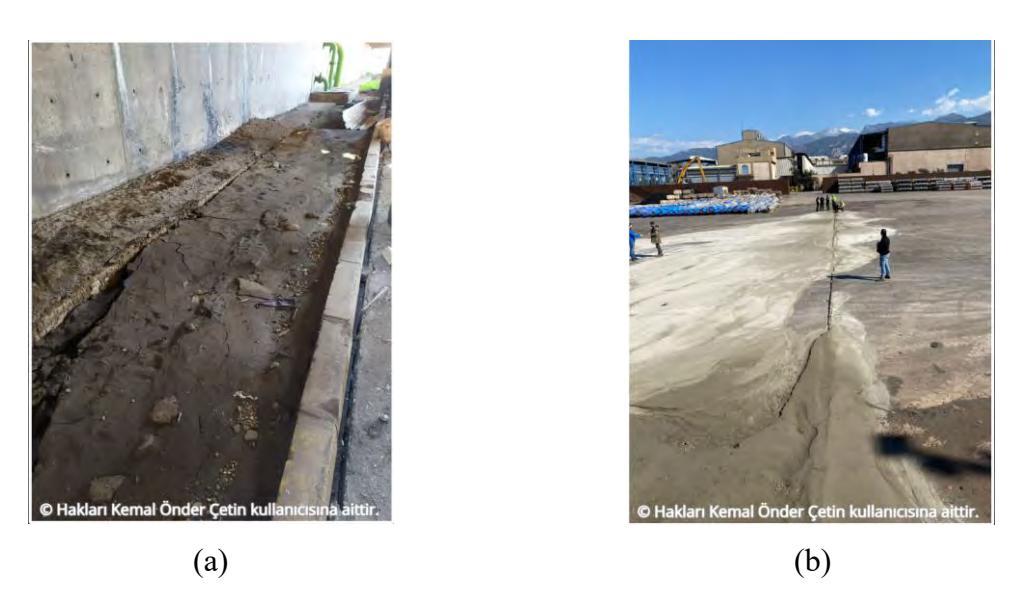
**Figure 5.173.** Seismic soil liquefaction induced settlements in Iskenderun Bay a) 36.78331,36.20379, b) 36.78189,36.20447 (photo taken by Dr. Kemal Onder Cetin).

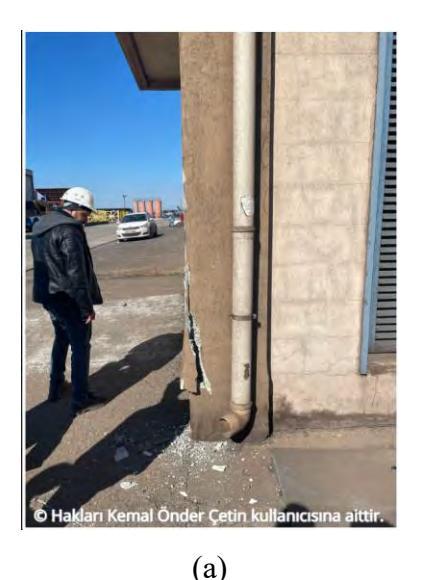
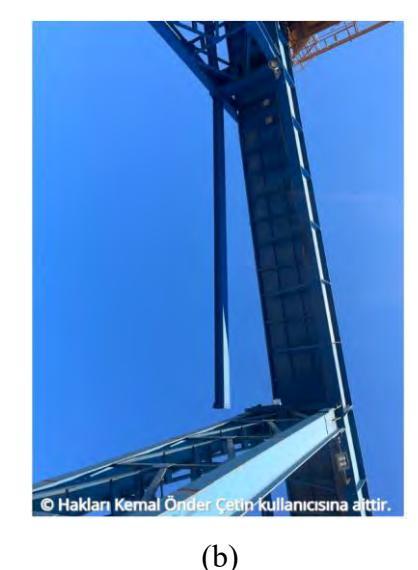
**Figure 5.174.** Seismic soil liquefaction induced surface manifestation in the form of soil ejecta in Iskenderun Bay a) 36.78236,36.20439, b) 36.78209,36.20302 (photo taken by Dr. Kemal Onder Cetin).

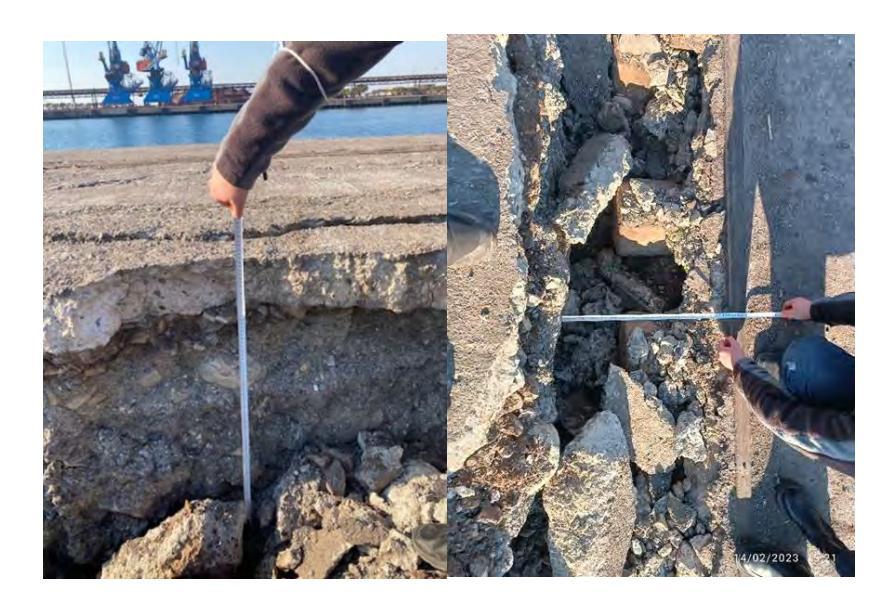
At the İskenderun district, another major port typically handling raw and manufactured industrial products was also visited. The investigated section of the port was mainly constructed in 1974 as a block type gravity quay wall, where significant cracks, vertical and horizontal deformations were observed in concrete blocks. The approximate values for the vertical and lateral deformations are measured as 90 cm and 60 cm respectively as shown in Figure 5.176.

**Figure 5.176.** Vertical and horizontal deformation measurements in a port section (Photo by M. Murat Monkul and Pelin Özener).

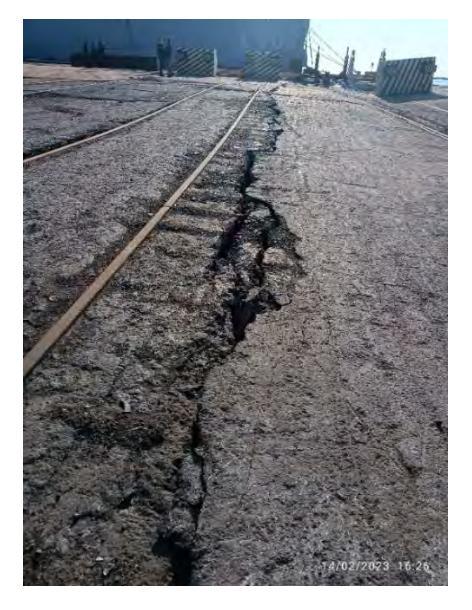
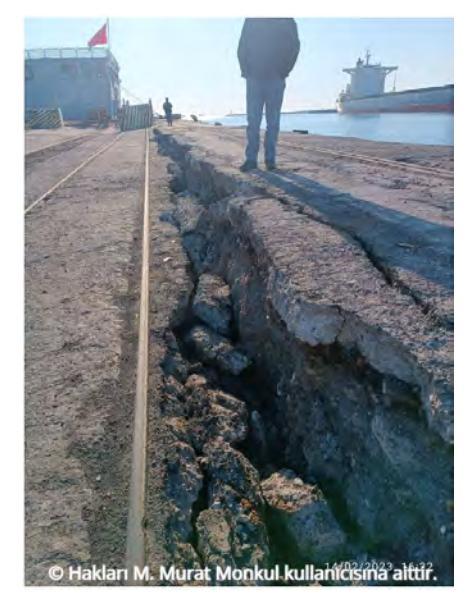
Seismic soil liquefaction-induced surface manifestations in the form of ejecta, lateral spreading, subsidence was accompanied to liquefaction triggering at the site as displayed in Figure 5.177.

**Figure 5.177.** Seismic soil liquefaction induced settlements in Iskenderun Bay 36.72949,36.19893 (photo taken by Dr. Pelin Ozener and Dr. Murat Monkul).

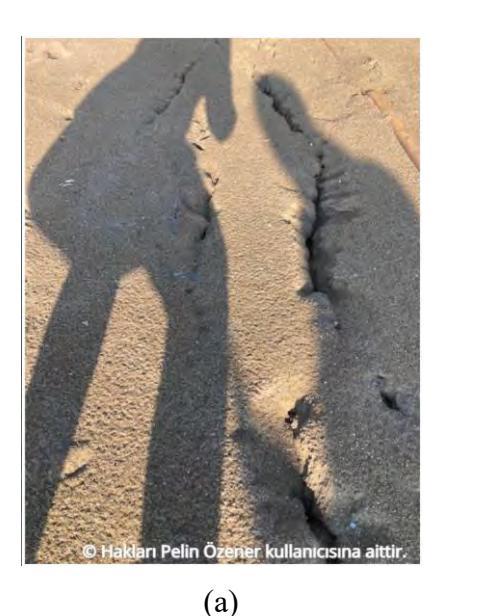
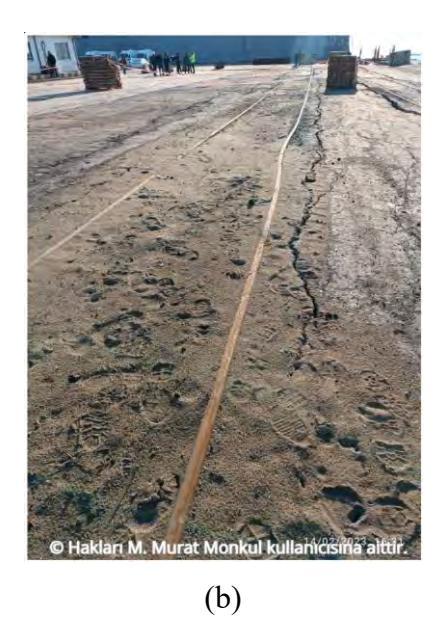
At various locations of the port, sand ejecta was observed on the surface indicating liquefaction of the underlying soils, which could also be considered among the main reasons for the large lateral deformations of the quay walls. A sand ejecta was observed on the surface of the port deck as shown in Figure 5.178.

Figure 5.178. Seismic soil liquefaction induced surface manifestation in Iskenderun Bay a) 36.72998,36.19625, b) 36.72996,36.19689 (photo taken by Dr. Pelin Ozener and Dr. Murat Monkul).

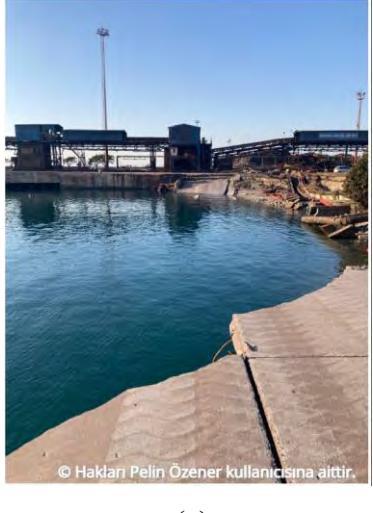
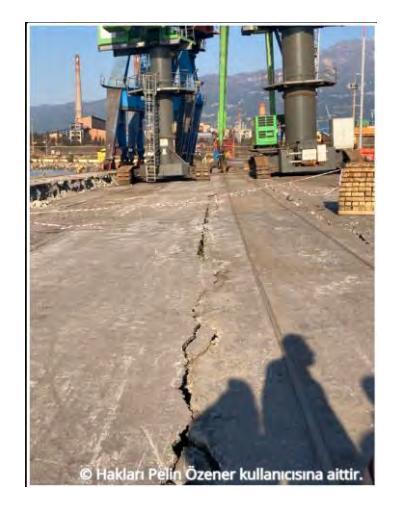
Some sections of the port way, being used by the loading trucks, were collapsed into the sea during the earthquake as shown in Figure 5.179 below. Deformations effecting the quay walls also caused damages in the rails and tilted some of the cranes at the port as shown in Figure 5.180.

**Figure 5.179.** a) Collapsed port way during the earthquake, where tire tracks of the loading trucks are 36.73208,36.19735, b) Significant deformations tilted crane 36.72059,36.20166 (photo taken by photo taken by Dr. Pelin Ozener and Dr. Murat Monkul)

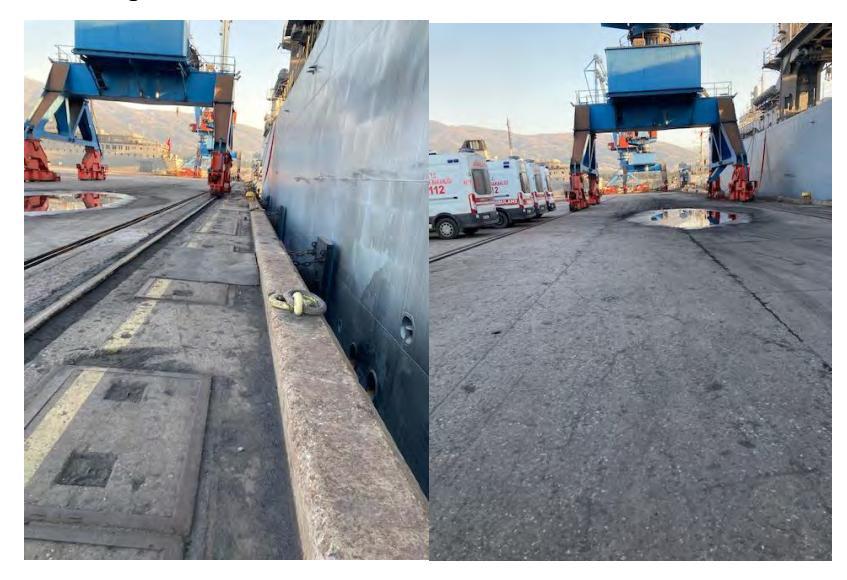
In 2006, a modernization study was conducted, and some sections of the port was extended on steel pipe piles. It was observed that the extended port section supported by piles performed quite well during the earthquakes. As shown in Figure 5.180 no damage was observed on the extended section of the port.

**Figure 5.180.** Extended section of the port on steel pipe piles performed well during the earthquake (Photo by M. Murat Monkul and Pelin Özener).

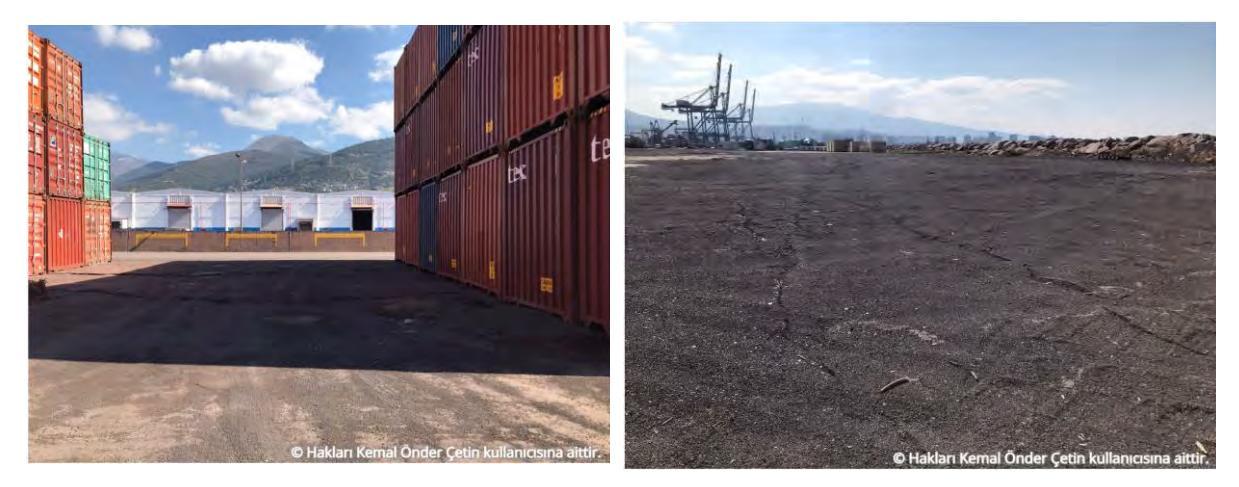
**Figure 5.181.** Seismic soil liquefaction induced lateral spreading in Iskenderun Zones of Ports / Hatay a) 36.60558,36.19426, b) 36.60356,36.19233 (photo taken by Dr. Kemal Onder Cetin).

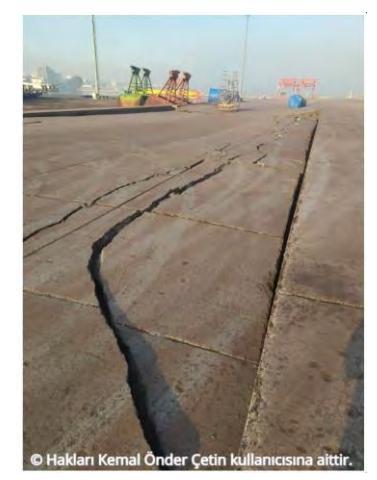
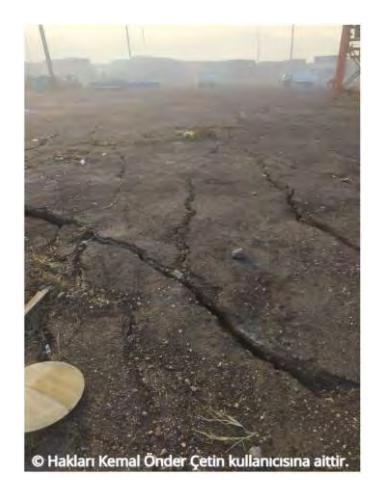
**Figure 5.183.** Seismic soil liquefaction induced lateral spreading in Iskenderun Customs / Hatay a) 36.59361,36.18735, b) 36.59389,36.18539 (photo taken by Dr. Kemal Onder Cetin).

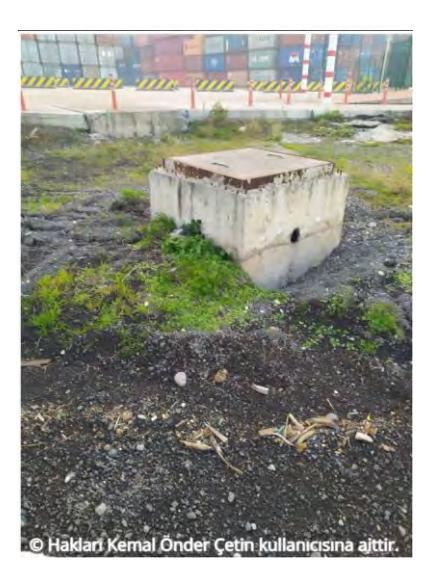
**Figure 5.184.** Settlement due to seismic soil liquefaction in Iskenderun Customs / Hatay 36.59284,36.18582 (photo taken by Dr. Kemal Onder Cetin).

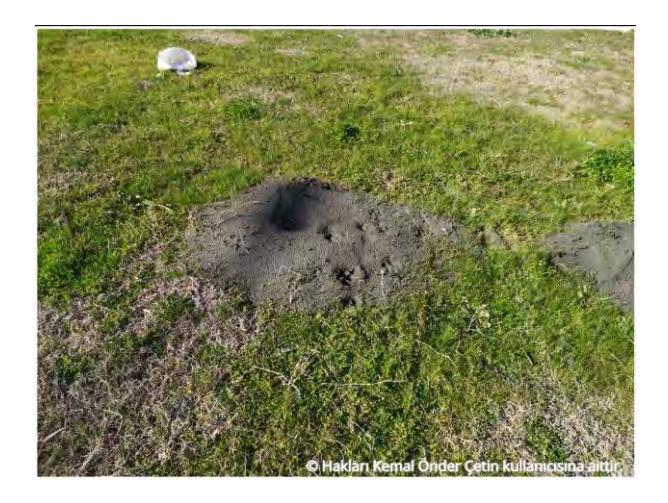
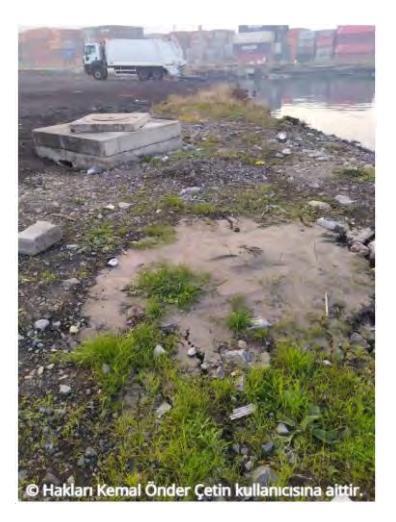
**Figure 5.185.** Seismic soil liquefaction induced surface manifestation in the form of soil in Iskenderun Customs Region / Hatay a) 36.59198,36.18390, b) 36.59313,36.18532 (photo taken by Dr. Kemal Onder Cetin).

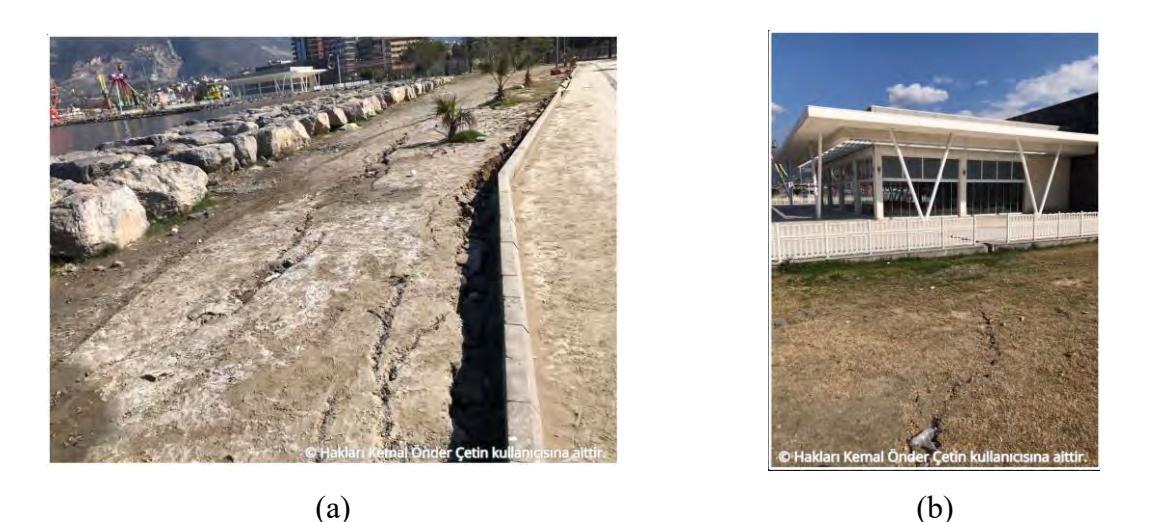
**Figure 5.186.** Seismic soil liquefaction induced lateral spreading in Iskenderun Fishery Port / Hatay a) 36.59218,36.17319, b) 36.59159,36.17426(photo taken by Dr. Kemal Onder Cetin).

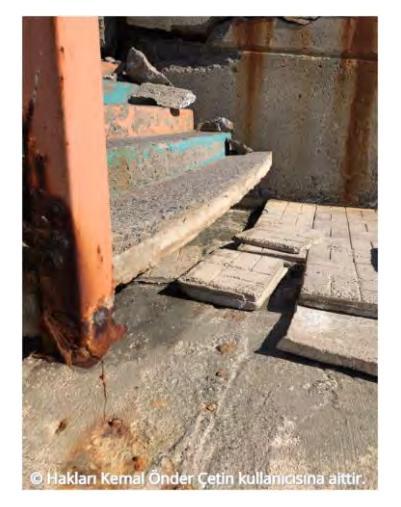
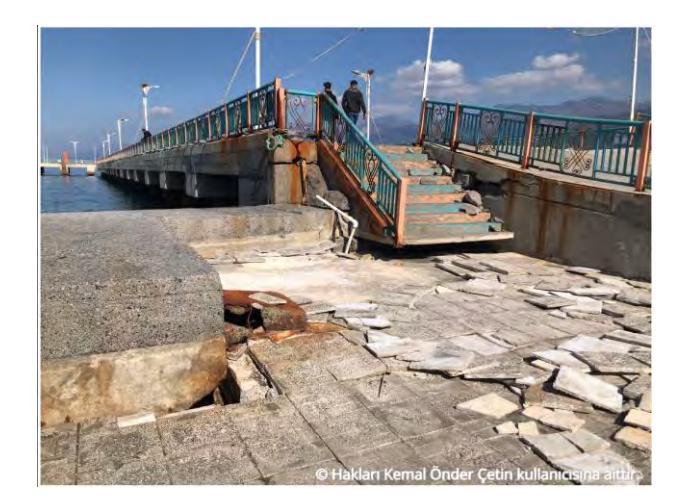
**Figure 5.187.** Settlement due to Seismic soil liquefaction in Iskenderun Fishery Port / Hatay a) 36.59274,36.17267, b) 36.5927,36.17263 (photo taken by Dr. Kemal Onder Cetin).

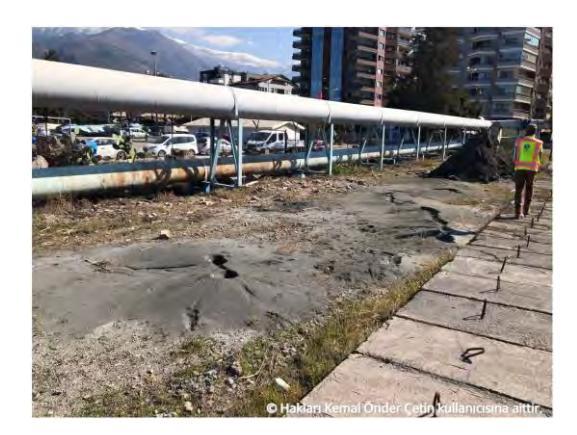
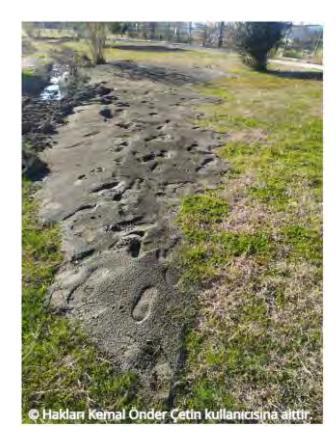
**Figure 5.188.** Seismic soil liquefaction induced surface manifestation in the form of soil ejecta in Dörtyol / Hatay a) 36.5914,36.175675, b) 36.59134,36.17894 (photo taken by Dr. Kemal Onder Cetin).

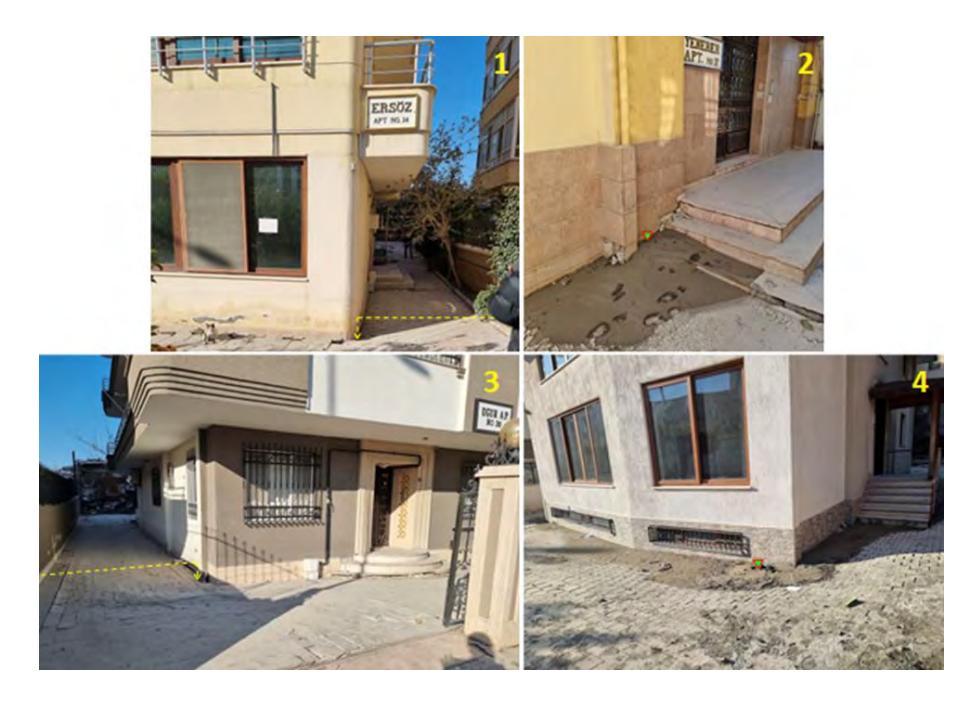
Figure 5.191. Structural deformations because of soil liquefaction (captioned by Ertan Bol, 1: Ersöz Apt.: B+6S, Lat: 36.590118 - Long: 36.177205; 2: Yenerer Apt.: B+5S, Lat: 36.59011 - Long: 36.17739; 3: Uğur Apt.: B+5S, Lat: 36.590119 - Long: 36.177459; 4: East neighbour building of Ugur Apt. B+5S, Lat: 36.590137 - Long: 36.177771)

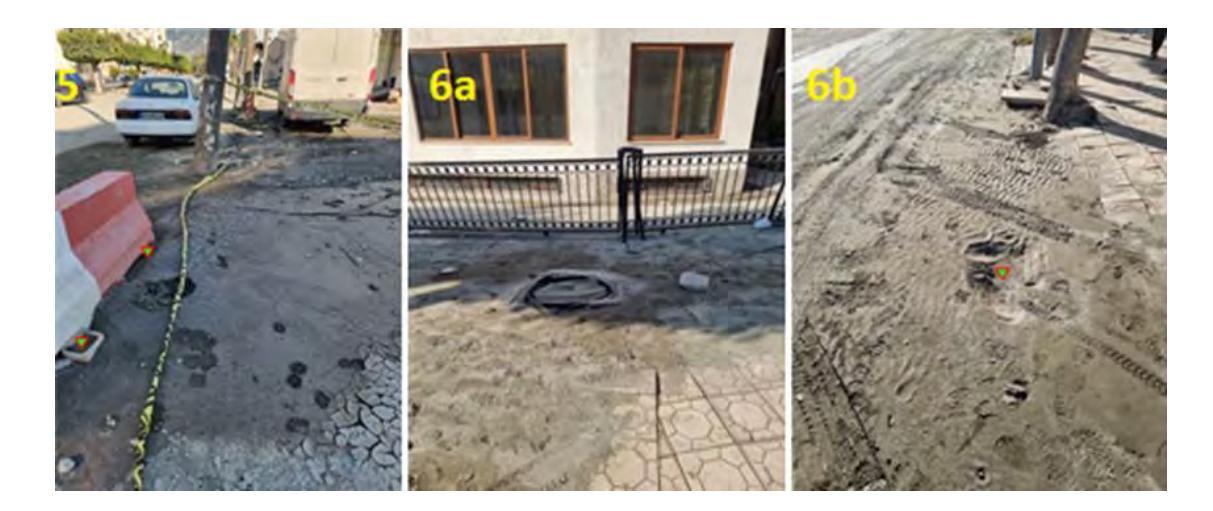
**Figure 5.192.** Sand boils on Bahçeli Sahil Evler Street (captioned by Ertan Bol, 5: Lat: 36.589992 - Long: 36.177186; 6a and b: Lat: 36.590044 - Long: 36.177747)

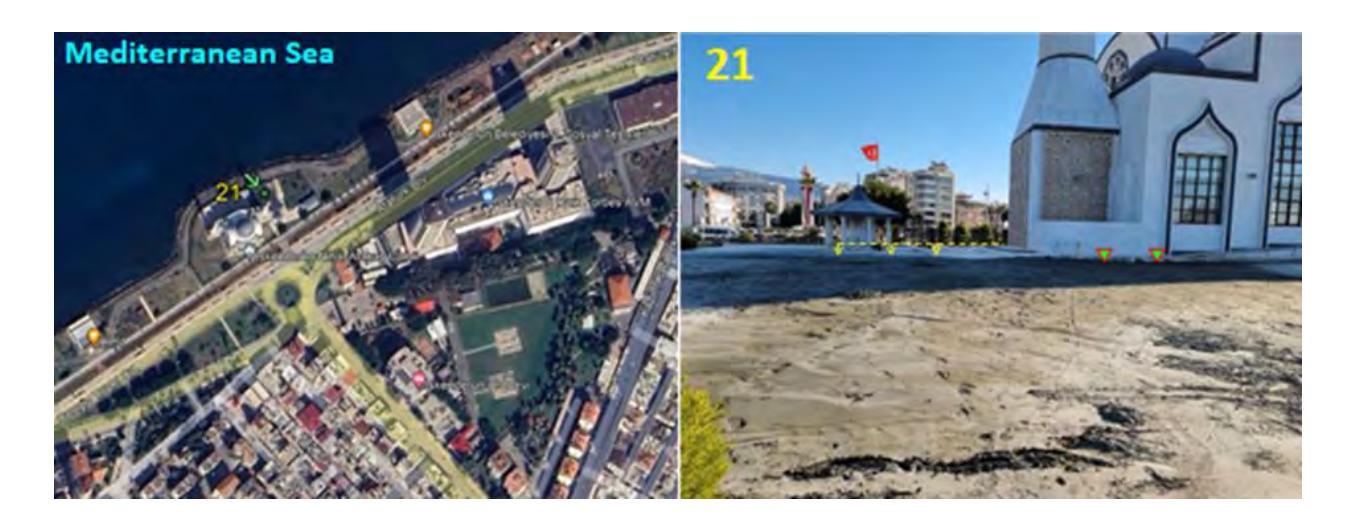
Figure 5.195 shows the satellite photo and the locations of the field studies carried out in the Nihal Atakaş Mosque. Pic. 21 shows the settlement of the ground around the mosque seen in the garden and the exit points of the liquefied sands. This site was determined by the research group as the westernmost point on the Iskenderun coast where liquefaction was observed in the field.

**Figure 5.195.** Iskenderun Beach, Pirireis District, Ataturk Boulevard, Nihal Akkaş Mosque (captioned by Ertan Bol, 21: 36.593336 - 36.157473)

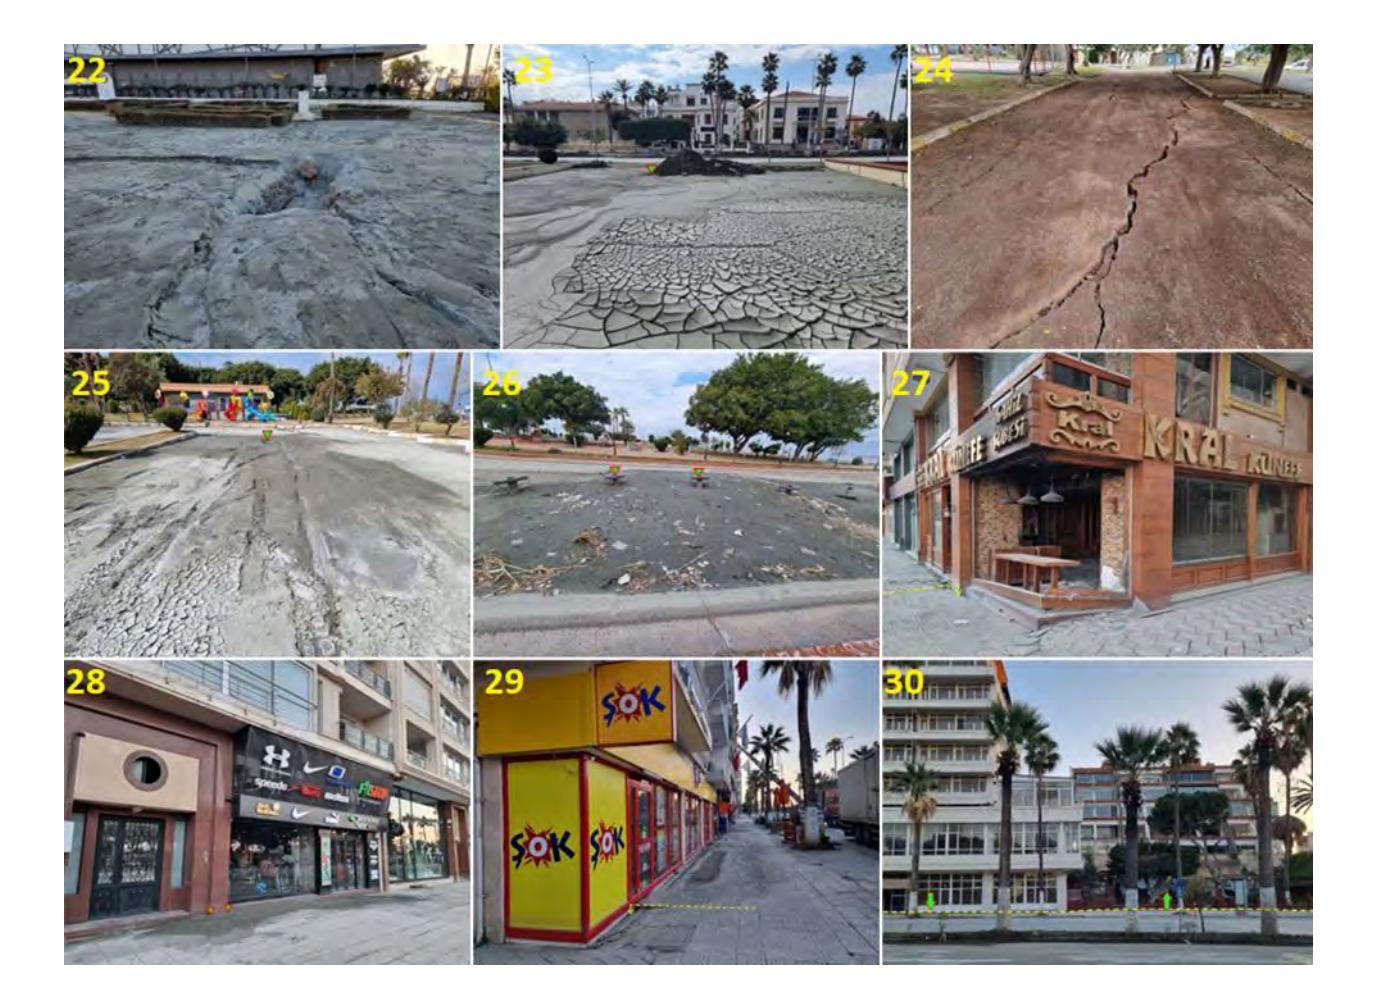
In Figure 5.196, the eastern border of the Nihal Atakaş Mosque, that is, the coastline covering the west of the research area and the photo directions are shown. In this region, signs of widespread liquefaction were observed both at the surroundings of the buildings and in the free field. (Fugure 5.197)

**Figure 5.197.** Sand ejecta points of the liquefied area in the coastal park on west part of the Atatürk Boulevard, Iskenderun, Hatay (captioned by Ertan Bol, 22: 36.593954 - 35.161100; 23: 36.59445 - 36.164121; 24: 36.595002 - 36.162275; 25: 36.59445 - 36.164121; 26: 36.593447- 36.166074; 27: 36.593007 - 36.166749; 28: 36.592703 - 36.167629; 29: 36.593031 - 36.166686; 30: 36.592281- 36.169286)
