# Türkiye Earthquake

## **RECONNAISSANCE REPORT**

February 6, 2023 Kahramanmaraş-Pazarcık ( $M_w$ =7.7) and

Elbistan (M<sub>w</sub>=7.6) Earthquakes

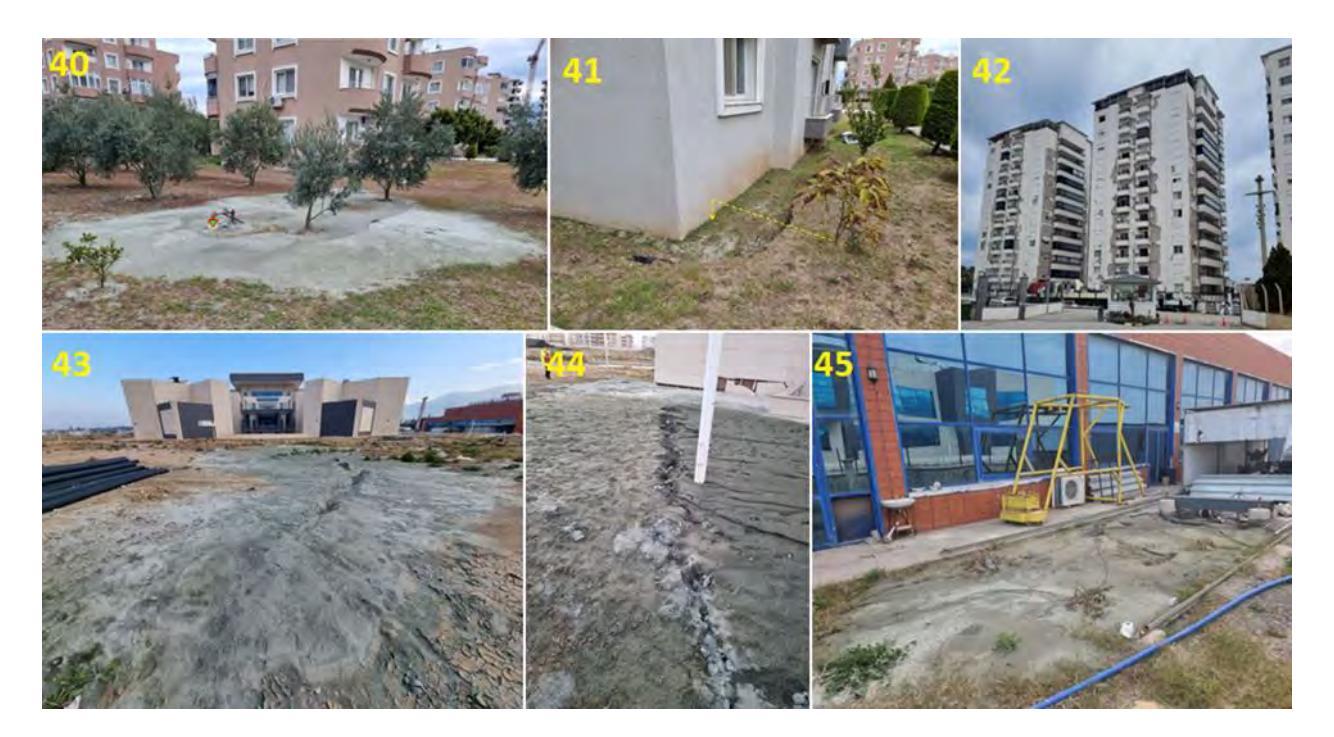
Figure 5.201 shows the determined liquefaction areas in Arsuz district, just south of Iskenderun. In this section, Defne Blocks, Elif Site and Güney Deniz Site were investigated in detail (Figure 5.202). In these blocks, which are adjacent to each other, the sand deposits coming out of the water well in the Güney Deniz Site are shown in the Figure 5.203-Pic. 40. While there was no damage in the Güney Deniz Site blocks, the settlements in some buildings in the Elif Site reached 40 cm (Figure 5.203, Pic. 40 and 41). These settlements were generally uniform. In the same region, settlement or any soil problem were not observed in even higher buildings (Defne Blocks) where pile foundation system was applied, but heavy damage was observed in the structural elements of these structures. It should be emphasized that soil engineering was good, but superstructure engineering was found to be weak in the Defne Blocks (Figure 5.203, Pic. 42). Additionally, excessive sand outflows were also observed in

front of the Iskenderun Technical University Library building and in the south-west corner in same region (Figure 5.203, Pic. 43, 44 and 45).

**Figure 5.203.** Sand ejecta points of the liquefied area in Arsuz, Hatay (captioned by Ertan Bol, 40: 36.577111 - 36.142776; 41: 36.577082 - 36.142006; 42: 36.577424 - 36.142169; 43: 36.577082 - 36.151119; 44: 36.577453 - 36.151857; 45: 36.577758 - 36.152203)

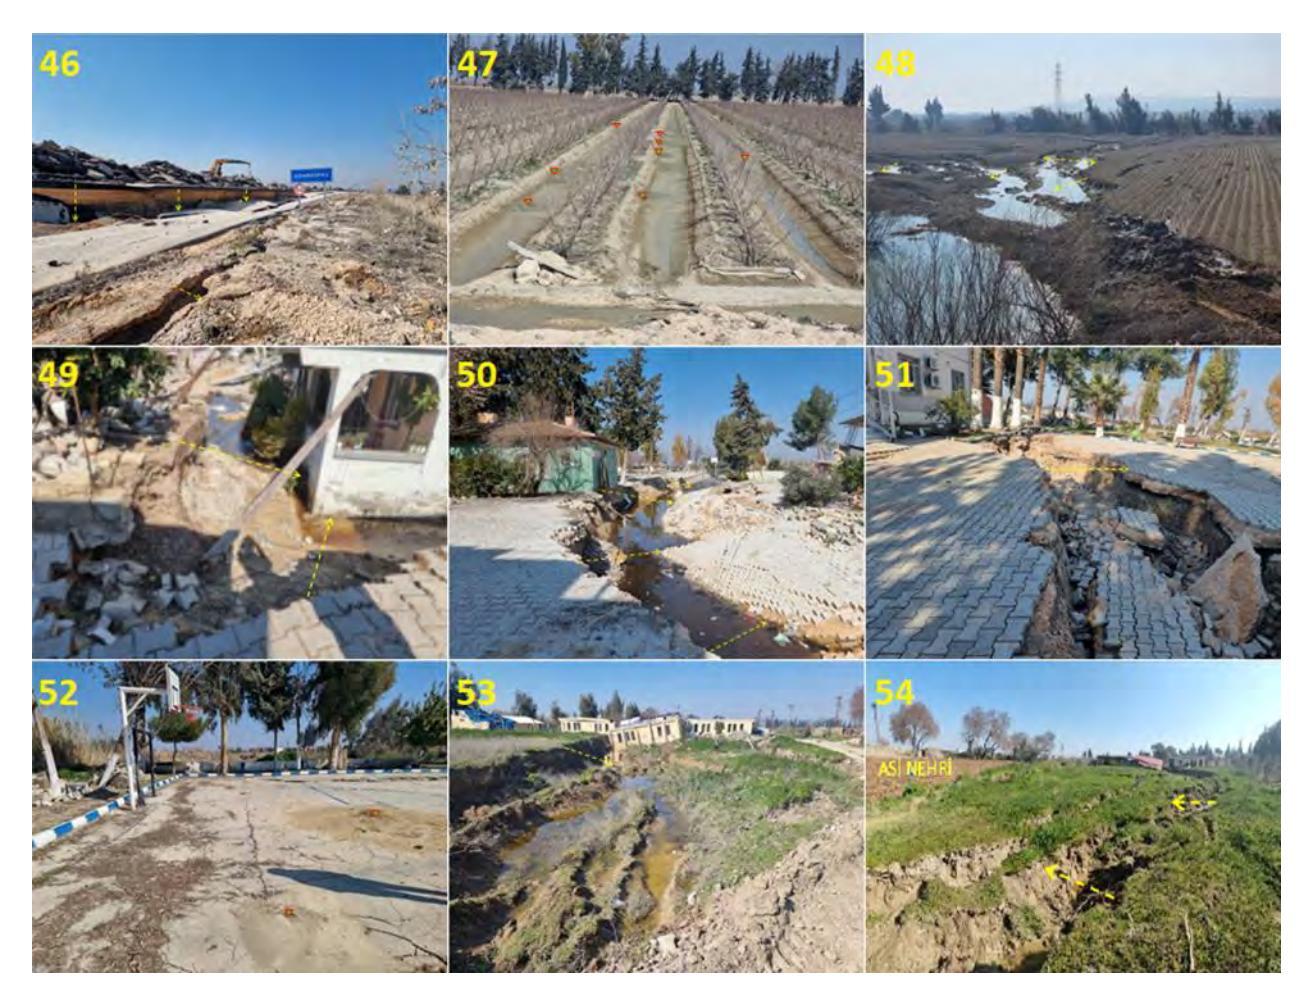
Demirköprü village is located on the Amik basin and near the Asi River (Figure 5.204). Both lateral and vertical deformations of up to 2 m were observed as a result of collapse in the road embankments (Figure 5.205, Pic. 46 and 47). In this region lateral spreading up to 7-8 meters towards the Asi River has been observed (Figure 5.205, Pic. 48-54). The shifted structures were submerged obliquely towards the soil. Village residents declared that during the earthquake, water erupted several meters high.

**Figure 5.205.** Lateral spreading sites of Demirköprü Village, Antakya, Hatay (captioned by Ertan Bol, 46: 36.245483 - 36.362605; 47: 36.245843 - 36.362492; 48: 36.248304 - 36.354500; 49: 36.249344 - 36.353289; 50: 36.249726 - 36.353004; 51: 36.249892 - 36.352822; 52: 36.250295 - 36.352775; 53: 36.250735 - 36.352309; 54: 36.251264 - 36.351299)

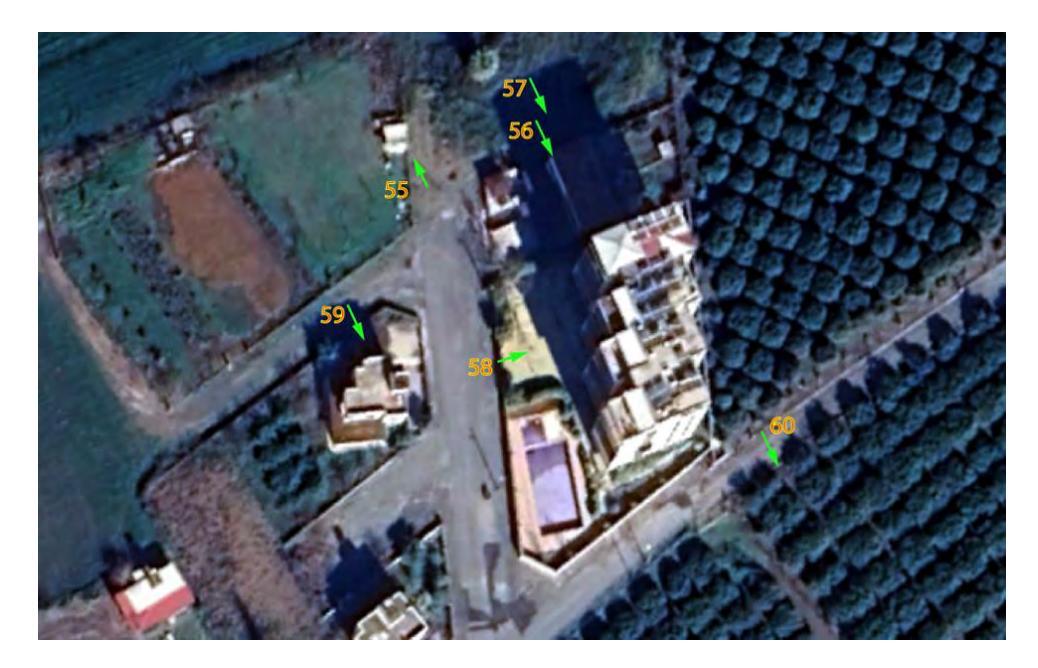
A linear deformation was detected in Dörtyol, 300 meters from the beach and 900 meters in length parallel to the seacoast. As a result of lateral spreading, this part has moved slightly towards the sea. Figure 5.206 shows the northern end of the lineament. In the Hatay Dörtyol region, horizontal and vertical deformations up to 80 cm occurred as a result of liquefaction and lateral spreading. Sand boils and surface fractures were observed even in the field, and excessive deformations were observed in the structures on the linearity (Figure 5.207, Pic. 55-60).

Figure 5.206. Lateral Spreading sites Dörtyol, Hatay (North Part)

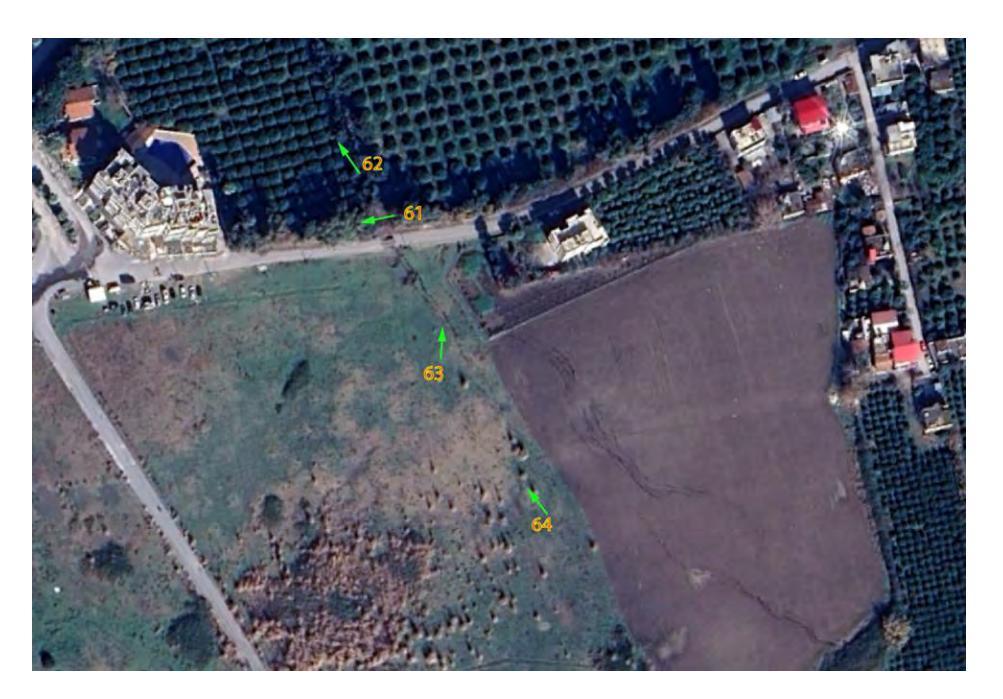
Figure 5.208 shows the south end section of linearity observed in the field. In this region, there are again both sand ejecta and a clear fracture line in the field (Figure 5.209, Pic. 61-64).

Figure 5.208. Lateral spreading sites Dörtyol, Hatay (South Part)

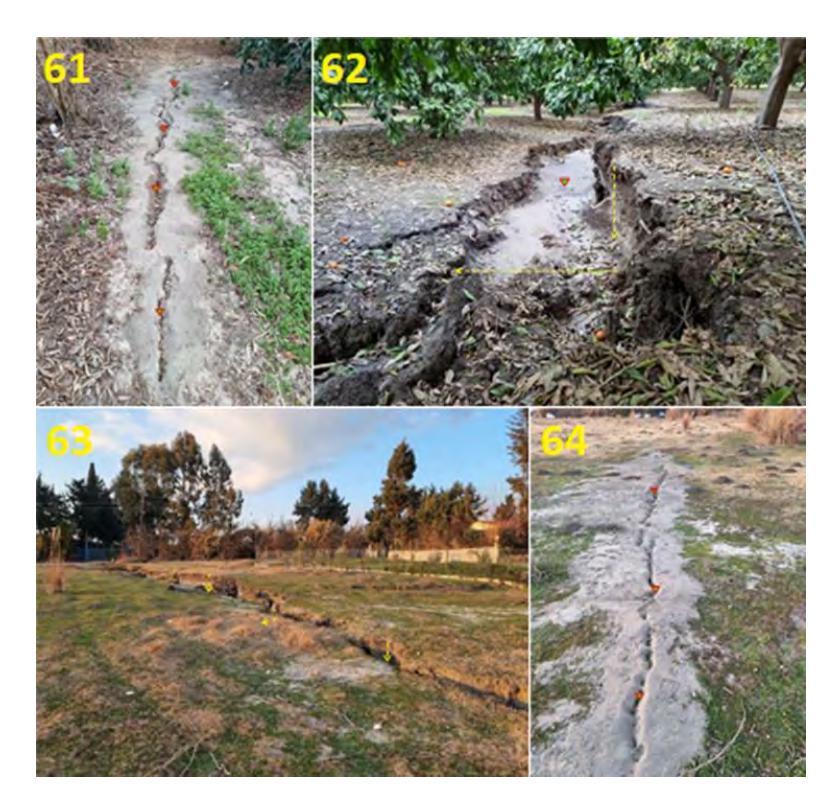
**Figure 5.209.** Lateral spreading sites of Dörtyol, Hatay (South Part) (captioned by Ertan Bol, 61: 36.817179 - 36.182109; 62: 36.817450 - 36.182037; 63: 36.816813 - 36.182482; 64: 36.816198 - 36.182913)
## **Hatay Airport**

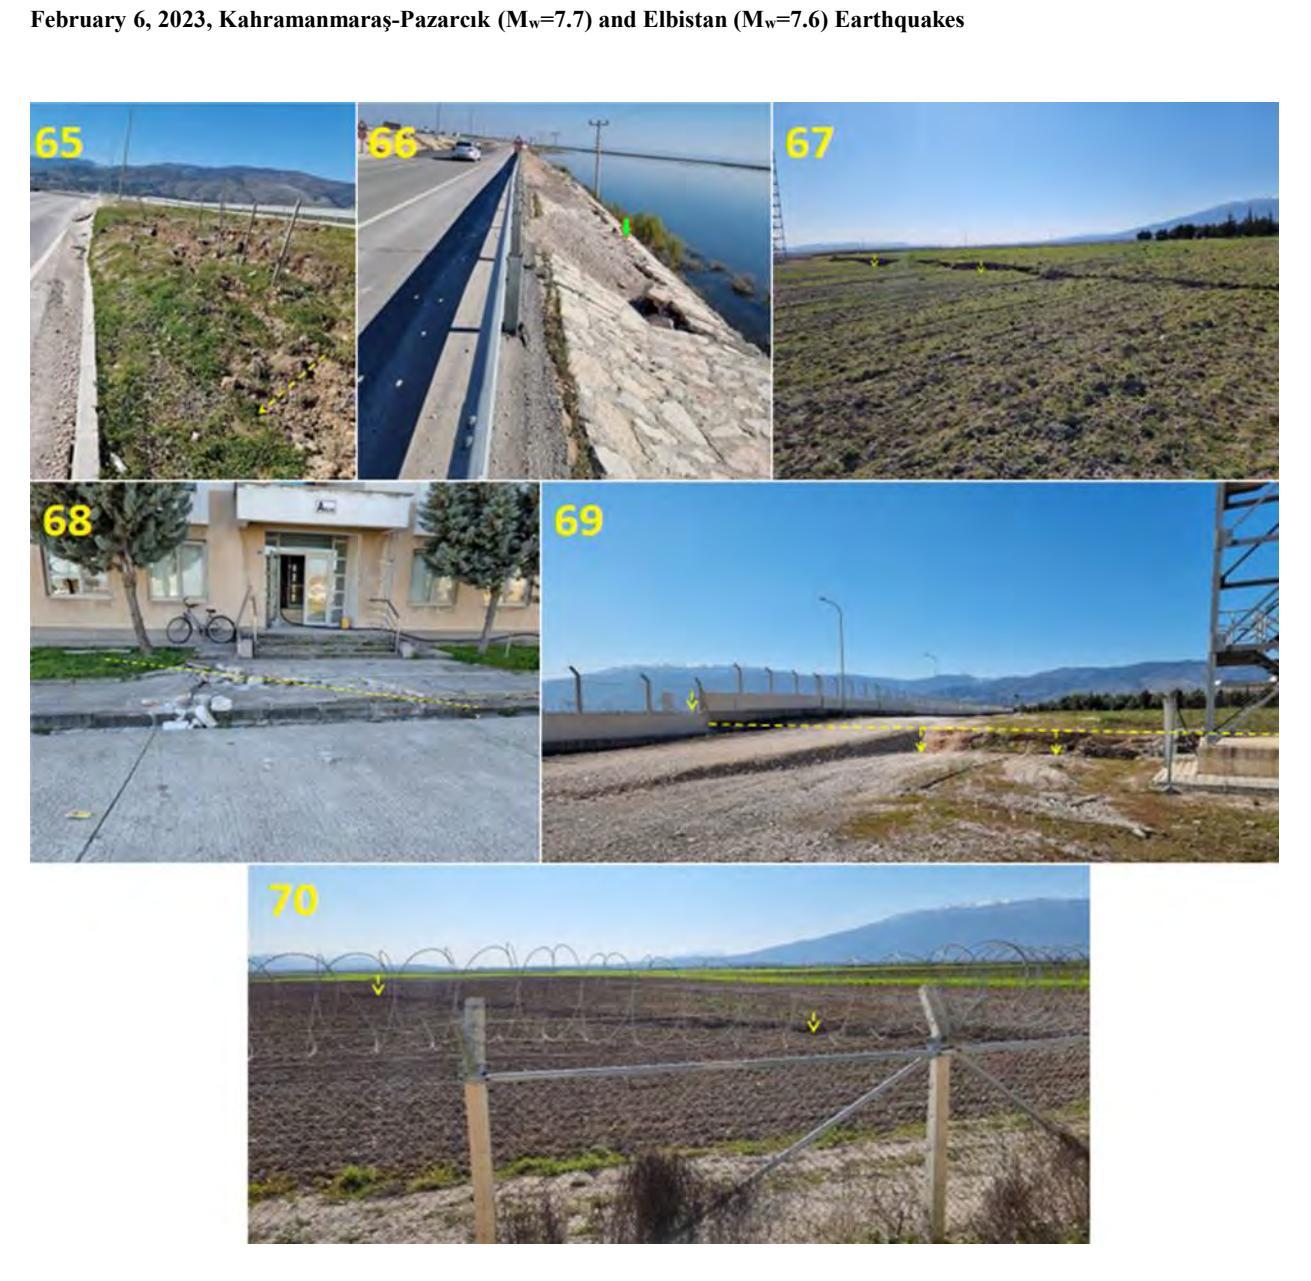
In the Hatay Airport region (Figure 5.210), horizontal and vertical deformations have occurred on the airport connection road and the retaining wall. It has been determined that the road has become undulated due to the earthquakes. The vertical deformations occurred in the southern extension of the fracture line that locates in the southern part of the terminal entrance of the airport have reached approximately 70 cm. It is thought that this phenomenon is lateral spreading because of sand boilings were detected on the airport connection road (Figure 5.211, Pic. 65-70 and Figure 5.212).

**Figure 5.211.** Lateral spreading sites of Dörtyol, Hatay (South Part) (captioned by Ertan Bol, 65: 36.367796 - 36.261389; 66: 36.367698 - 36.261591; 67: 36.363901 - 36.277886; 68: 36.363901 - 36.277886; 69: 36.363037 - 36.277857; 70: 36.362907 - 36.277540)

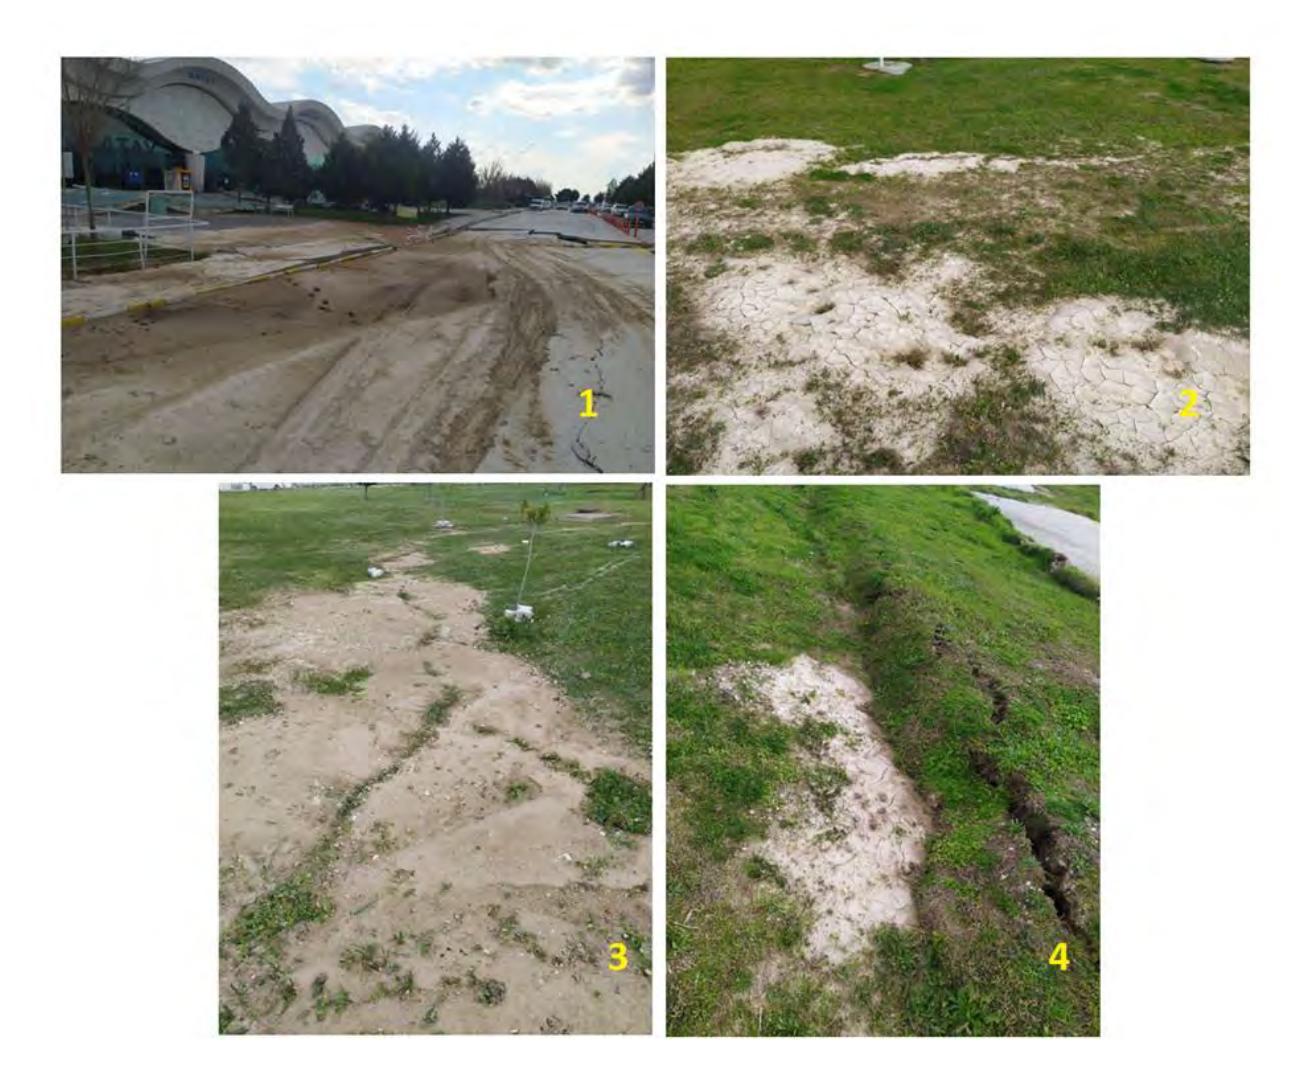
**Figure 5.212.** Hatay Airport and sand ejecta (captioned by Kemal Önder Çetin 1: 36.3646°N, 36.281492°E; 2: 36.362518°N, 36.280952972°E; 3: 36.364491972°N, 36.281483°E; 4: 36.362479°N, 36.281070972°E)

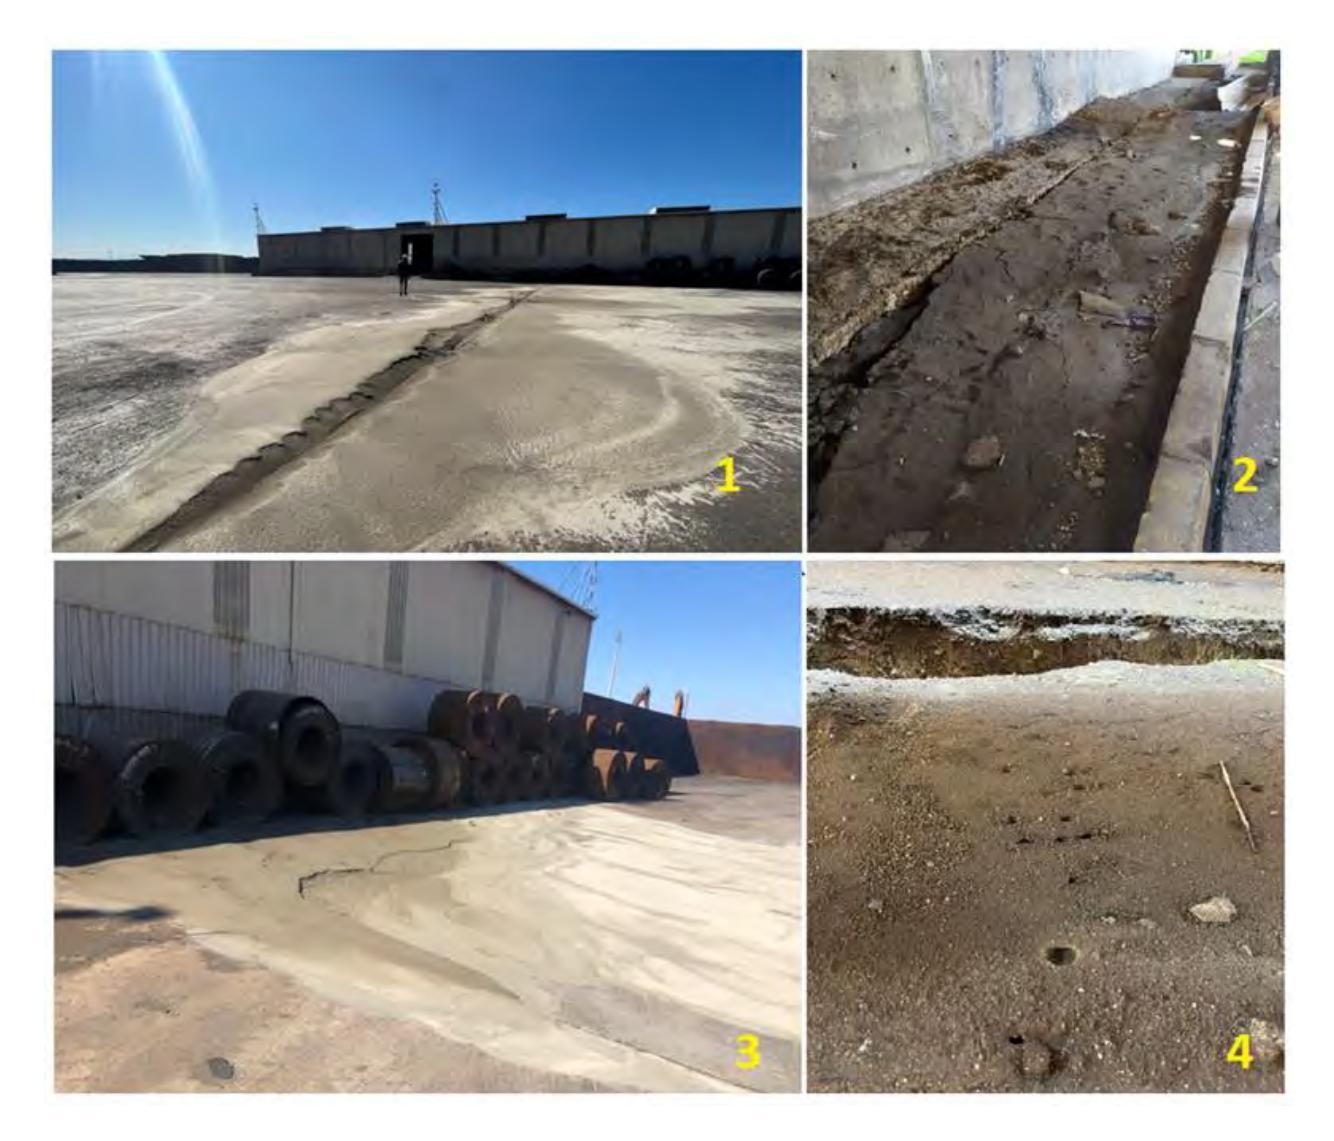
**Figure 5.213.** Liquefaction induced sand ejecta in Payas, near Hatay-Dörtyol district (captioned by Kemal Önder Çetin 1: 36.7819583°N, 36.20253°E; 2: 36.782358°N, 36.204391972°E; 3: 36.78184167°N, 36.20233056°E; 4: 36.782199°N, 36.20472°E)

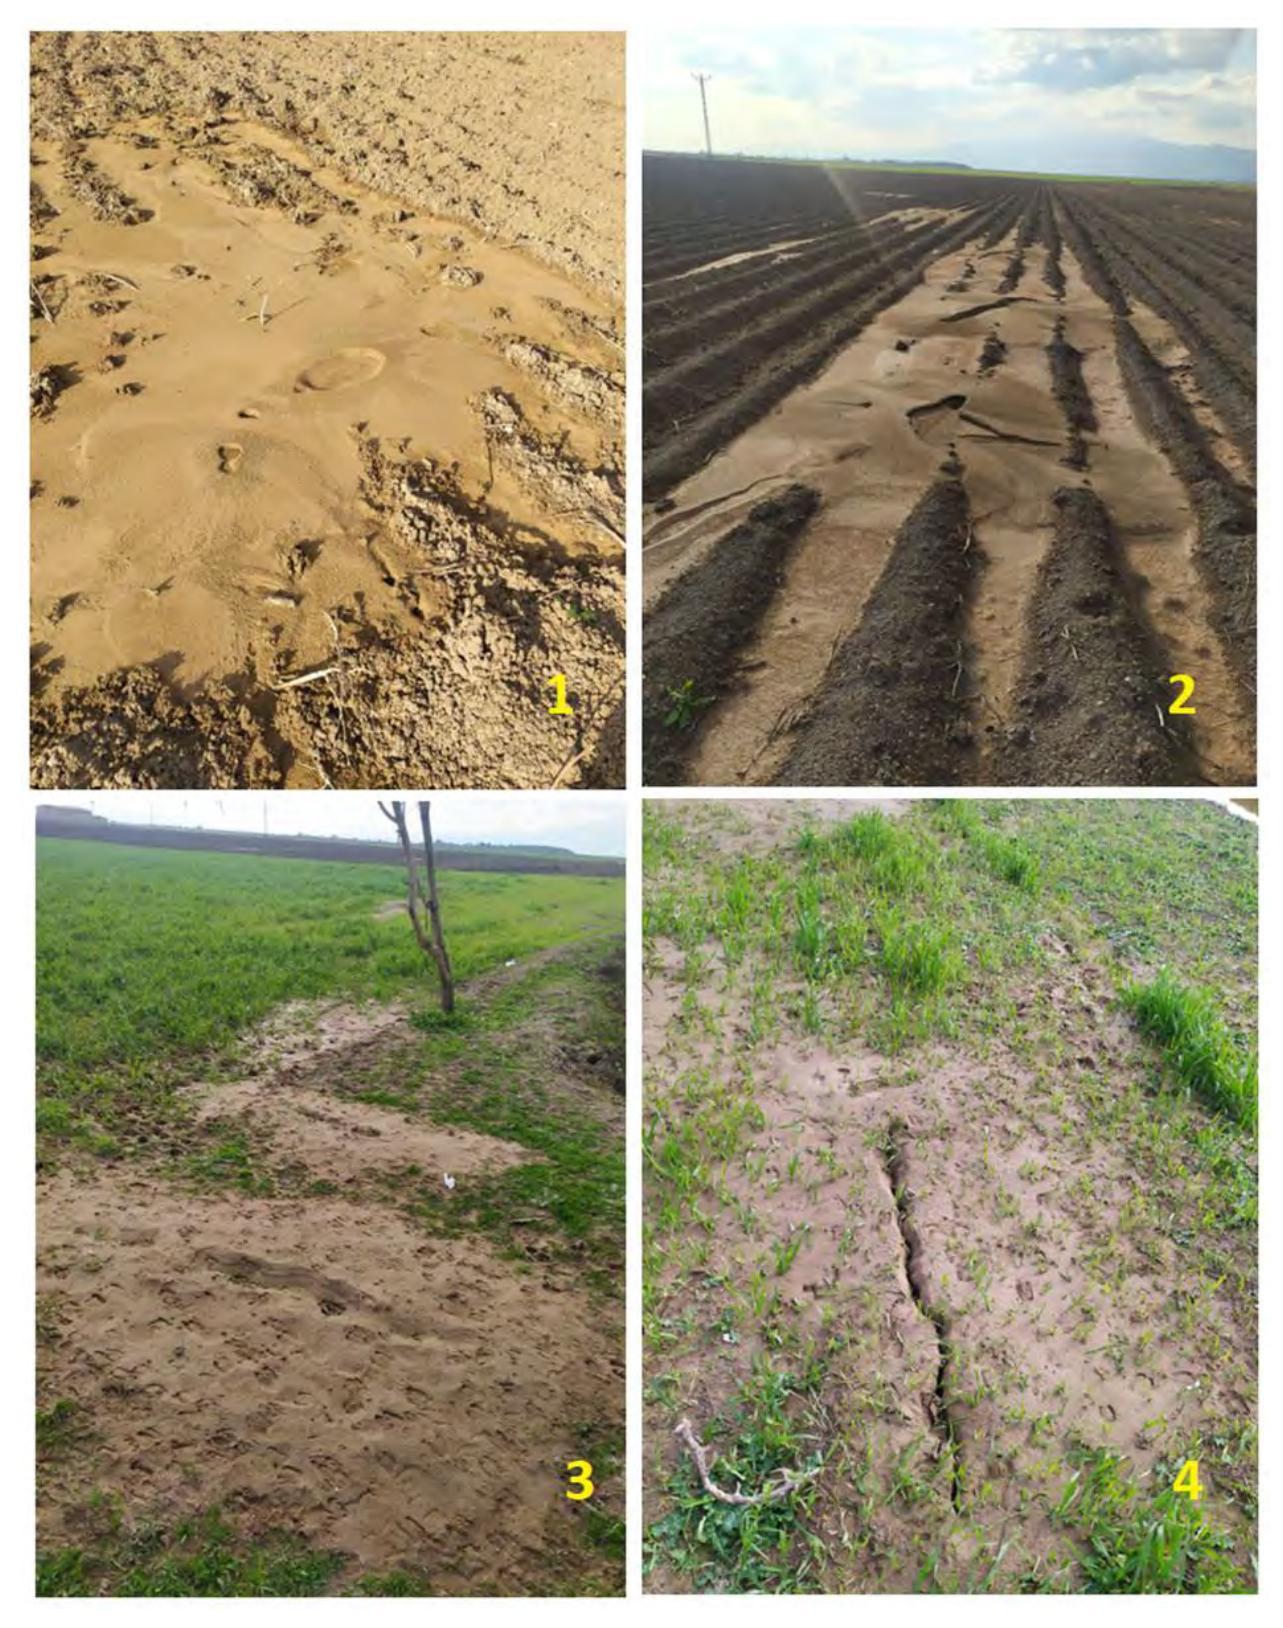
**Figure 5.215.** Sand ejecta fields and sand cones near Hatay Kırıkhan road (captioned by Kemal Önder Çetin 1: 36.356901972°N, 36.393472°E; 2: 36.350989°N, 36.379424°E; 3: 36.351291°N, 36.380054972°E; 4: 36.3512089722°N, 36.379545972°E)

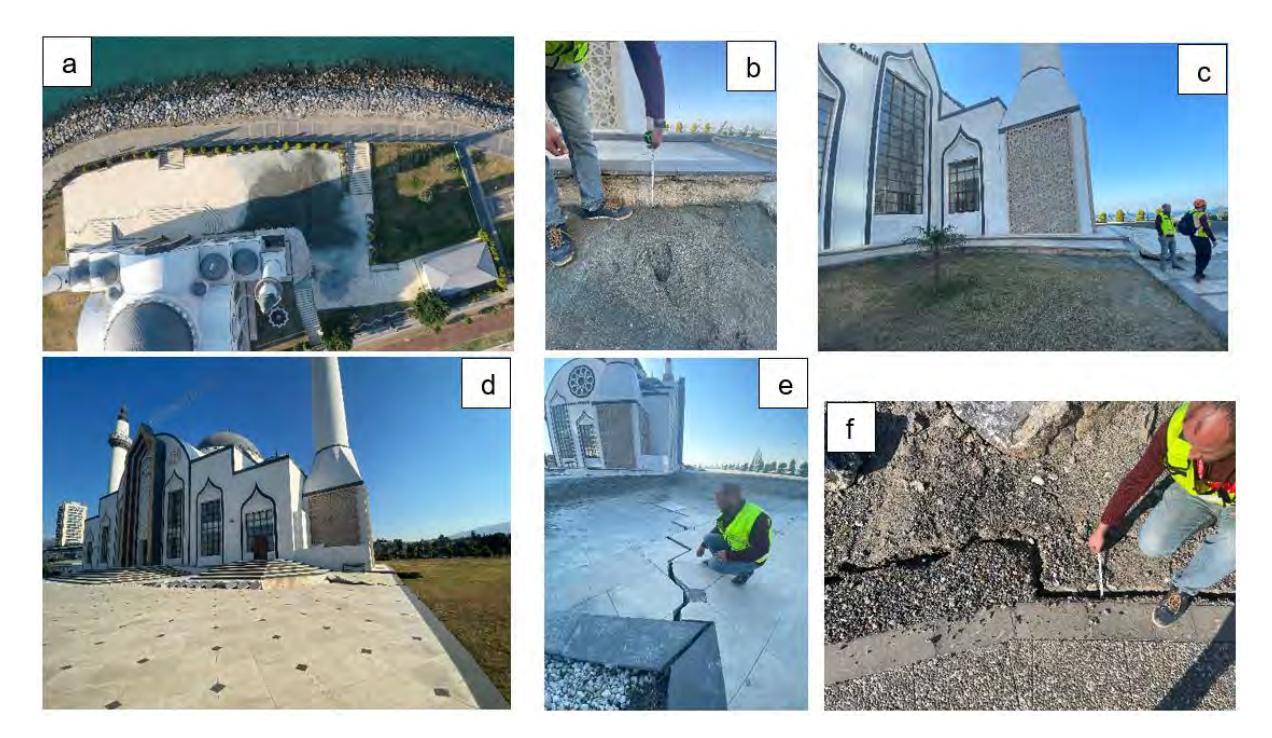
**Figure 5.217.** Liquefaction manifestations in Nihal Atakas Mosque (~ 36°35'35.27"N/ 36° 9'26.74"E): a) Bird's-eye view of the sand ejecta at the corner; b) settlements of the sand near the mosque; c) front view outlining the settlements; d) severe deformations observed on the marble ground due to liquefaction induced settlements; e) lateral spreading in front of the mosque; f) lateral spreading near the mosque towards the sea. Photo by Ozgun Numanoglu, Tugce Baser, and Serhat Erinmez

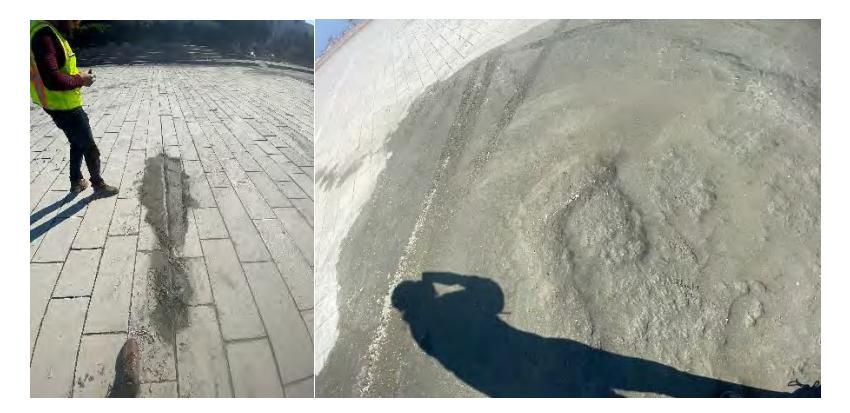
**Figure 5.219.** Liquefaction manifestations (sand boils) on Ataturk Boulevard near Ataturk (~ 36°35'29.50"N/ 36° 10'20.23"E) Photo by Ozgun Numanoglu, Tugce Baser, and Serhat Erinmez

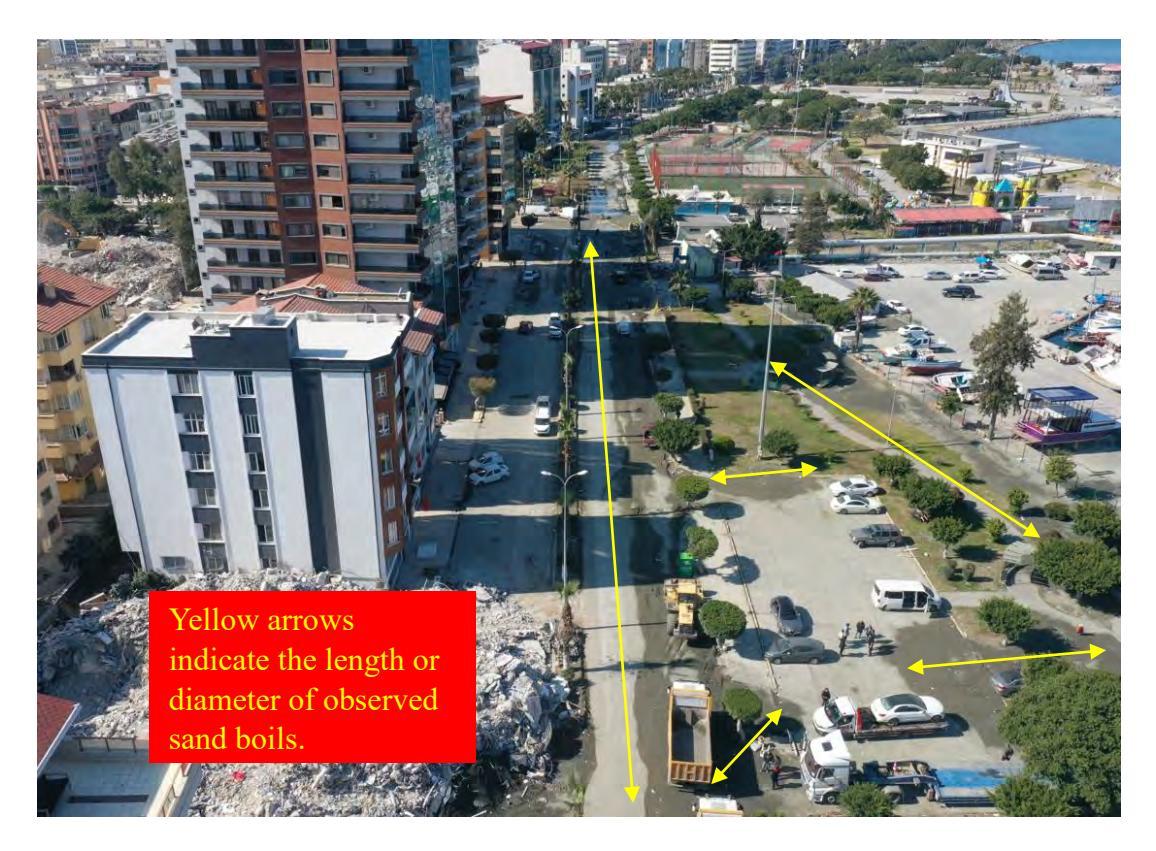
**Figure 5.220.** Liquefaction manifestations (sand boils) on Ataturk Boulevard (~ 36°35'26.86"N/ 36° 10'40.39"E) *Photo by* Ozgun Numanoglu, Tugce Baser, *and* Serhat Erinmez

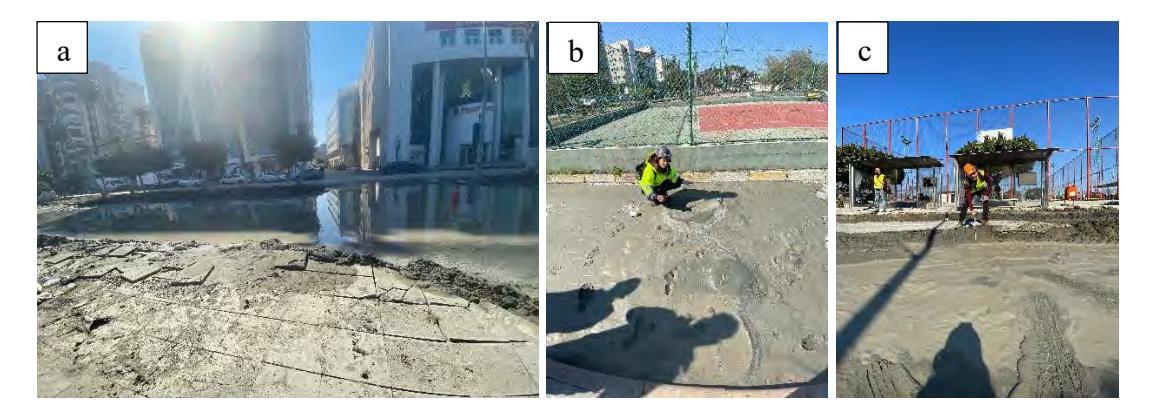
**Figure 5.221.** Liquefaction manifestations on Ataturk Boulevard near Tennis Courts (~ 36°35'26.95"N/ 36° 10'28.39"E): a) water accumulation and sand boils; b) sand boils; c) ground settlement. *Photo by* Ozgun Numanoglu, Tugce Baser, *and* Serhat Erinmez

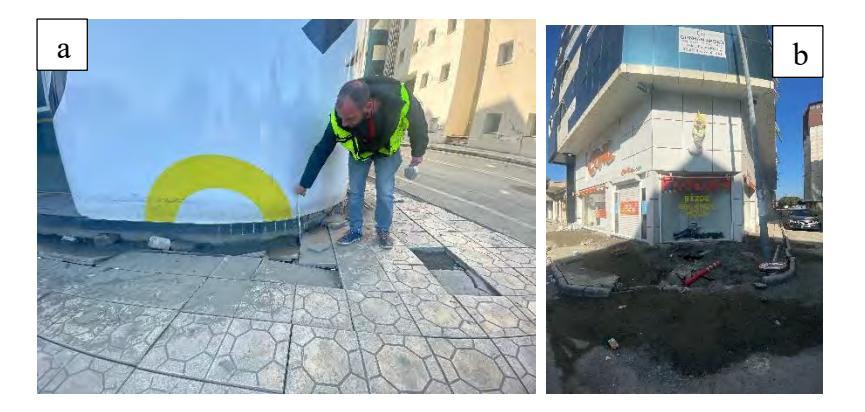
**Figure 5.222.** Liquefaction manifestation): a) Odeo Bank corner: sand ejecta and liquefaction induced settlements (~ 36°35'25.92"N/ 36° 10'25.46"E); b) Civilim building corner: sand ejecta (~ 36°35'23.48"N/ 36° 10'23.89"E). Photo by Ozgun Numanoglu, Tugce Baser, and Serhat Erinmez

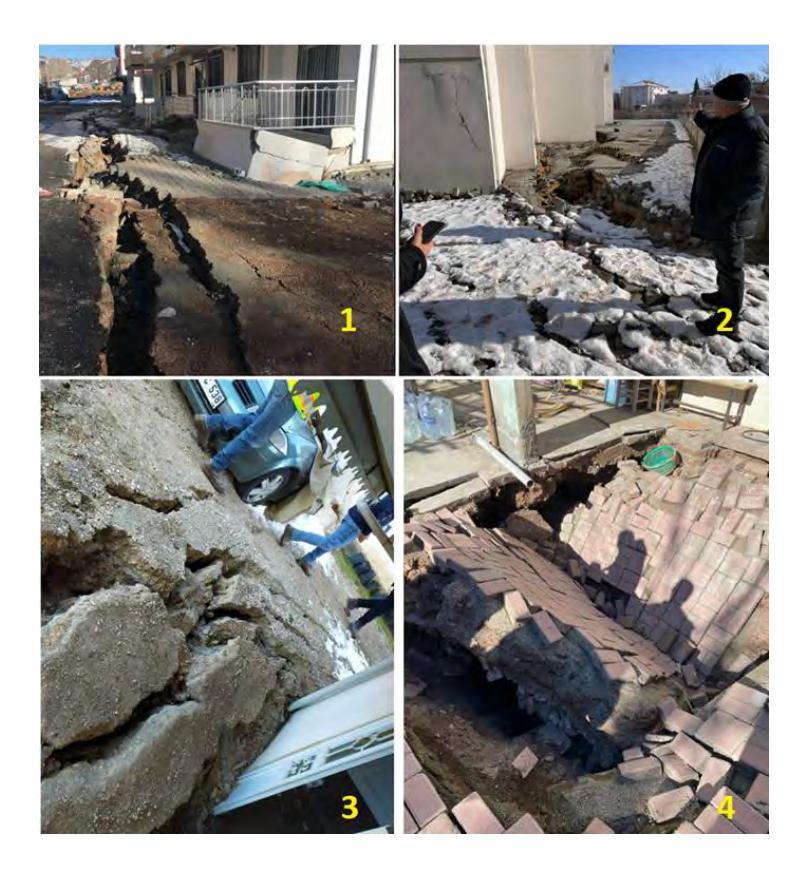
**Figure 5.225.** Cracks and fractures caused by liquefaction in the Gölbaşı district of Adıyaman (captioned by 1: Mustafa Kerem Koçkar 37.78880278°N, 37.64811389°E; 2: Ayhan Gürbüz 37.7827083°N, 37.62888056°E; 3: Kemal Önder Çetin 37.786661972°N, 37.632413972°E; 4: Kemal Önder Çetin 37.7863083°N, 37.63233056°E)

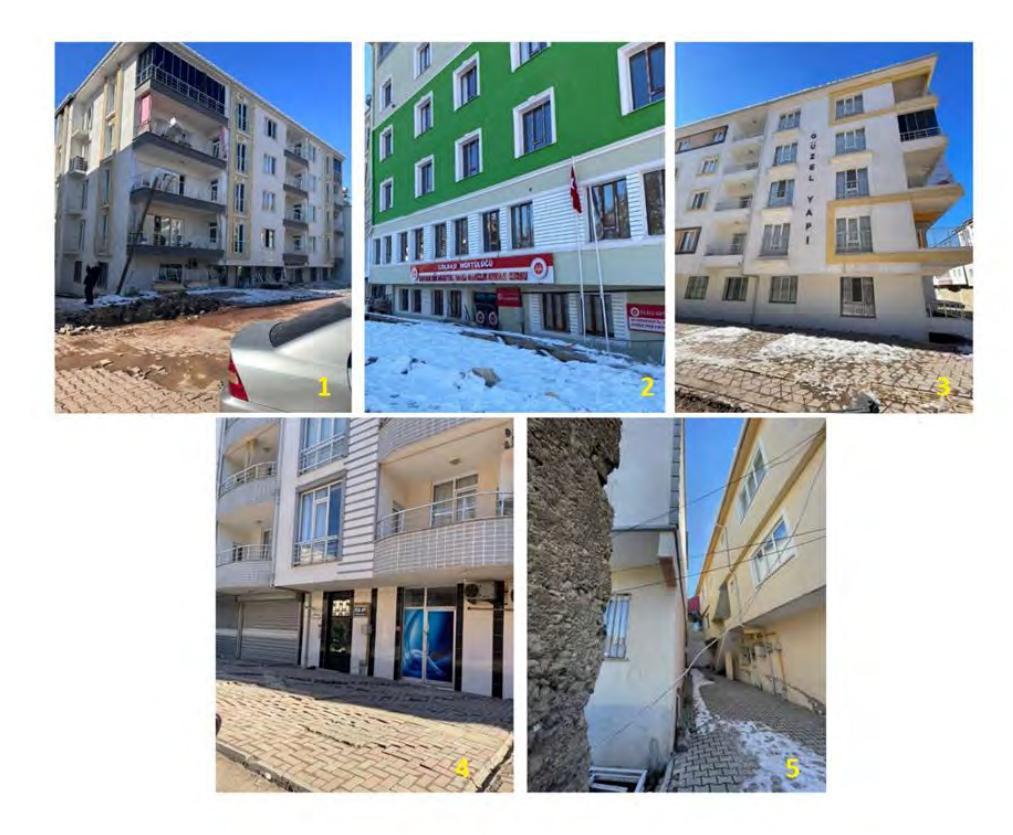
**Figure 5.226.** Uniform building settlements caused by liquefaction in Gölbaşı district of Adıyaman (captioned by 1: Ayhan Gürbüz 37.7873167°N, 37.6430083°E; 2: Berna Unutmaz 37.7875861°N,37.642125°E; 3: Kemal Önder Çetin 37.7827194°N, 37.6362°E; 4: Kemal Önder Çetin 37.7839694°N, 37.63324°E; 5: Kemal Önder Çetin 37.7866972°N, 37.631078°E)

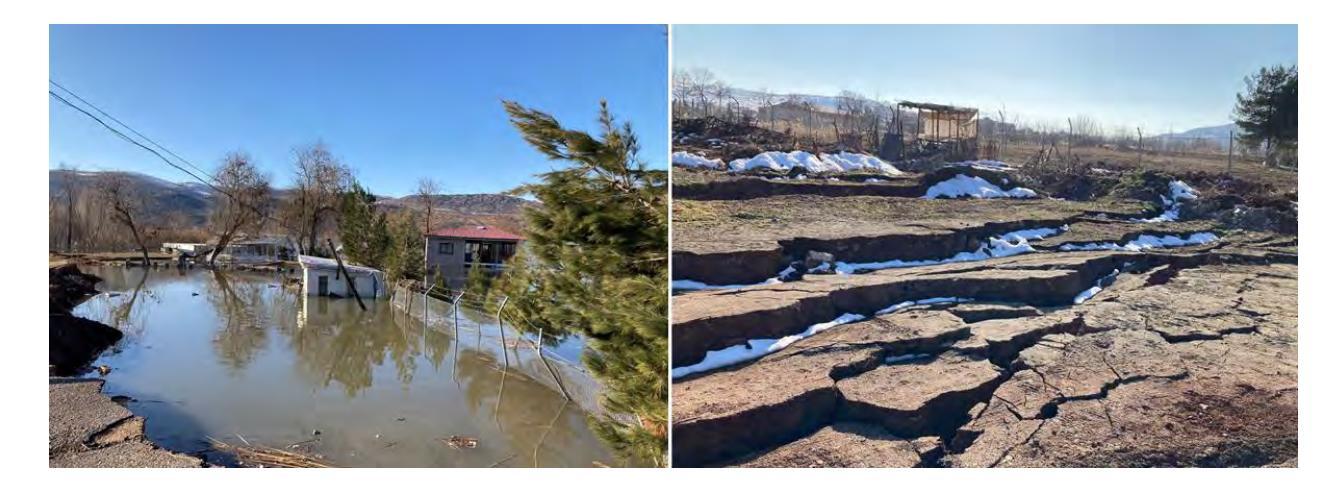
**Figure 5.227.** Liquefaction induced deformations in Gölbaşı district of Adıyaman (captioned by 1 and 2: Müge Akın 37.794105,37.648625)

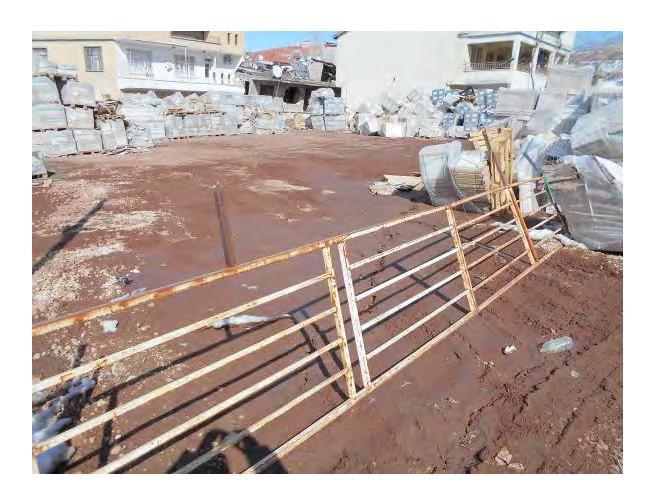
Figure 5.228. Sand ejecta in Gölbaşı, Adıyaman (captioned by Sedat Sert, 37.781342 37.635246)

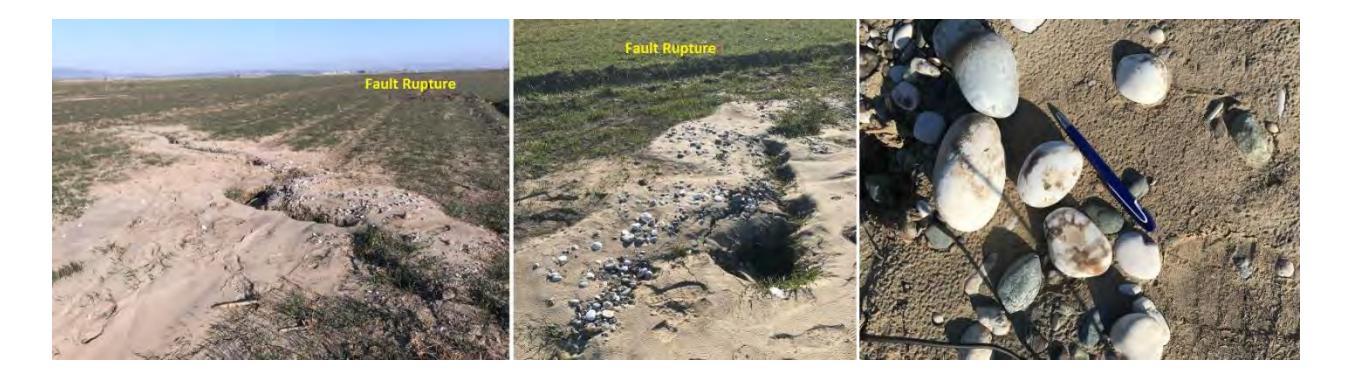
**Figure 5.229.** Sand ejecta near the fault rupture in Kuyumcular Village, Türkoğlu, Kahramanmaraş (captioned by Sedat Sert, 37.412425, 36.910369)

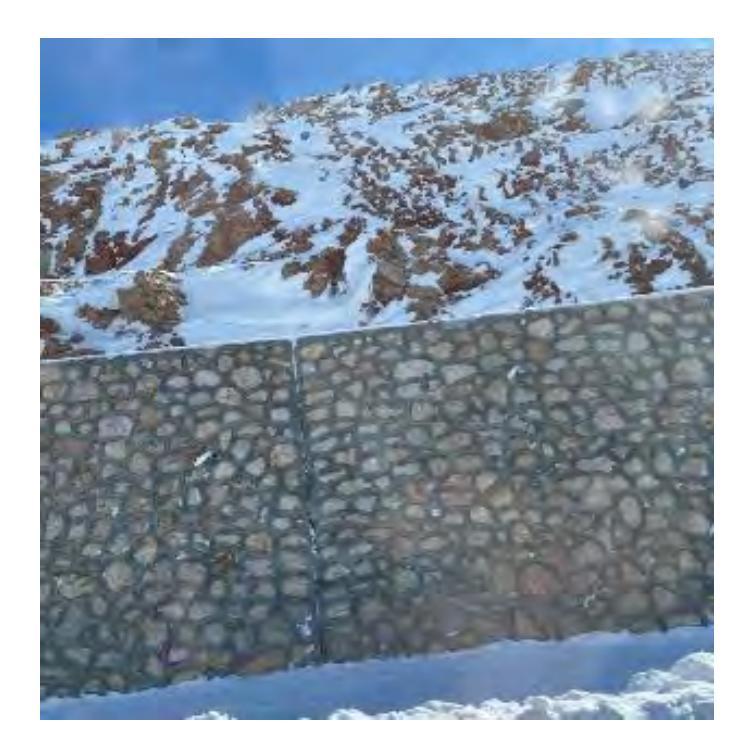
Along the road from Elbistan to Malatya, there was no signs of geotechnical-related problems were observed on the retaining walls of about 5m high (Figure 5.232) and the slopes behind the walls were not damaged. It should be noted that, no cracks, no slope failures, etc. were observed along the road.

Figure 5.232. Stable retaining wall – Elbistan-Malatya Road

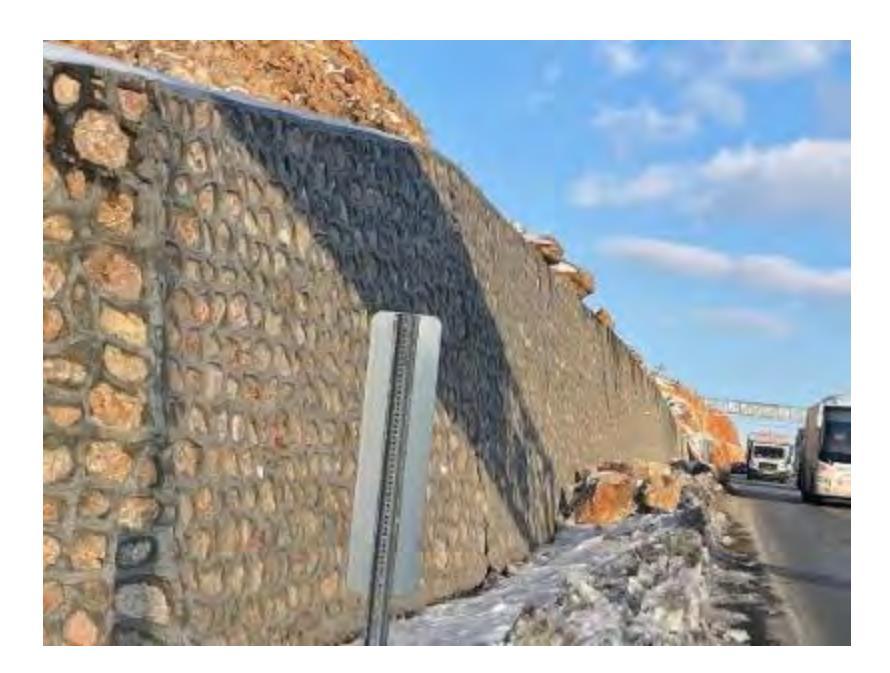
Along the road from Malatya to Gölbaşı, on Km: 74+600-75+800, near the entrance of Erkenek Tunnel, the retaining walls performed well with light damage.

Figure 5.233. Stone retaining wall performed relatively well in the entrance of Erkenek tunnel.

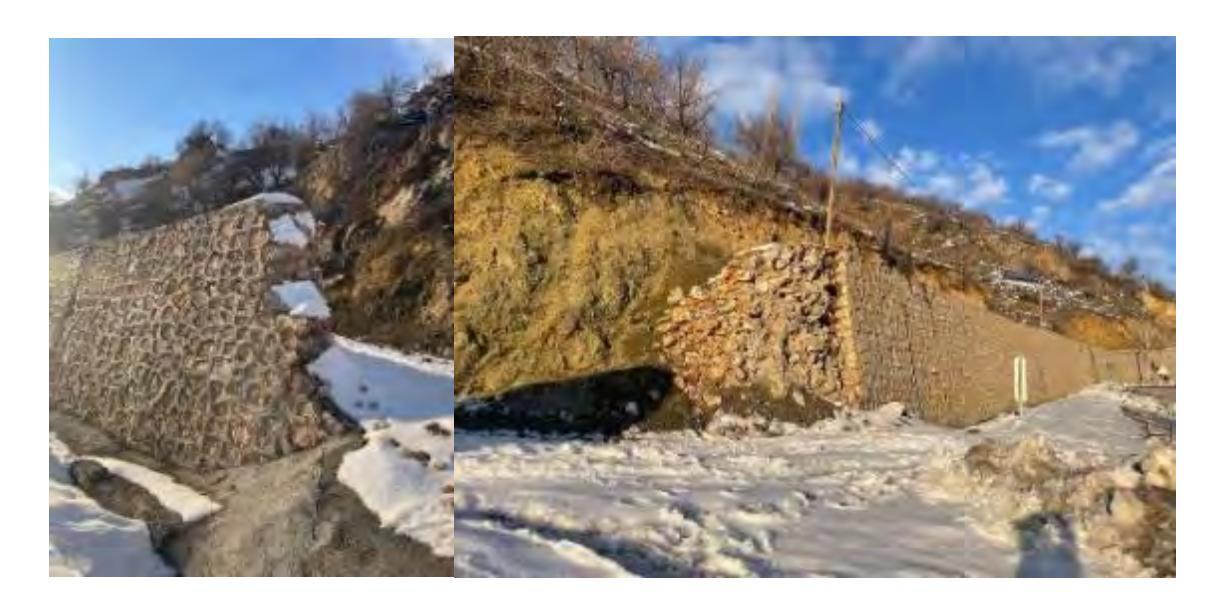
Figure 5.234. Stone retaining wall lightly damaged in the entrance of the tunnel.

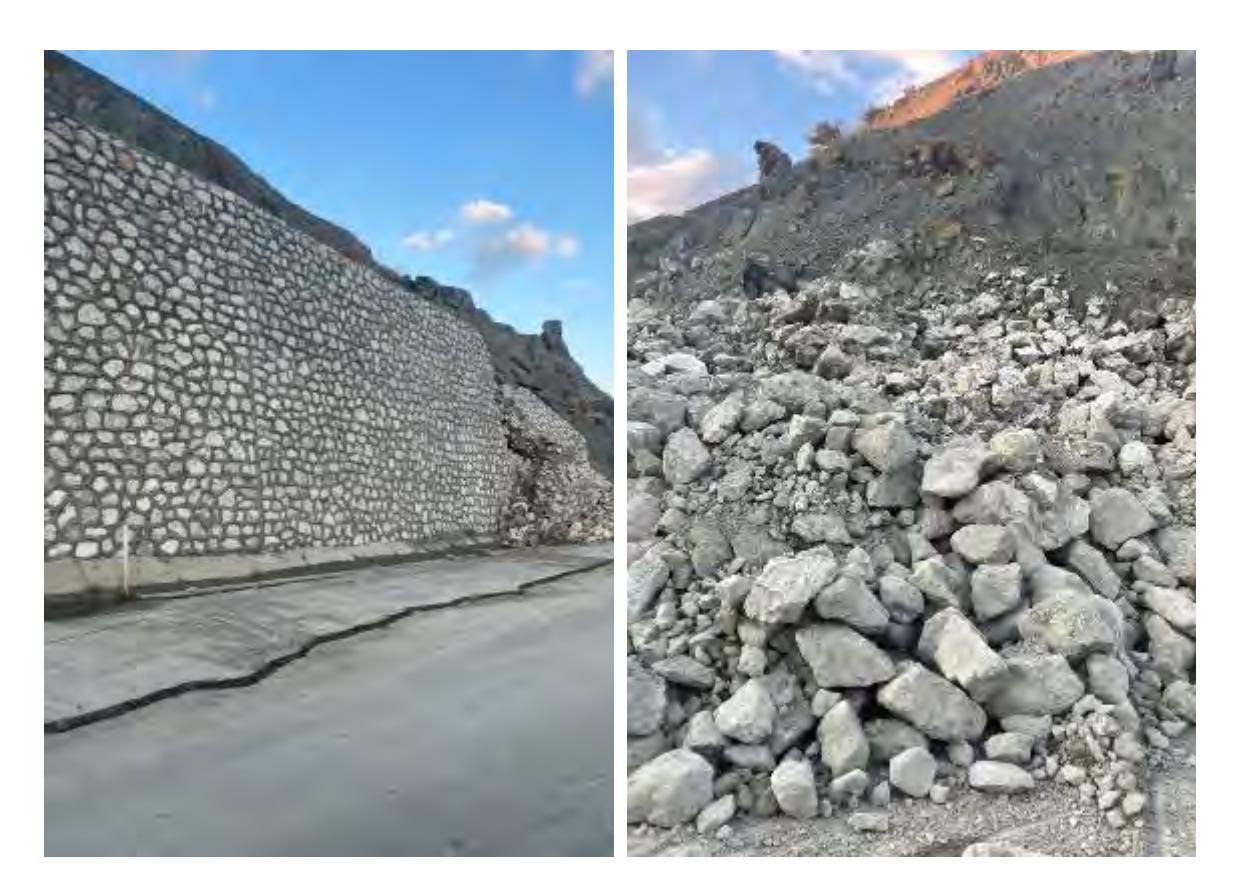
However, on Malatya-Gölbaşı Road, approximately around the coordinates 37.86345N, 37.76782E, near Göksu Çayı, probably because of the liquefied soil and slope, some cracks were observed at the stone retaining walls.

Figure 5.236. Collapsed/cracked stone walls, Location: around37.86345N, 37.76782E
