# Türkiye Earthquake

## **RECONNAISSANCE REPORT**

February 6, 2023 Kahramanmaraş-Pazarcık ( $M_w$ =7.7) and

Elbistan (M<sub>w</sub>=7.6) Earthquakes

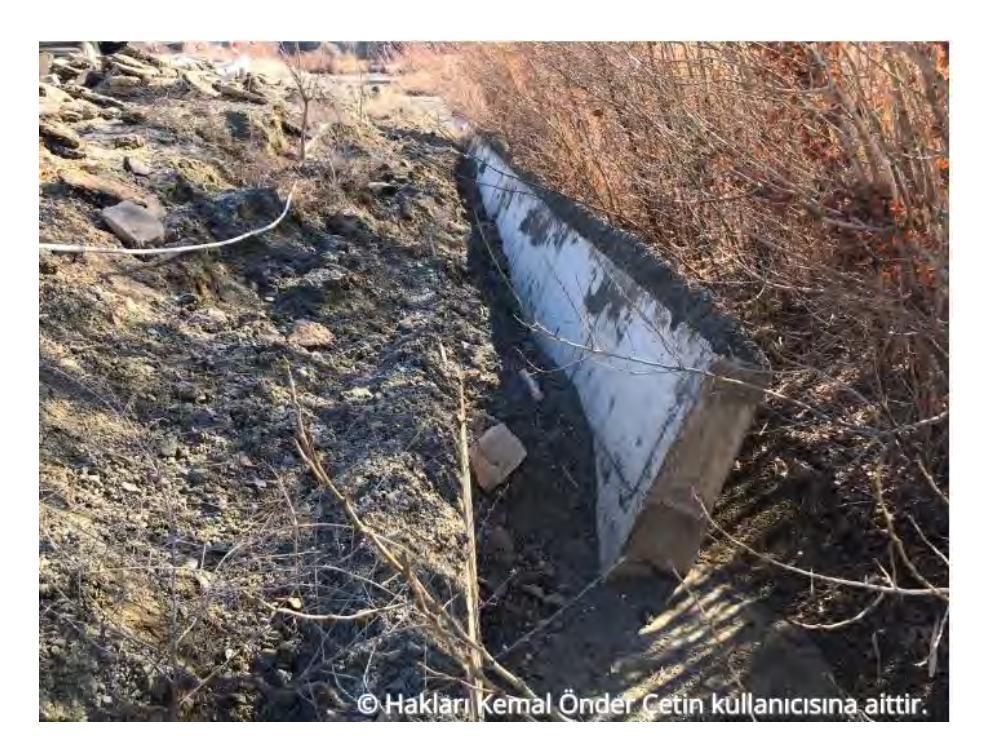
At the similar location very close to the green mark in Figure 5.235, a small, reinforced concrete retaining wall was observed to fail due to slope failure as can be seen in Figure 5.237.

**Figure 5.237.** Reinforced concrete retaining wall failed due to slope failure, location: 37.863208,37.767095

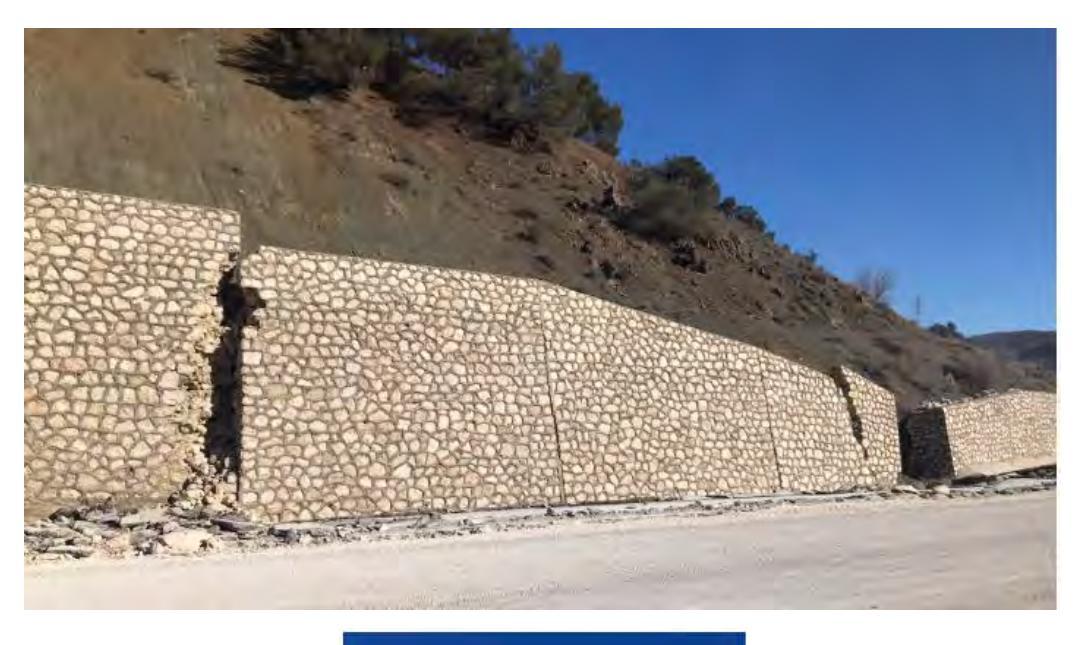
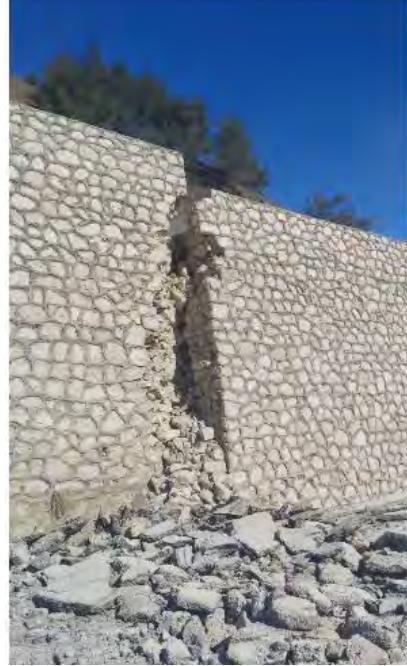
Similarly, at the location of the mark 7 in Figure 5.235, a total view of the wall can be seen and the cracked part is observed as can be seen in Figure 5.238.

Figure 5.238. Collapsed/cracked stone walls.

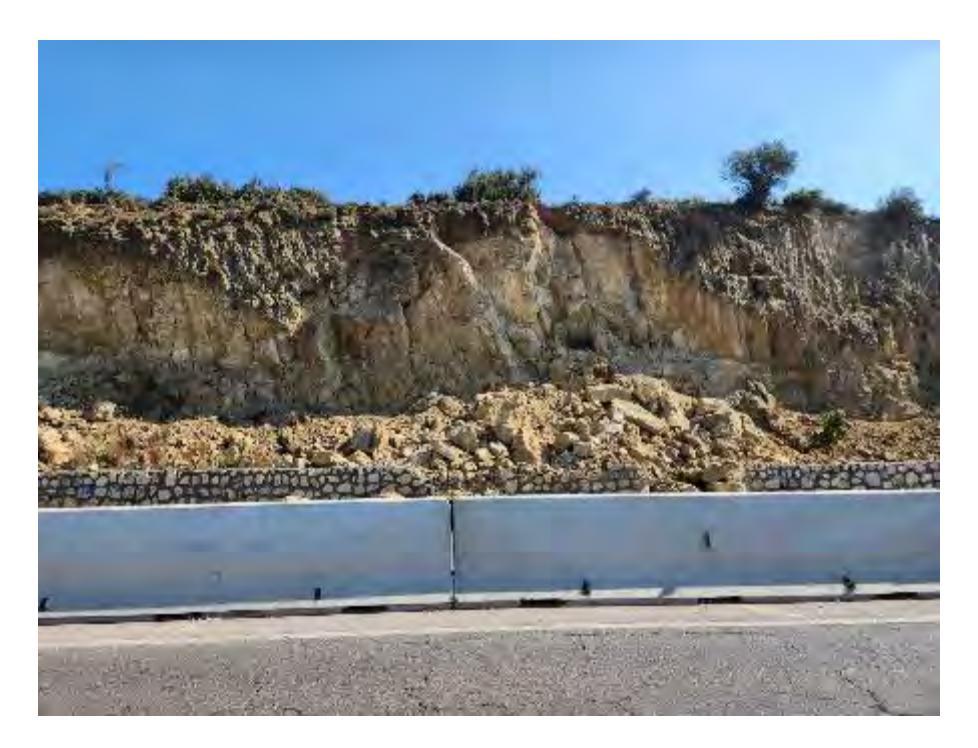
On the steep highway slopes between Iskenderun and Hatay, rock overturns and falls can be widely observed on steep slopes possibly composed of clayey limestone. However, the failure of the stone retaining wall and fill constructed on the same road was observed. Stone walls often perform poorly.

**Figure 5.239.** Stone walls, performed poorly on Iskenderun-Hatay Road, Photo by Prof. Dr. Kemal Önder Çetin and Prof. Dr. Candan Gökçeoğlu

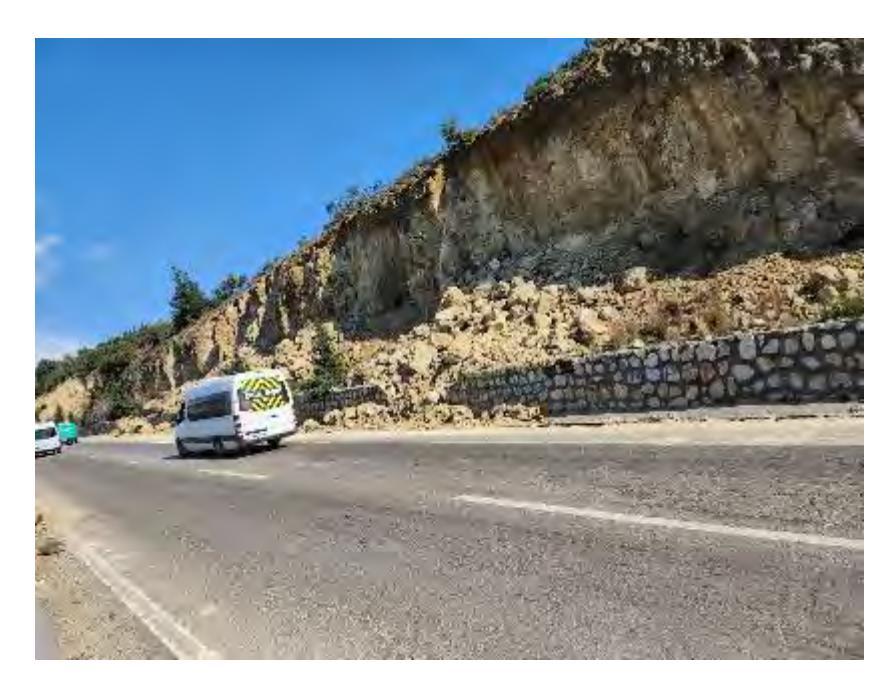
**Figure 5.240.** Stone walls, performed poorly on Iskenderun-Hatay Road, Photo by Prof. Dr. Kemal Önder Çetin and Prof. Dr. Candan Gökçeoğlu

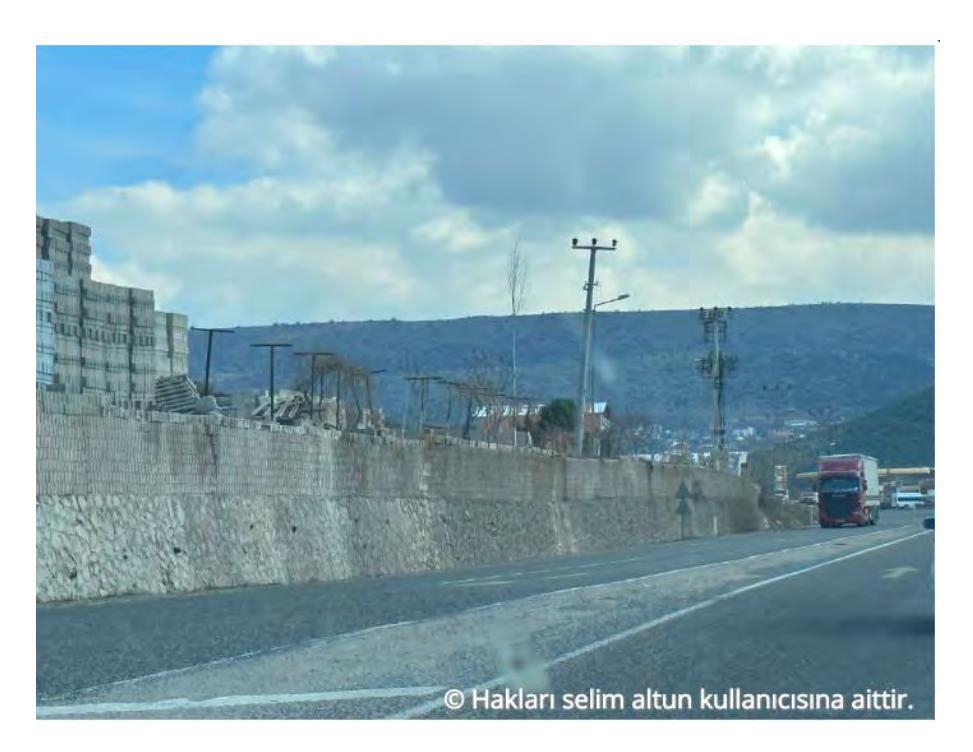
Figure 5.244. No damage stone (composite) wall, Location: 37.50768,37.33958

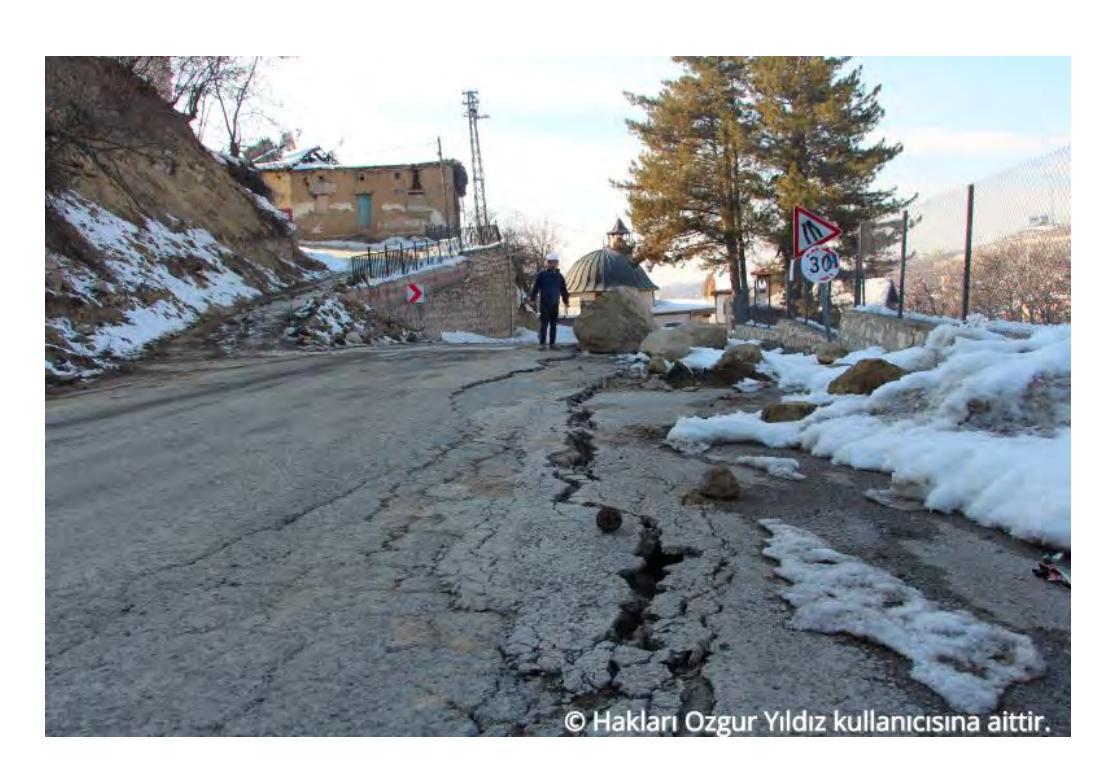
On Yeşilyurt – Gündüzbey yolu, although some cracks were observed along the road, no damage has been seen in the adjacent retaining wall (Figure 5.245).

Figure 5.245. No damage on stone wall, Location: 38.30536289,38.23547732

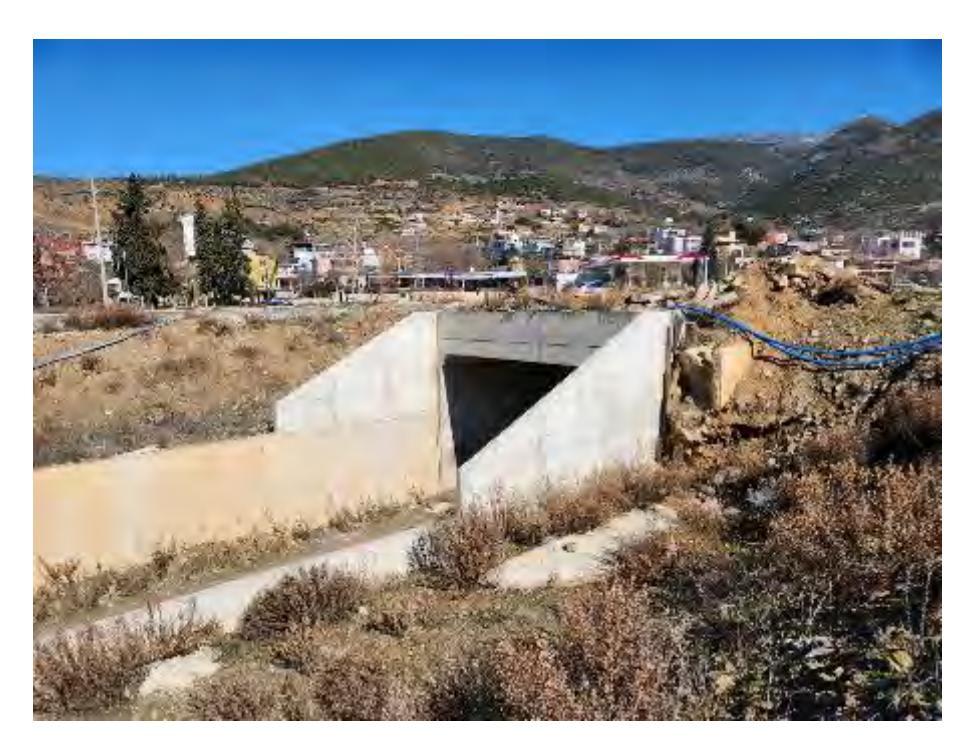
Figure 5.248. Photo by Prof. Dr. Kemal Önder Çetin ve Prof. Dr. Candan Gökçeoğlu

As can be seen from the Figure 5.248, no damage was observed at the cut-and-cover of T2 tunnel exit on Bahçe and Nurdağı railway and the reinforced concrete support walls following it.

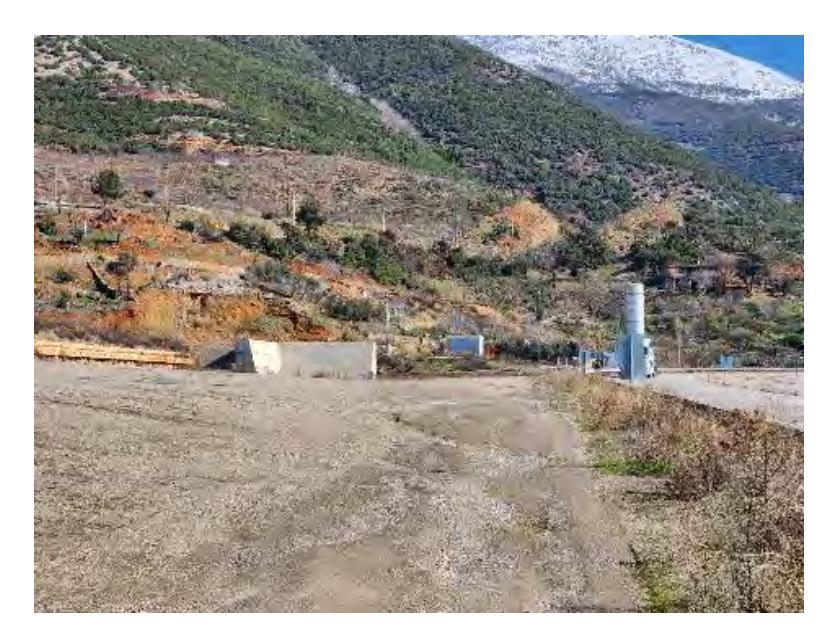
Figure 5.249. Photo by Prof. Dr. Kemal Önder Çetin and Prof. Dr. Candan Gökçeoğlu

The photo in Figure 5.249 is a view from west to east, showing the TBM exit portal, the conventional railway running just above it. An L-shaped retaining wall was constructed between the top of the portal and the conventional railway. A small landslide occurred, but the retaining wall separated it from portal structure, prevented further progress of the slide and damage to both the portal and the conventional railway.

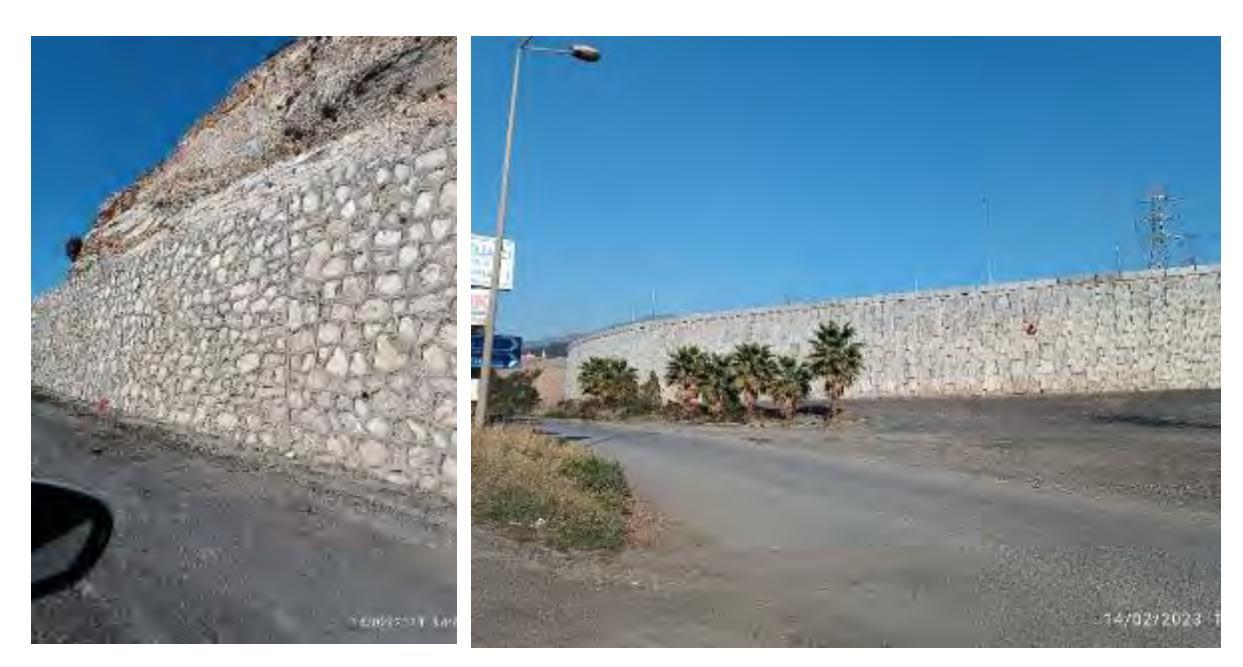
Mechanically Stabilized Earth Wall (MSEW) and gravity type retaining walls were observed along the transportation network. General performance of the retaining walls was observed to be good, and no visible damages were observed for the investigated walls due to seismic shaking as shown in Figure 5.253.

Figure 5.253. No damage on retaining walls due to seismic shaking.

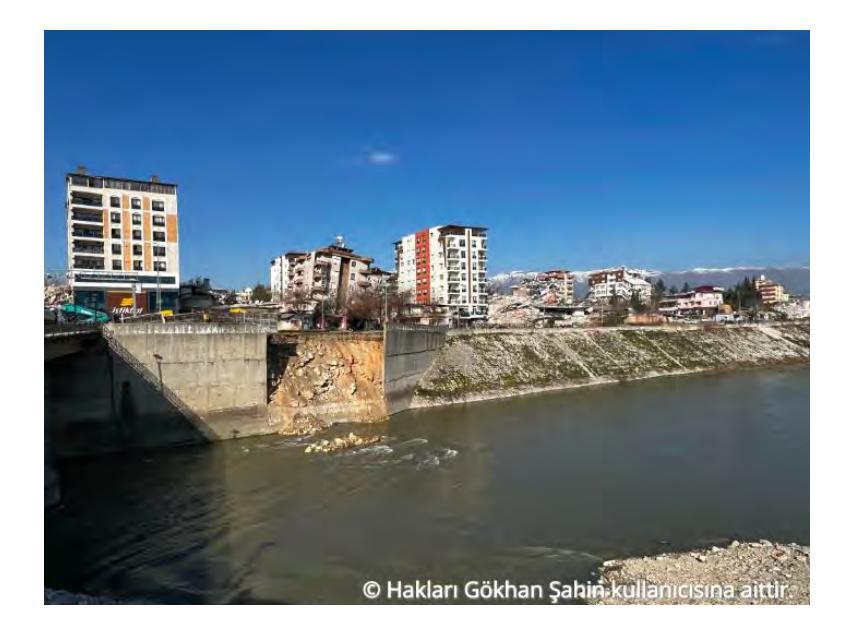
Some damage has been reported along the retaining walls adjacent to hydraulic structures and rivers. For example, as can be seen in Figure 5.254 below, near Asi River in Hatay, the retaining wall has collapsed. Similarly, near this crack, the retaining wall under the bridge abutments (Figure 5.255) has failed.

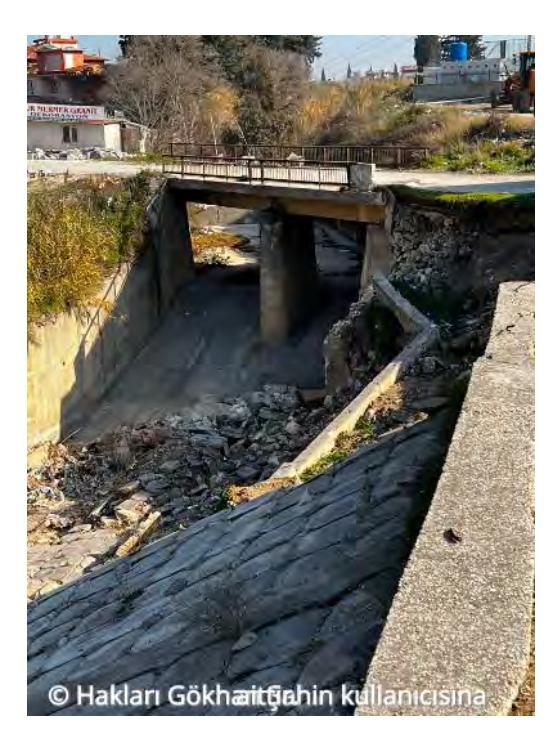
Figure 5.255. Failed retaining structure, location 36.21548476,36.16233899

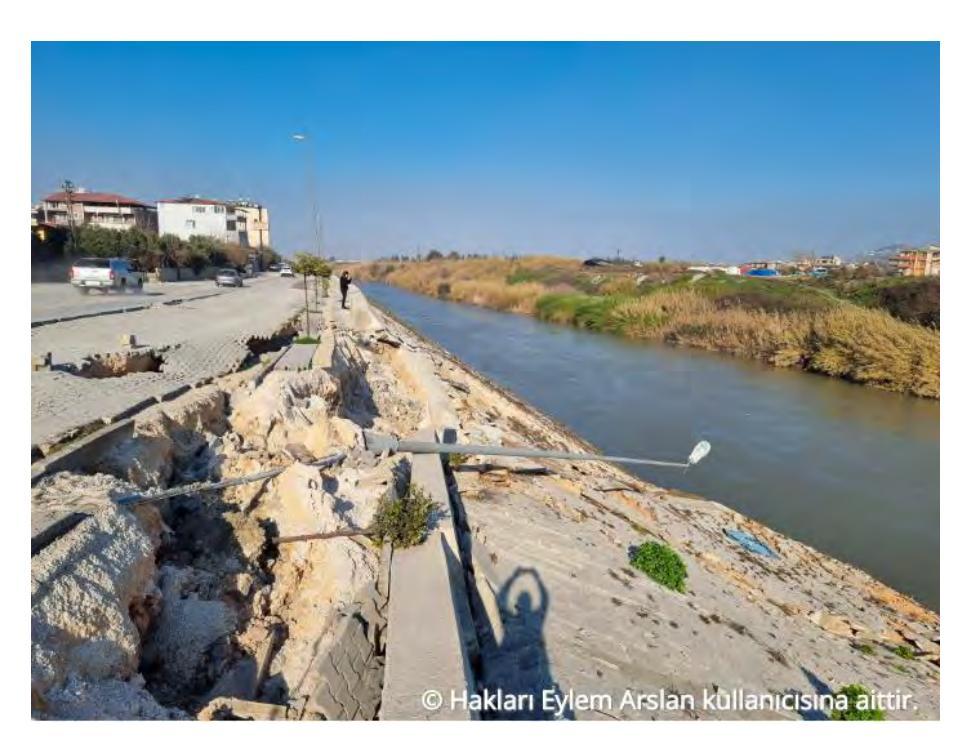
At a different location still along Asi River, a failure of the retaining wall is presented in Figure 5.256.

Figure 5.256. Failed retaining structure, Location 36.221139,36.1641857

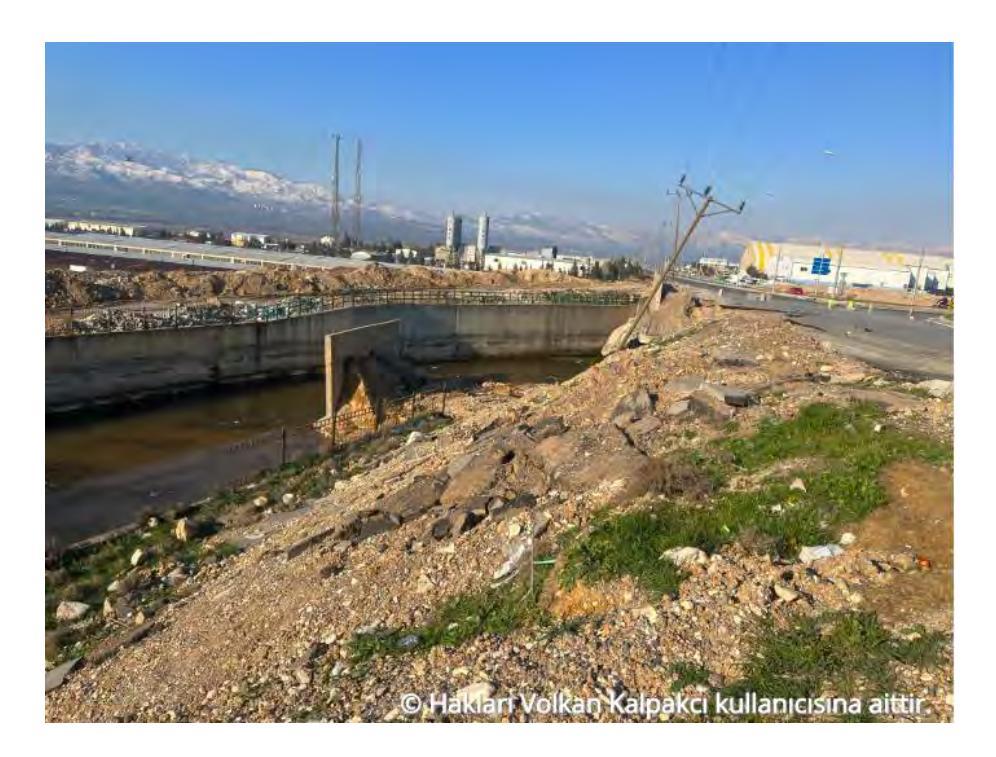
A similar failure (Figure 5.257) of the has been reported along the water channels in Kahramanmaraş. This failure is going along with a slope failure (Figure 5.258)

Figure 5.257. Failed retaining structure, Location 37.56588,36.872208

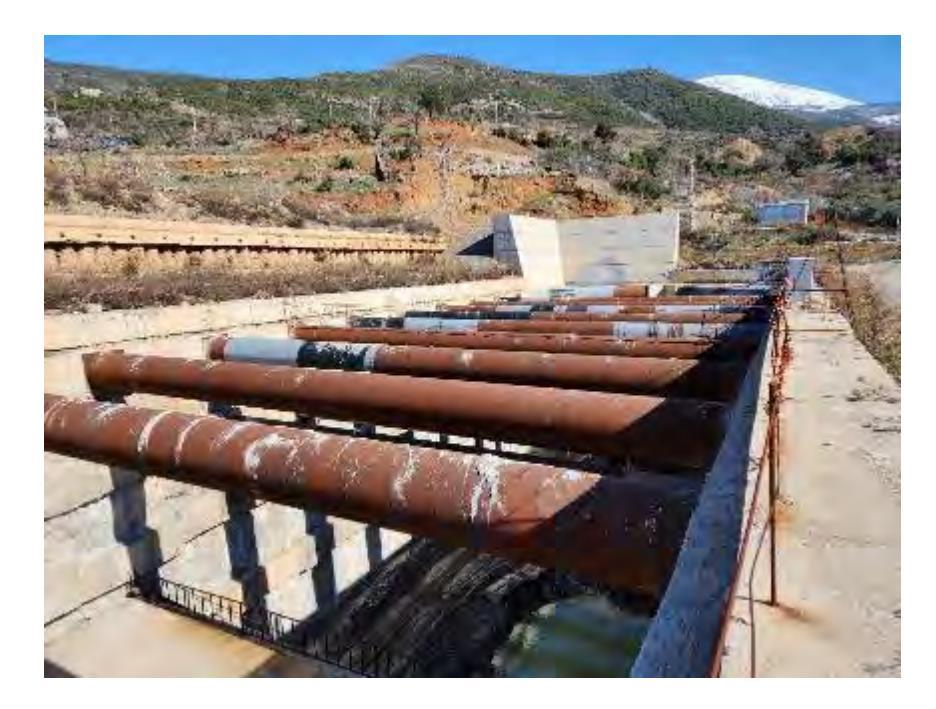
The photo in Figure 5.259, is taken from an angle extending from west to east, showing the TBM exit portal, the conventional railway line is running just above it. An L-shaped retaining wall was constructed between the top of the portal and the conventional railway (Figure 5.260) A small landslide occurred, but the retaining wall prevented the landslide from continuing, preventing damage to both the portal and the conventional railway (Fig. 5.259).

Struts (steel pipes) were designed to support pile elements in Bahçe. A certain section of the cut-and-cover tunnel built right in front of the garden portal is temporarily supported by struts and kept open for the removal of the TBM, which is currently being excavated in the tunnel. As can be seen in Figures 5.259 and 5.260, all struts performed well as designed and no damage was occurred.

**Figure 5.259.** General overview of temporary struts over the cut section, Photo by Prof. Dr. Kemal Önder Çetin and Prof. Dr. Candan Gökçeoğlu

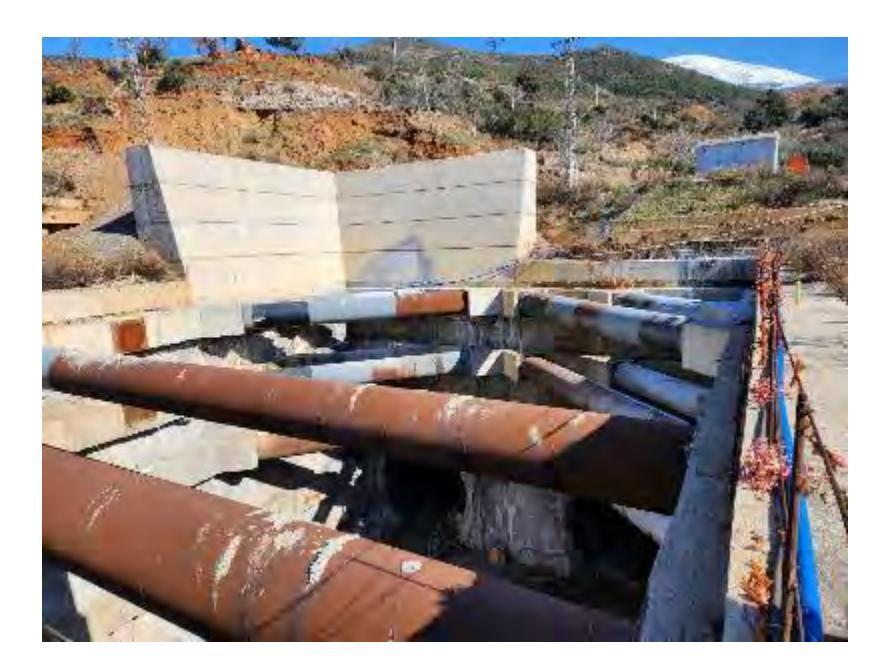
**Figure 5.260.** Temporary struts over the cut section, Photo by Prof. Dr. Kemal Önder Çetin and Prof. Dr. Candan Gökçeoğlu

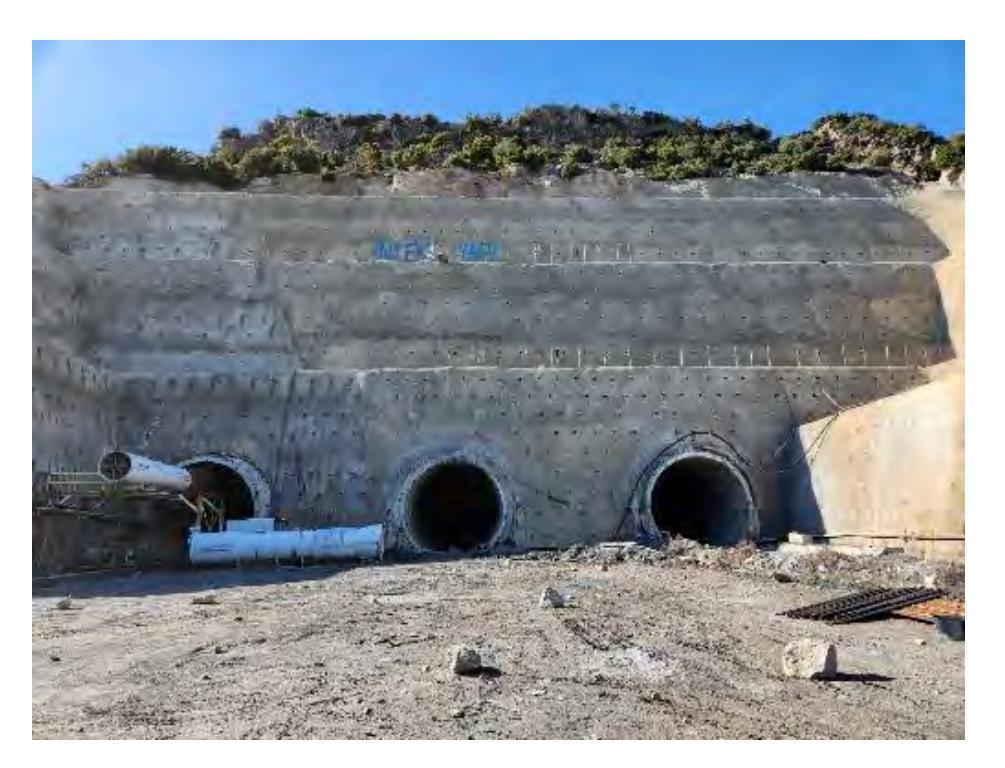
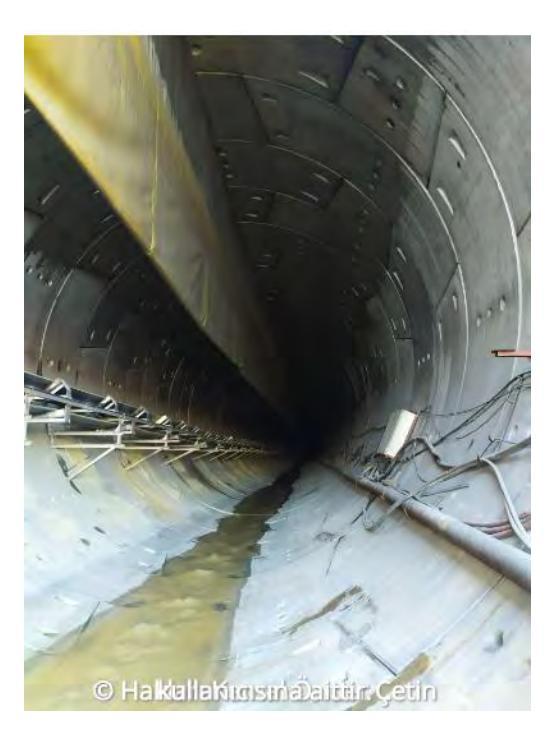
Figure 5.261. Photo by Prof. Dr. Kemal Önder Çetin and Prof. Dr. Candan Gökçeoğlu, Location: 37.16989197,36.708058

No damage was observed at the portal of the Bahçe-Nurdağı tunnels. However, some rockfalls are observed. However, the surface fracture passes approximately 50 m in front of the portal.

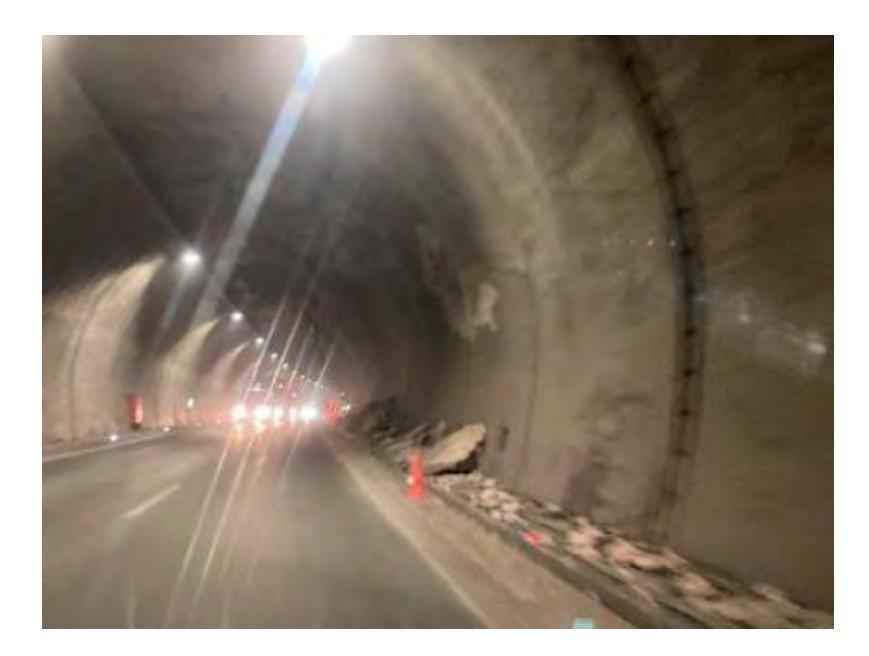
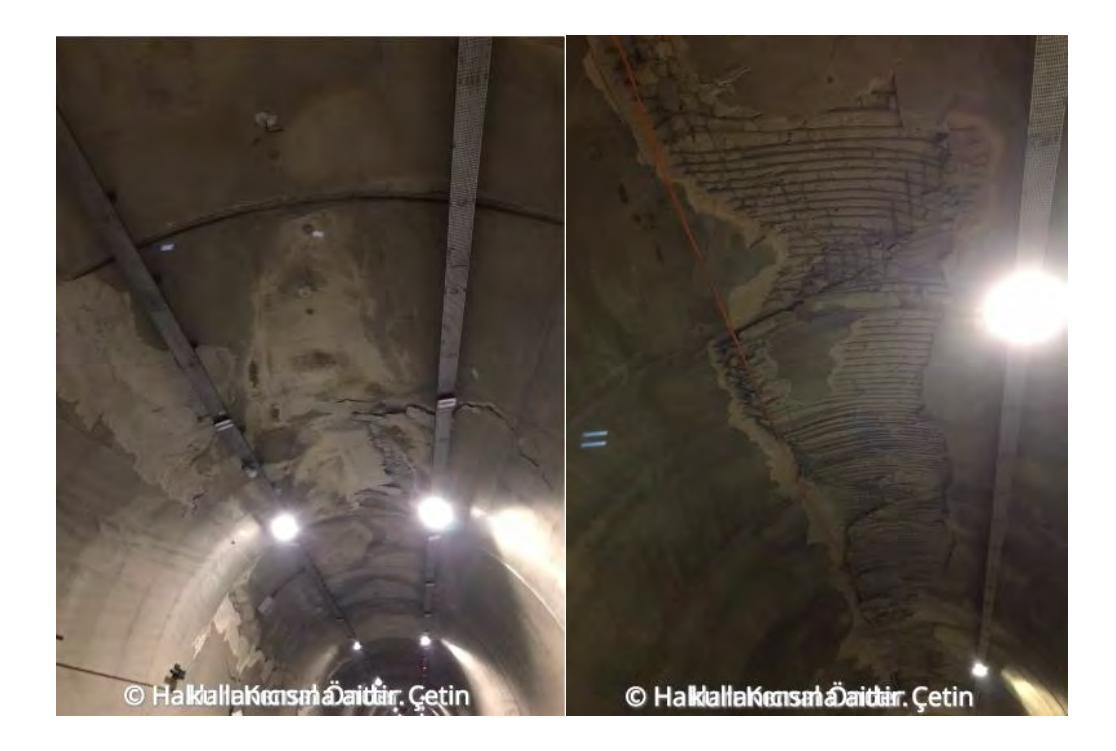
The traffic along the Erkenek tunnel was flowing in only one of the tunnels, the one in the direction of Malatya to Gölbaşı. However, some spalling and rock pieces were observed along the tunnel.

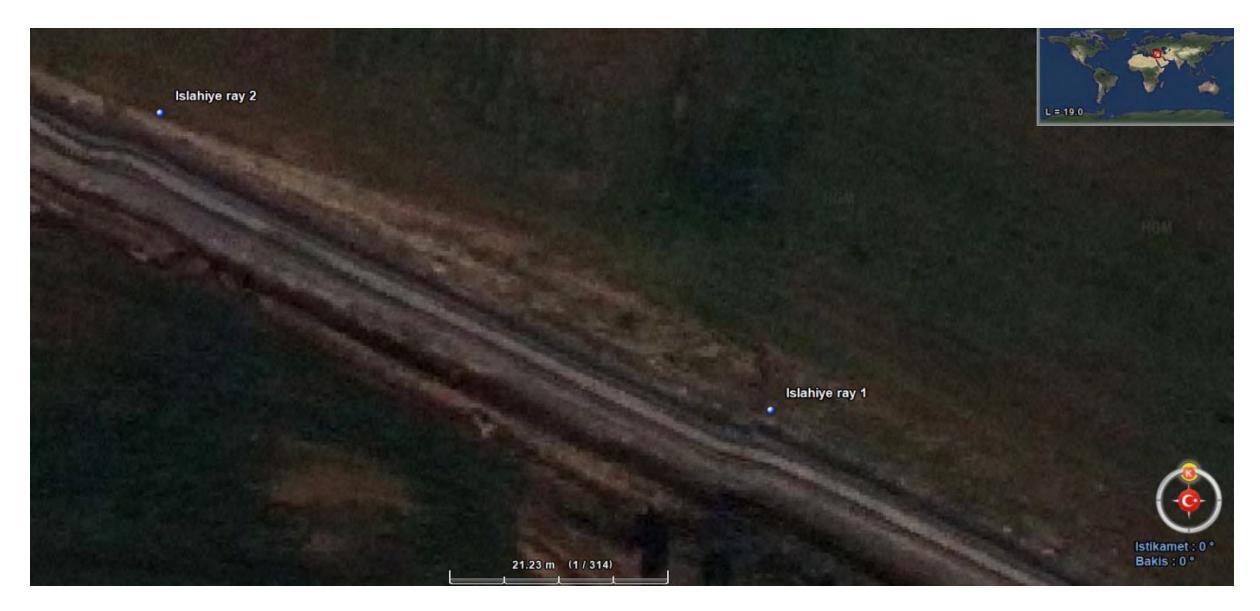
Figure 5.265. İslahiye railway deformations. Source: HGM küre

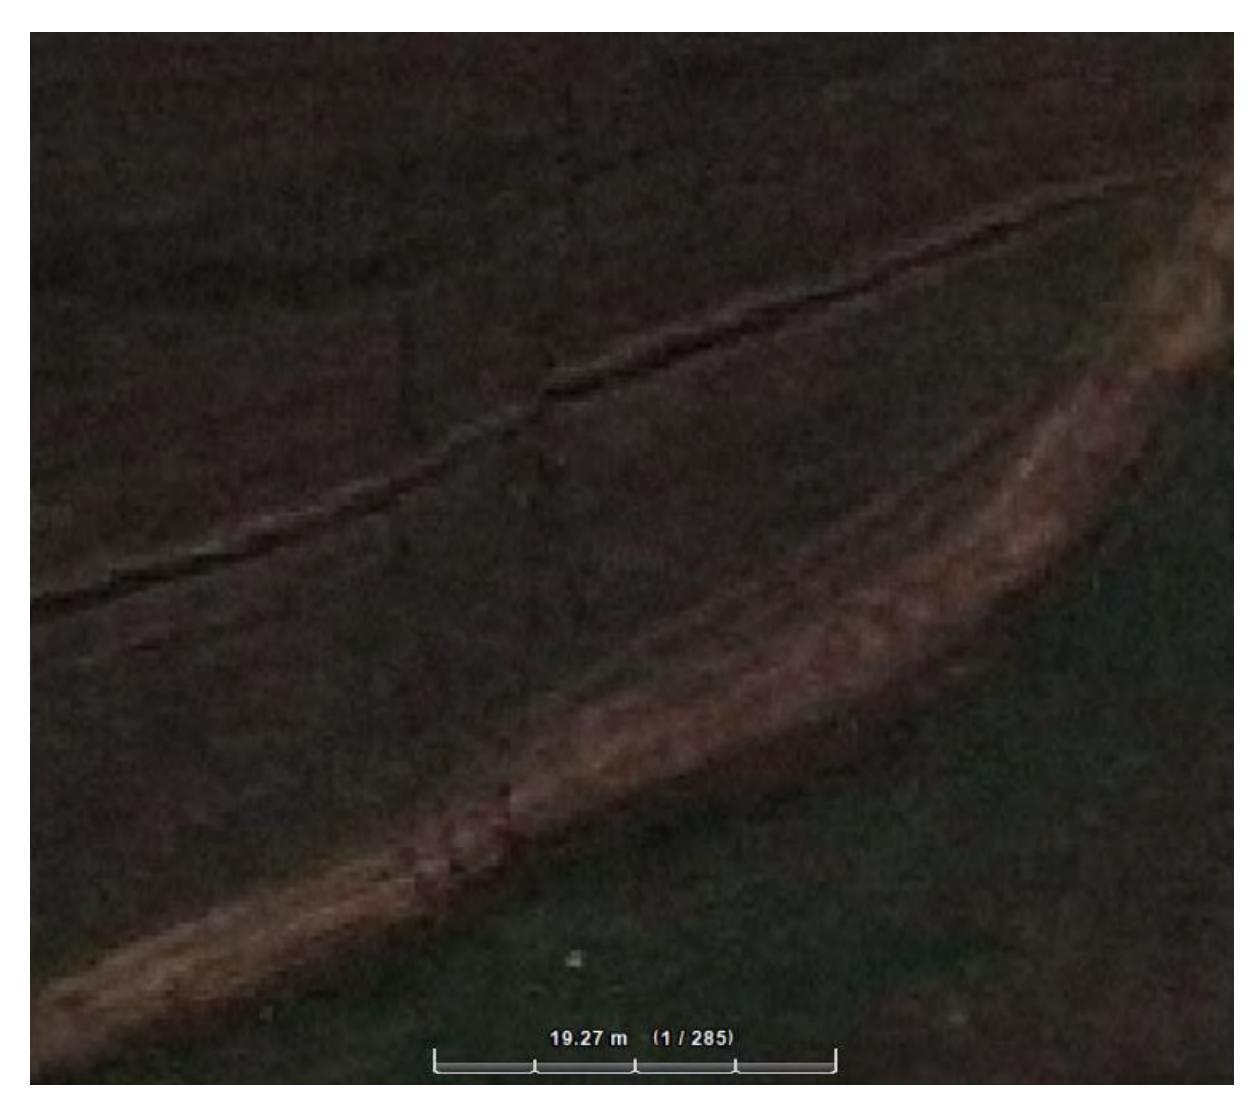
Figure 5.266. İslahiye surface rupture. Source: HGM küre

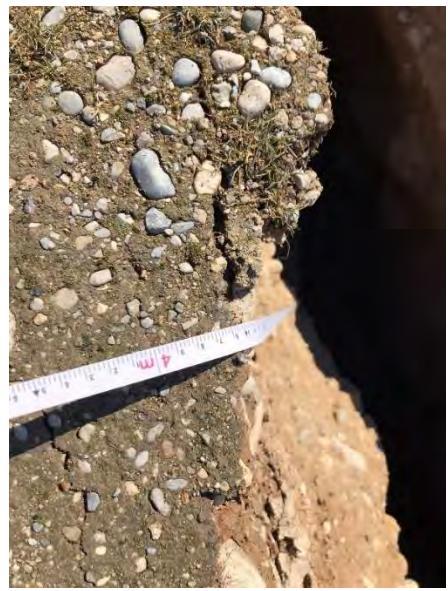
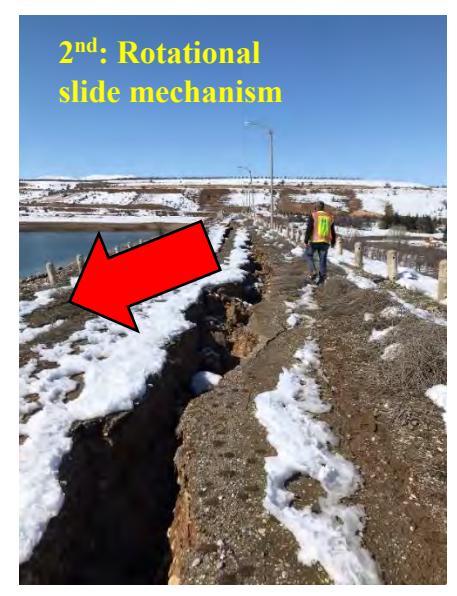
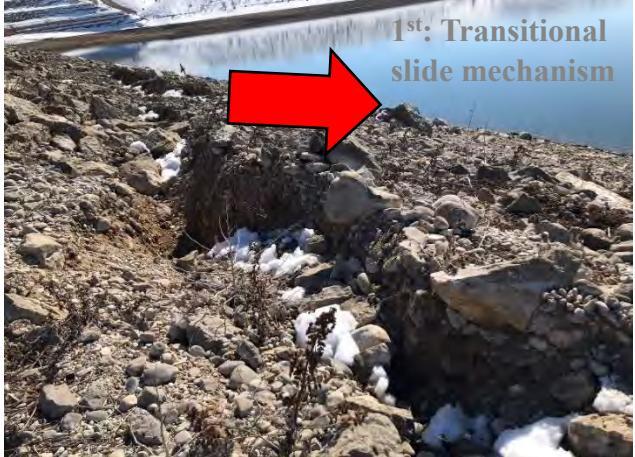
Sultansuyu Dam is a clay core sand-gravel dam constructed between 1986-1992 in Malatya for irrigation purposes. The crest height from the foundation level is about 60 meters. After the earthquake, cracks formed with varying depths, and earthquake-induced permanent deformation occurred on the crest and upstream side of dam body (see Figure 6.1a-c). All permanent lateral displacements are towards upstream side.

**Figure 6.1.** Earthquake-induced permanent deformations on the crest, a) illustration of depth, b) general overview, c) lateral movement on the dam body (1<sup>st</sup> failure, transitional slide)

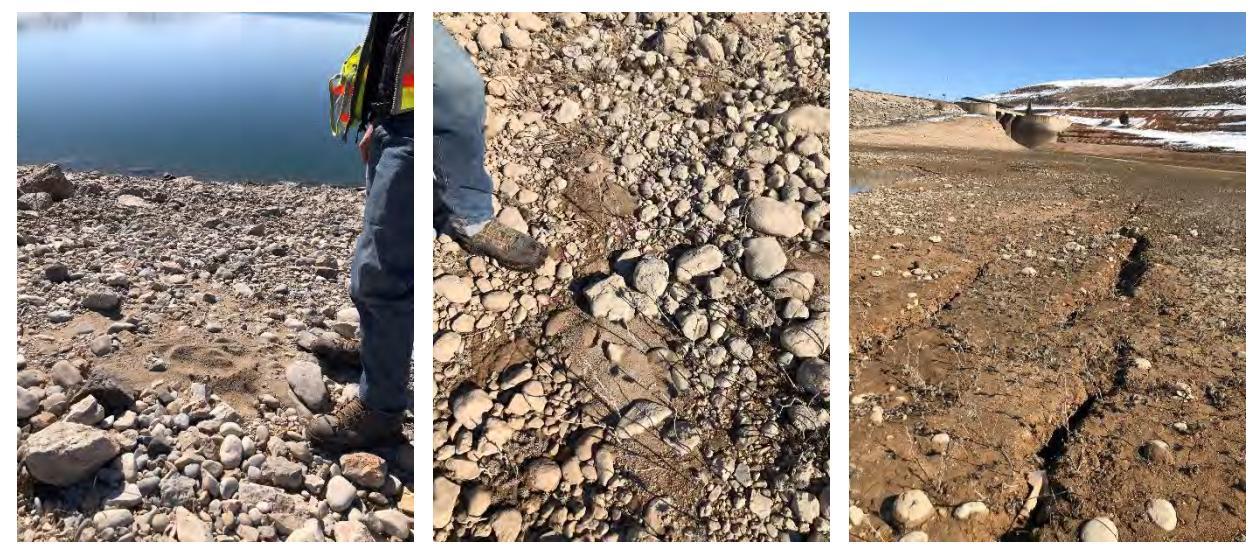
On the dam body nearby the water level at the reservoir, liquefaction manifestation (soil ejecta) was observed (see Figure 6.2). Findings at the site reveal the suspicion of a composite failure mechanism. First, a transitional slide took place due to liquefaction on the dam body near the water level (see Figure 6.1c). Then, a rotational slide occurred starting from the crest due to loss of strength at the point where cracks formed due to the first mechanism (see Figure 6.1b). On the other hand, no damage was detected on hydraulic structures (spillways, bottom outlets, gates, etc., see Figure 6.3).

a) 38.31860° N, 38.05129° E b) 38.31770° N, 38.05549° E c) 38.34652° N, 38.0593° E **Figure 6.2.** a, b) Sand boils on dam surface, c) lateral movements on reservoir area

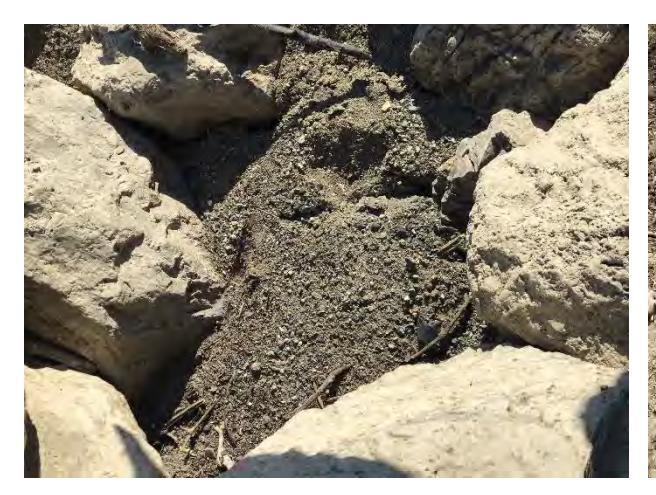
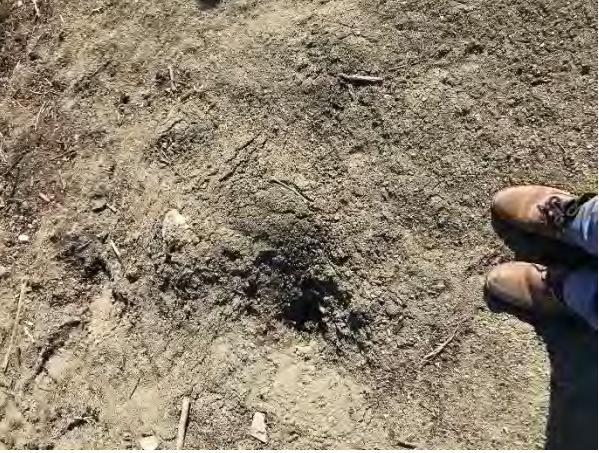
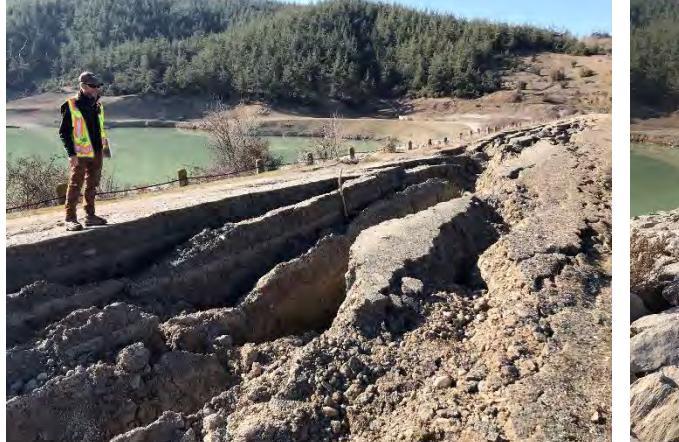
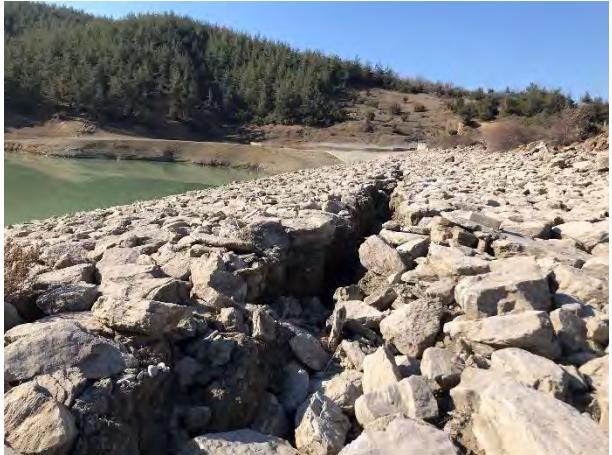
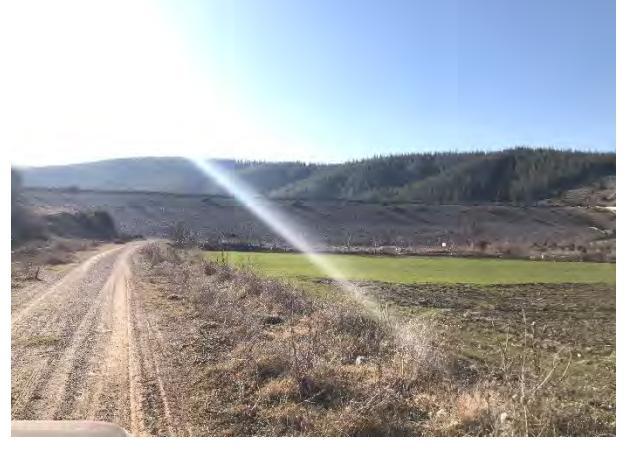
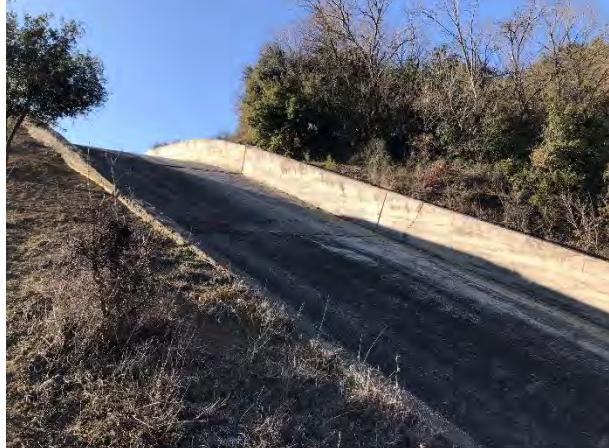
Arıklıkaş Dam is another critical zoned earth-fill dam constructed between 1994-1998 in Osmaniye for irrigation purposes. The crest height from the foundation level is 25 meters. The earthquake-induced permanent lateral displacement was observed at the crest and the upstream side of dam body similar to Sultansuyu Dam (see Figures 6.4a and b). Besides, the failure mode is similar. The surface manifestation of liquefaction was observed on the dam body near the water level and reservoir area.

The earthquake-induced lateral deformation towards upstream side was observed as 1.95 m at most at the crest whereas the maximum lateral deformation was 1.2 m on the dam body toward upstream (see Figures 6.4c and 6.4d). No damage was detected on the hydraulic structures except for minor cracks on the wing walls at the spillway outlet. The downstream dam body performed great against leakage since no water leakage was detected on the surface (see Figures 6.4e and 6.4f). No manifestation regarding the liquefaction at downstream side was noted. The ground water level was about 6 m below the talweg level which confirms the positive cut-off of Arıklıkaş dam is still functioning well.

**Figure 6.4.** Sand boils on a) dam body, b) on reservoir near dam body; Permanent lateral displacement c) at crest, d) at upstream dam surface; e) earth-dam view from downstream, f) wings at the outlet of spillway

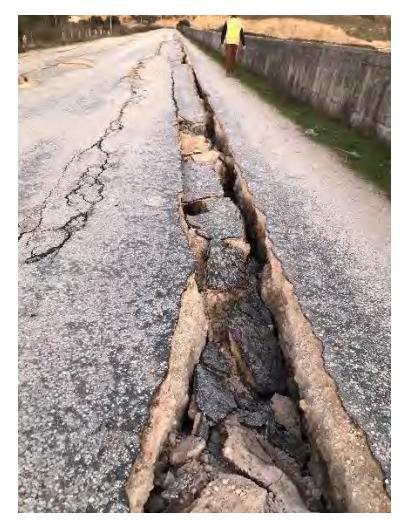
Yarseli Dam is a clay sand-gravel dam constructed between 1985-1991 in Antakya for irrigation purposes. The crest height from the foundation level is almost 43.5 meters. A typical cross-section of Yarseli Dam is given in Figure 6.5. Unlike the previous earth dams, the lateral movement was toward downstream (see Figure 6.6a). The hydraulic structures seemed functional because they experienced no damage (see Figure 6.6b).

a) 36.19436° N, 36.32891° E b) 36.19497° N, 36.32190° E Figure 6.6. a) Cracks on the crest of Yarseli Dam, b) gates and spillways (courtesy of DSI)

The seismic compression during earthquakes resulted in the crest cracks. The permanent lateral displacements vary between 5-30 cm. There was no sand boil on the earth-dam body, but at the edge of the dam body on the downstream side, where the projection of the crest with the broader lateral deformation lay on this location, sand boils, and liquefaction-induced lateral spreading was detected. (see Figure 6.7).

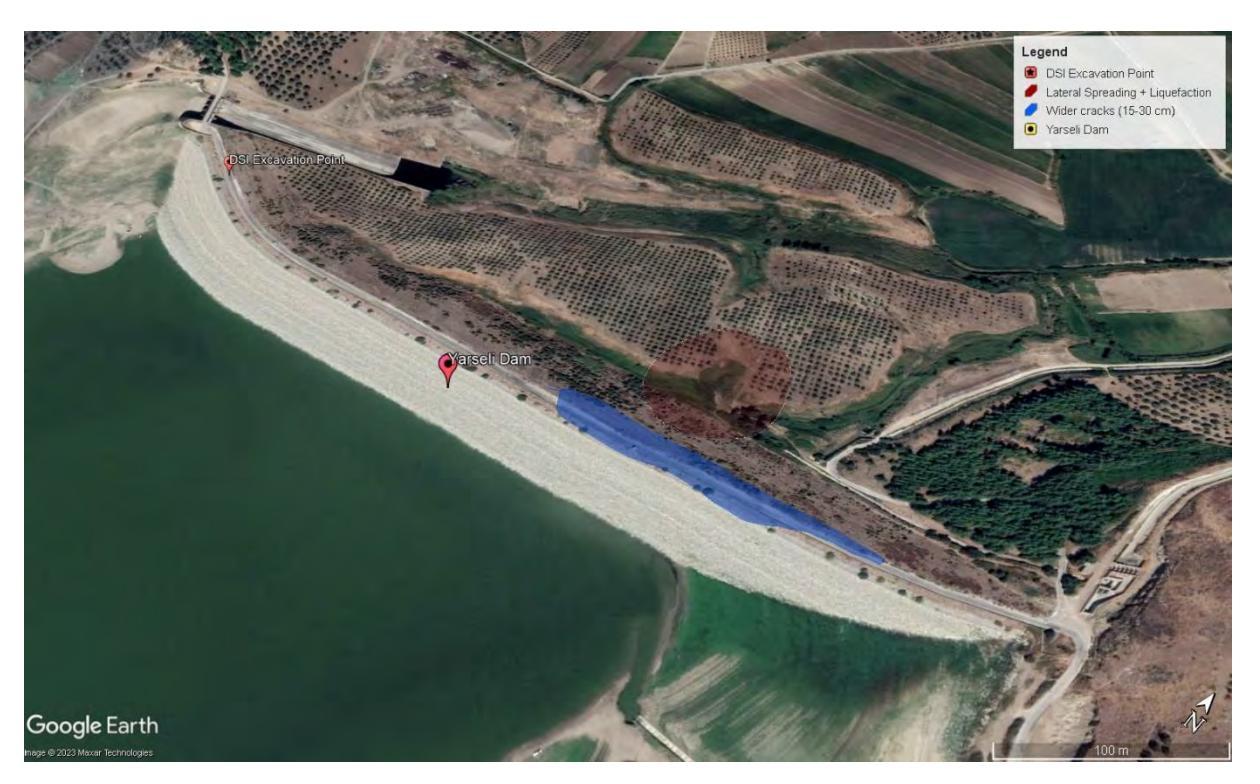
Figure 6.7. Demonstration of Yarseli Dam regarding findings obtained site visit

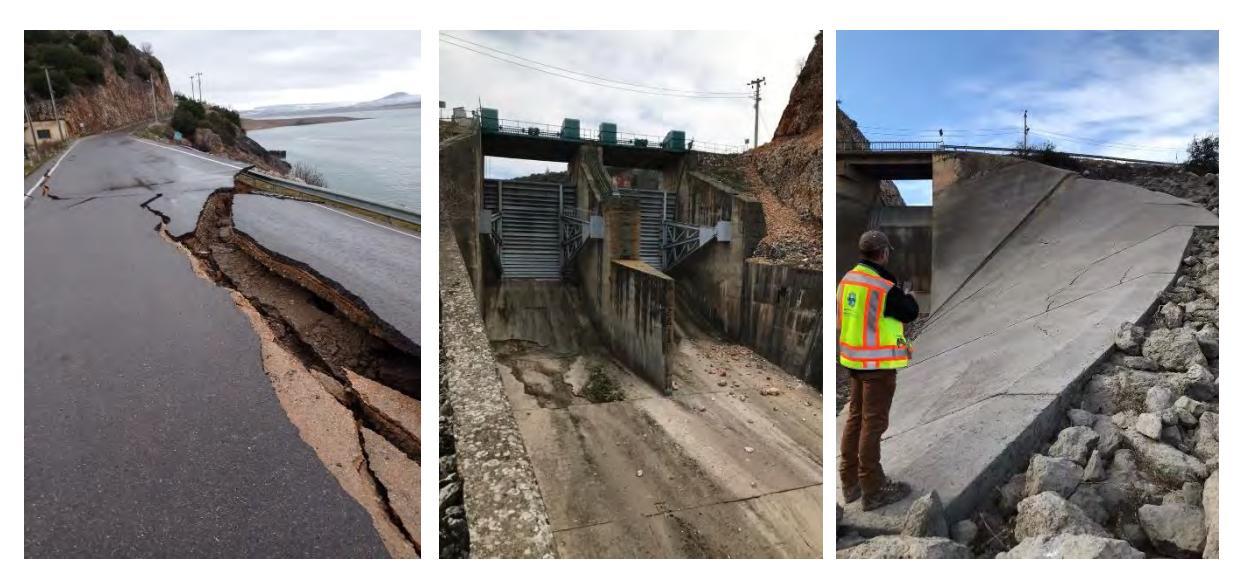
Since the reservoir has already been almost empty due to the present climate conditions, leakage through the spillway gates has not been controlled, yet (see Figure 6.8b). Wings located at the water inlet through the gates have damage due to intense shaking because the dam is too close to the epicenter of Mw=7.7 Pazarcık Earthquake (see Figure 6.8c). One segment moved toward the earth dam, where seismic compression occurred. Besides, there are no connections between segments on the wings so that damaged segments easily move apart. Surface manifestation of liquefaction was not detected neither on the dam surface, nor nearby the dam body.

a) 37.46811° N, 37.23947° E b) 37.46838° N, 37.23856° E c) 37.46811° N, 37.23947° E **Figure 6.8.** a) Cracks on crest, b) radial gates and spillway, c) wings on the inlet of gates
