# Türkiye Earthquake

## **RECONNAISSANCE REPORT**

February 6, 2023 Kahramanmaraş-Pazarcık ( $M_w$ =7.7) and

Elbistan (M<sub>w</sub>=7.6) Earthquakes

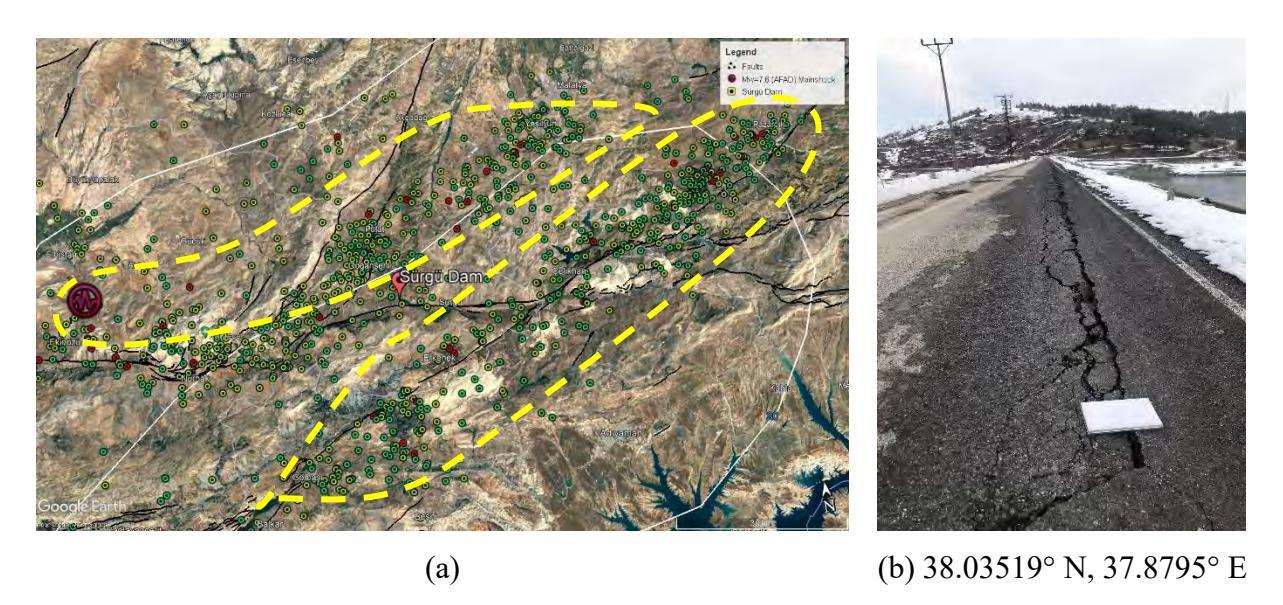
The Sürgü Dam is an earth-fill dam constructed between 1965-1969 in Malatya for irrigation purposes. The crest height from the stream level is almost 57 meters. Dam's location is critical since the nearby faults ruptured during the 7.7  $M_w$  and 7.6  $M_w$  events according to the spatial distribution of aftershocks, except for the one passing through the dam (see Figure 6.9a). For this reason, no significant damage was detected on the crest and the earth-dam body. Cracks on the crest seem like seismic landslide stability problem with 14-20 cm crack width (see Figure 6.9b). Hydraulic structures got no damage except for the small cracks on the wings of the spillway at the outlet.

Figure 6.9. Sürgü Dam, a) spatial distribution of aftershocks, b) cracks on the crest

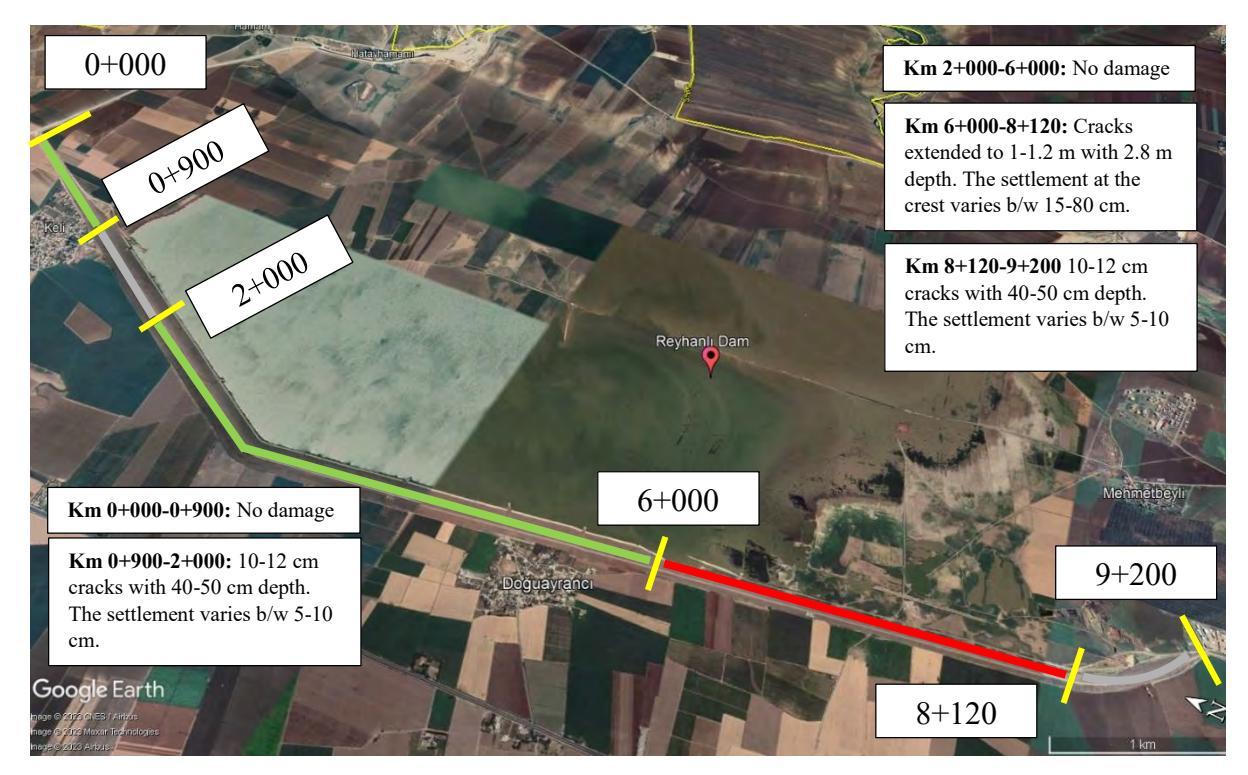
Figure 6.10 depicts the spatial distribution of the cracks on the crest roughly regarding the dam position. The red line code emphasizes the most critical part, where the dam cross-section is the second one shown in Figure 6.11b. The cracks extended to 1-1.2 meters with 2.8 meters depth, whereas the settlement at the crest reaches 50-80 cm according to the site observations (see Figure 6.11). The earthquake-induced permanent lateral deformation is toward the upstream side. The surface manifestation of liquefaction was not observed at the dam body and the ground nearby the dam.

Figure 6.10. Spatial distribution of cracks and settlements on the crest in Reyhanlı Dam

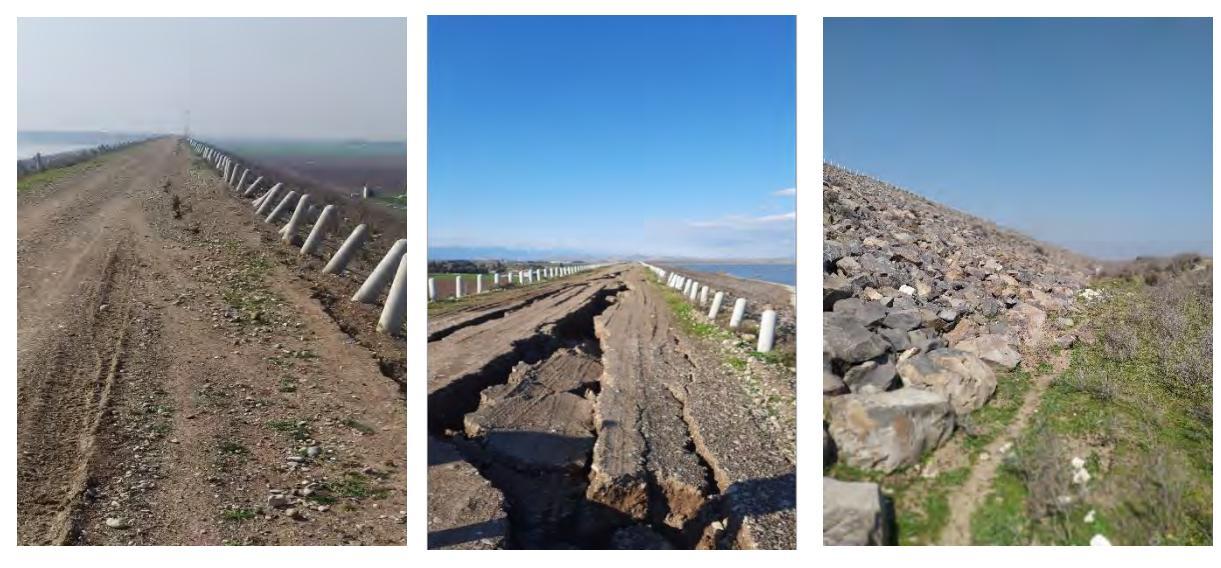
a) 36.37758° N, 36.56494° E b) 36.55659° N, 36.55659° E b) 36.32988° N, 36.55695° E **Figure 6.11.** a, b) Cracks on the crest and c) dam body view from upstream (courtesy of DSI)

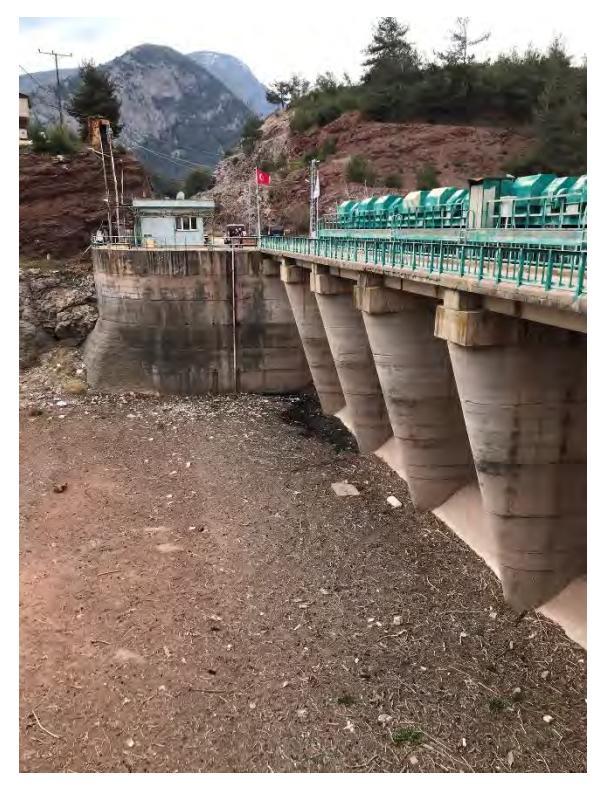
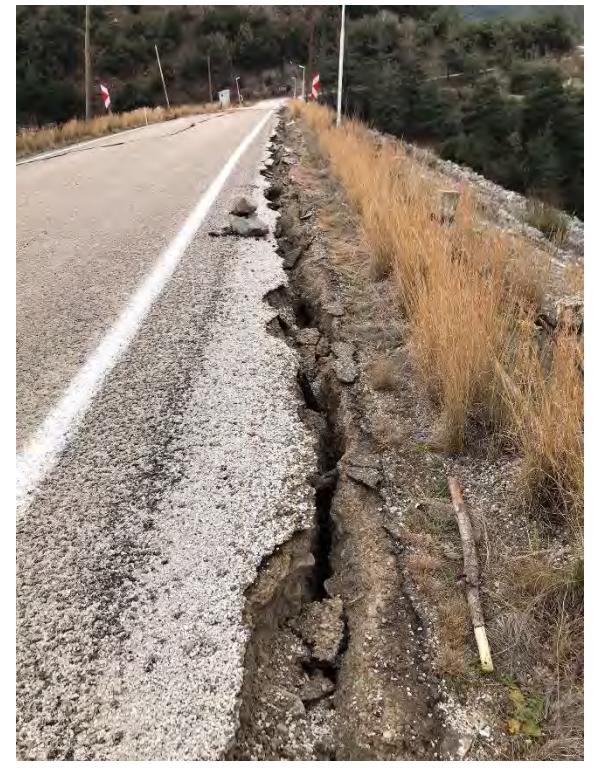
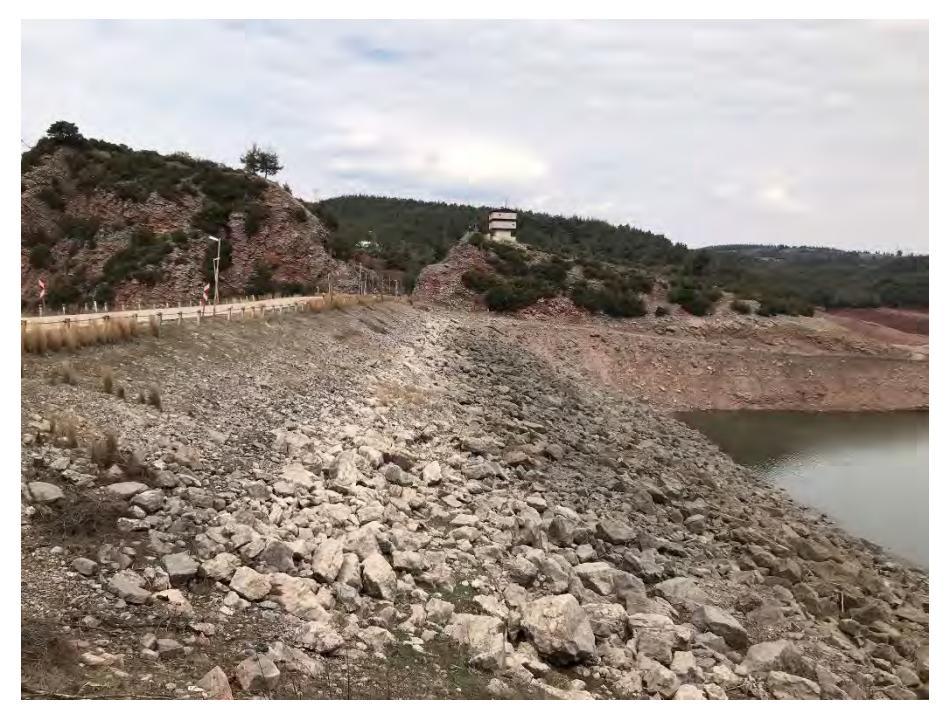
The Kalecik Dam is a clay core rockfill dam constructed between 1983-1985 in Osmaniye for irrigation purposes. The crest height from the foundation level is 80 meters. Earthquake-induced lateral deformations and settlements were observed at the crest. The deformation direction is upstream and downstream, but the failure mechanism has not been clearly understood yet. The settlement values vary 10-40 cm along with the crest, and the maximum lateral deformation was measured as 40-50 cm towards both upstream and downstream separately. Bulges formed on the dam surface in both directions around 5-8 m away from the crest level. The hydraulic structures seem functional, and no liquefaction manifestation was detected (see Figure 6.12).

**Figure 6.12.** a) Hydraulic strucres in Kalecik Dam, b) cracks observed at the crest and c) slope at upstream (courtesy of DSI)

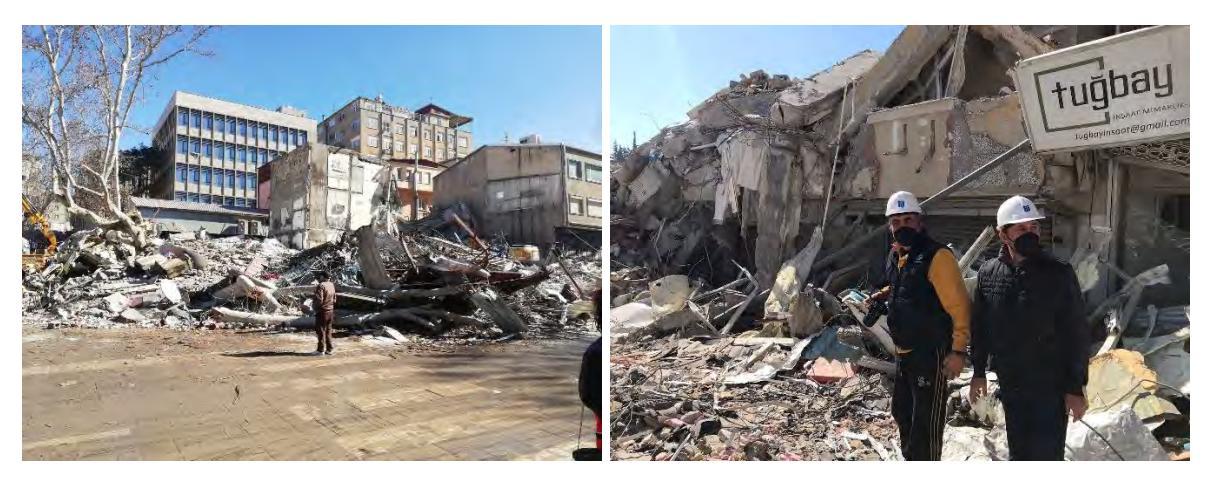
Typical deficiencies of the frame buildings constructed before 2000 were the use of smooth reinforcing bars, insufficient steel reinforcement detailing and possibly low concrete strength resulting in heavy damage and collapse (Figure 7.1). The presence of soft story in the ground level or above the plinth was one of the key reasons of collapse in many buildings. The use of the ground floors as commercial stores with little or no infill walls were responsible for plastic hinging in columns occurred resulting in pancake type collapse as observed in previous earthquakes (Kocaeli 1999, Van 2011). This is displayed in Figure 7.2. Several buildings have experienced beam-column joint failures. Another interesting type of failure was the overturning of the building from its base due the inability of transferring lateral forces to the foundation (Figure 7.3).

Figure 7.1. Building Collapse in Antakya and Kahramanmaraş

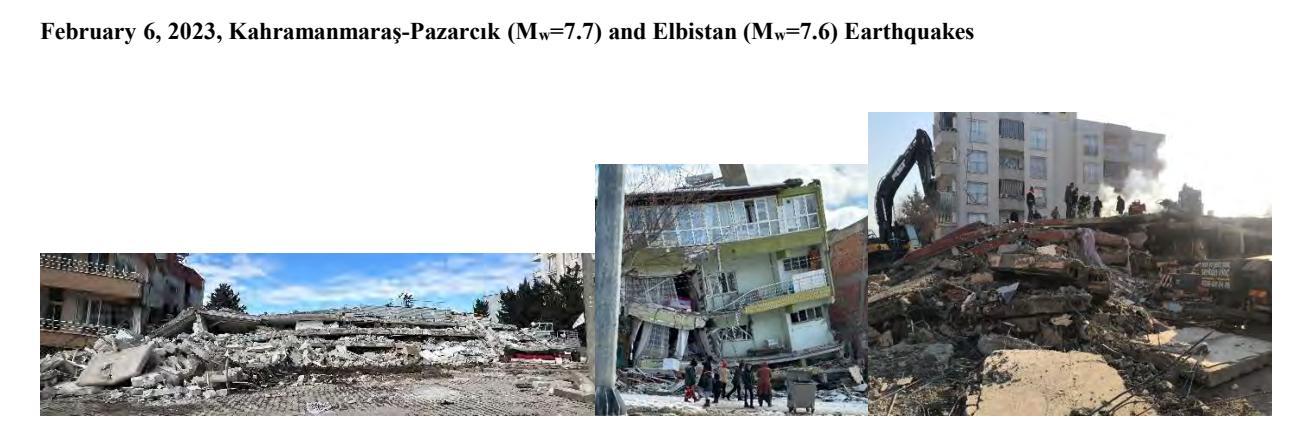
Figure 7.2. Building Collapse in Malatya

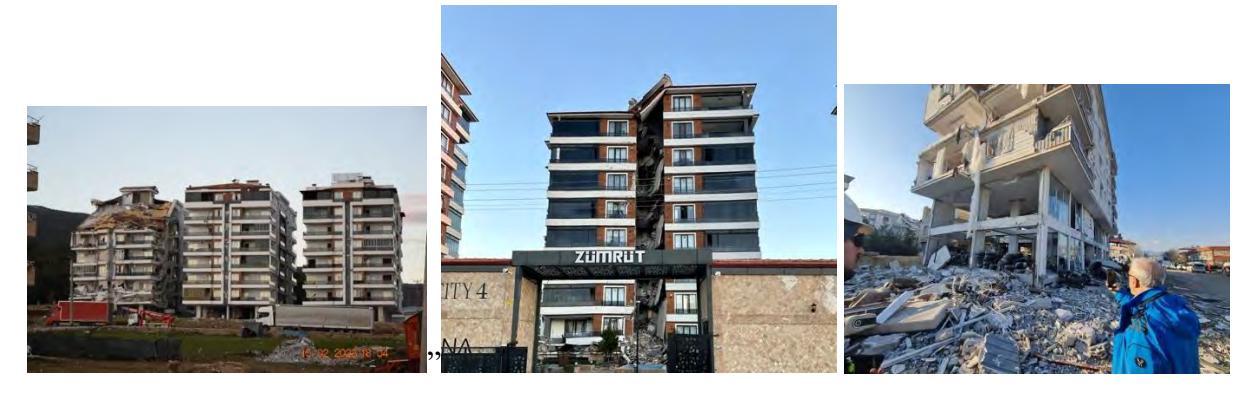
These buildings presumed to be designed and constructed according to the codes performed better than the older buildings. However, more than 1000 buildings constructed after 2000 were heavily damaged or collapsed violating the code given performance objective. This appears to be an important observation demanding further investigations on the design and construction quality of those buildings. Some examples of these heavily damaged buildings are shown in Figure 7.4. The possible reasons for these damages can be attributed to i) the use of flexible joist slabs as diaphragms, ii) insufficient engineering design to distribute lateral forces to vertical load bearing elements perhaps due to the blind use of building design softwares, iii) possible detailing errors on building construction site, iv) underestimation of seismic demands, iv) insufficient investigations geotechnical site investigations prior to building construction and poor foundation design especially in Hatay and Gölbaşı regions. Such heavy damage observed in new buildings bring concerns about the target seismic performance of residential buildings nearly in compliant with the current seismic code. The significant disruption of city life, heavy monetary loss, and long recovery times may require reassessing the performance targets of buildings. Tunnel form buildings in the region performed in an outstanding manner (Figure 7.5) with some damage in the coupling beams and infill walls due to the following key reasons: i) the use of more shear wall area more than usually 2.5% of the floor area, ii) siting at stiff soil or rock sites, iii) midrise construction ranging from (4 to 8 stories). This performance provided further confidence in the use of significant shear wall area for the buildings constructed in high seismic zones.

Figure 7.4. Heavily damaged new buildings in Adıyaman and İslahiye

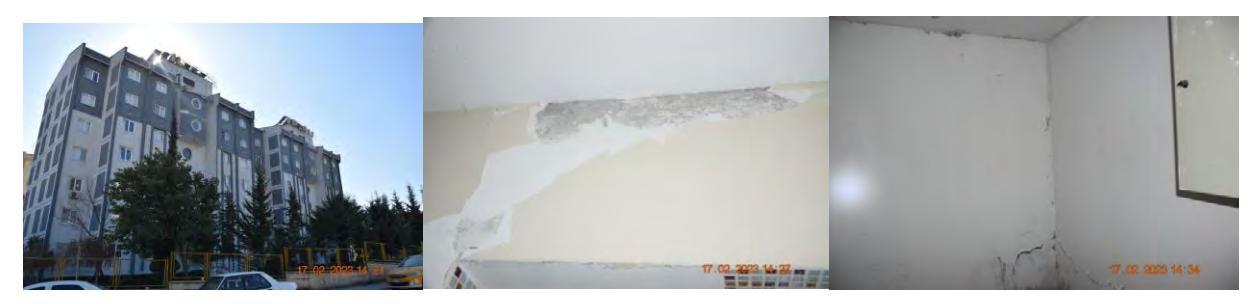
Figure 7.5. Performance of a tunnel form building

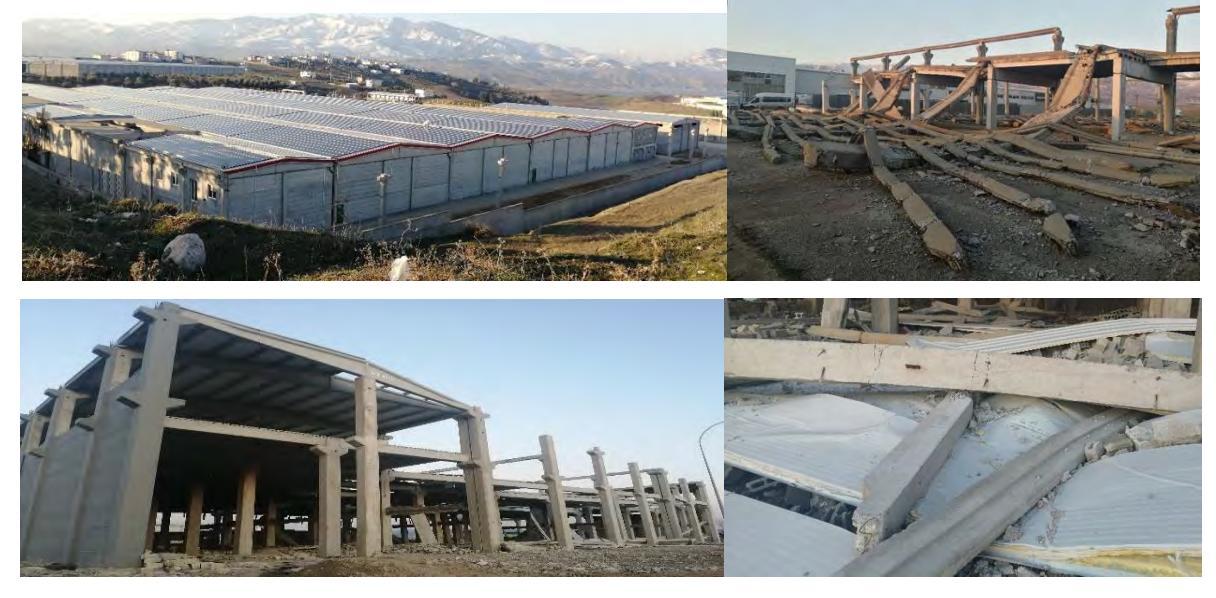
Industrial Regions in Kahramanmaraş and Gaziantep have many precast concrete buildings with one or two stories. Typical main direction of the buildings has a span of about 20 m, and the other direction has a span of 7.5 m. The story heights vary between 7 to 10 m. The building frame columns are fixed at the base with a socket connection, whereas the prestressed (for long spans) roof girders are pinned to the column corbels usually with two grouted anchors embedded into the corbels. Typical buildings are shown in Figure 7.6. Two buildings that were under construction collapsed due to overturning of the girders. The failure is assumed to be initiated at the pin connections under the lateral force demands. Interestingly no indication of column base hinging was observed. In Gaziantep, most of the prefabricated buildings showed satisfactory performance.

Figure 7.6. Overview of precast industrial building connection damage in Kahramanmaraş

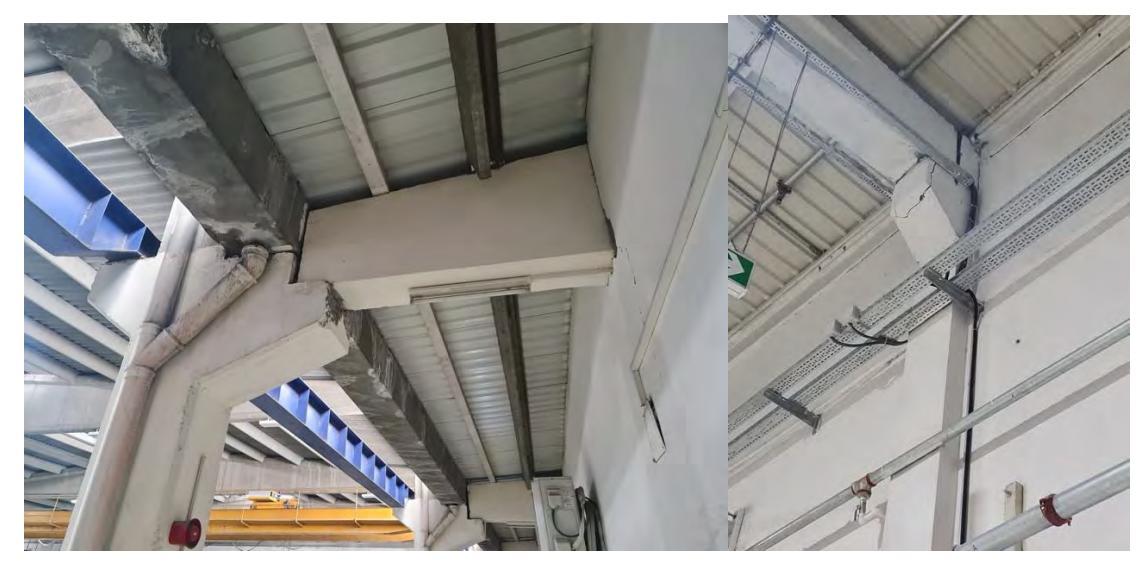
In a few lightly damaged buildings, the typical damage was observed in column corbels due to the girder rotations causing local crushing of concrete, which is repairable (Figure 7.7).

Figure 7.7. Corbel damages in Gaziantep

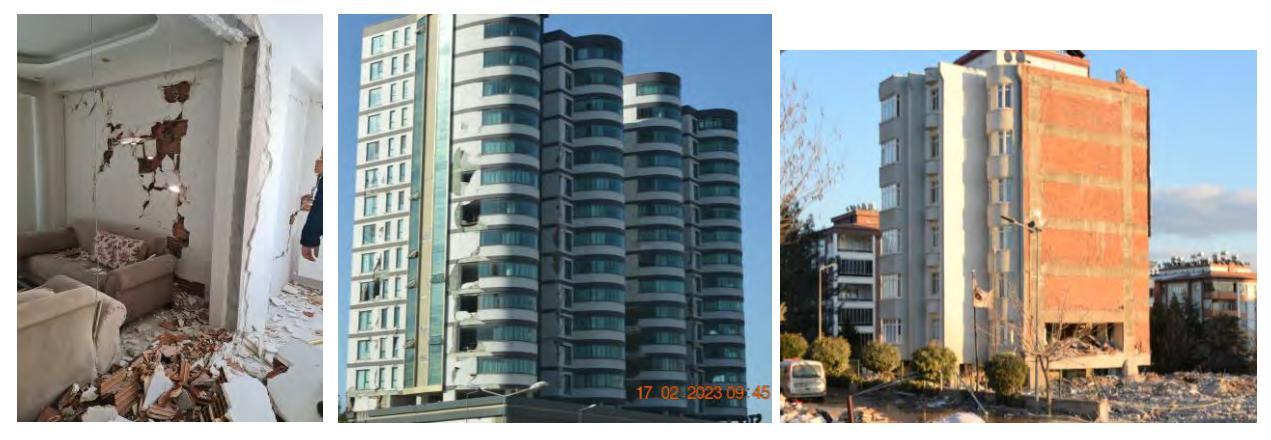
One of the most important non-structural damage in the region was observed in the infill walls. Several levels of damage events were observed depending on the strong ground motion levels (Figure 7.8). At low ground motion levels (< 0.1 g), the infill wall-column/beam interfaces cracked. At moderate levels, the infill walls sustained inclined cracks with varying widths (0.5-2 mm).

Figure 7.8. Infill wall damage examples

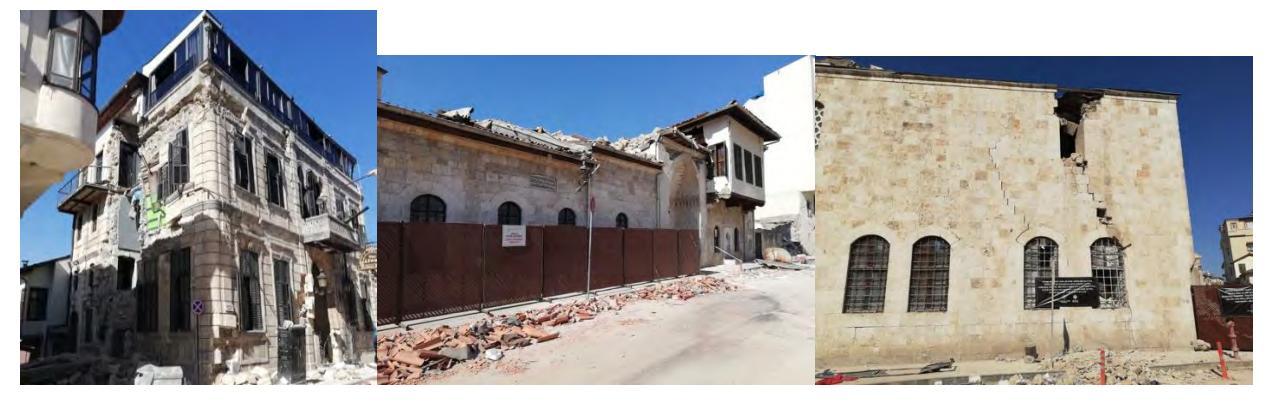
Masonry construction constitutes the second largest type in Turkish building inventory. Although the percentage of masonry buildings in urban areas is low, it is more common in rural areas. Similar to the other buildings, non-engineered masonry building stock in the region either suffered significant damage or collapsed under the two earthquake motions (Figure 7.9). However, the collapse of masonry buildings constructed with relatively better materials having 1-3 stories was less compared to 8-10 story RC buildings. It appears that the height and rigidity of the buildings played an important role. Besides, many historical masonry buildings suffered heavy damage or collapse due to strong shakings that they experienced.

Figure 7.9. Damage in masonry structures

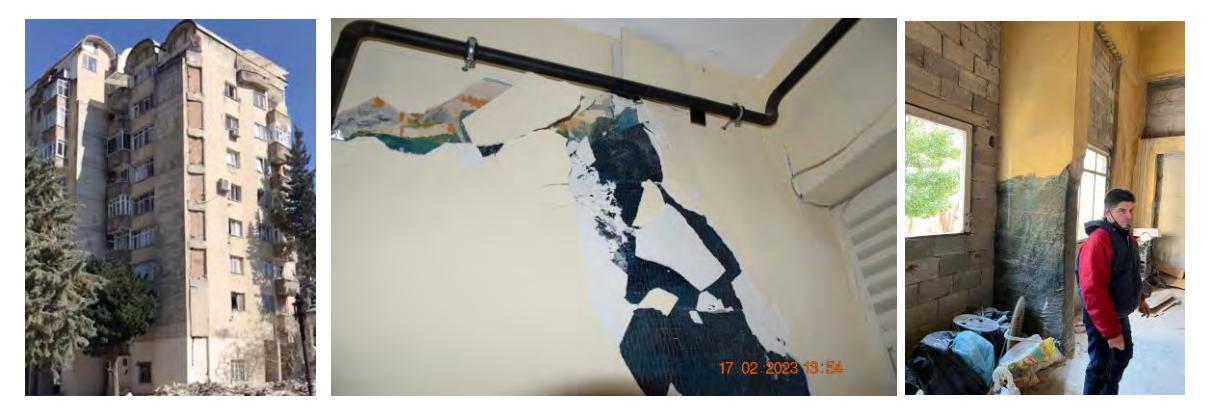
One building strengthened in 2008 by the METU team with the addition of shear walls, fiber reinforced polymers was visited in Hatay. None of the strengthened buildings collapsed while some damage was observed, as shown in Figure 7.10. These observations that will be extended in further site visits seem to encourage the wider spread application of building strengthening.

Figure 7.10. Performance of the strengthened building in Hatay

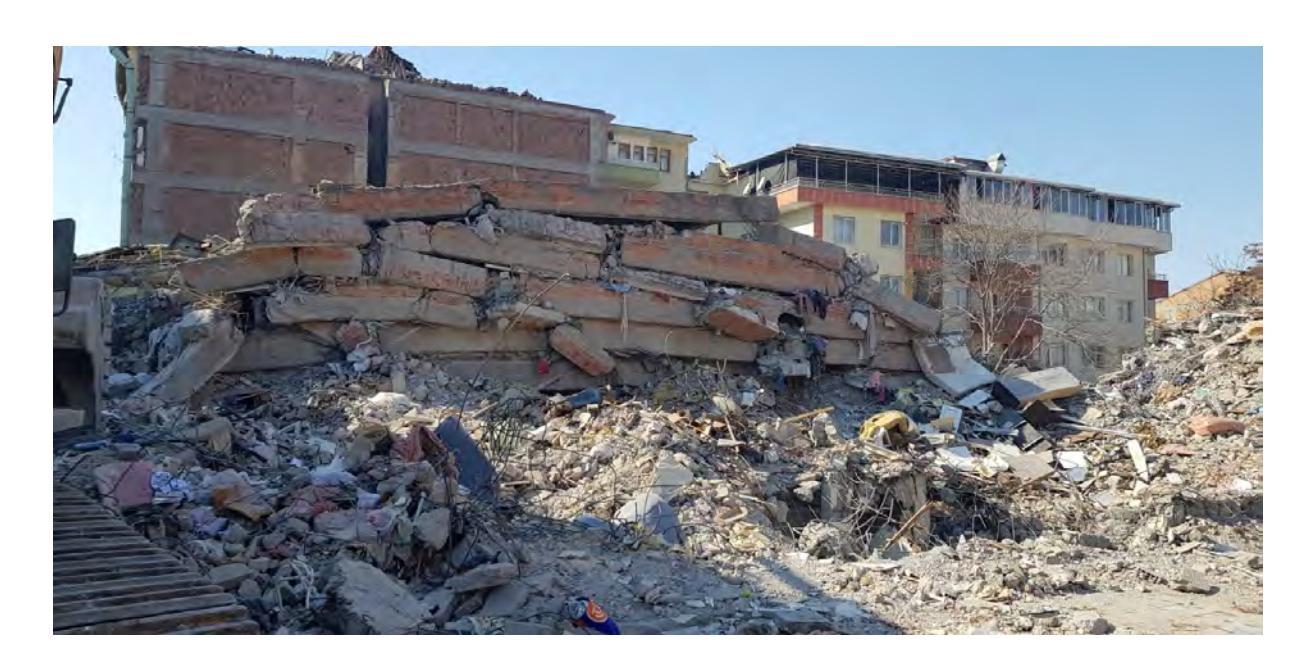
The results of the field survey conducted in the center of Malatya reveal that there are numerous collapsed structures. The old building stock is typically to blame for these collapses. Also, new buildings were collapsed in the Bostanbaşı District, Malatya. Due to aftershocks, the exact number of the collapsed buildings increase. According to observations, structural design, material defects are the main causes of collapses. The first notable factors are inadequate reinforcement, design mistakes in structural system, use of unribbed reinforcement, low concrete strength and inappropriate aggregate gradation (Figure 7.12-17).

Figure 7.12. Structural collapses in Malatya city center-1

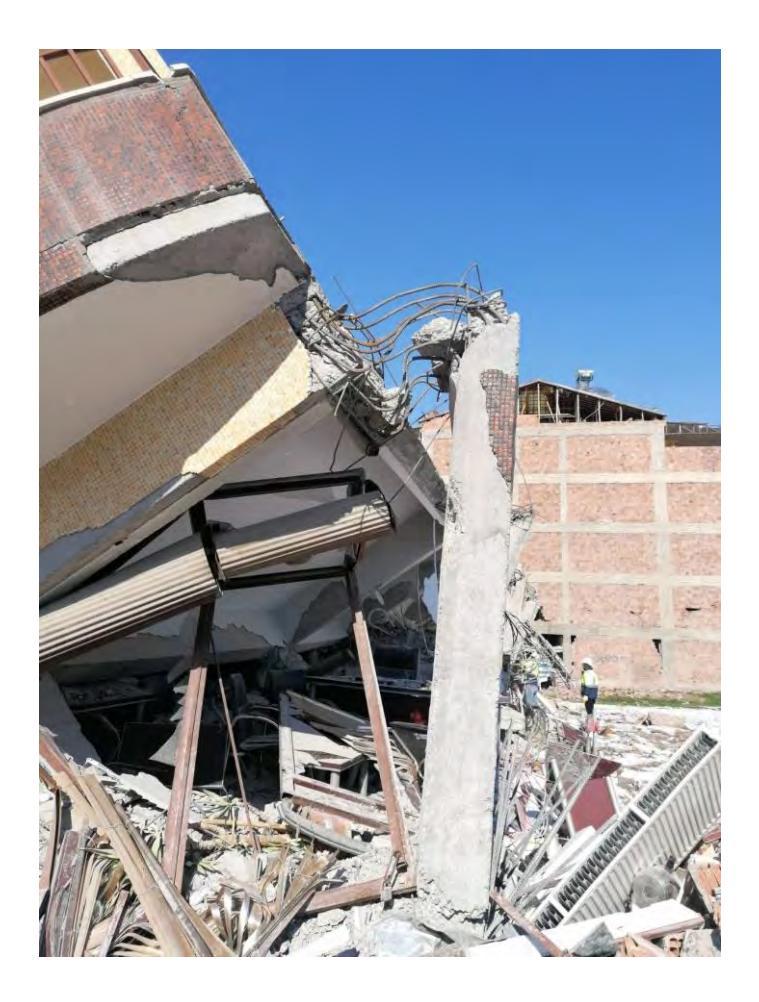
Figure 7.13. Structural collapses in Malatya center-2

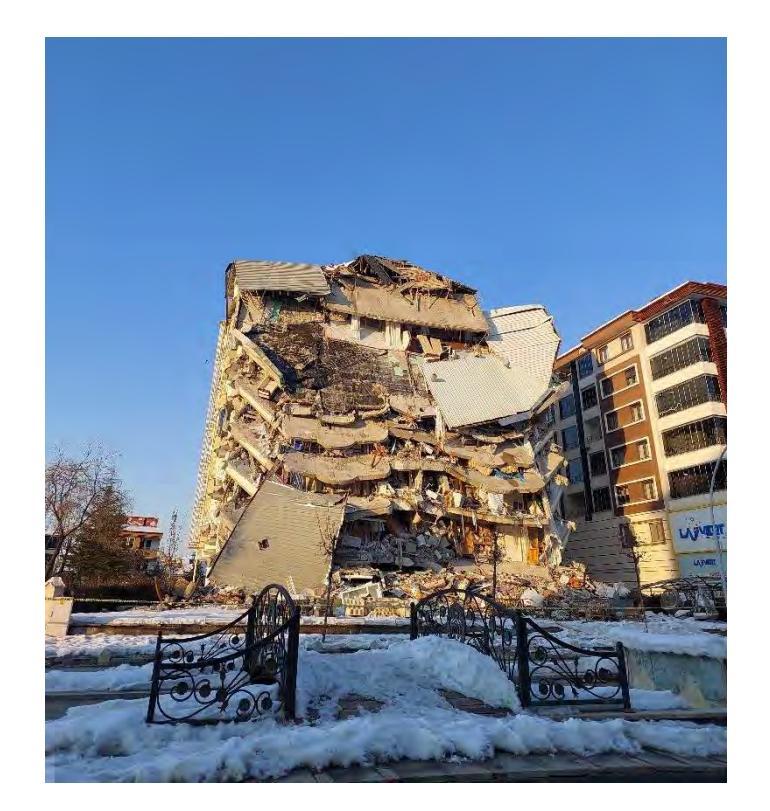
Figure 7.14. Structural collapses in Malatya center-3

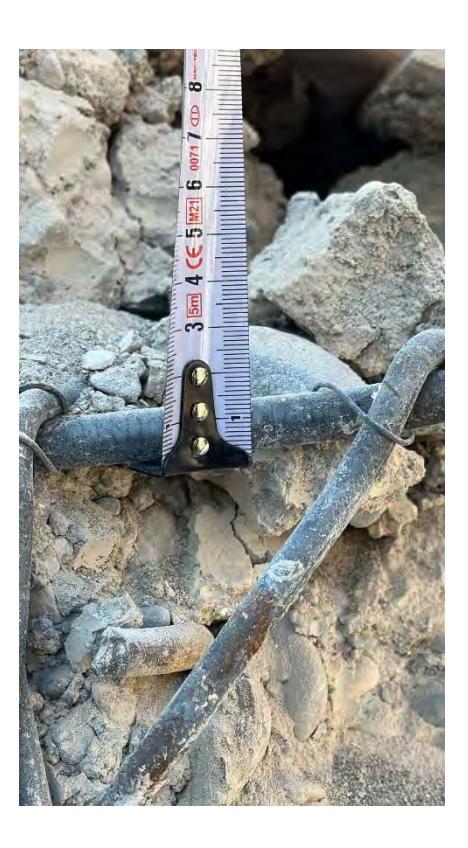
Figure 7.15. Unribbed reinforcement in Malatya Center

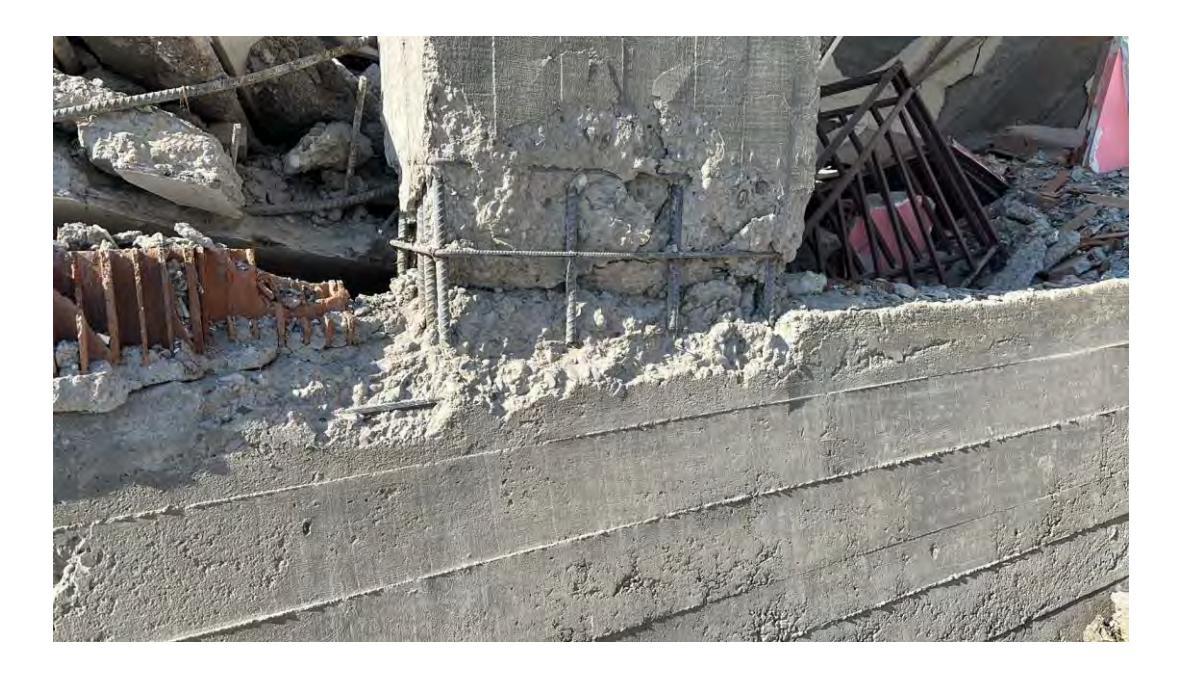
Figure 7.16. Structural collapses in Malatya center-4

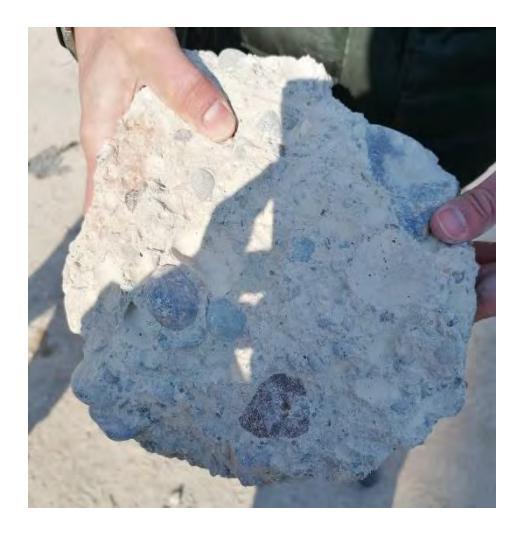
Figure 7.17. Inappropriate aggregate gradation in Malatya

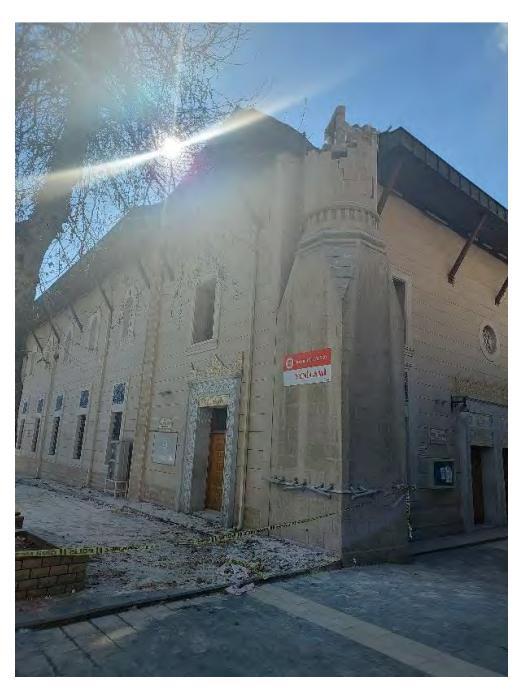
Structural damages were not observed related to soil, liquefaction, lateral spread in the preliminary field surveys conducted in Elazığ. Also, no damage was seen at the retaining structures. One building was collapsed, and about 3309 buildings have been severely damaged so far. In the field studies, it was observed that collapse and damage were caused by structural design, building ages, material, and design defects (Figure 7.18-23). Short columns, improper beam-column connections,

Figure 7.18. Heavy damaged minaret in Elazığ

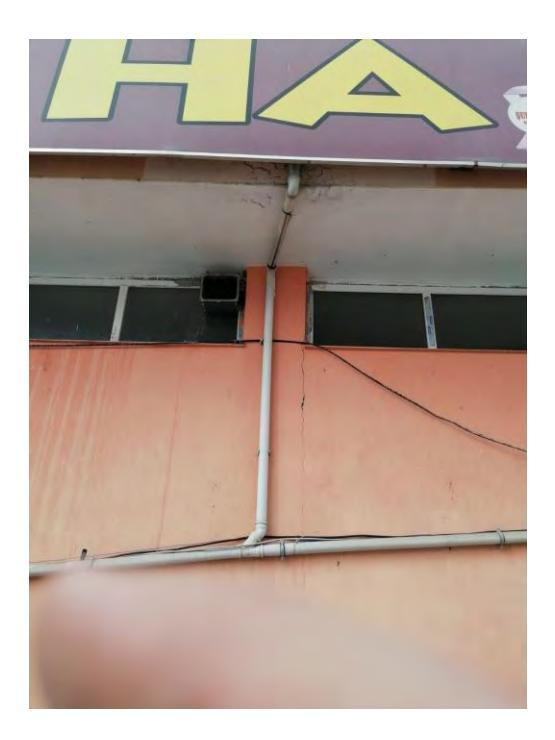
Figure 7.19. An example of short column in Elazığ

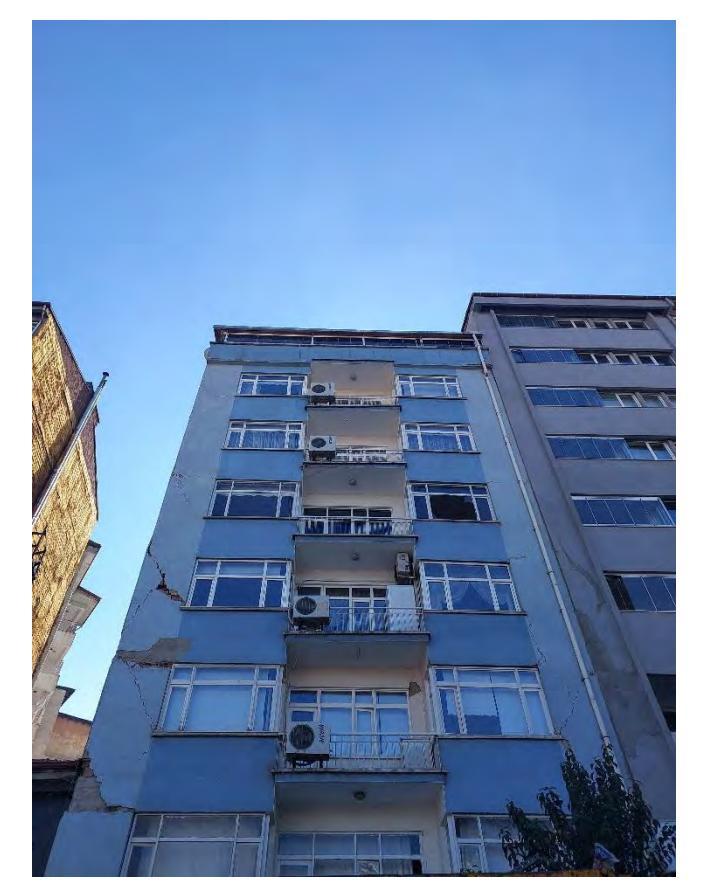
Figure 7.20. Structural damages in Elazığ

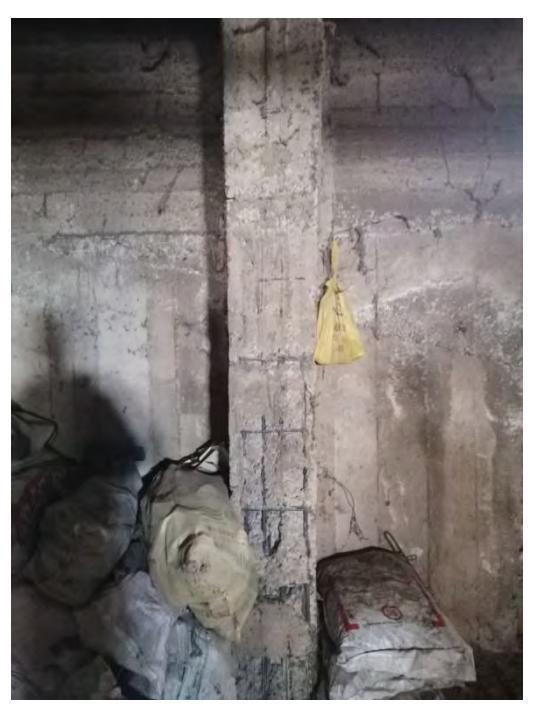
Figure 7.21. Concrete cover and corrosion in Elazığ

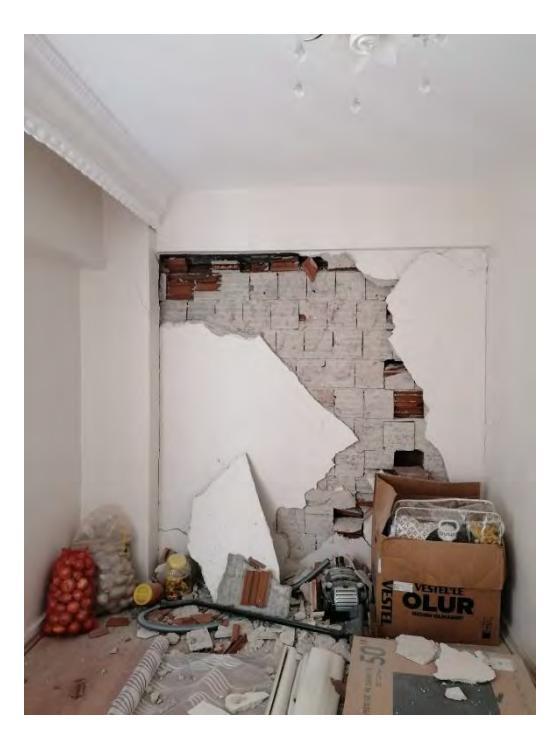
Figure 7.22. Infill wall damage in Elazığ

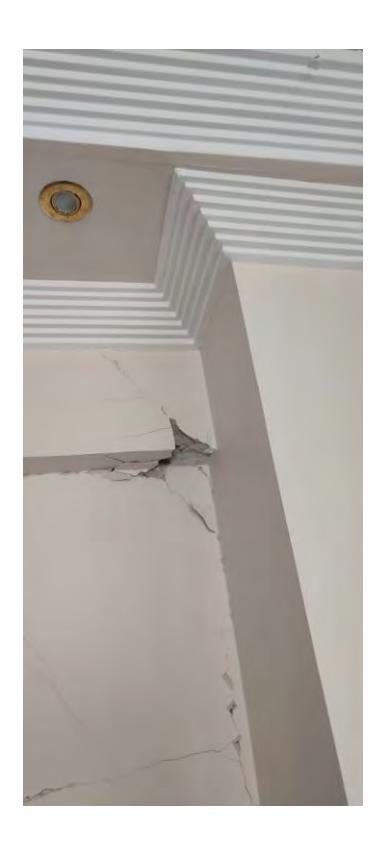
Figure 7.23. Beam damage in Elazığ

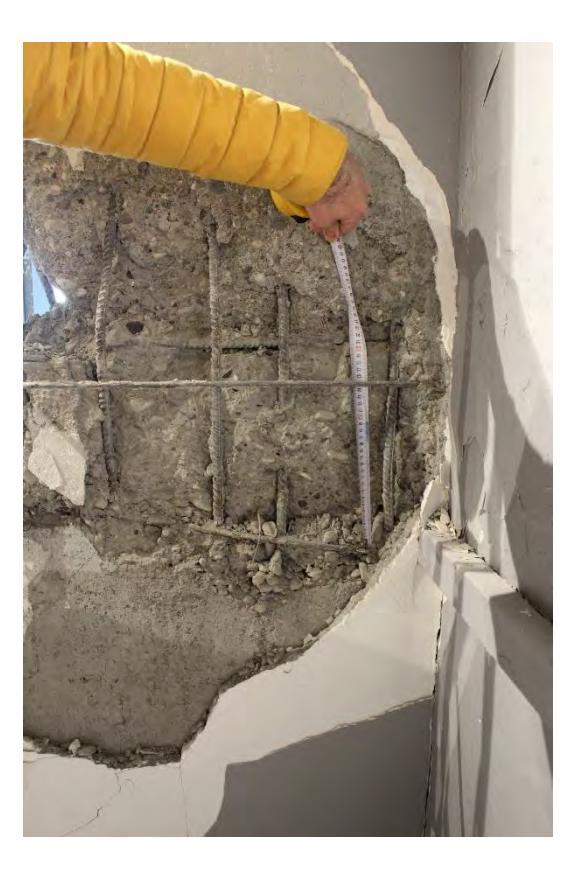
During the Diyarbakır field surveys, no structural damage was not observed caused by soil issues (liquefaction, settlement, etc.). It is believed that the collapses are the result of material defects and improper structural design (Figure 7.24-27) since the city's terrain is typically rock. 194 severely damaged buildings and 7 completely collapsed buildings were observed. The retaining walls in the city center did not have any damage, and there were no issues with slope stability. In the field investigations, there was no evidence of liquefaction.

Figure 7.25. Structural damages at column in Diyarbakır

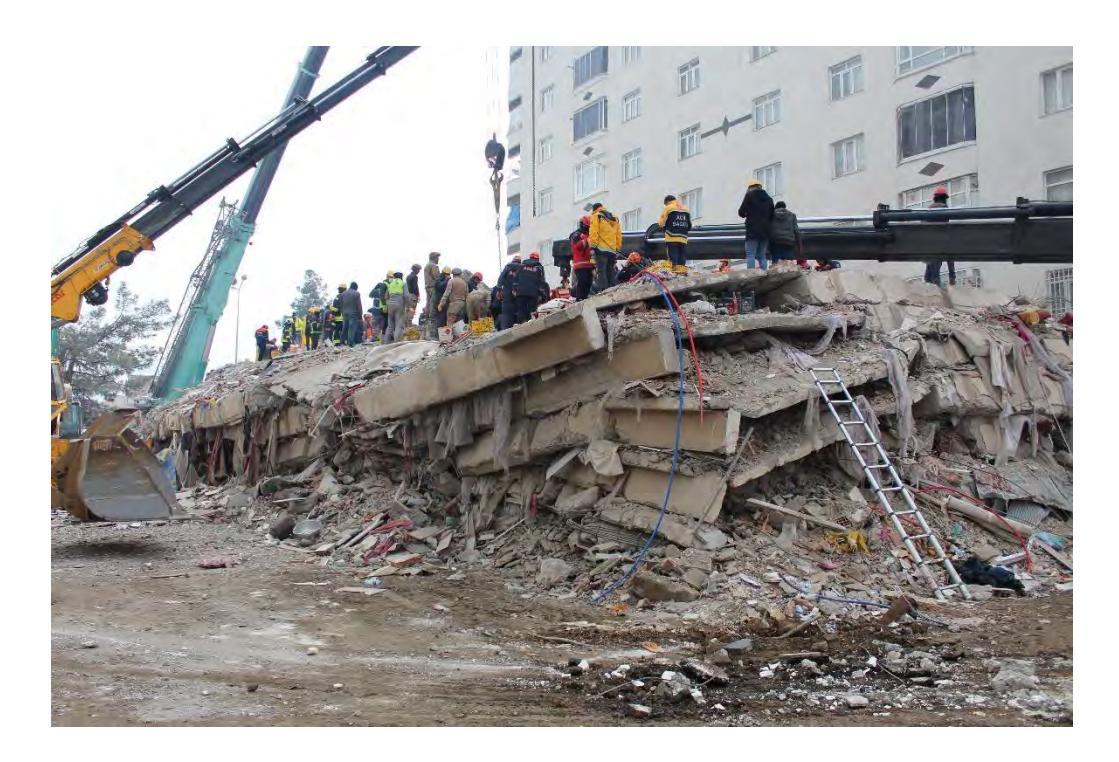
Figure 7.26. Structural collapses in Diyarbakır

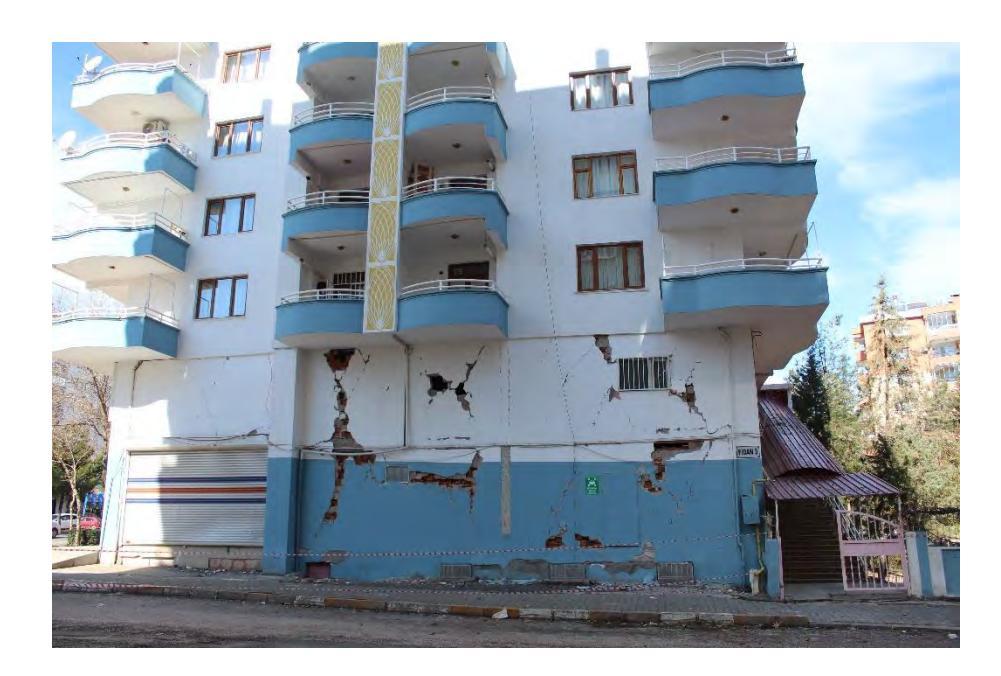
Figure 7.27. Infill wall damages in Diyarbakır

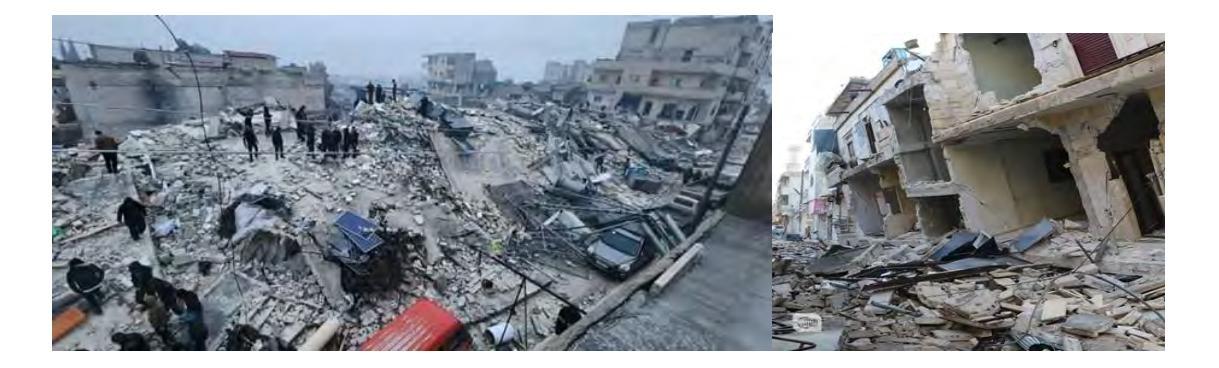
The greatest damage was in the city of Aleppo and its northwestern suburbs (Mostly in Jindires, Afrin, A'zaz, and Sawran). Figure 7.29 shows an example of the destruction in Jindires, where most of the buildings have been totally collapsed or damaged severely.

Figure 7.29. Destruction in Jindires – Afrin, Aleppo, approximate location (36°23'46.76"N, 36°41'14.26"E)

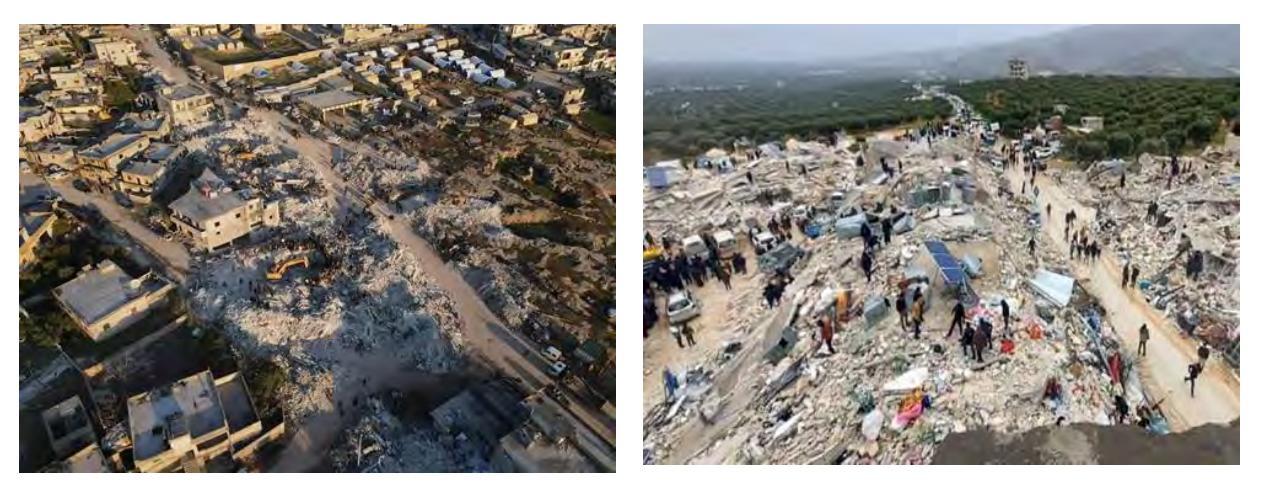
Nevertheless, in Idlib North suburban (Mostly in Harem, Sarmada, Aldana, Salqin, and Armanaz). Figure 7.30 shows the destruction in Harem due to the earthquake.

Figure 7.30. Destruction in Harem, Idlib, approximate location (36°12'45.01"N, 36°31'13.72"E)

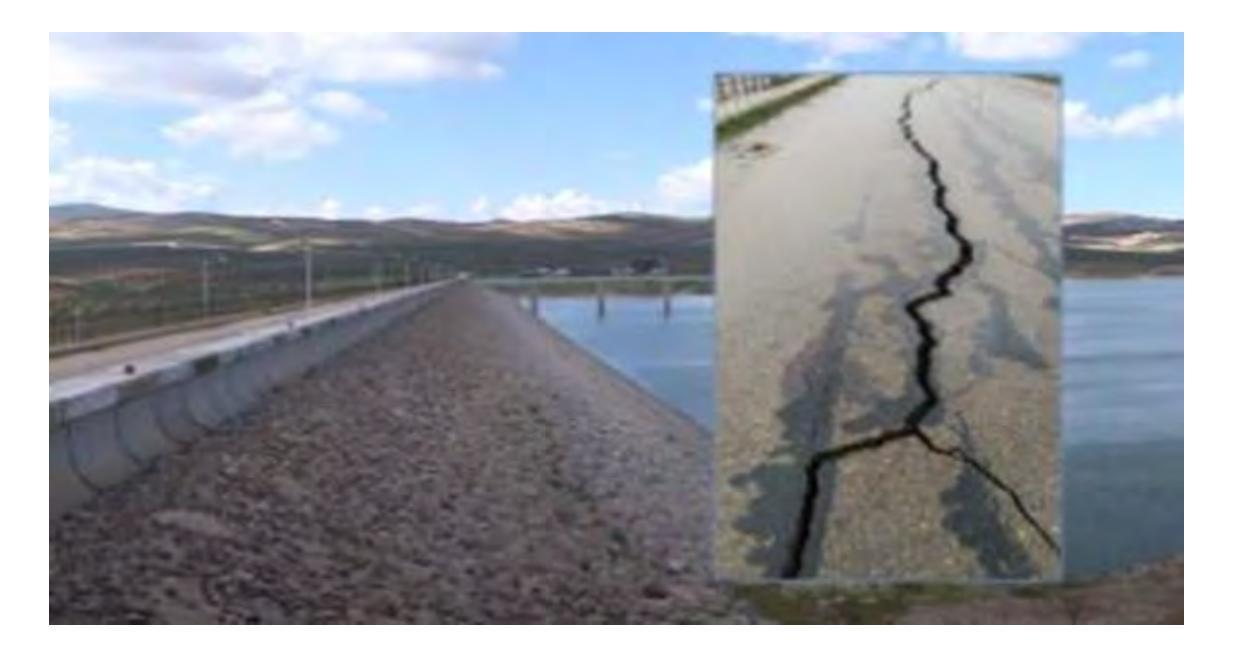
Regarding affected service structures, it was spoken of 17<sup>th</sup> April or Medanki dam in Afrin as being damaged due to the earthquake. But, as per reported by a committee of civil engineers who inspected the dam, there is no visible damage in the body of the dam and there is no water leakage observed. The seen cracks at the top road constructed over it are just in the asphalt layer of the road with a 4cm width and 40cm depth, Figure 7.31.

Figure 7.31. Medanki dam showing the cracks in the road at the crest, (36°37'18.56"N, 36°52'17.19"E), (syria.tv).
