# Türkiye Earthquake

## **RECONNAISSANCE REPORT**

February 6, 2023 Kahramanmaraş-Pazarcık ( $M_w$ =7.7) and

Elbistan (M<sub>w</sub>=7.6) Earthquakes

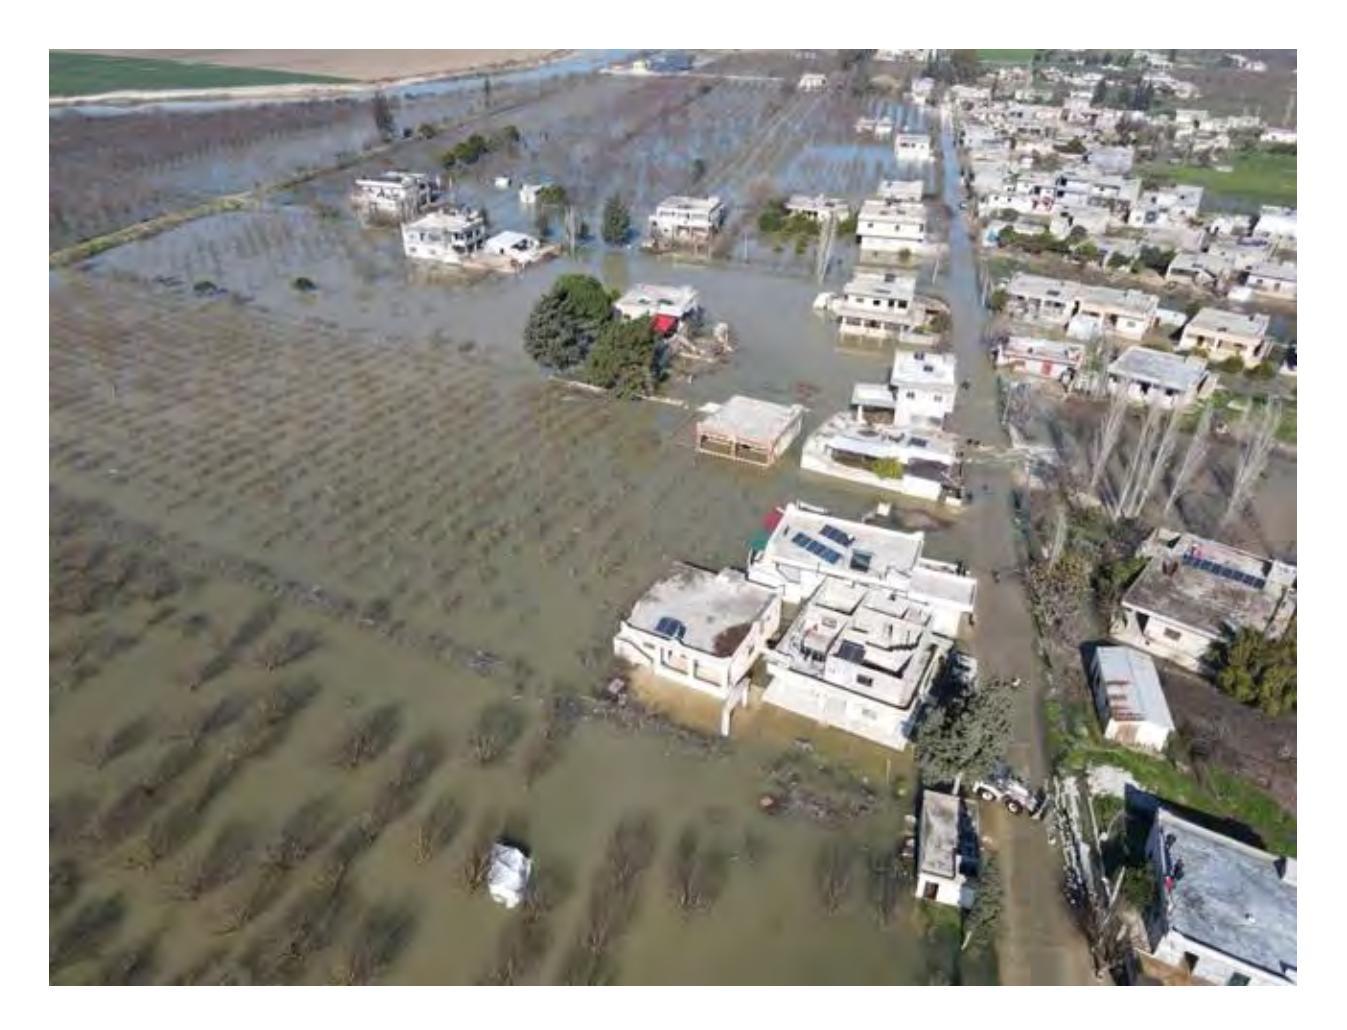
In the Tloul village in the subdistrict Salqin, Idlib, a flood occurred due to an increase in the AlAsi river water level due to the winter season and damage to the constructed mud shoulders on the sides of the river in the mentioned village and its neighborhood resulting in approximately 1000 home affected and evacuation of 7000 people, Figure 7.32.

Figure 7.32. Flooded village of Tloul in Salqin, Idlib, (36°12'42.82"N, 36°23'40.89"E), (nasnews.com).

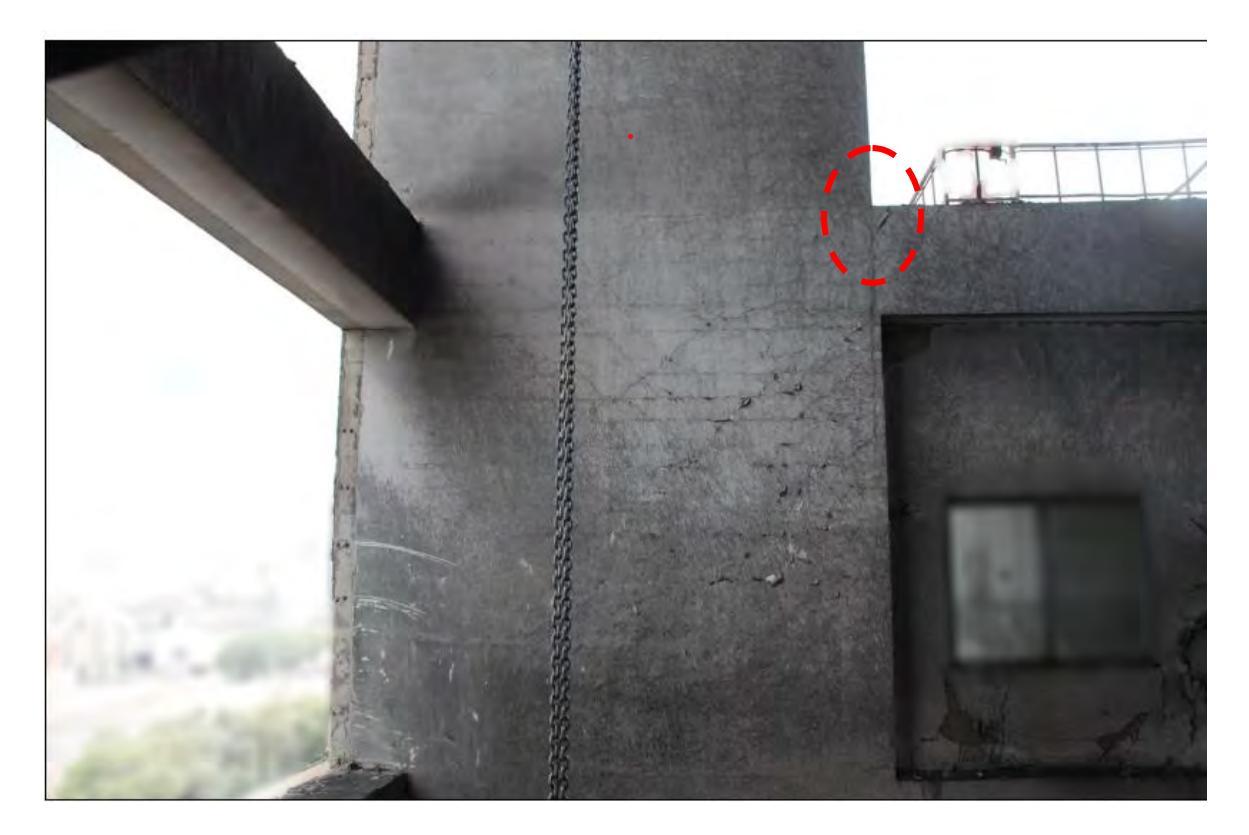
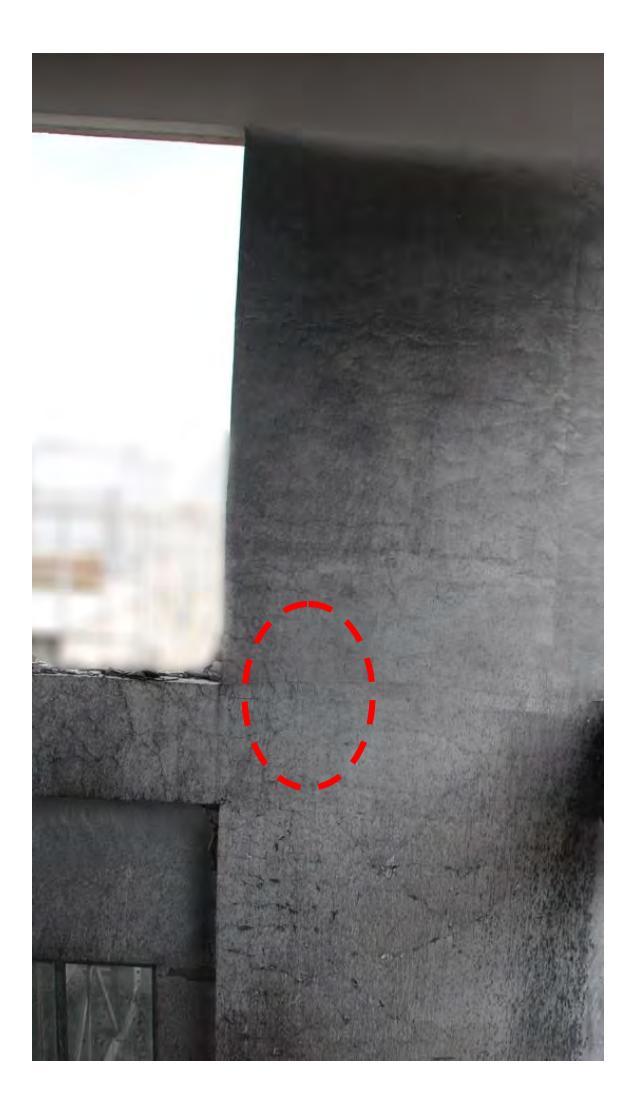
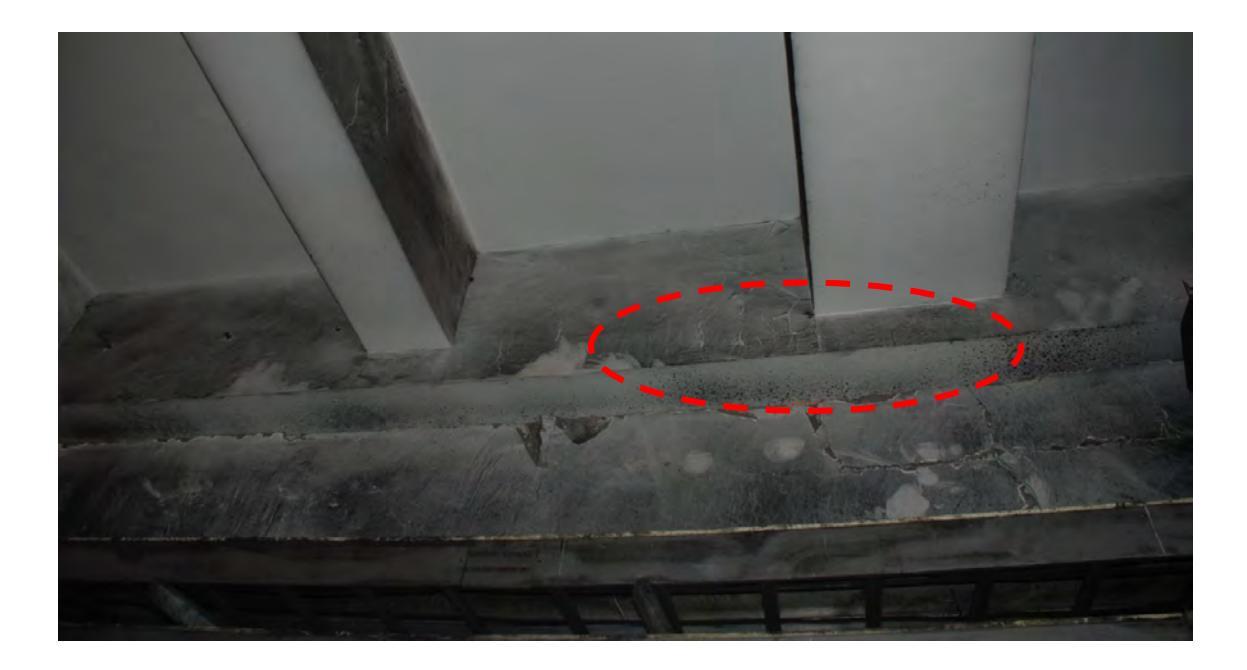
• Flexural cracking: This type of cracking is caused by bending stresses that occur when the beam or shear wall is subjected to lateral or gravitational forces. Flexural cracks are generally

localized at mid span of the beam due to gravitational forces, at support connection due to cyclic forces of earthquake. These cracks run across the depth of the beam.

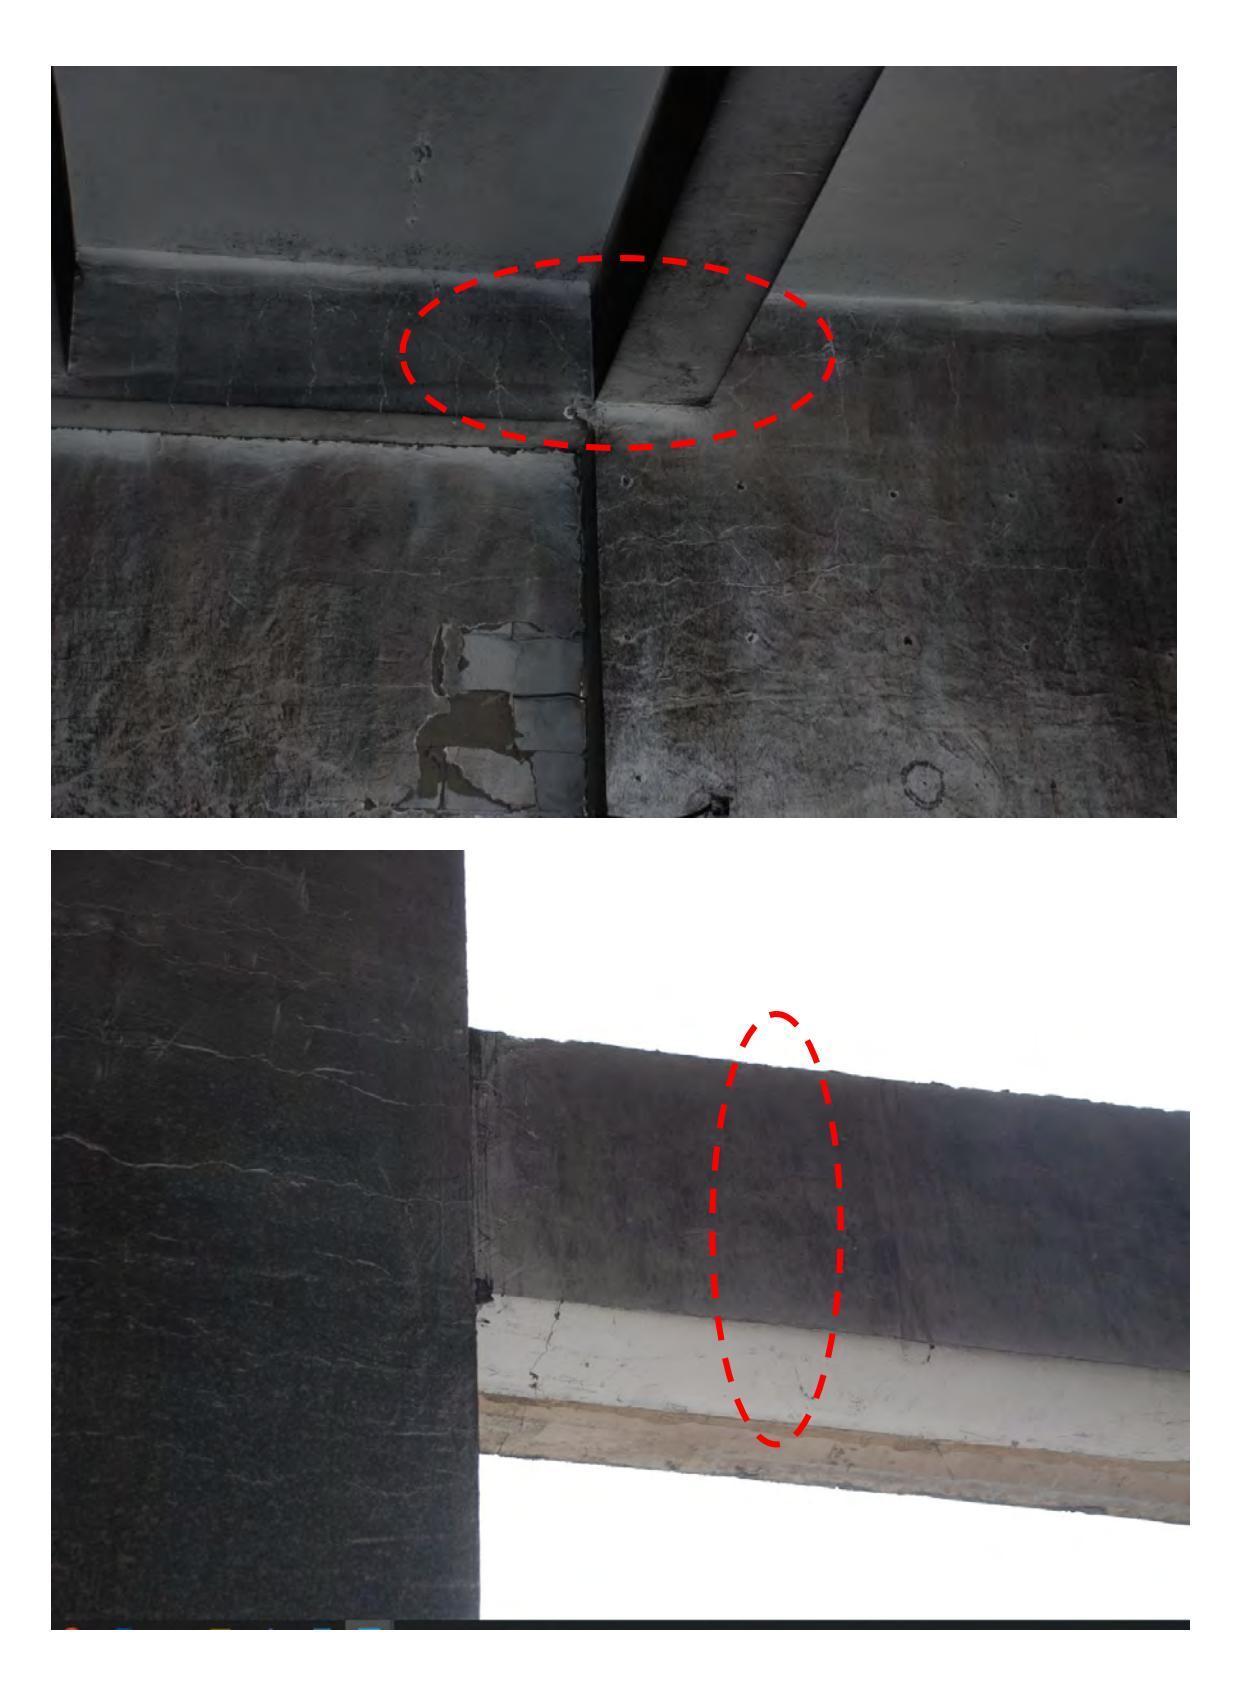
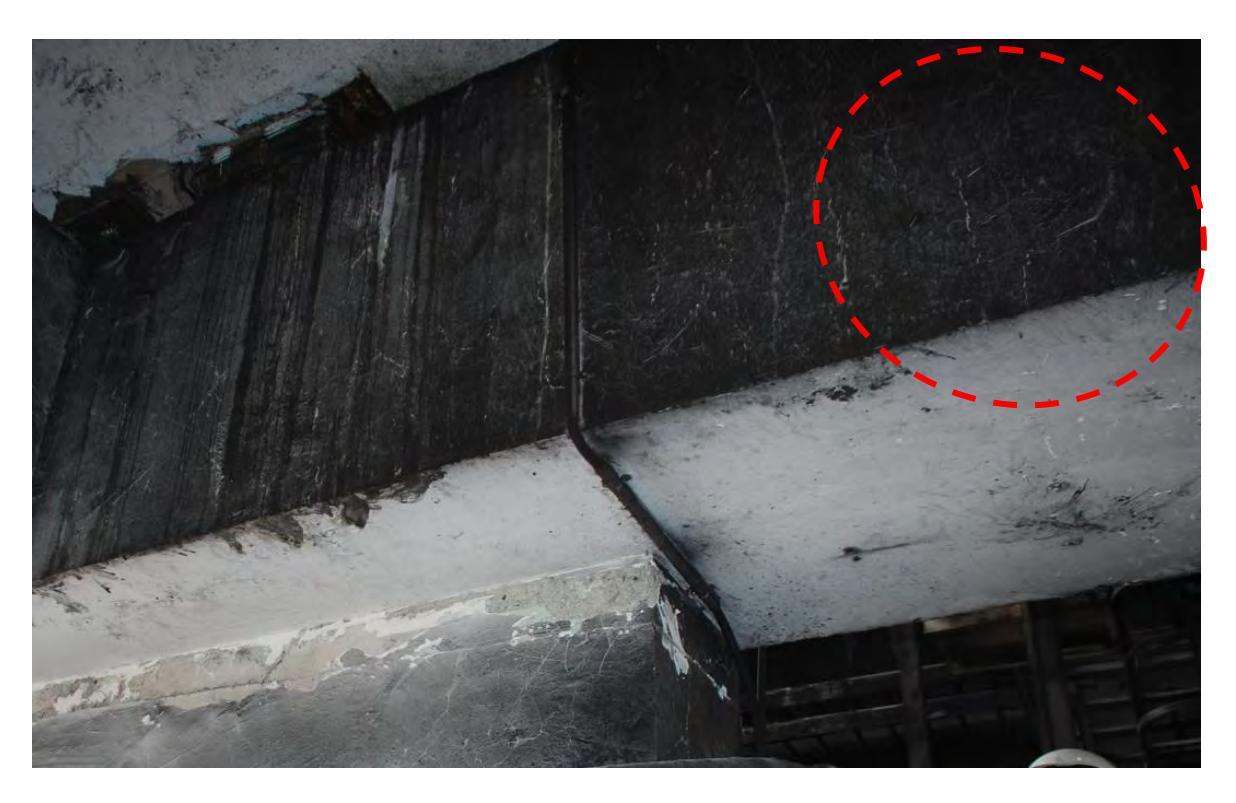
• Shear cracking: Shear cracks occur when the beams are subjected to shear stresses transferred from shear walls. Shear cracks are typically inclined at 45 degrees with the horizontal and runs parallel to the direction of the shear force. When properly designed shear reinforced beams, some microcracks will occur where shear reinforcements are located through the beam length.

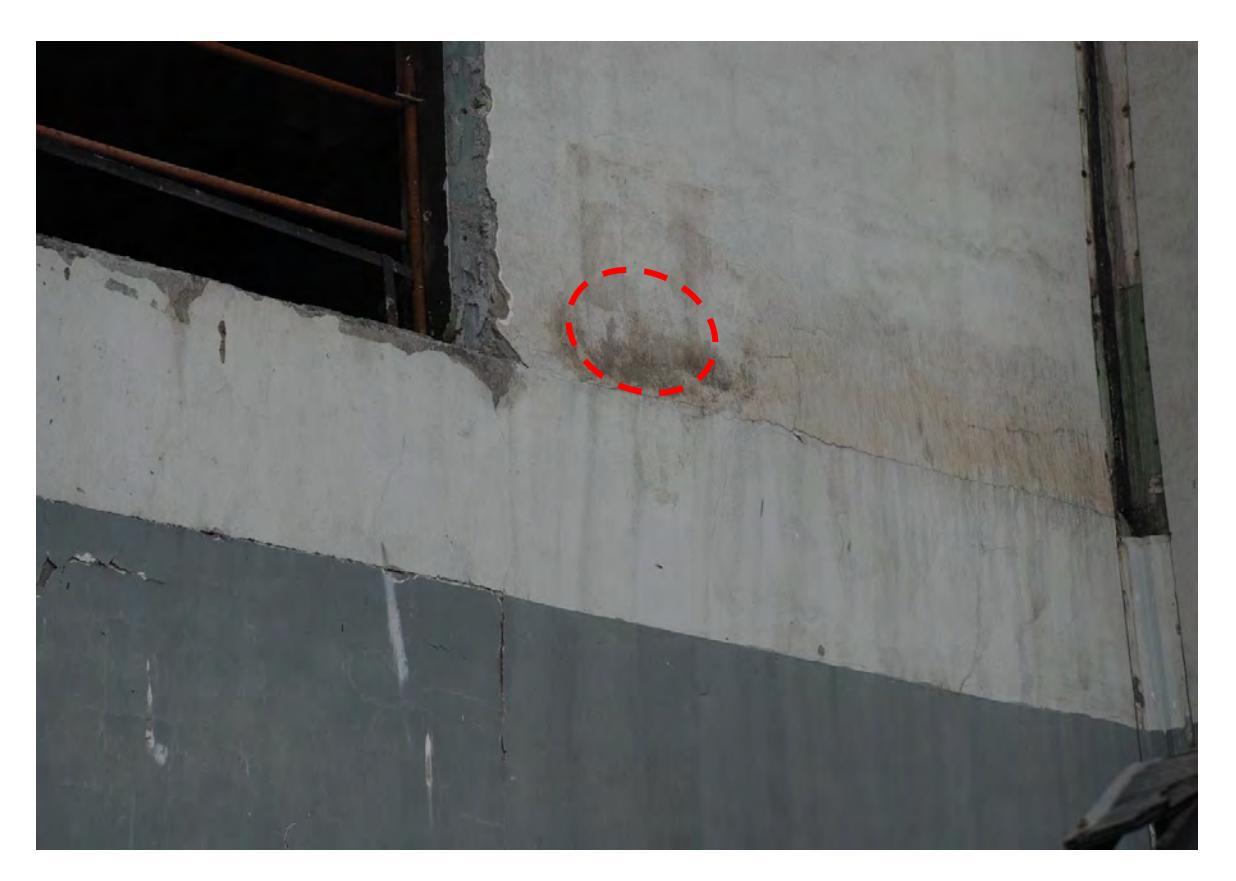
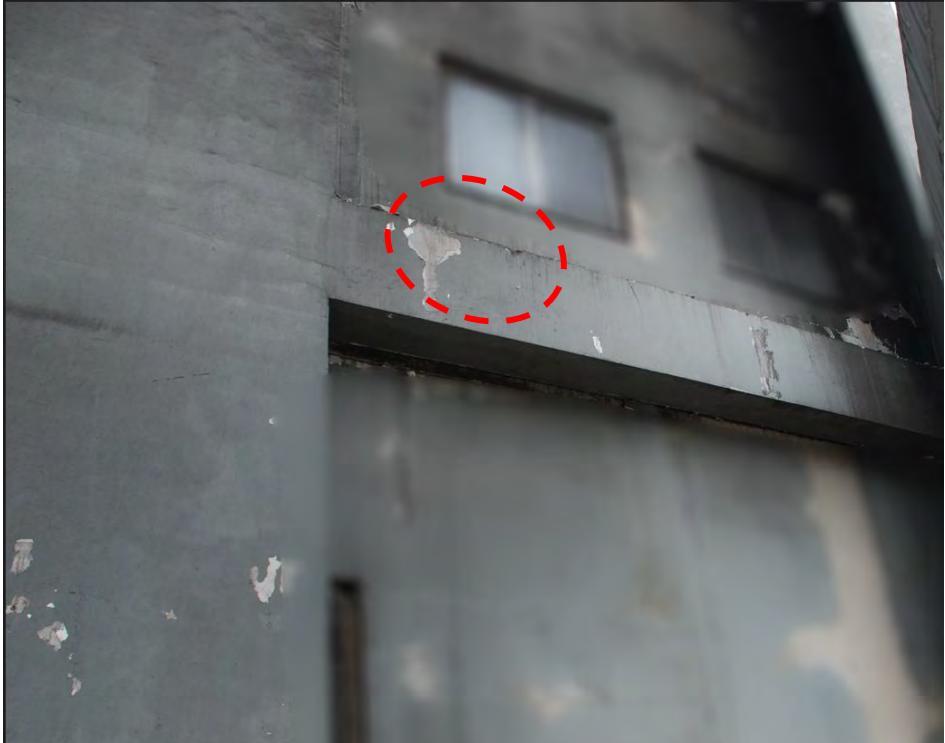
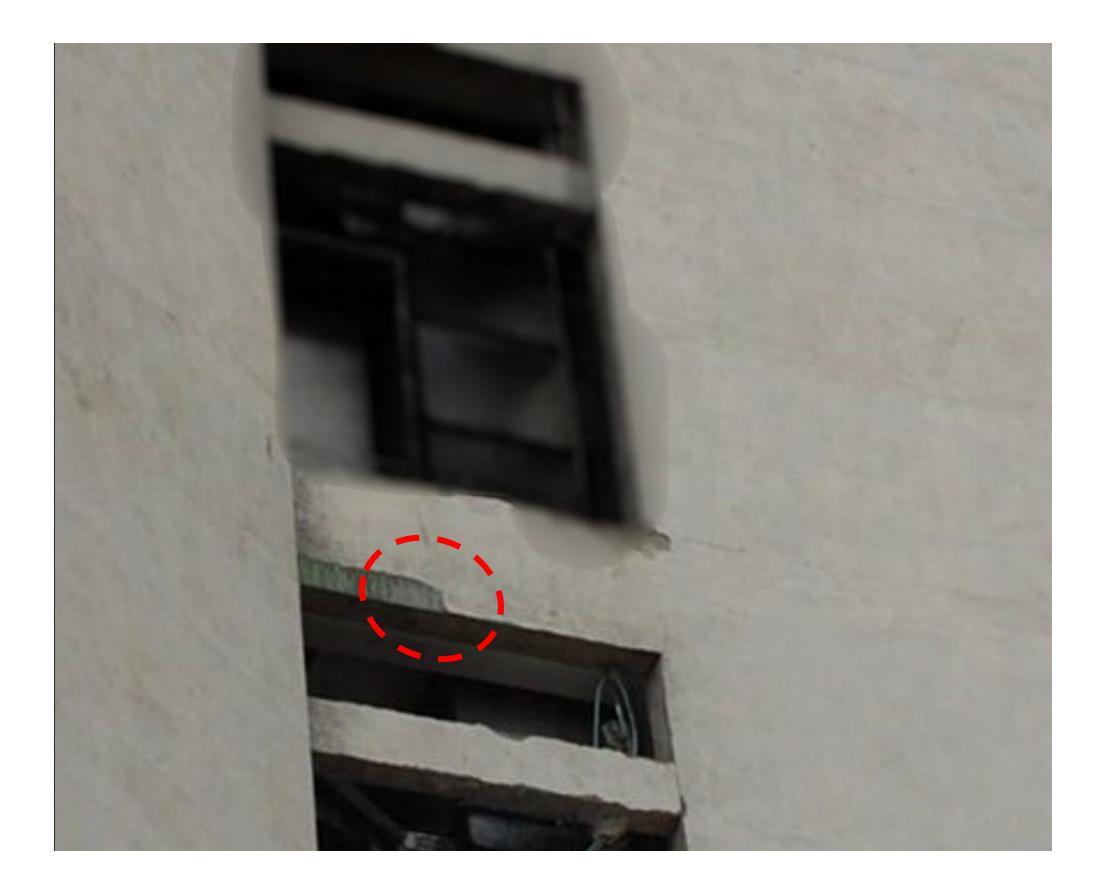
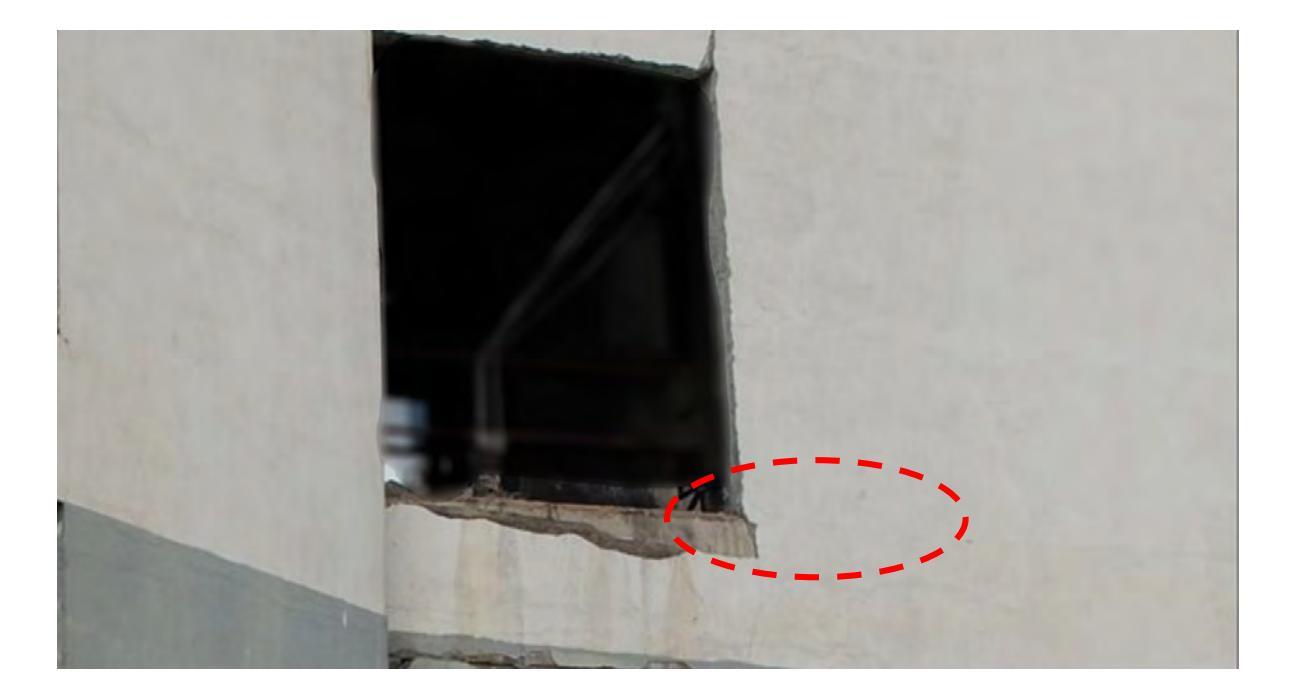
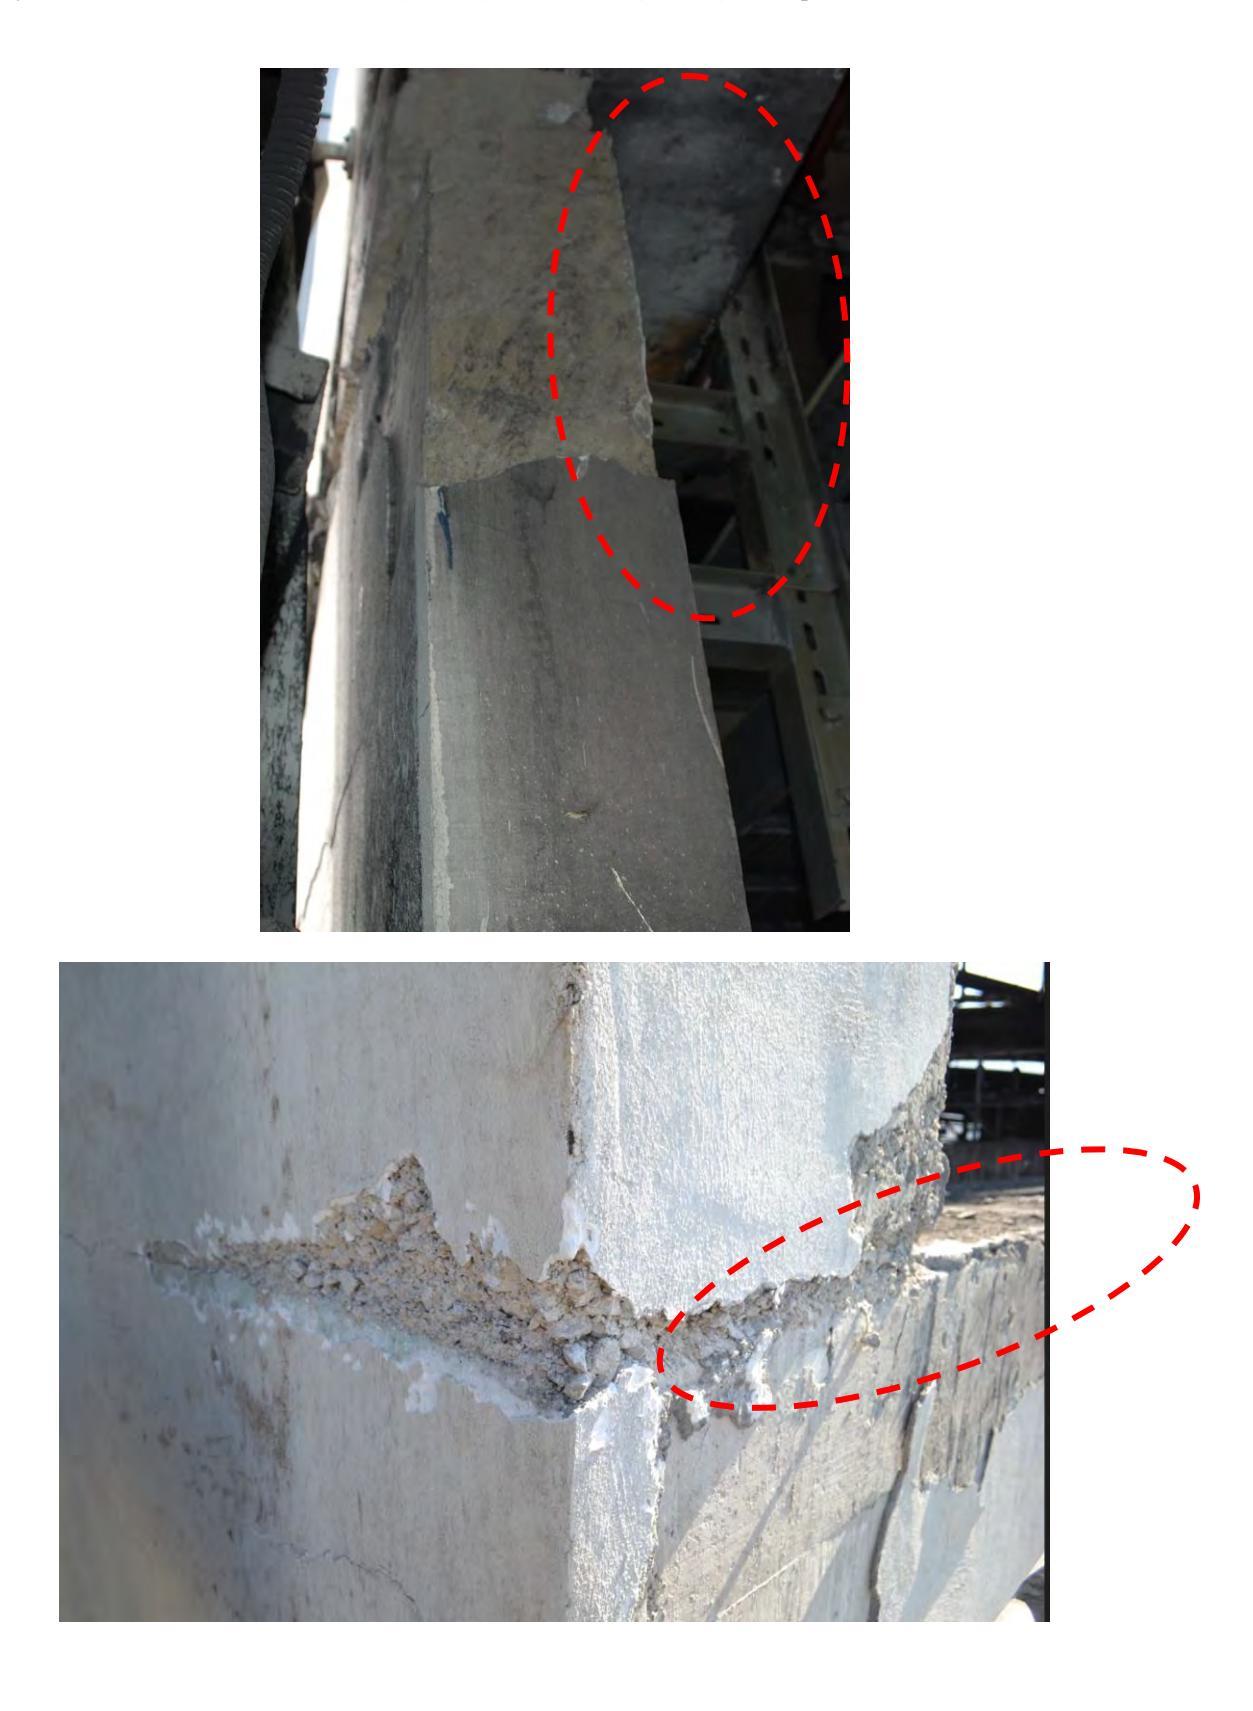
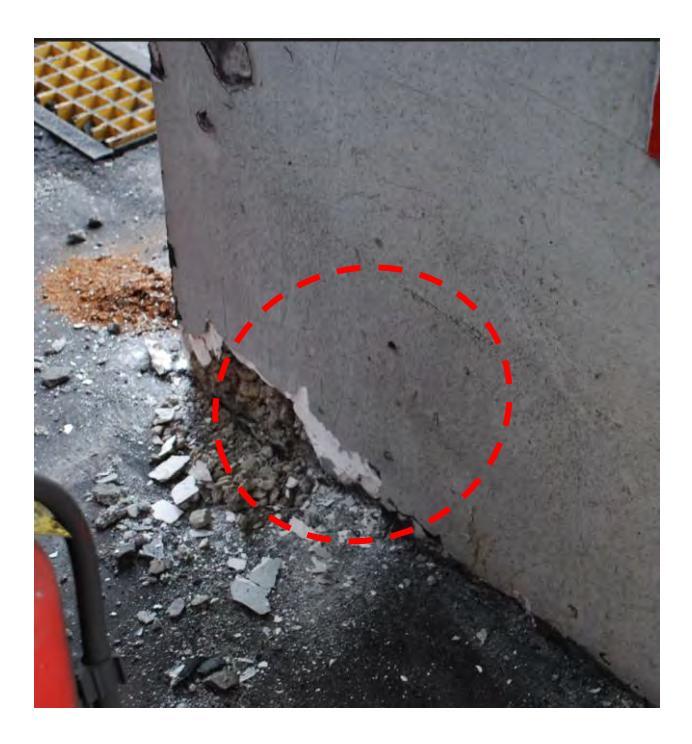
• Spalling: Spalling occurs when the surface layer of the beam or shear wall peels away due to the high stresses that occur during an earthquake. High concrete cover thickness and concrete segregation may lead to spalling cracks on beams or shear walls.

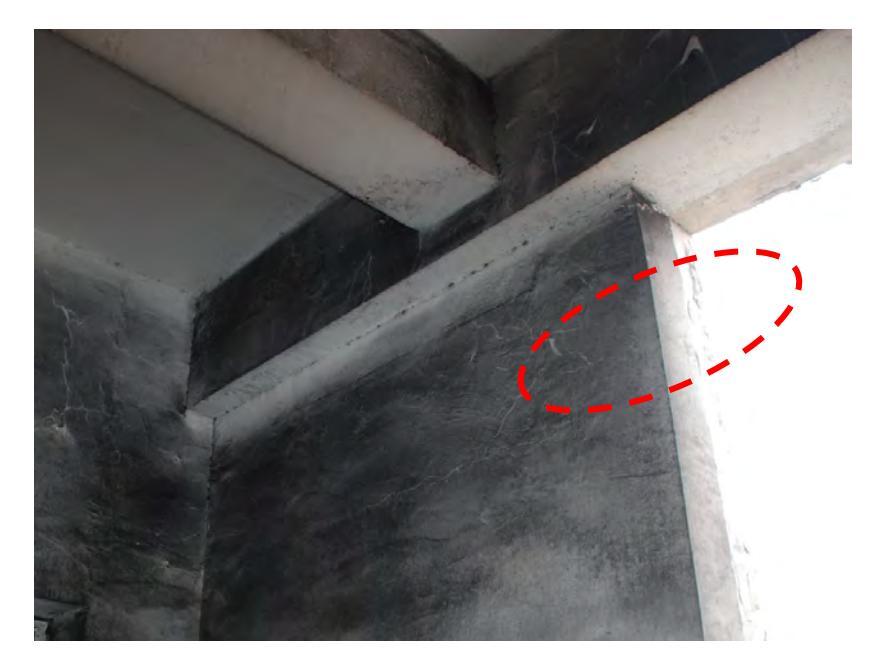
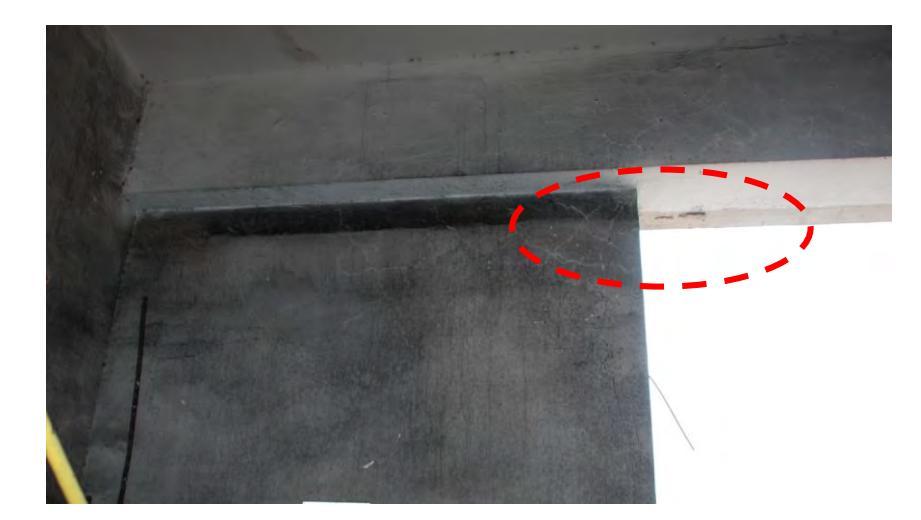
• Shear Flow Cracking: Flexure flow cracking occurs at the body of the shear wall starting from beam connection joints and spreading through the beam body. This type of cracking is caused by shear stress flow through the shear wall cross section. Typically diagonally cracks are observed

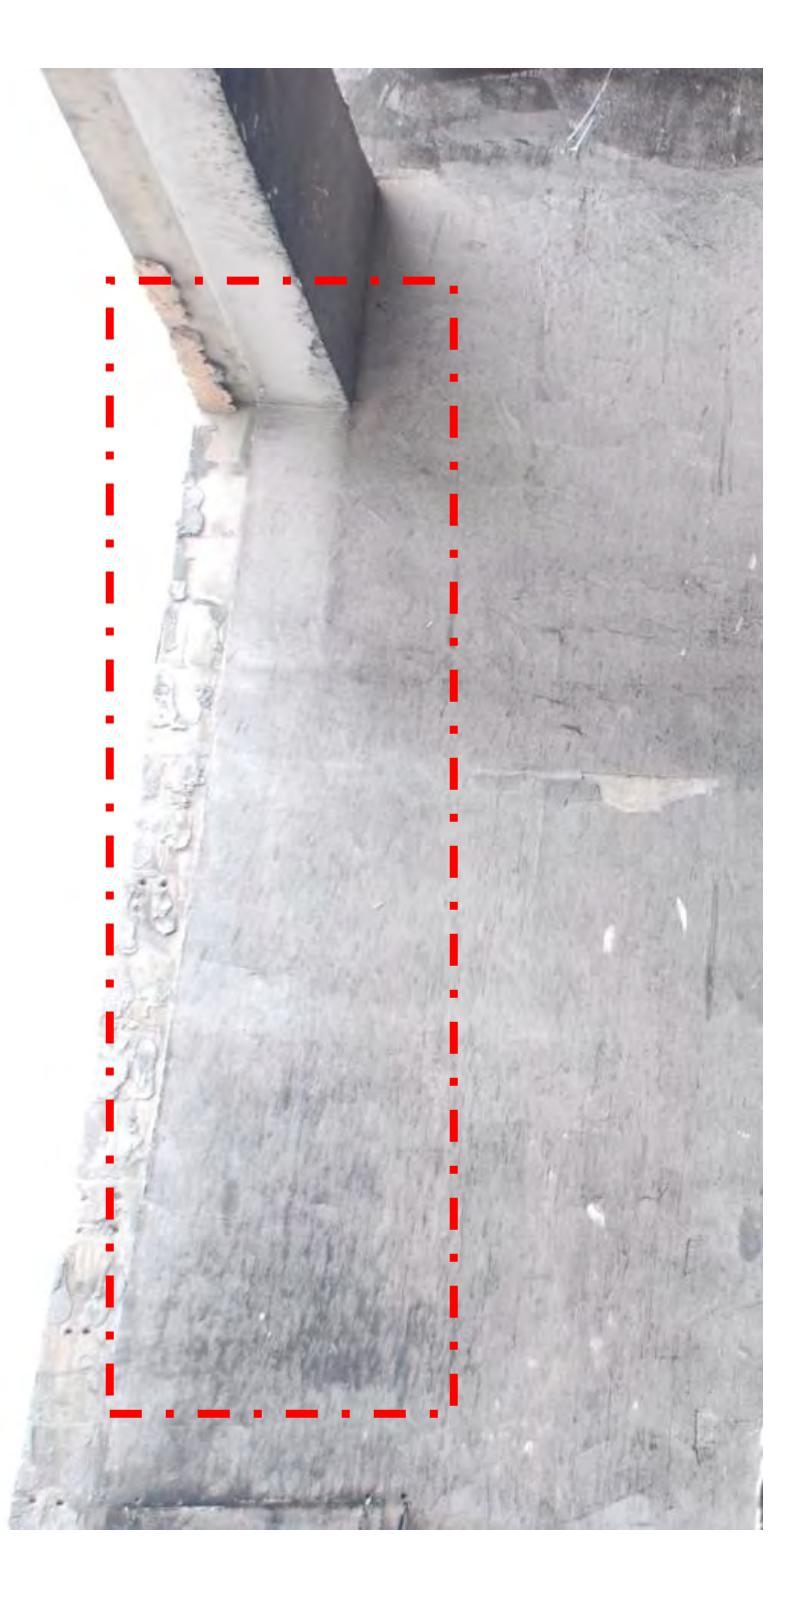
Below figures shows the poorly designed / constructed non-structural walls. As a result of the earthquake loads infill walls are collapsed and reinforced non-structural walls showed a weak contribution to the seismic performance of the building.

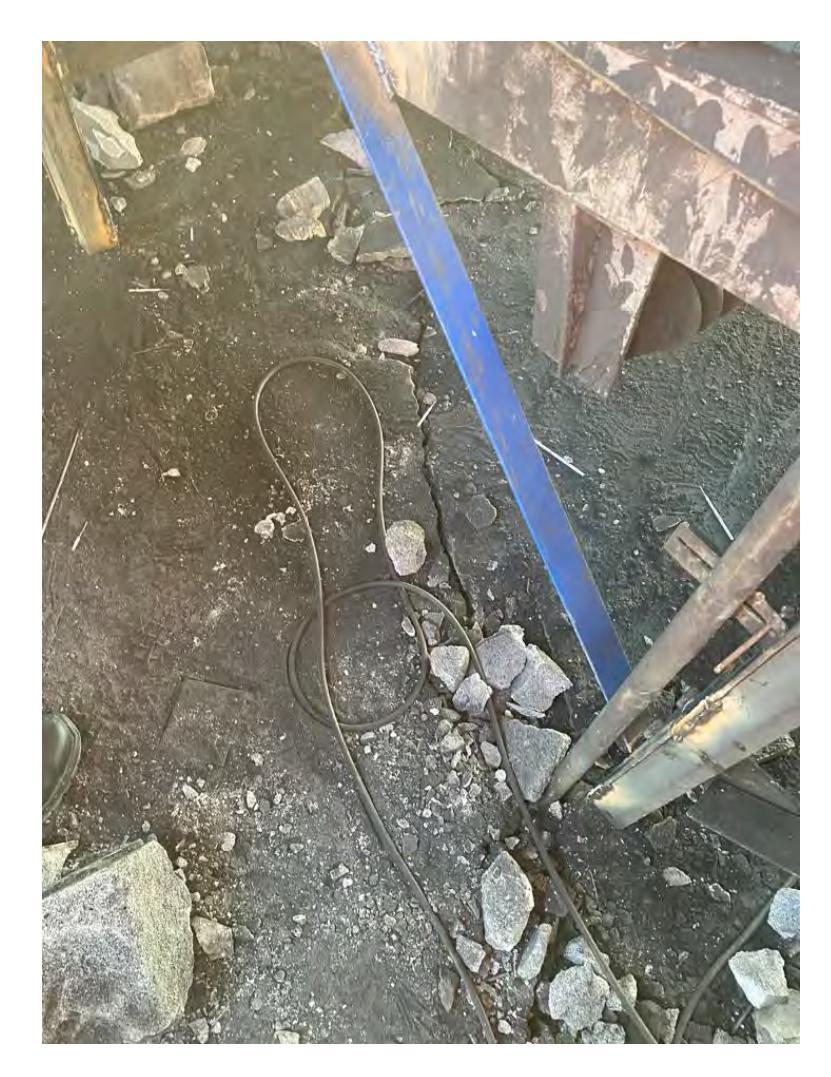
Additionally, another improper case is the application of reinforced ground slab. In order to ensure the architectural integrity of these two buildings, contractor had poured the ground slab together for the two buildings. Thus, when the dilatation failure occured, there were cracks encountered on ground slab. In next photo, cracks on ground slab are shown.

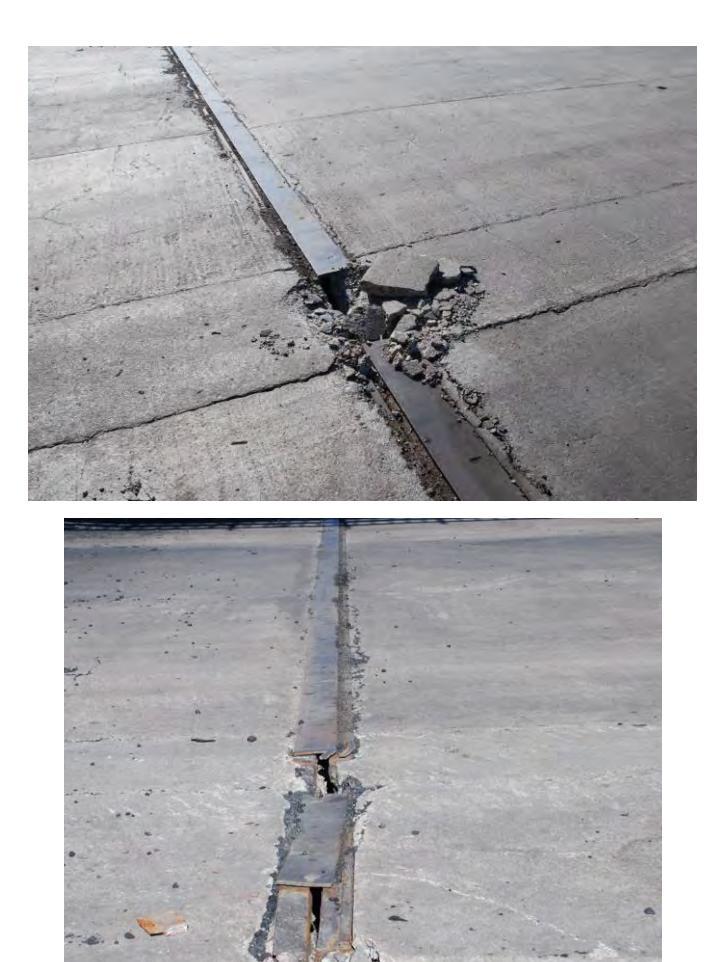
Figures below show when the construction joint is not designed or constructed properly, such cracks occur due to displacement caused by earthquake.

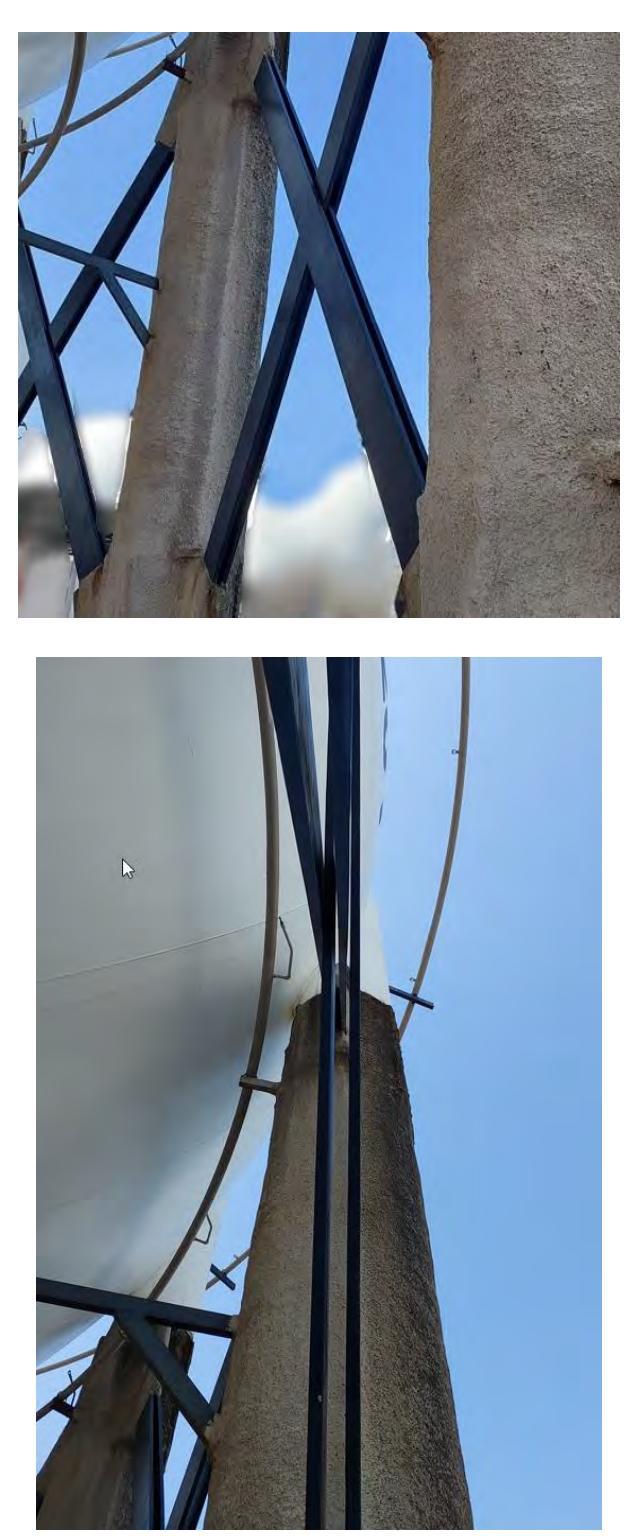
Another major issue about the braces is the unbraced lengths and out plane behavior of the members. As seen in the figures below, the intersection points of X bracing are free to displace in out of plane individually. This case is not an effective way for the buckling design of cross-section.

Two increase the buckling capacity of compressive members, additional connection plates shall be used in the mid portion of bracings.During earthquake, horrible sound was heart coming from the clash of the bracing members.

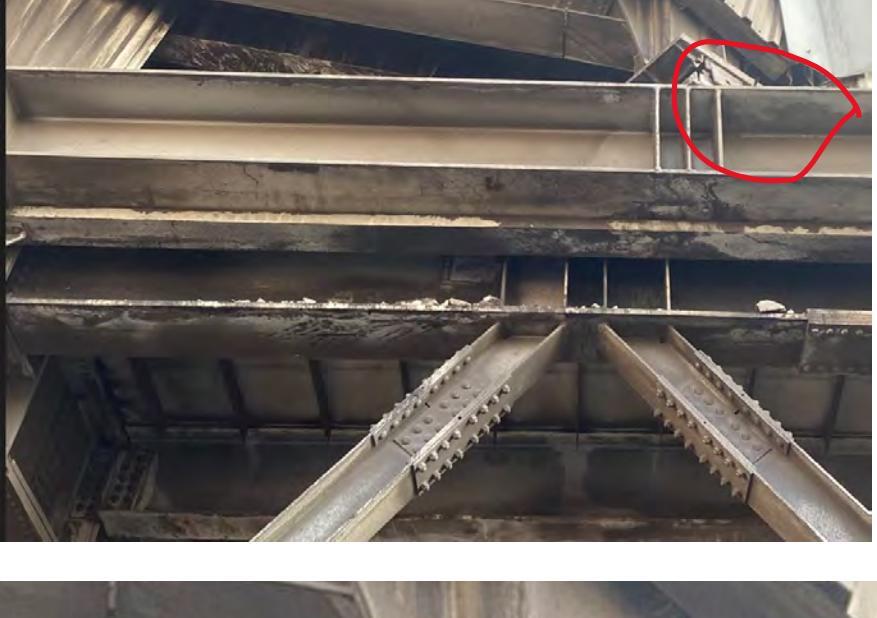
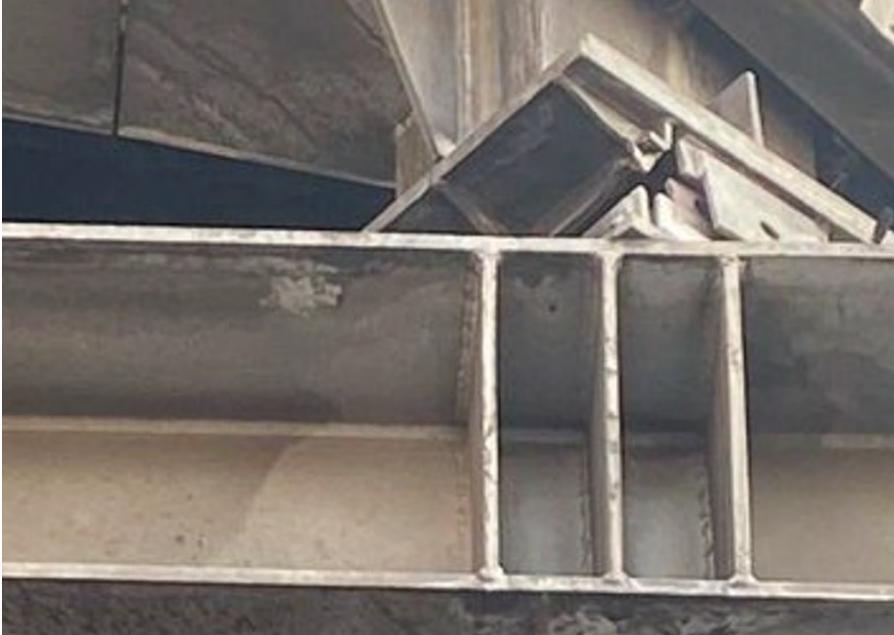
However, during the investigations after earthquake, it is detected that the movement during earthquake is absolutely more than predicted, so the sliding connection dimension is not sufficient. There are several reasons for this issue, for example tilt of foundations, unexpected mechanism cases and plastic hinges. Please see following figures to see the insufficient sliding connection details after earthquake. The stoppers are clashed with members and deformation occurred.
