# Türkiye Earthquake

## **RECONNAISSANCE REPORT**

February 6, 2023 Kahramanmaraş-Pazarcık ( $M_w$ =7.7) and

Elbistan (M<sub>w</sub>=7.6) Earthquakes

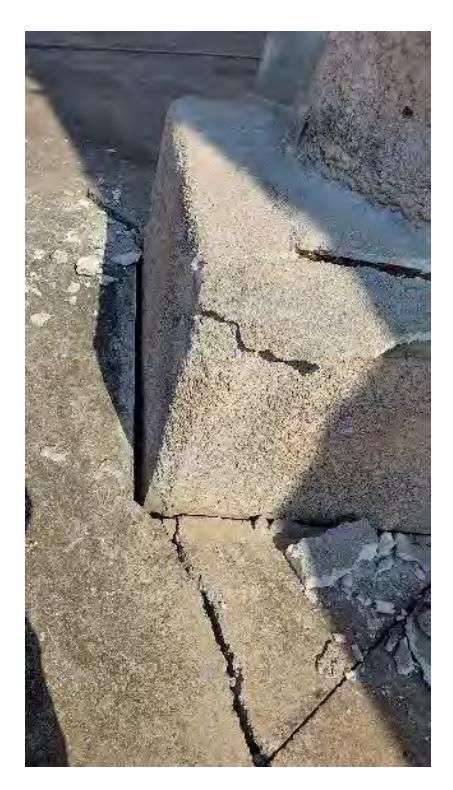
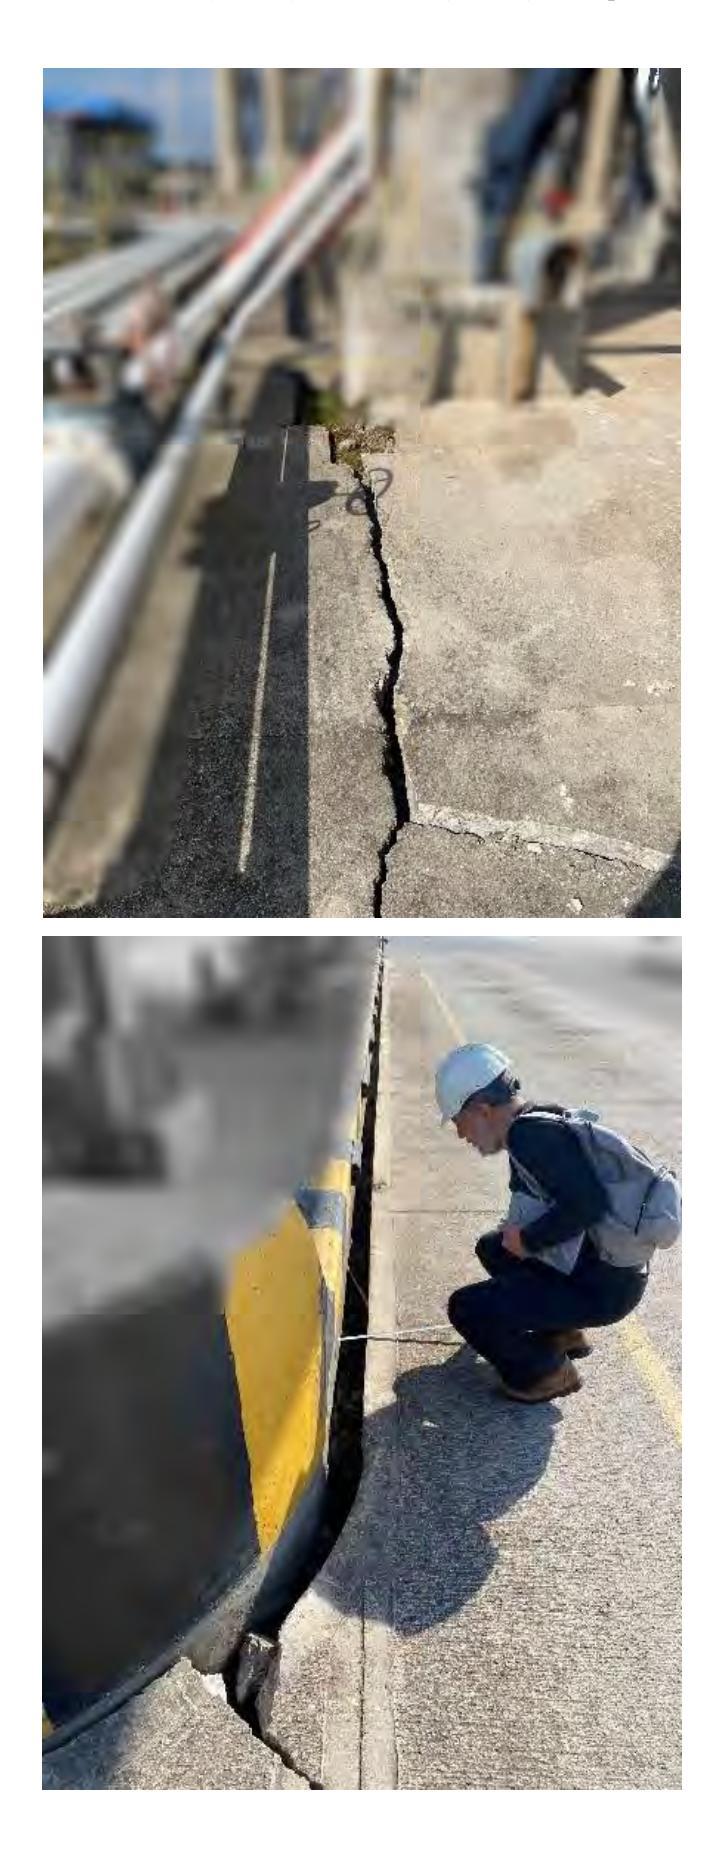
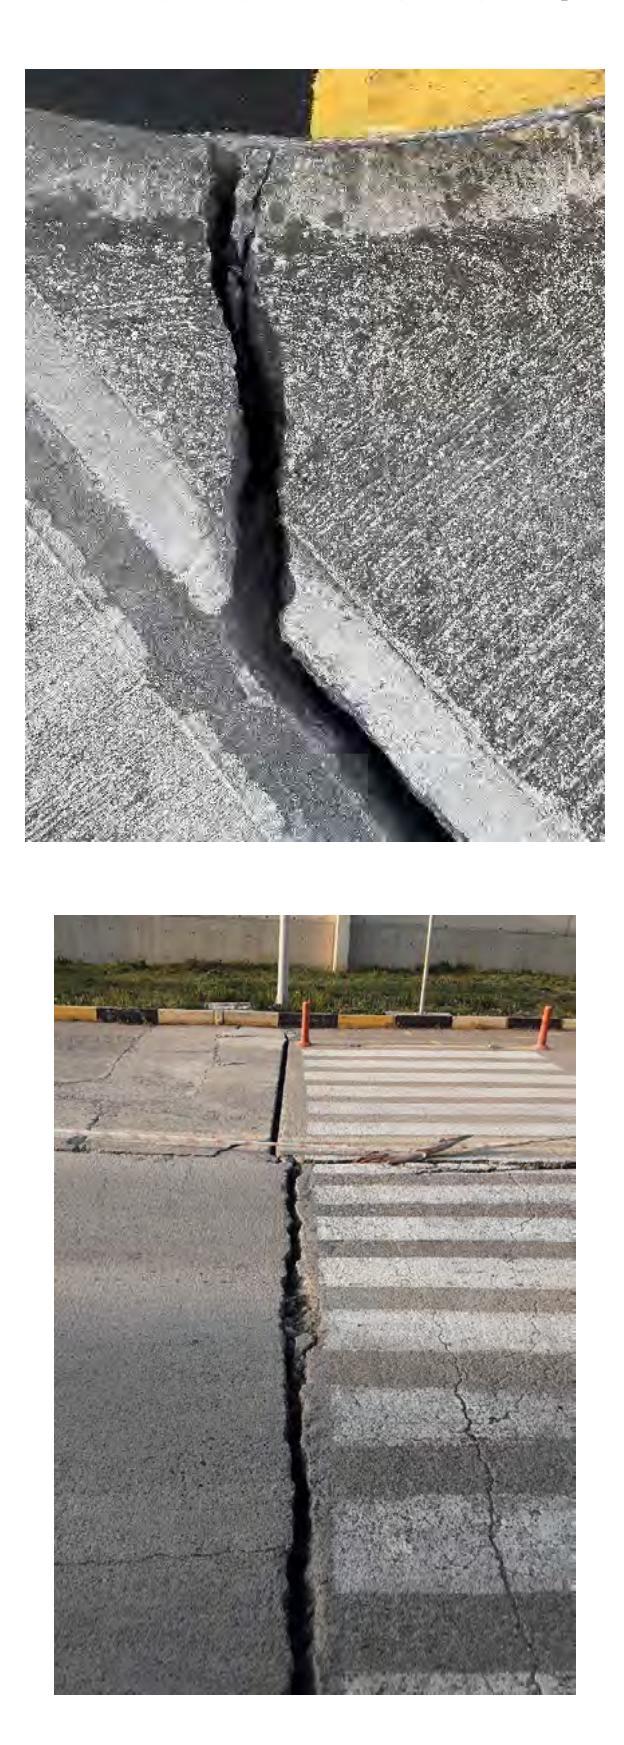
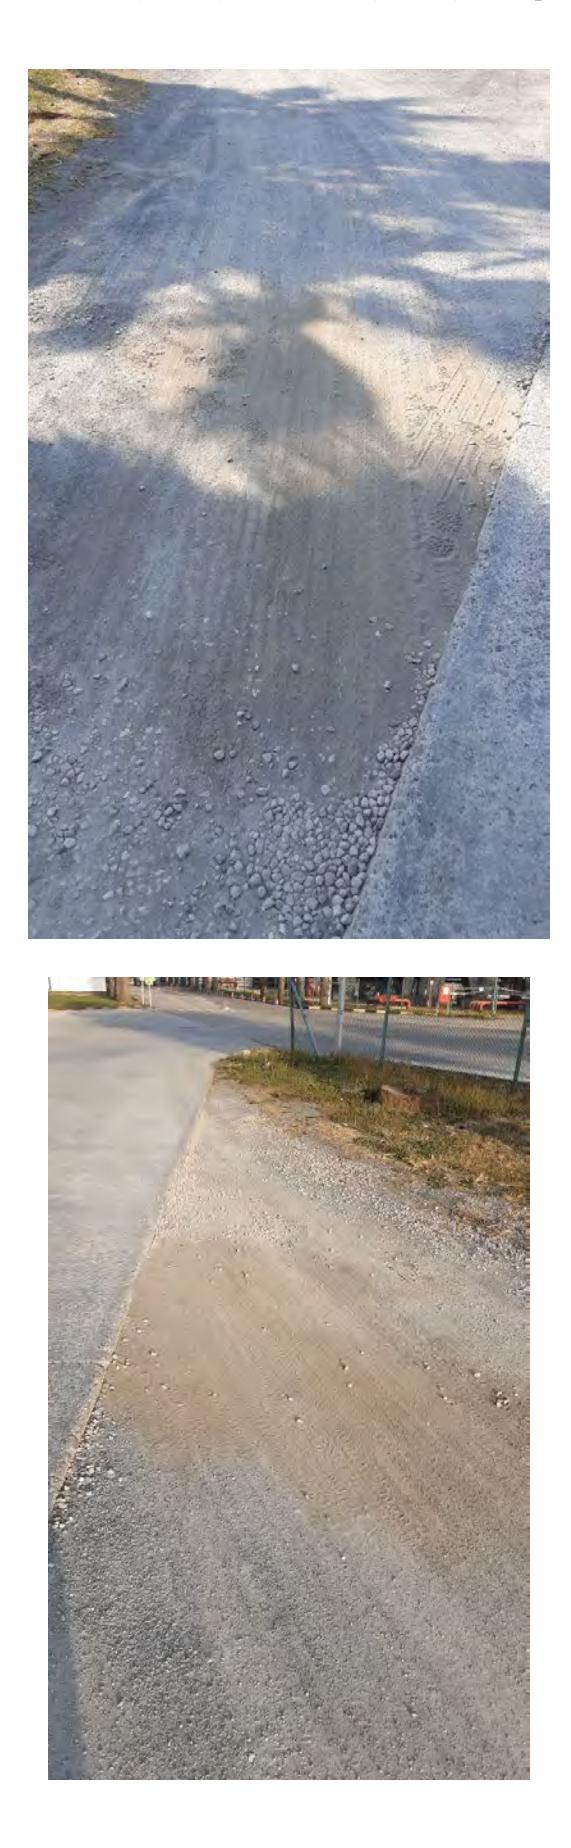
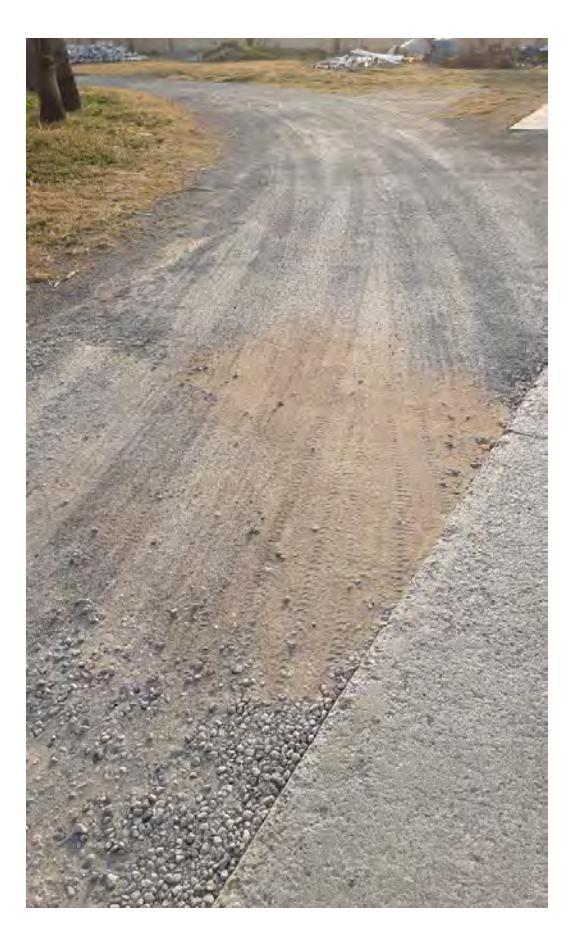
As can be seen from the photographs given below, a liquefaction area formed in the area where the spherical tanks were located during the earthquake and this liquefaction continued along the line and progressed along the facility. During this progress, the liquefaction zone continued around the spherical tank area due to the jet grout improvement made at the location of the spherical tanks. This determined situation shows how successful the jet grout soil improvement method is against soil liquefaction. The jet grout application stands out as a proven ground improvement method for areas with such liquefaction risk.

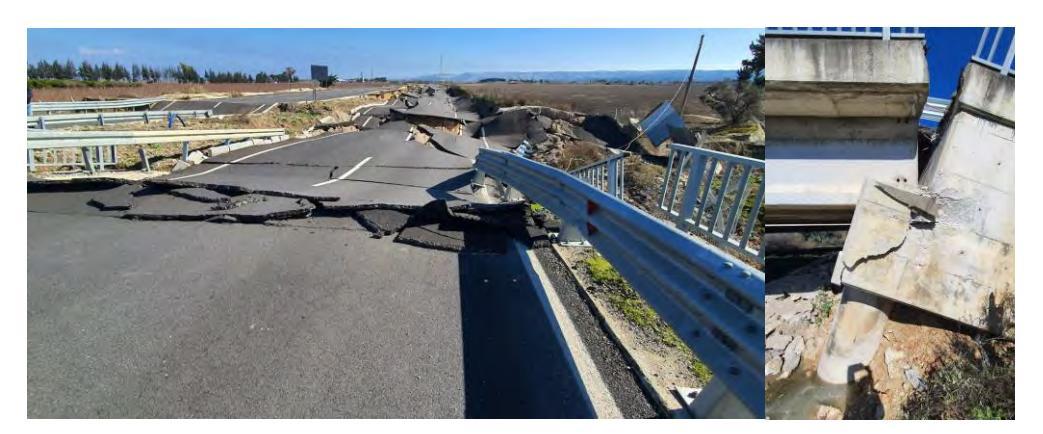
Figure 9.1. Abutment rotation due to seismic soil liquefaction induced foundation failure

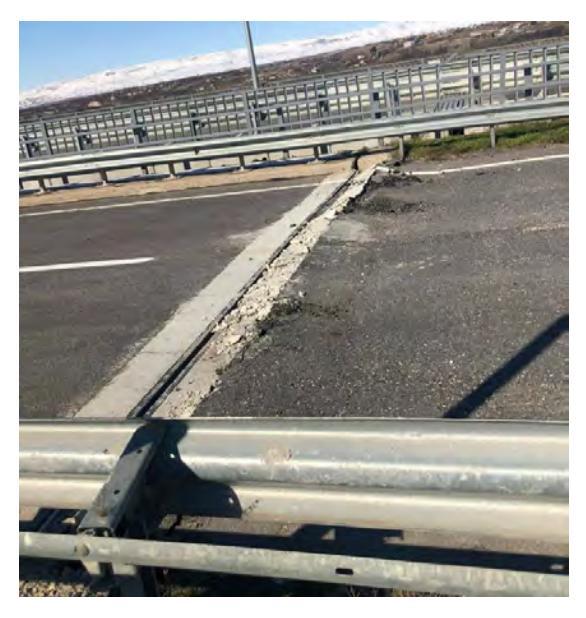
Figure 9.2. Joint movements

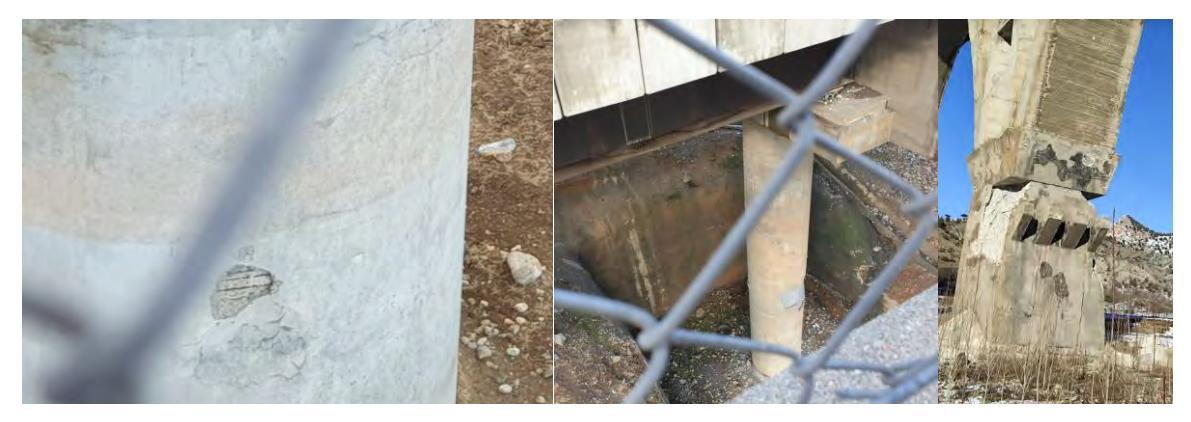
Figure 9.3. Concrete spalling

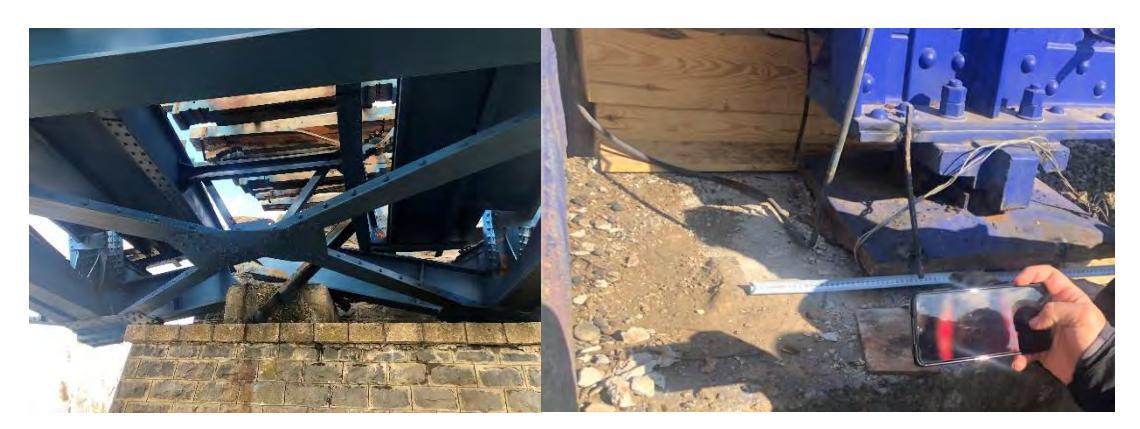
Figure 9.4. Bearing dislocation and movement

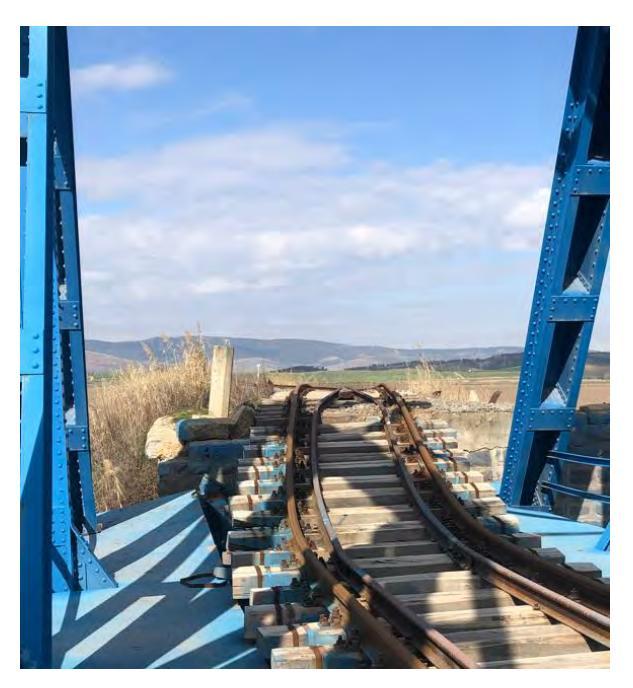
Figure 9.5. Rail misalignment

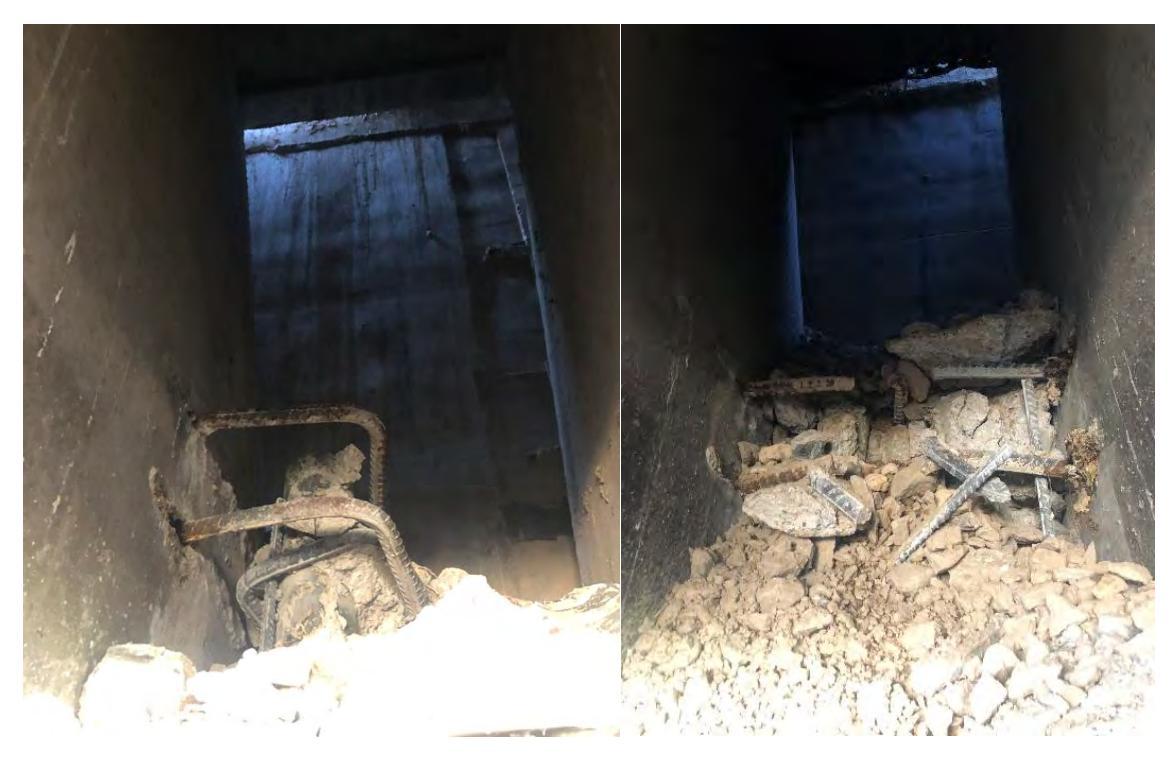
Figure 9.6. Shear key damage

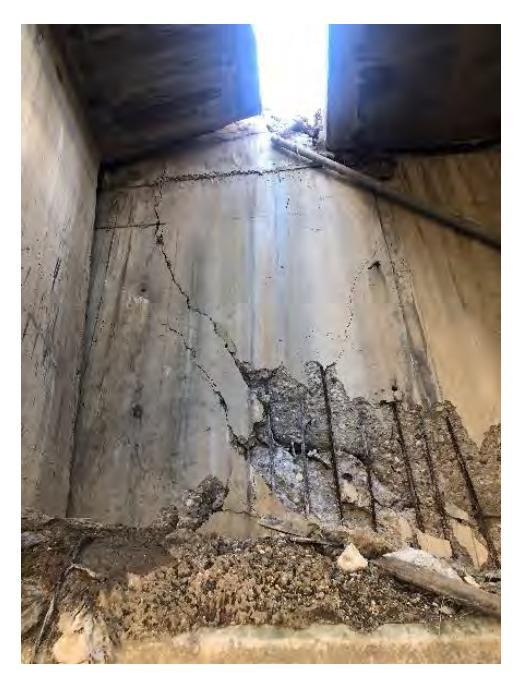
Figure 9.7. Abutment wall concrete spalling

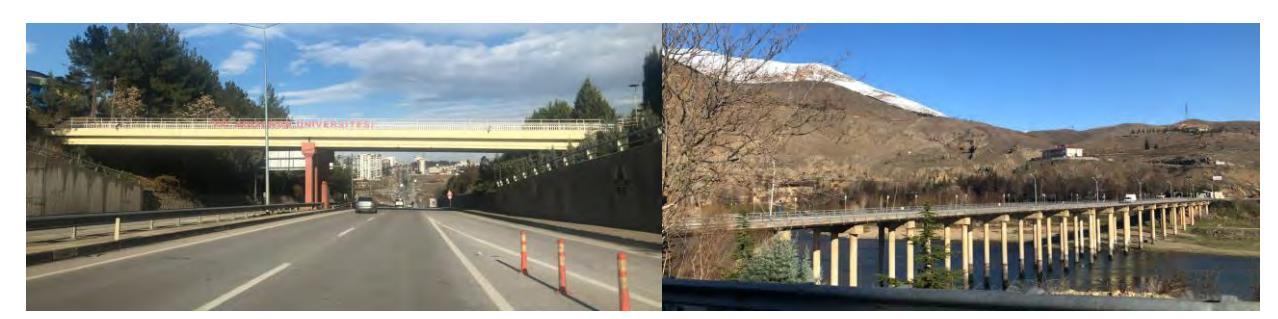
Figure 9.8. Bridge typical have no damage

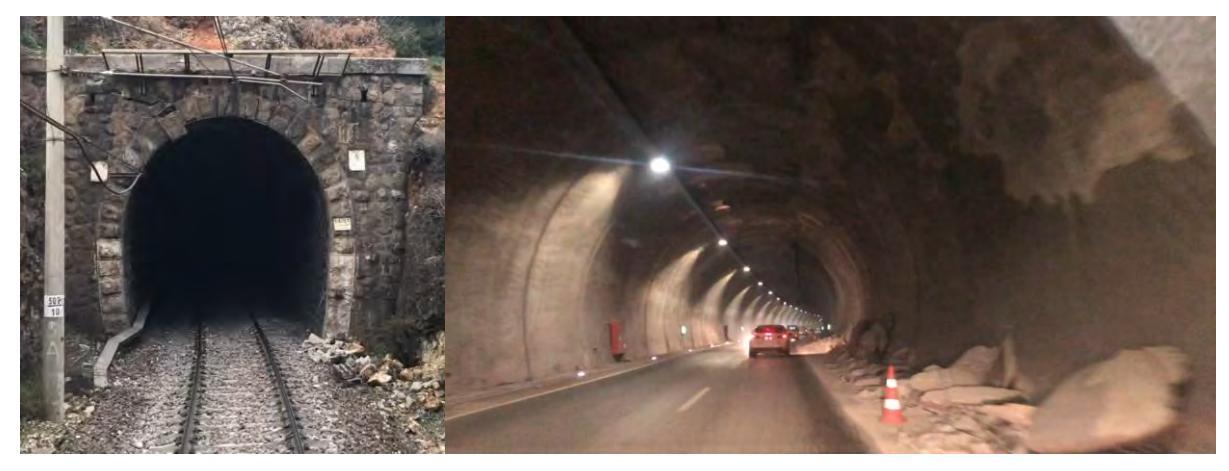
Figure 9.9. Tunnel portal movement and concrete spalling

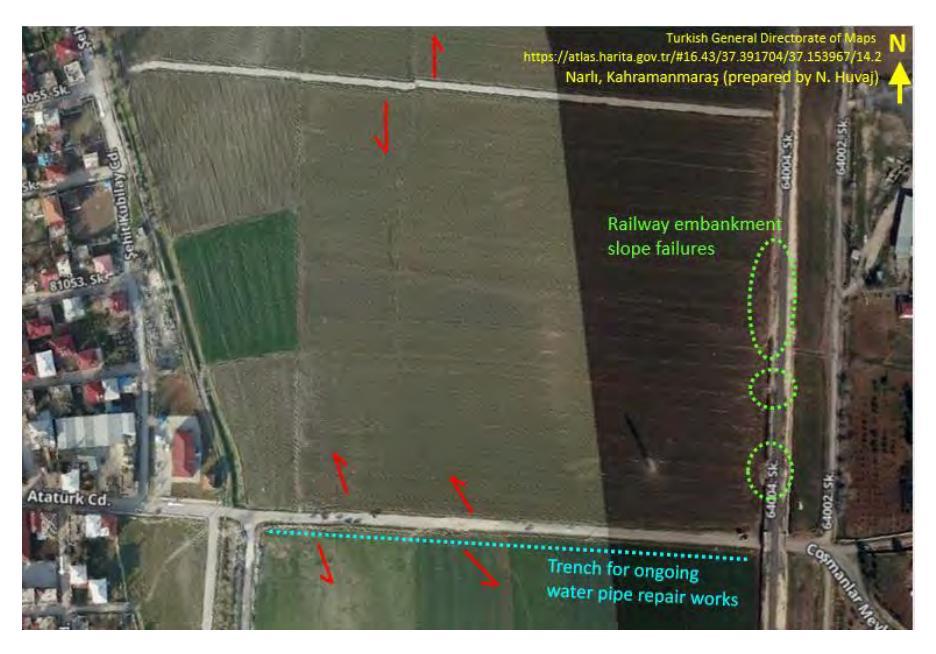
**Figure 10.2.** Aerial view of the surface fault rupture and examples of damages caused by the two earthquakes on some of the lifelines: railway line, roads and water distribution network, near Narlı, Kahramanmaraş (Satellite images are provided by Turkish General Directorate of Maps via atlas.harita.gov.tr website)

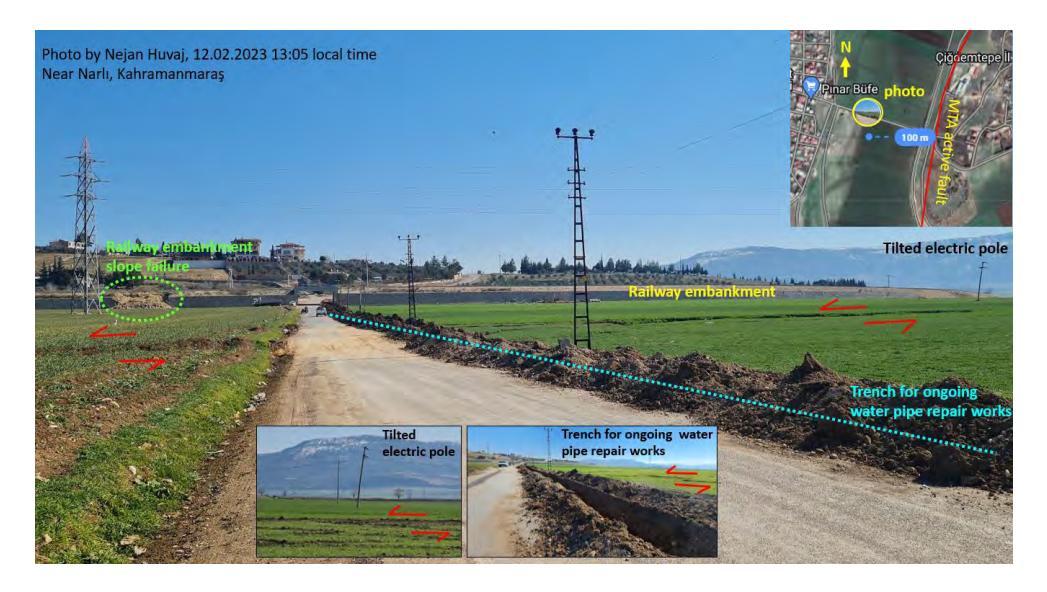
**Figure 10.3.** Referring to Figure 10.2 for locations of the photos: offset on the road due to surface fault rupture, railway embankment slope instability, water pipeline repair works, and a tilted electric pole can be seen, near Narlı, Kahramanmaraş. (Active fault data is taken from Emre et al. (2013) published by the General Directorate of Mineral Research and Exploration, MTA (Maden Tetkik ve Arama Genel Müdürlüğü)).

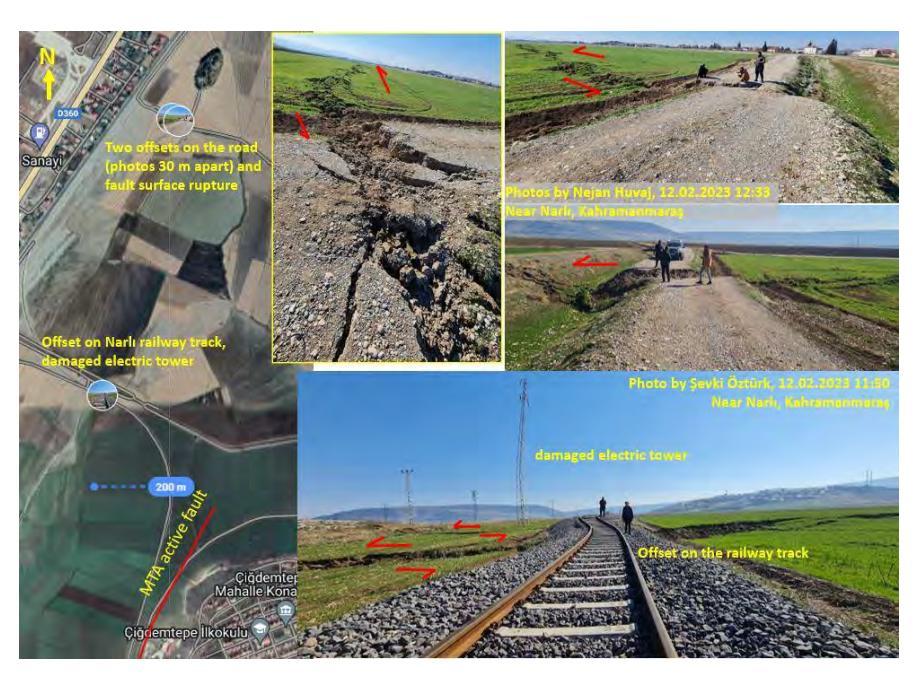
**Figure 10.4.** Surface rupture, offset, cracks and damages on railway tracks and roads, as well as a damaged electric tower, near the surface rupture (Narlı, Kahramanmaraş). (Active fault data is taken from Emre et al. (2013)).

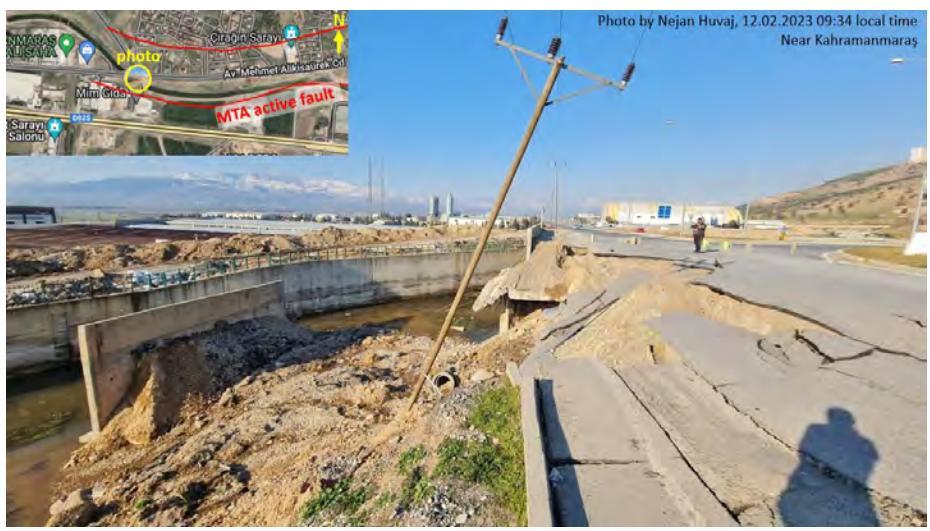
**Figure 10.5.** A landslide and crack/damages on the road next to a water canal, causing significant lateral displacement of a concrete retaining wall (pushed towards the water canal), a tilt on an electric pole, in southern part of the city of Kahramanmaraş (active fault data from Emre et al. (2013)).

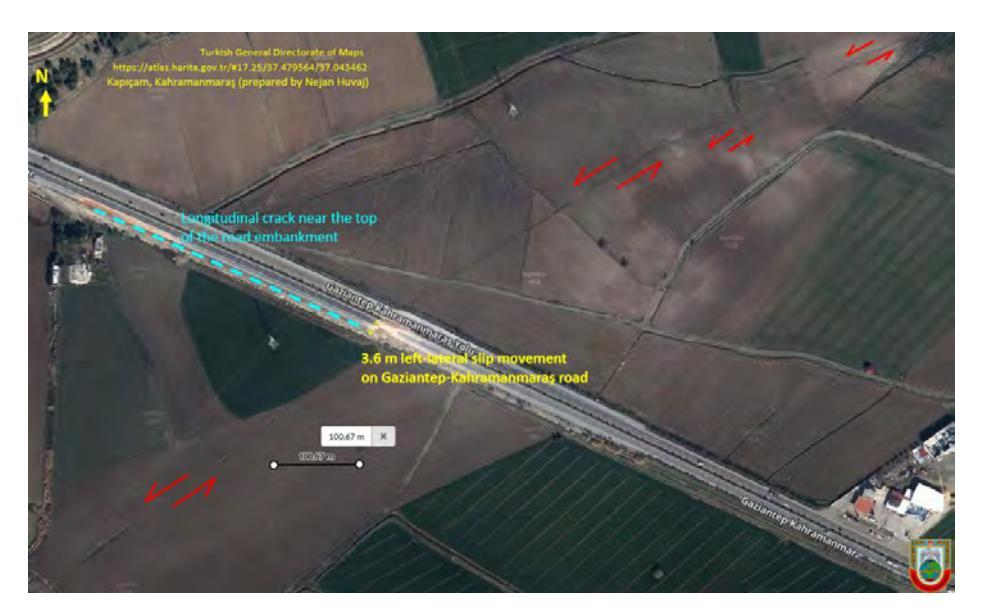
**Figure 10.6.** Surface rupture observations causing a 3.6 m offset on Gaziantep-Kahramanmaraş Road, cracks on the asphalt road at several locations, road embankment instability and more than 250 m-long longitudinal cracks at the top of the road embankment as well as on the asphalt road, near Kapıçam, Kahramanmaraş (Satellite images are provided by Turkish General Directorate of Maps via atlas.harita.gov.tr website)

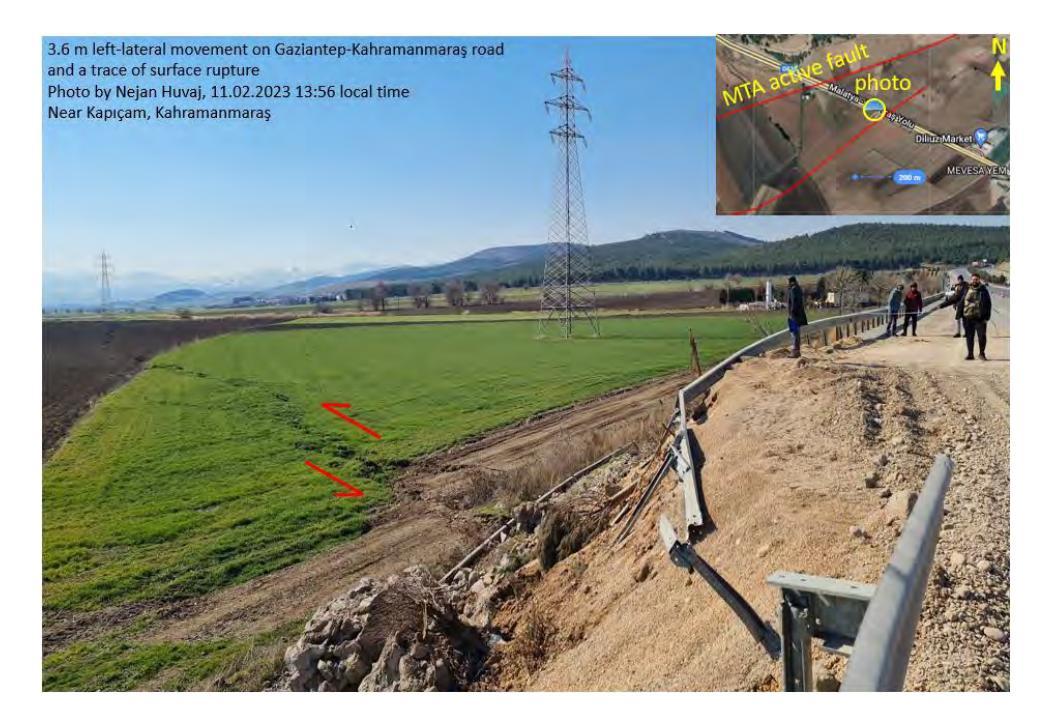
**Figure 10.7.** Referring to Figure 10.6 for the location: surface rupture observations and 3.6 m offset on Gaziantep-Kahramanmaraş Road (active fault data from Emre et al. (2013)).

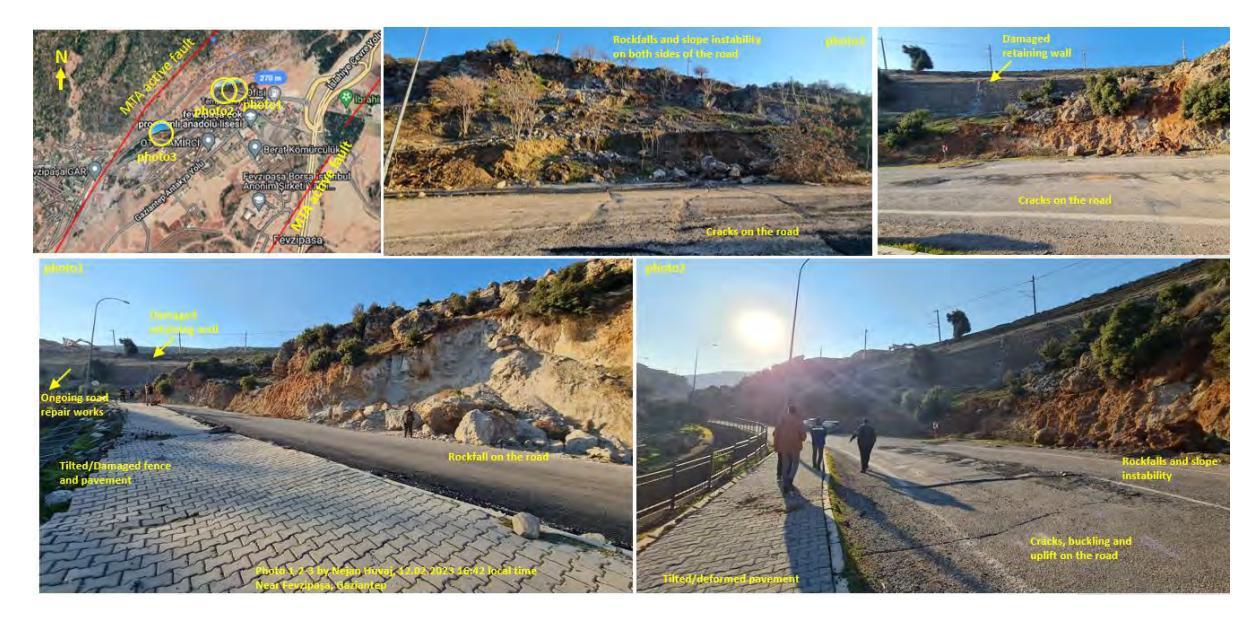
**Figure 10.9.** Landslides, rockfalls and surface cracks on the roads, near Fevzipaşa, Gaziantep causing disruption in the service (Active fault data from Emre et al. (2013)).

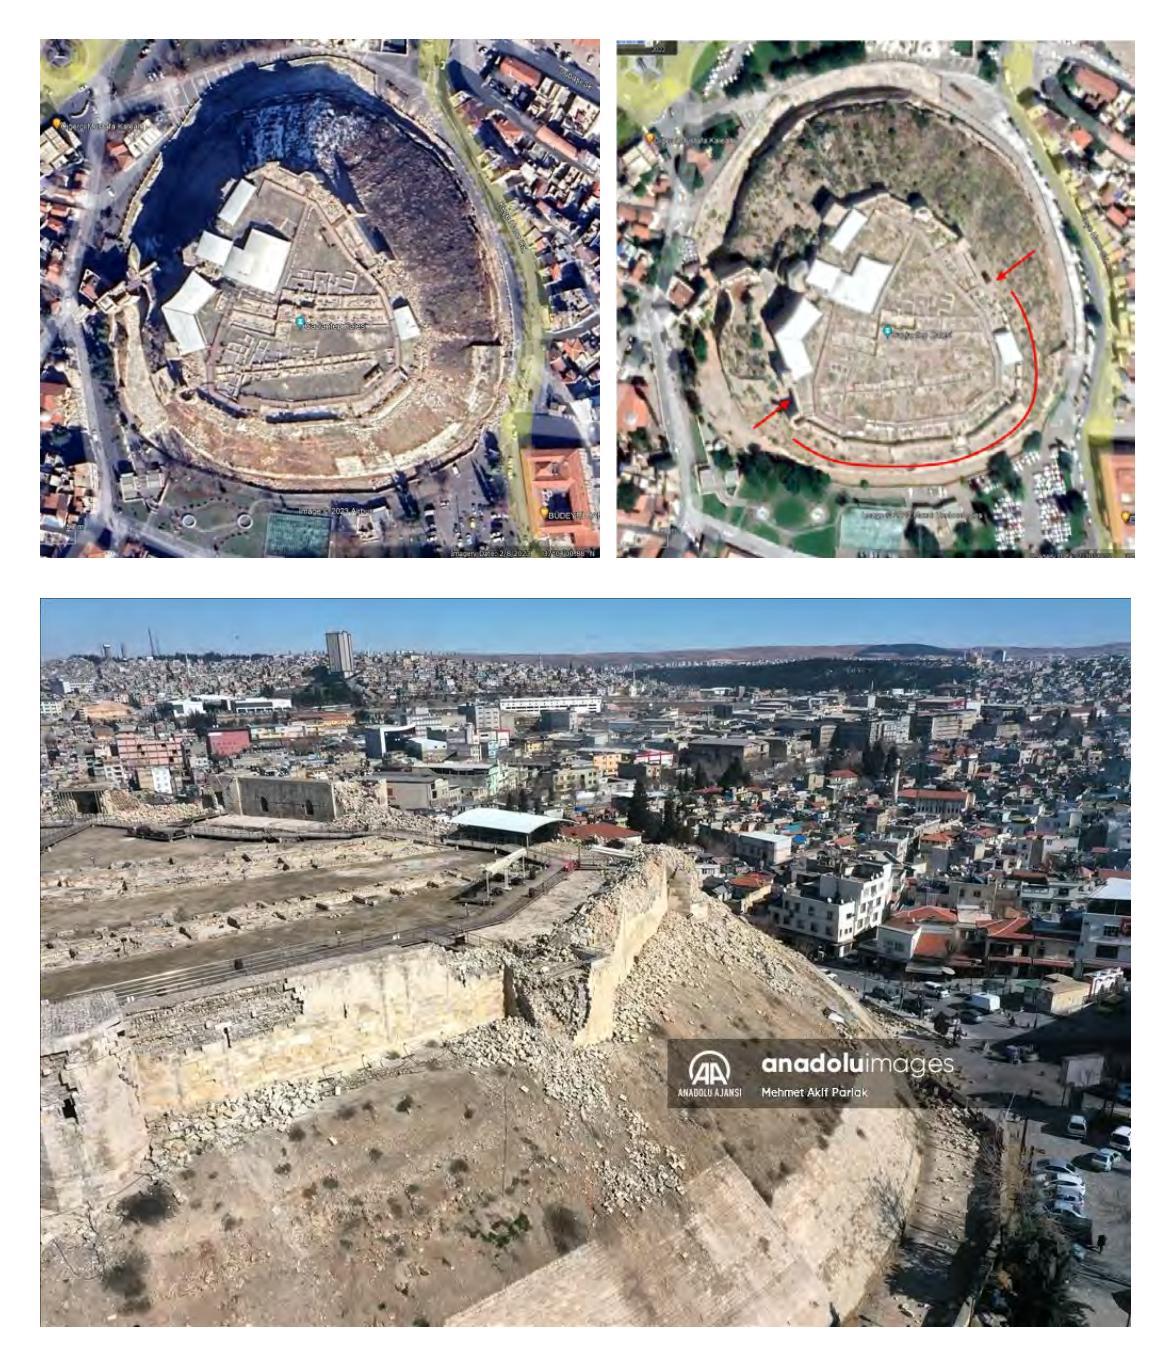
An important historic heritage located in southeastern Türkiye is Gaziantep Castle (Figure 11.5). Unfortunately, Gaziantep to the epicenter of the first earthquake is only about 32 km and the second earthquake is about 115 km distance. The orientation of the castle walls to the earthquake epicenter may be the reason of south-west castle walls to suffer the largest damage when the first impact

must have pushed these walls and sending wall stones towards the slope towards the city. It is fortunate that the castle wall stones did not cause major damage to people, houses, businesses at the skirts of the castle. The castle being located at the top of a hill may also had lens action amplifying the pga and damaging effects of the earthquakes.

Figure 11.5. Gaziantep Castle before and after the earthquakes.

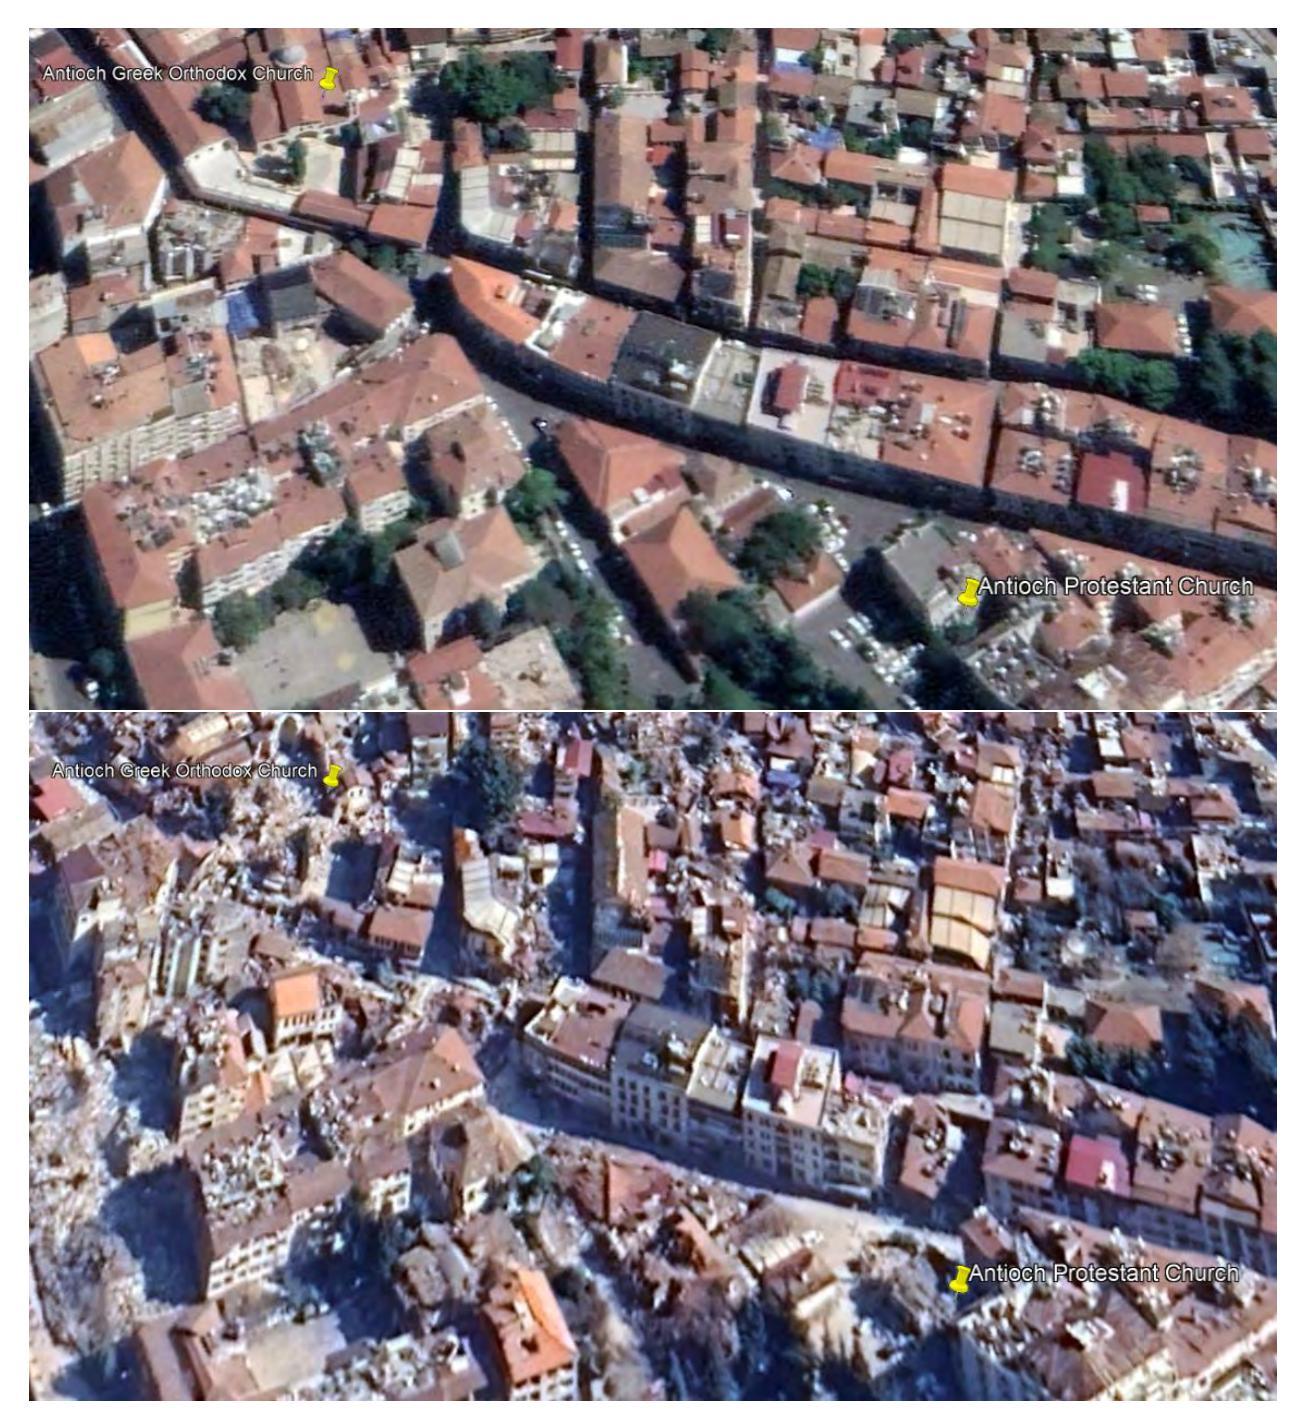
Last examples of historic structures were selected from Hatay region. The Antakya Rum Orthodox Church (Antioch Greek Orthodox Church) and Antakya Protestant Church are located very close to each other within 150 meters, and both suffered significant damage during the earthquakes. The distances between the churches and the first and second earthquakes are about 135 km and 225 km respectively. Satellite images before and after the earthquakes (Figure 11.6) <sup>8</sup> indicate that both structures suffered immense damage. The after-earthquake picture of the Antakya Rum Orthodox Church (Figure 11.7) shows total roof collapse while only west wall and partial south cylindrical walls are standing. The collapsed picture of the Antakya Rum Orthodox Church also shows roof collapse with probably south wall collapse. The epicenter to the historic structures' distances are comparable between Malatya and Hatay, both cities with significant damage to their historic buildings. Majority of the mosques showed acceptable performance in Malatya (exception of Yeni Cami) while both studied churches suffered major damage in Hatay.

Figure 11.6. The Antakya Rum Orthodox and Protestant Churches Before and After Earthquakes

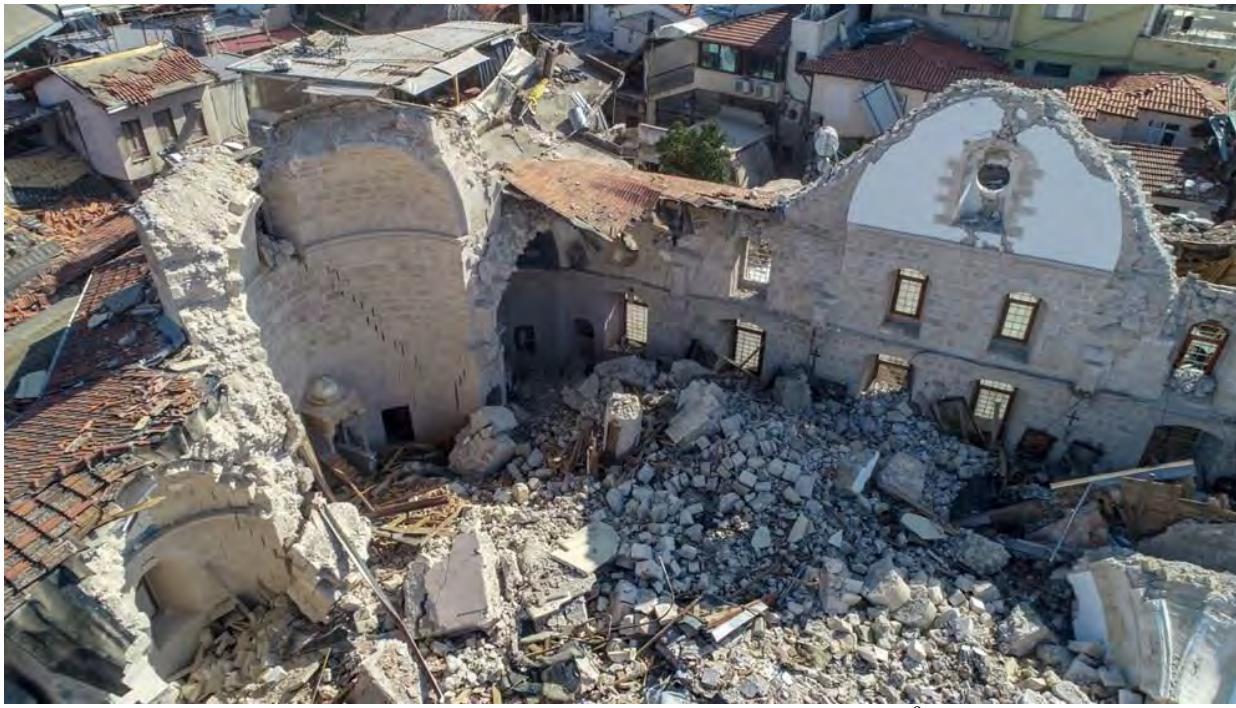
Figure 11.7. The Antakya Rum Orthodox Church after the earthquake <sup>9</sup>

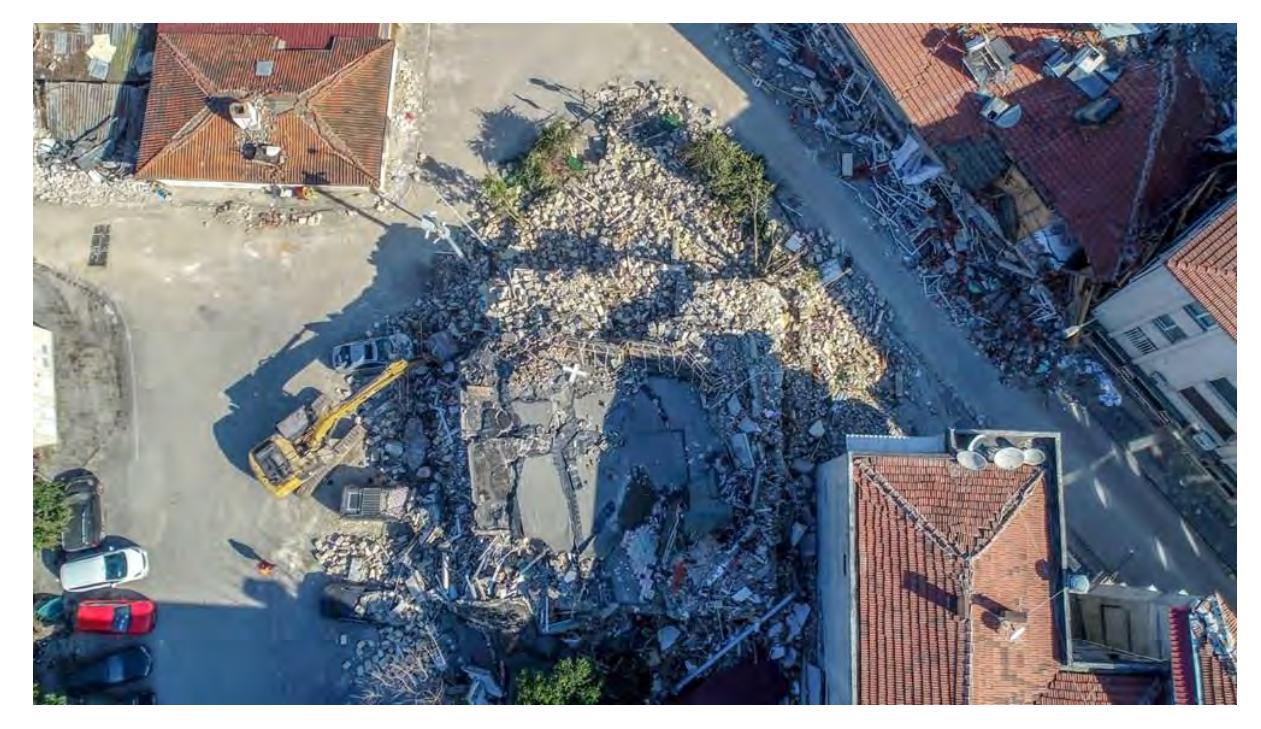
Figure 11.8. The Antakya Rum Protestant Church after the earthquake <sup>10</sup>

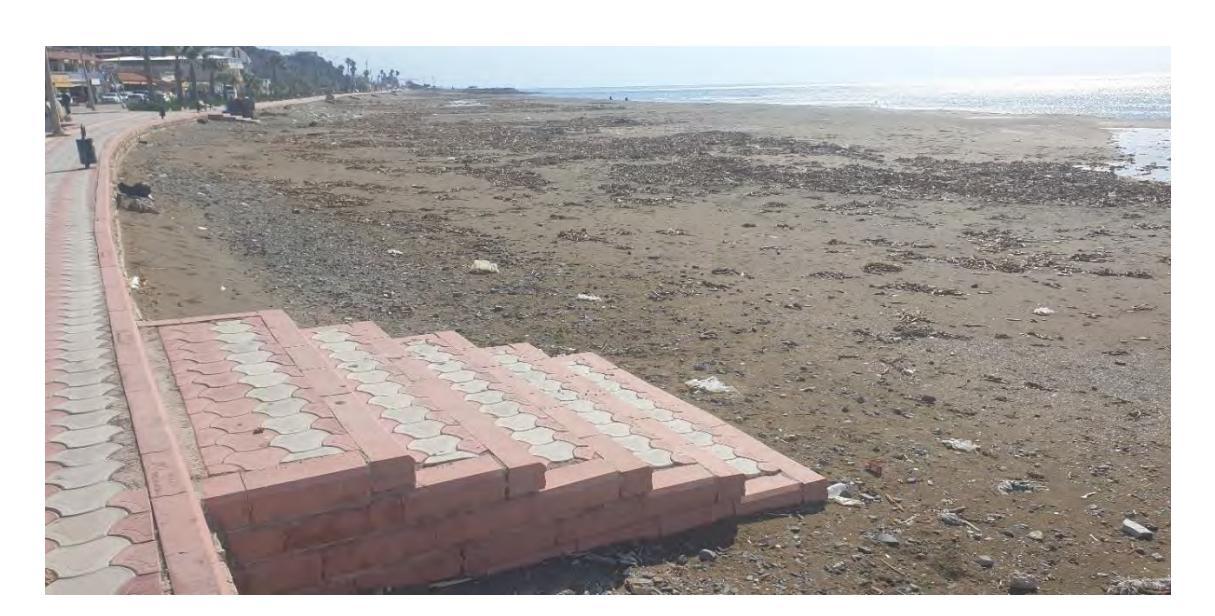
Some of the pictures taken during the field survey are also presented in Figures 11.4, 11.5 and 11.6. Figure 12.4 shows the traces of the coastal inundation observed in the morning after the earthquake near the Samandag fishery port at Cevlik village. Figure 12.5 shows the damages to the coastal structure and the pier of Iskenderun fishery port, which are the results of the coastal subsidence at the reclamation area, backside of the fishery port and nearby coastal region. Figure 12.6 shows the damages to the coastal structure in Dortyol fishery port.

Figure 12.4. Coastal Inundation and traces, South of Samandag-Cevlik Fishery Port

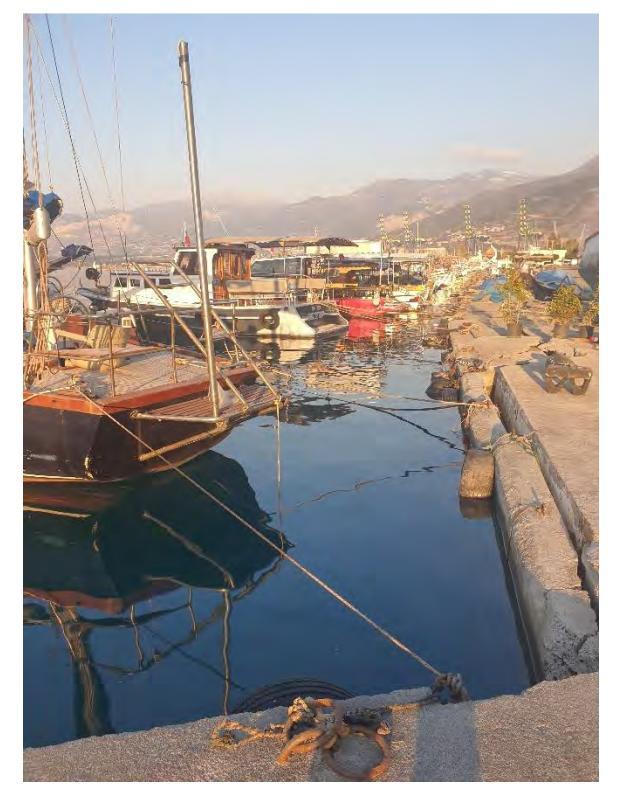
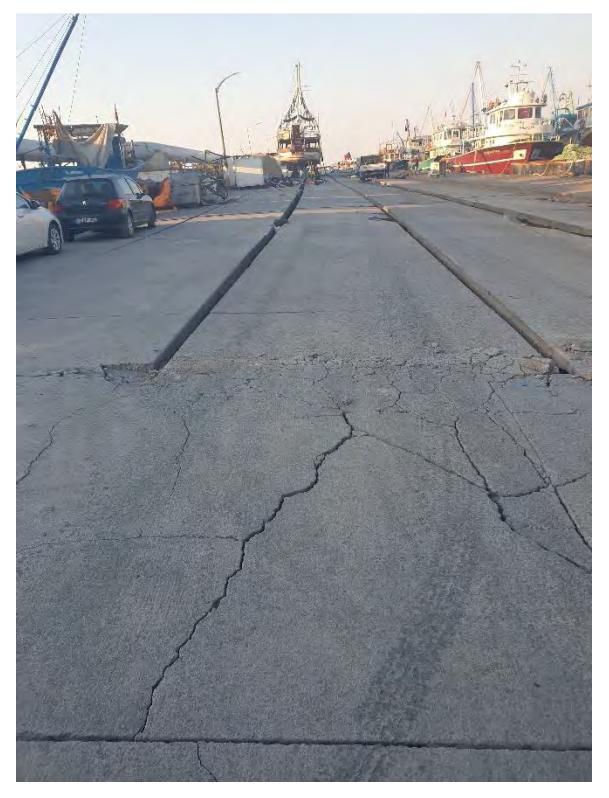
Figure 12.5. Structural damage at Iskenderun Fishery Port

Days after the earthquake, considerable water inundation has been observed behind and on the eastern side of the Iskenderun Fishery port, which has drawn the attention of the general public to consider the tsunami as a reason. However, the observations and evidence obtained during the field survey clearly identified that the reason was the subsidence of the coastal area behind the fishery port during the earthquake shaking most probably due to the liquefaction or similar means. During high tide (because of full moon days), seawater gradually invaded the subsided area and could not be drained because of collapsed surface water drainage system. Therefore, the phenomenon that occurred in the area is the gradual invasion of seawater by the high tide during the full moon phase to the area, where the ground subsided considerably.
