# Türkiye Earthquake

## **RECONNAISSANCE REPORT**

February 6, 2023 Kahramanmaraş-Pazarcık ( $M_w$ =7.7) and

Elbistan (M<sub>w</sub>=7.6) Earthquakes

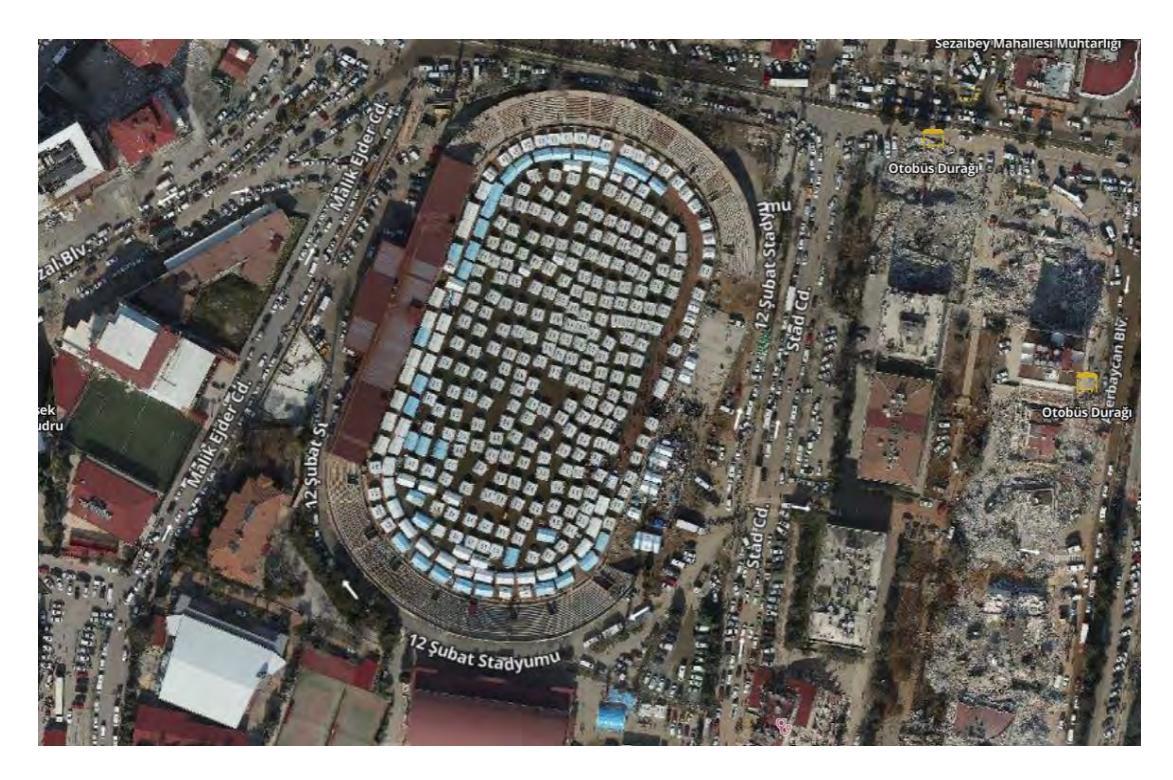
To provide detailed information on emergency and temporary housing, the data obtained from AFAD's Twitter account (AFAD, 2023b) were examined. On 8 February 2023, AFAD (2023b) established tents on the field of 12 Şubat Stadium in Kahramanmaraş. However, the video published by AFAD (2023b) on Twitter and HGM Atlas (2023) shows that tents were located without a settlement plan, which indicates a planning problem (Figure 13.5). On the site visit done by the authors on 25 February 2023 to the 12 Şubat Stadium, it is observed that people who are

responsible for the settlements were trying to change the settlement plan according to the minimum dimension between the tents to avoid fire.

**Figure 13.5.** Established tents on the field of 12 Şubat Stadium in Kahramanmaraş (HGM Atlas, 2023)

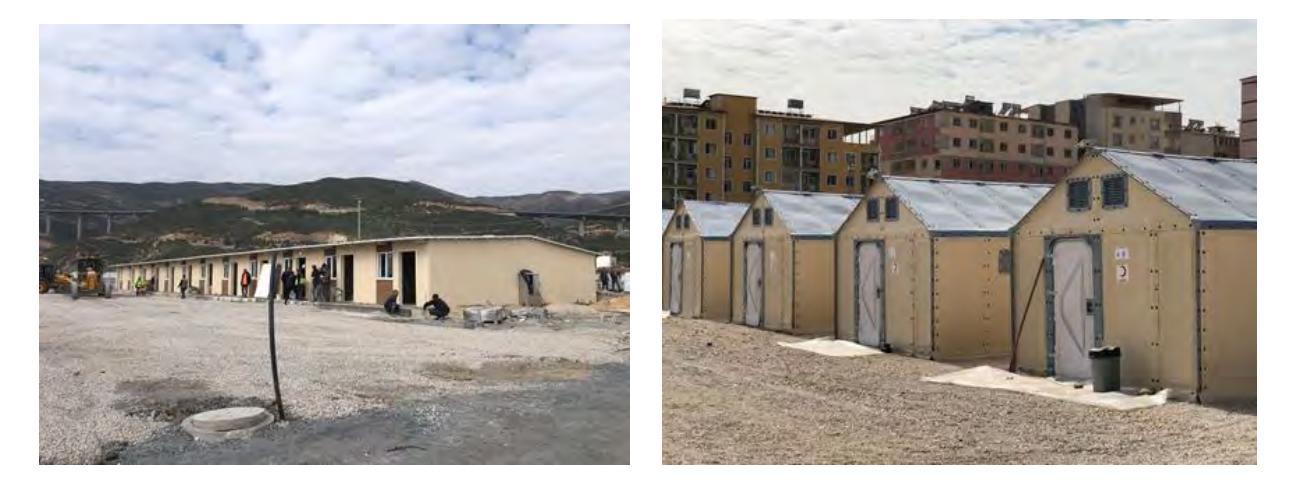
**Figure 13.6.** Left: Temporary houses constructed by TOKİ in Nurdağı; Gaziantep; Right: Better Shelter Settlement in Hassa, Hatay, photographed by Nil Akdede and Özay Özaydın
