SDSU STRUCTURAL ENGINEERING RESEARCH PROJECT

Report No. SERP - 23/03

Reconnaissance Report of Observed Structural Bridge Damage

M_w 7.8 Turkiye (Turkey) Earthquake of 2023

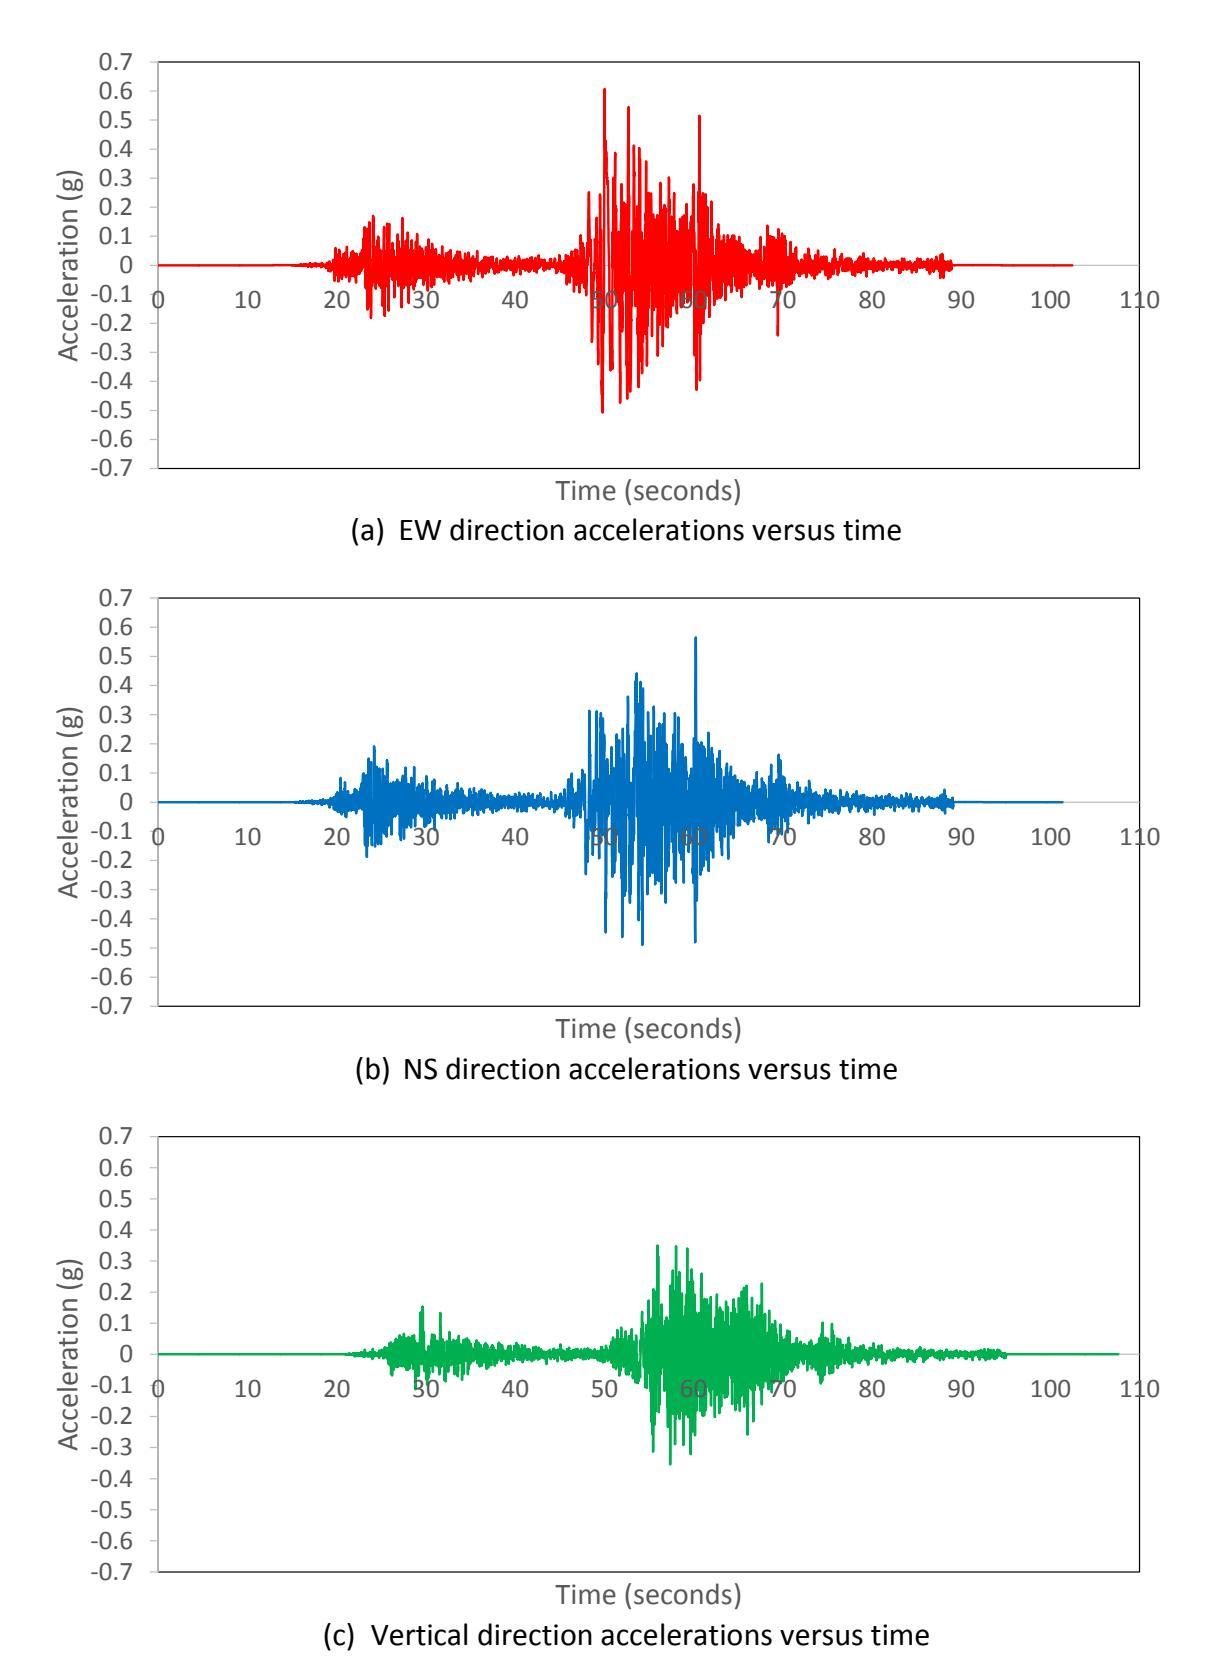
Station 2712 was the closest strong motion station to Bridge 1 - 2.00 miles (3.21 km) away. Free-field ground accelerations from Station 2712 during the M_w 7.8 earthquake in the horizontal East-West (EW) and North-South (NS) directions are given in Figs. 3-1a and b, respectively. Peak horizontal ground accelerations (PGA) are 0.607 g for the EW direction and 0.565 g in the NS direction, with PGA of 0.354 g in the vertical direction, as seen in Fig. 3-1c. The 5%-damped spectral acceleration graphs for the EW and NS directions are given in Fig. 3-2a, with maximum values of 1.83 g and 1.90 g, respectively. Also shown in Fig. 3-2a is the smoothed Caltrans, 5%-damped bridge design spectral curve for a M_w 8 earthquake (plus or minus M_w 0.25) having PGA of 0.7 g and a rock or stiff soil profile [10], with maximum value of 1.82 g. This Caltrans design curve was obtained from an earlier version of the Caltrans Seismic Design Specifications (SDC) [10] since the latest version of the SDC [8] does not have such a graph readily available for stiff soil and rock sites. Vertical spectral accelerations are given in Fig. 3-2b, with maximum value of 1.37 g.

Fig. 3-1. Station 2712 for Bridge 1, M_w 7.8 earthquake, measured accelerations in all three directions

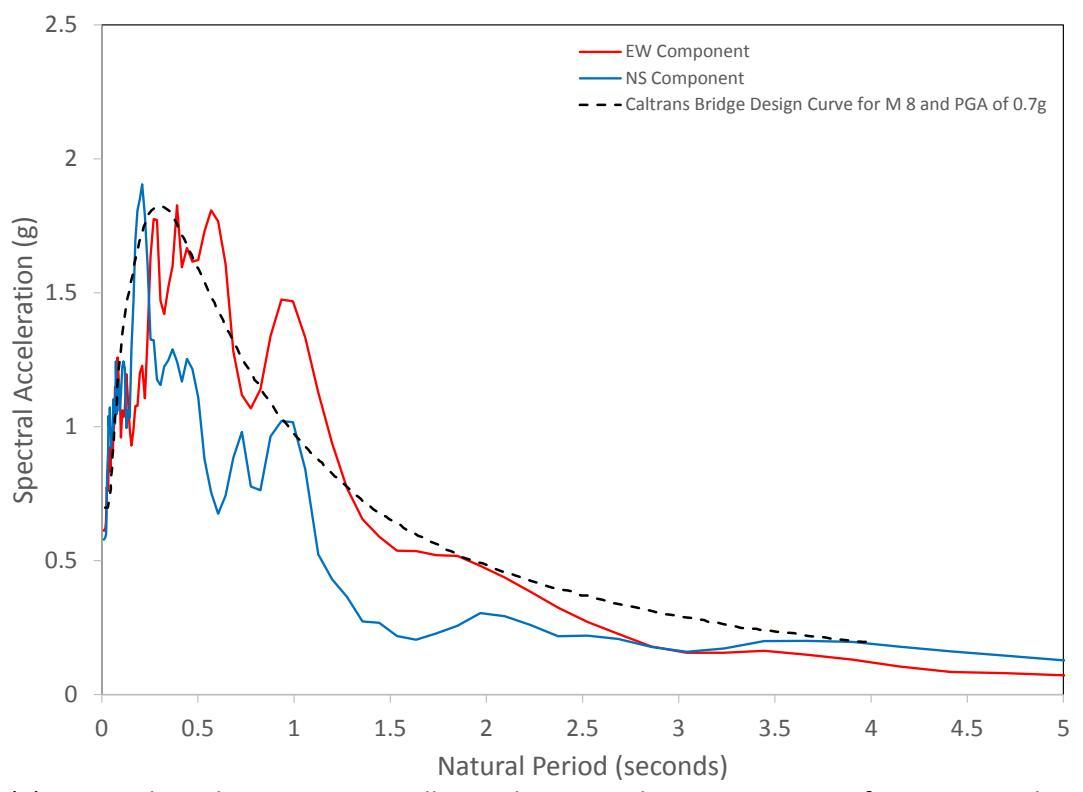
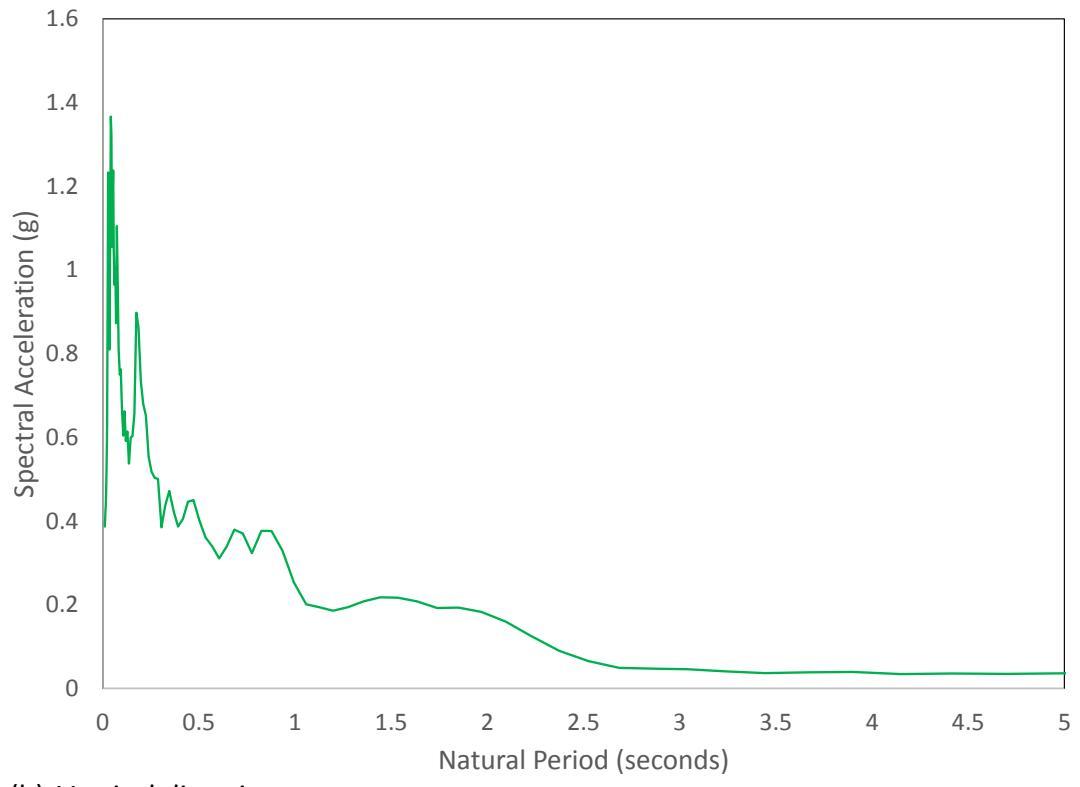
Fig. 3-2. Station 2712 for Bridge 1, M_w 7.8 earthquake 5% damped spectral accelerations

(a) EW and NS directions, as well as Caltrans Bridge Design Curve for M_w 8 earthquake with PGA of 0.7 g at a rock or stiff soil site

(b) Vertical direction

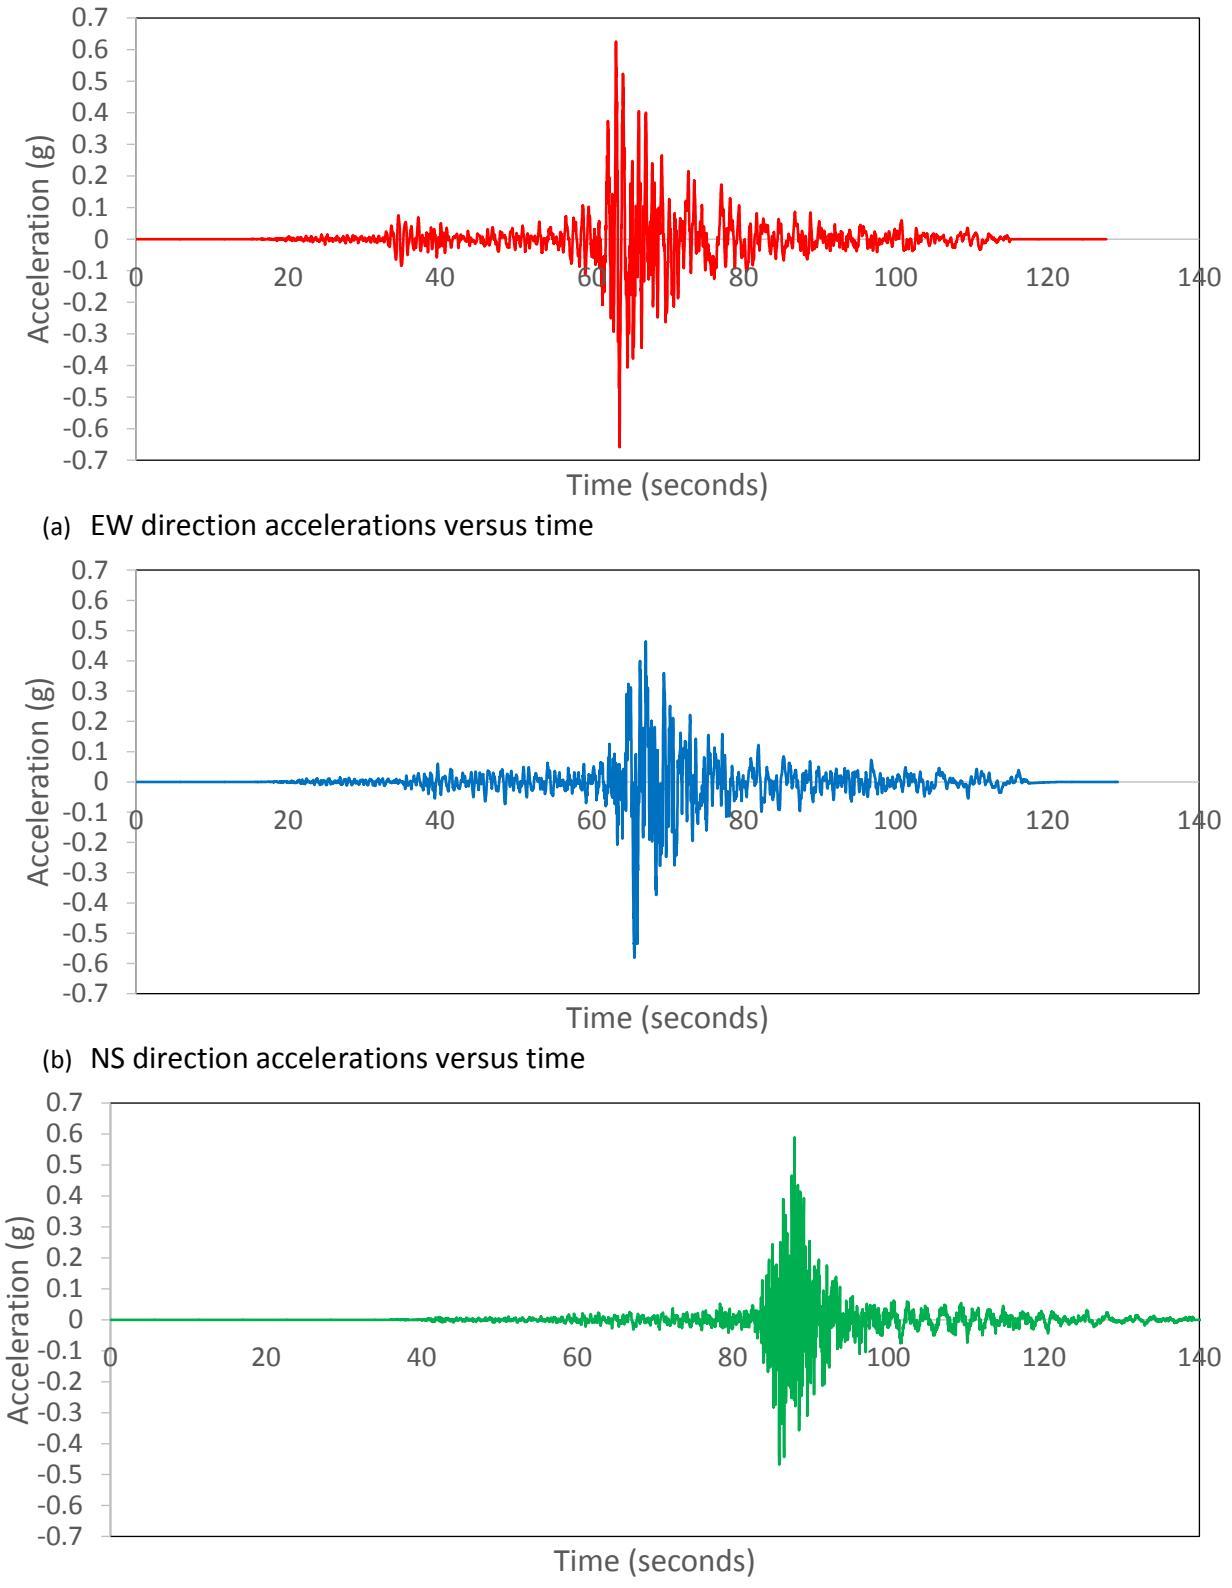
Station 3124 was the closest strong motion station to both Bridges 2 and 3 at 2.14 miles (3.44 km) from Bridge 2 and 2.33 miles (3.75 km) from Bridge 3. Recorded accelerations versus time at this station from the M_w 7.8 earthquake are given in Figs. 3-3a and b for the horizontal EW and NS directions, respectively. PGAs are 0.659 g in the EW direction and 0.581 g in the NS direction, as seen in Figs. 3-3a and b. In the vertical direction the PGA was 0.589 g (Fig. 3-3c). Acceleration spectra results with 5% damping are given in Fig. 3-4a for the two horizontal directions as well as the Caltrans bridge design curve for M_w 8. The vertical direction spectrum is given in Fig. 3-4b. By comparing the horizontal acceleration spectra developed from ground motions measured at Station 3124 to the smoothed Caltrans bridge design acceleration spectrum for M_w 8 and PGA of 0.7 g at a rock or stiff soil site, it is clear that Station 3124 must have a deep layer of soft soil beneath it (or soft soil from the earthquake epicenter to the station) for the peak spectral responses to shift to such long natural structural periods (Fig. 3-4a). This is seen in both EW and NS directions.

(c) Vertical direction accelerations versus time

Fig. 3-3. Station 3124 for Bridges 2 and 3, M_w 7.8 earthquake, measured accelerations in all three directions

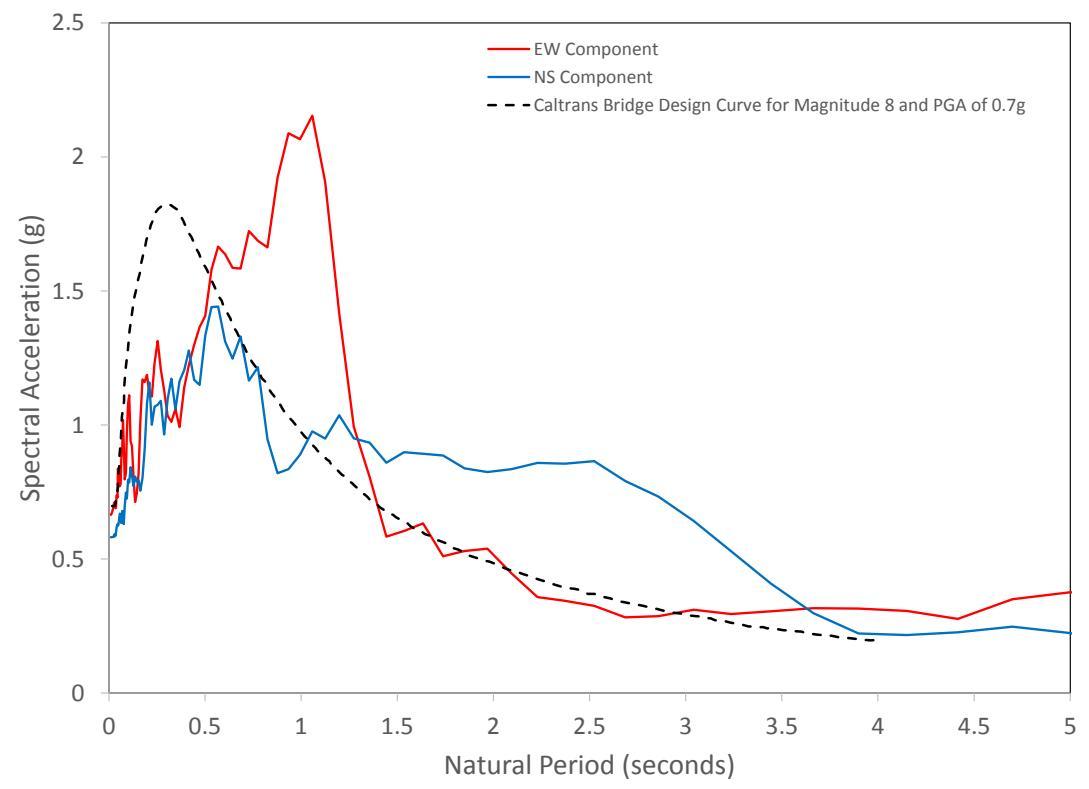
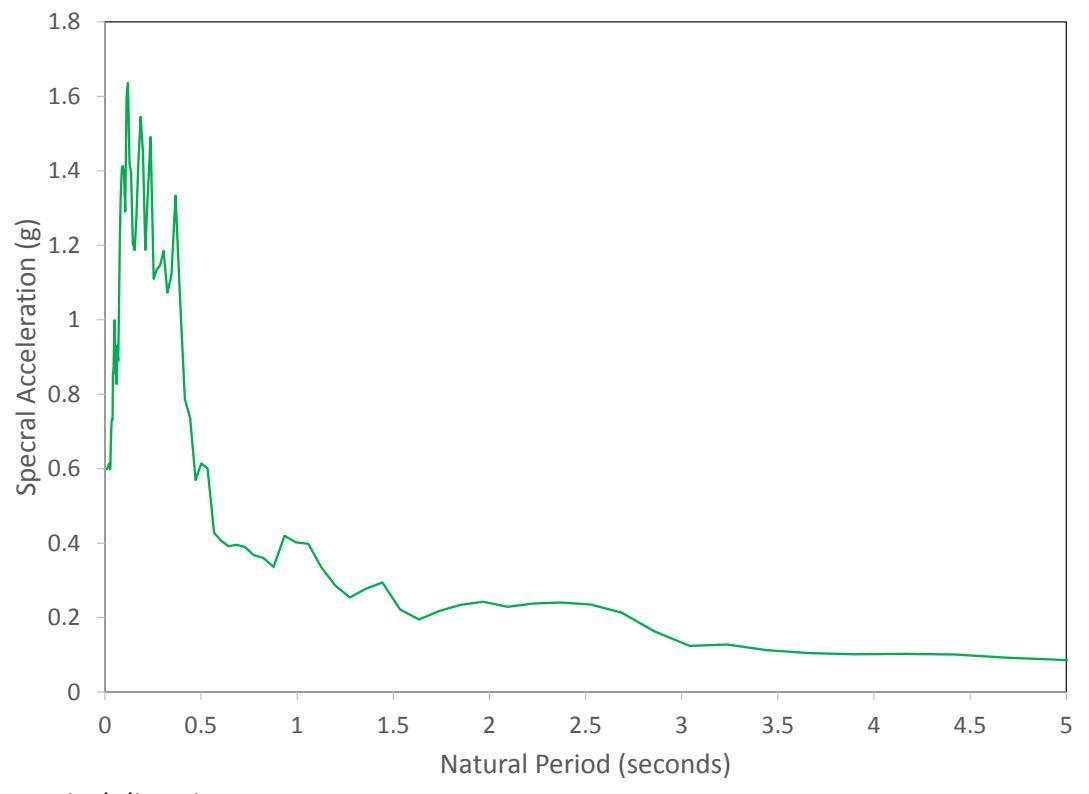
Therefore, Bridges 2 and 3 are probably on deep, soft soil. In the EW direction the maximum spectral acceleration of 2.15 g (Fig. 3-4a) was greater than the maximum value of 1.82 g from the smoothed Caltrans design curve for M_w 8 earthquakes (Fig. 3-4a), demonstrating the intense level of shaking that occurred at Bridges 2 and 3. For the NS direction, the maximum spectral value was 1.44 g (Fig. 3-4a). In the vertical direction, the peak spectral acceleration was 1.64 g, which is important as it implies that the precast girders of both Bridges 2 and 3 lifted off of their simple supports and slammed back down, multiple times, significantly contributing to the observed damage discussed below for both of these bridges, especially for Bridge 2.

(a) EW and NS directions, as well as Caltrans Bridge Design Curve for M_w 8 earthquake with PGA of 0.7 g at a rock or stiff soil site

(b) Vertical directions Fig. 3-4. Station 3124 for Bridges 2 and 3, M_w 7.8 earthquake 5% damped spectral accelerations

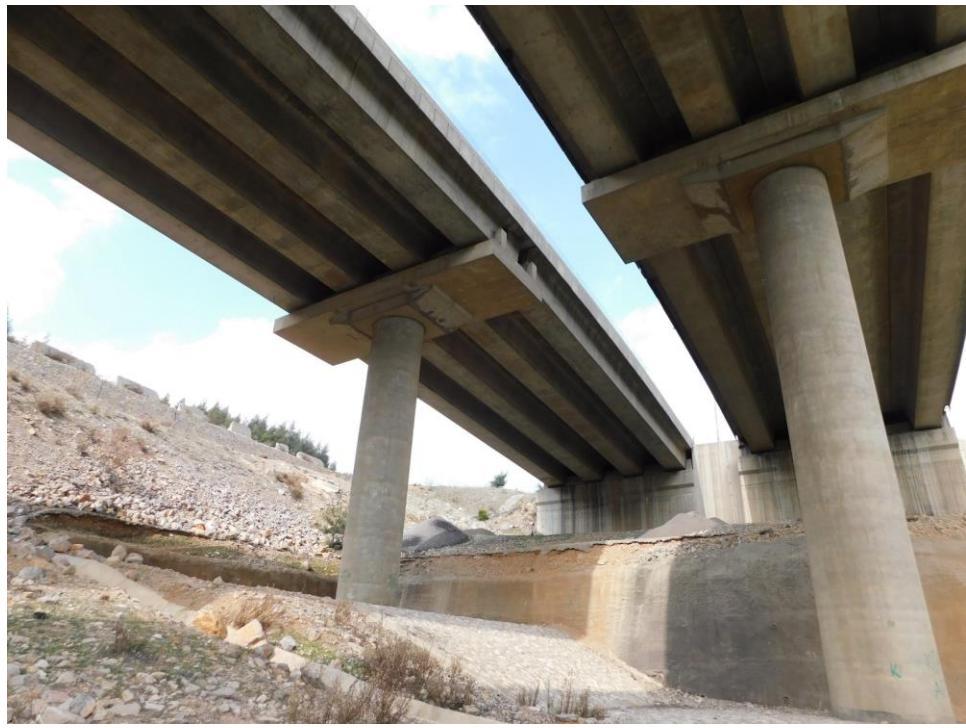
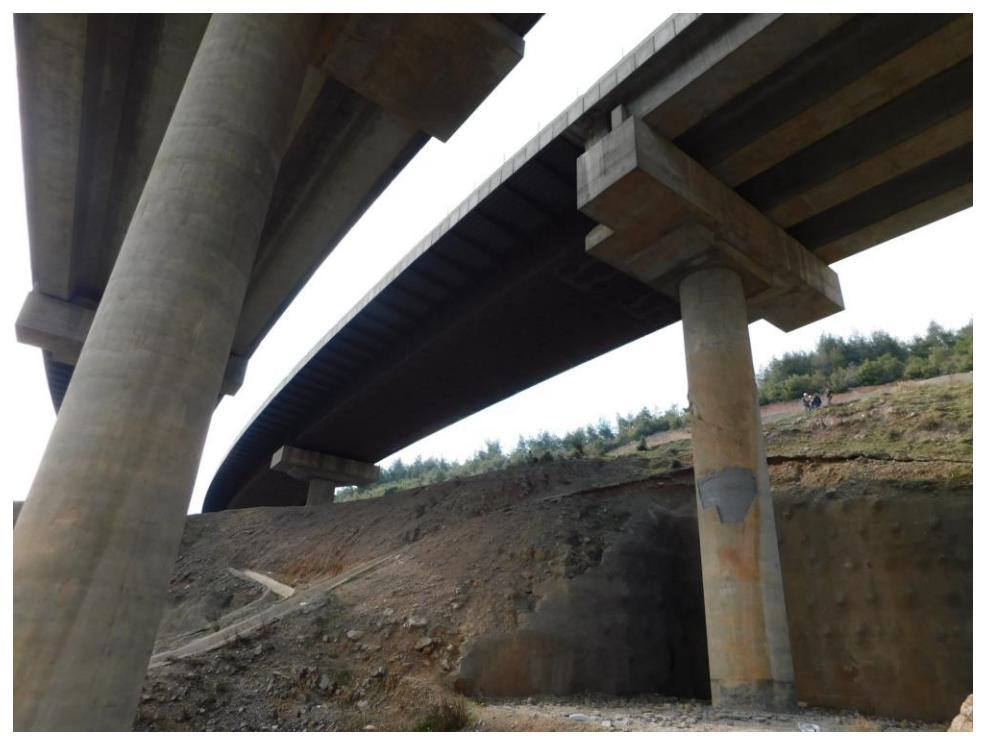
Fig. 4.1-2. Overall view of parallel and curved structures of Bridge 1

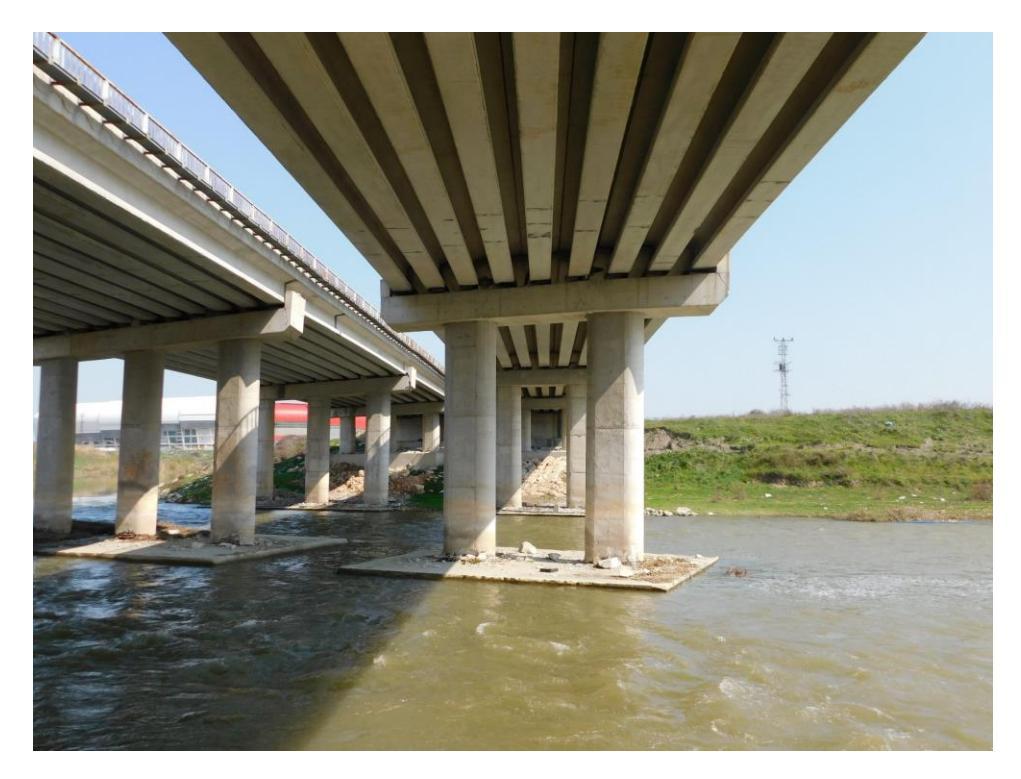
These two parallel and straight bridges are over water and located at GPS coordinates N 36.25505^o E 36.20430^o and elevation of 315 feet. They consist of precast, prestressed, I-girders with RC topping slab and RC columns (Fig. 4.2-1).

Fig. 4.2-1. Overall view from under Bridge 2

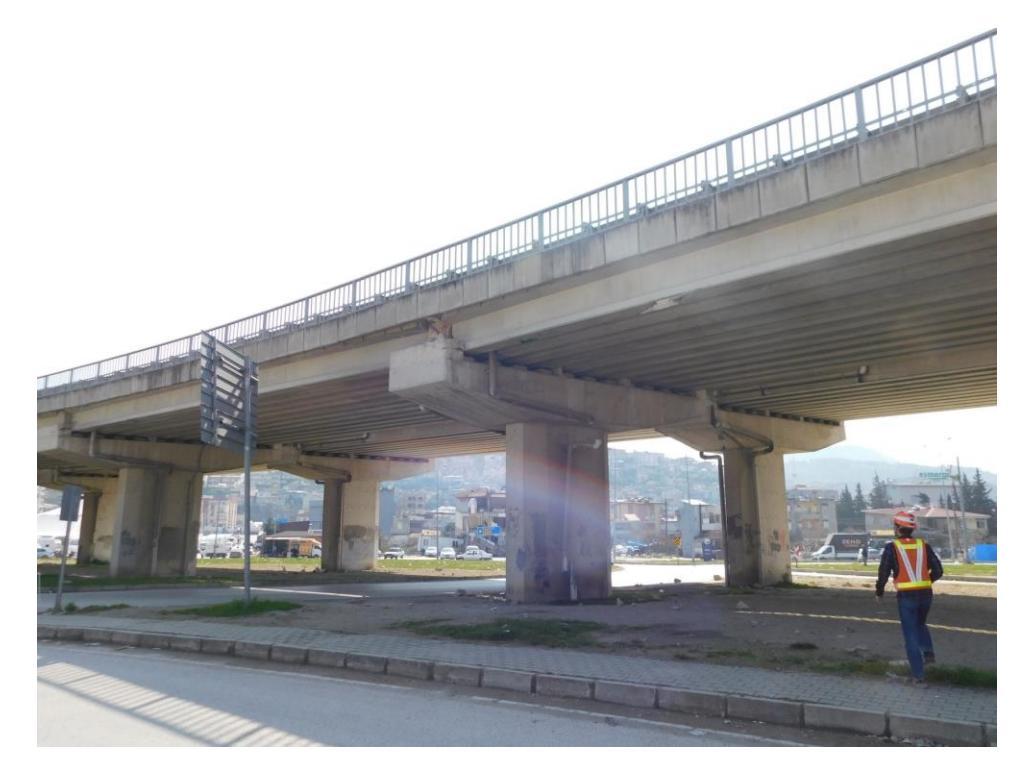
These two parallel and curved bridges have six-spans with 11 precast, prestressed, lgirders per span and RC columns (Figs. 4.3-1 and 4.3-2), located at GPS coordinates N 36.24060⁰ E 36.21406⁰ and elevation of 336 feet. Damage observed for Bridge 3 includes cracking and spalling at the ends of the precast girders (Figs. 4.3-3 and 4.3-4), as well as failure of external (Fig. 4.3-5) and internal shear keys (Fig. 4.3-6). The maximum vertical acceleration recorded for this bridge was 0.589 g, with peak vertical spectral acceleration of 1.64 g. This indicates that the shear forces at the ends of the simply-supported precast girders were much larger than from just the static dead load of the structure, and that the girders were lifting off of the supports and slamming back down, resulting in impact shear forces that were larger than the girders were designed for, causing the shear cracking and concrete spalling seen at the girder ends (Figs. 4.3-3 and 4.3-4), which is similar to, but not as severe as, what was observed at Bridge 2.

Fig. 4.3-1. Overall view of Bridge 3

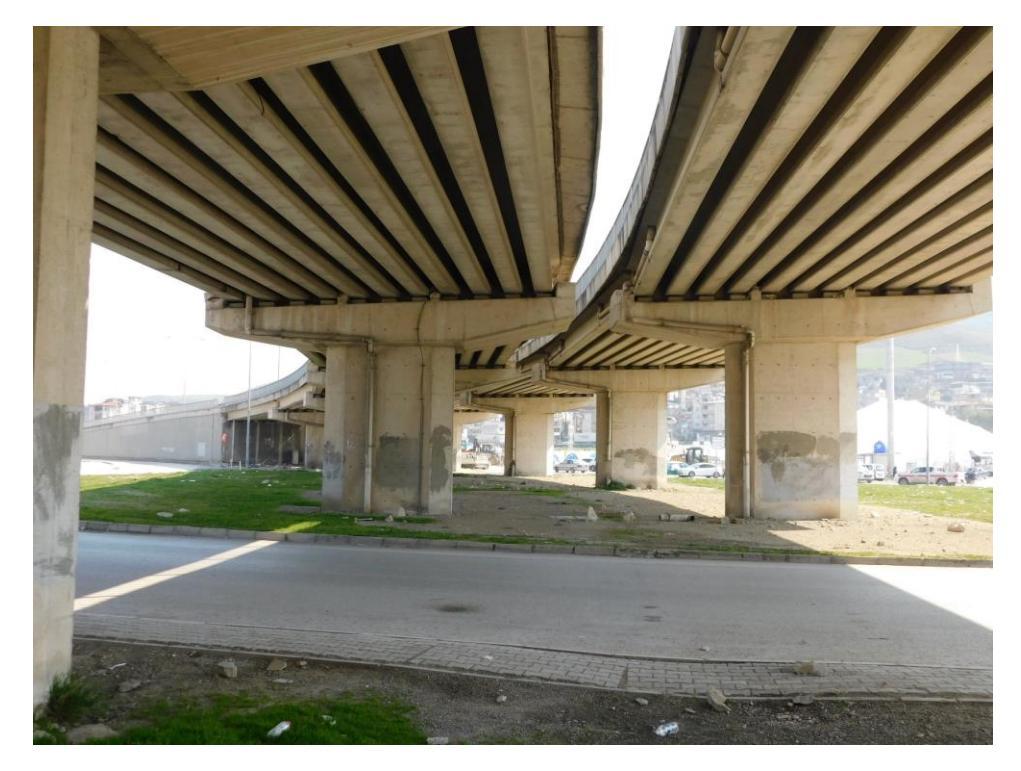
Fig. 4.3-2. View under Bridge 3, showing 11 precast I-girders per span for each bridge
